COLORADO DIVISION OF RECLAMATION, MINING AND SAFETY
MINERALS PROGRAM INSPECTION REPORT
PHONE: (303) 866-3567

MINE NAME: Luke the Duke Gravel Pit	MINE/PROSPECTING ID#: M-2013-036	MINERAL: Gravel	COUNTY: La Plata
INSPECTION TYPE: Monitoring	INSPECTOR(S): Wallace H. Erickson	INSP. DATE: October 9, 2014	INSP. TIME: 14:00
OPERATOR: LUKE THE DUKE, LLC	OPERATOR REPRESENTATIVE: John Avery	TYPE OF OPERATION: 110c - Construction Limited Impact	
REASON FOR INSPECTION: Normal I&E Program	BOND CALCULATION TYPE: Partial Bond	BOND AMOUNT: \$14,631.48	
DATE OF COMPLAINT: NA	POST INSP. CONTACTS: None	JOINT INSP. AGENCY: None	
WEATHER: Raining	INSPECTOR'S SIGNATURE:

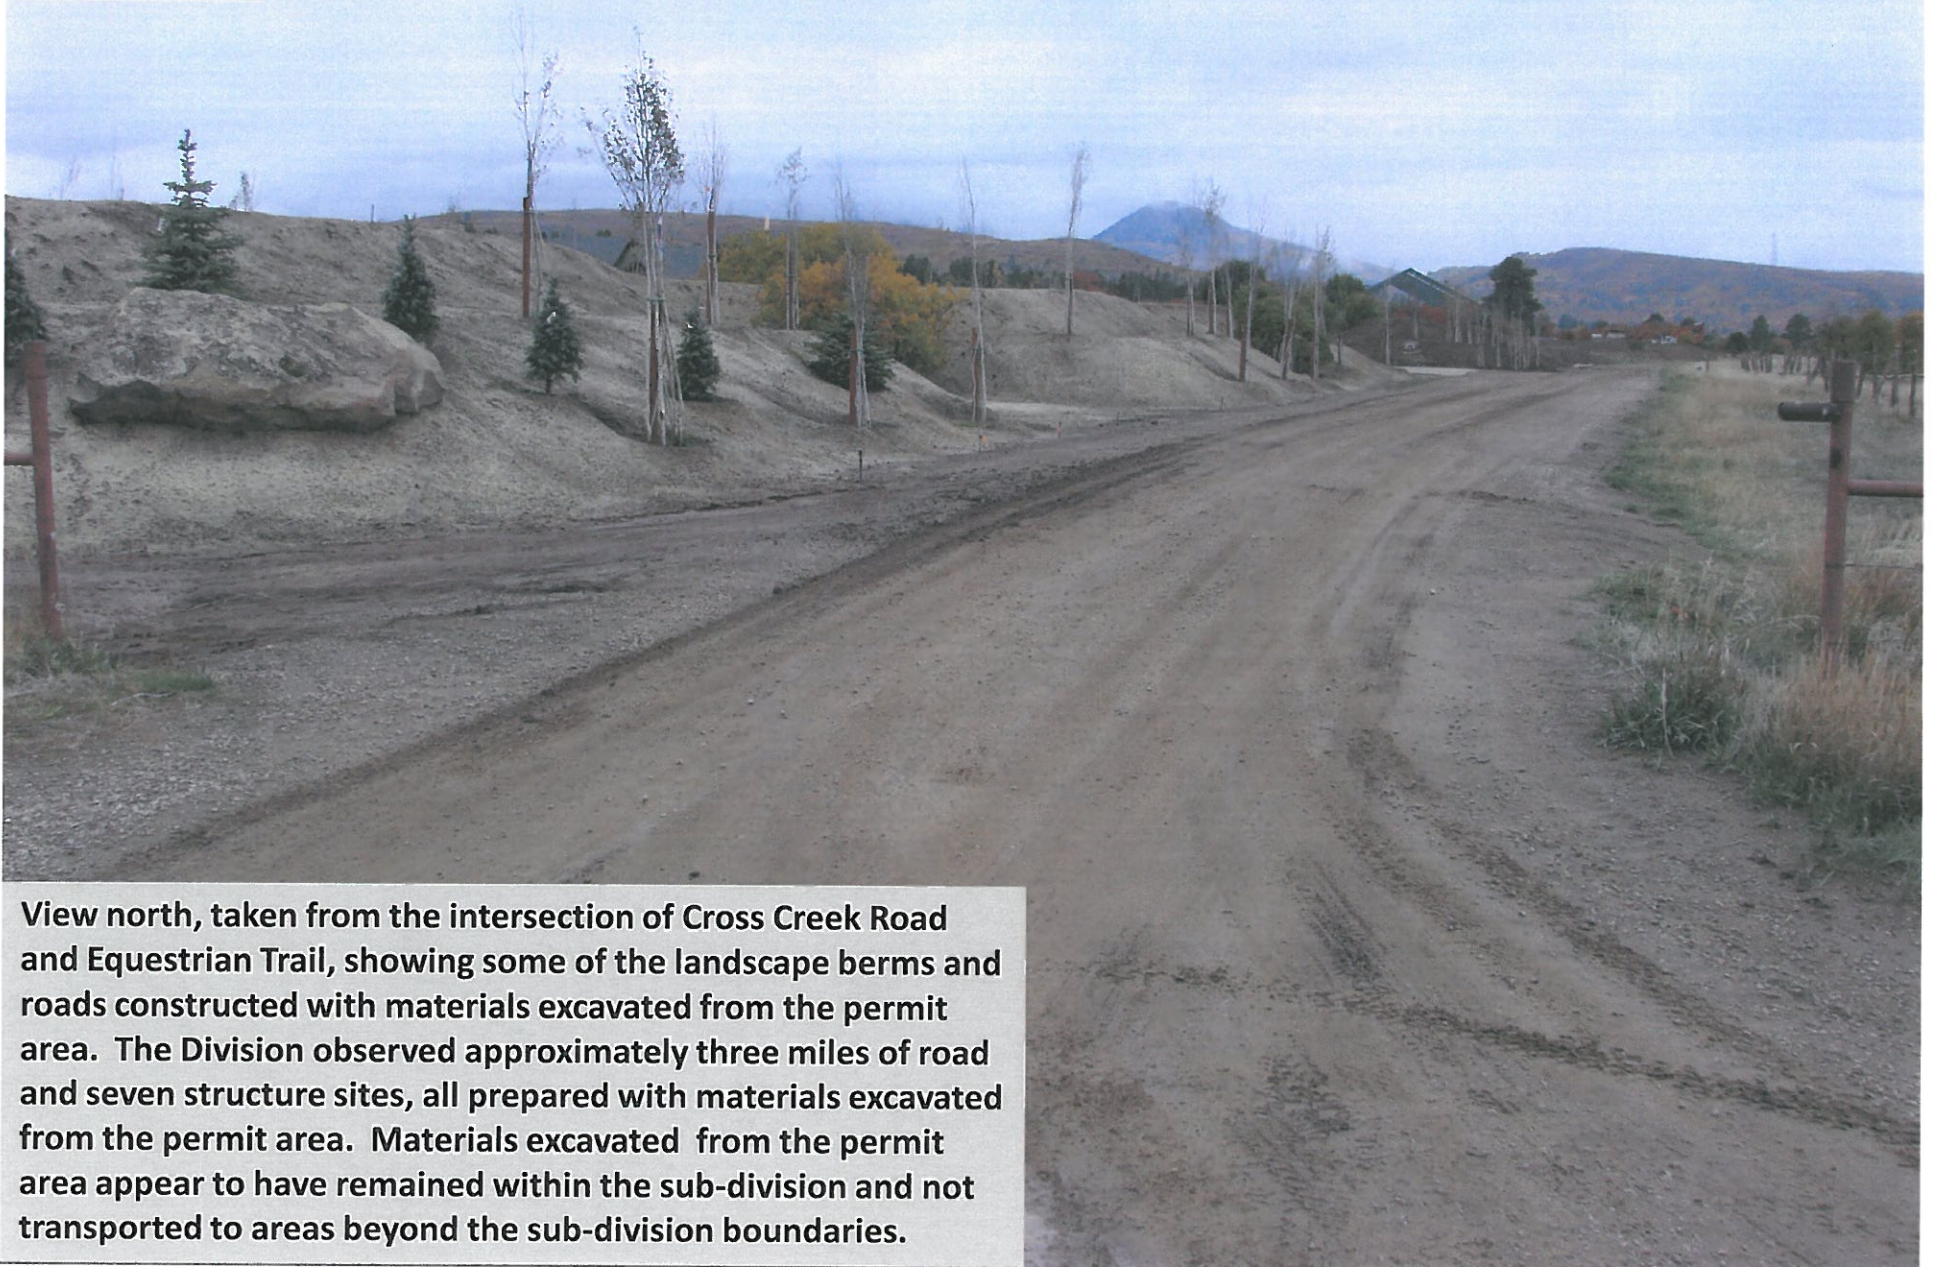
Luke the Duke
M-2013-036
October 9, 2014
Photo 1

View north, taken from the intersection of Cross Creek Road and Equestrian Trail, showing some of the landscape berms and roads constructed with materials excavated from the permit area. The Division observed approximately three miles of road and seven structure sites, all prepared with materials excavated from the permit area. Materials excavated from the permit area appear to have remained within the sub-division and not transported to areas beyond the sub-division boundaries.

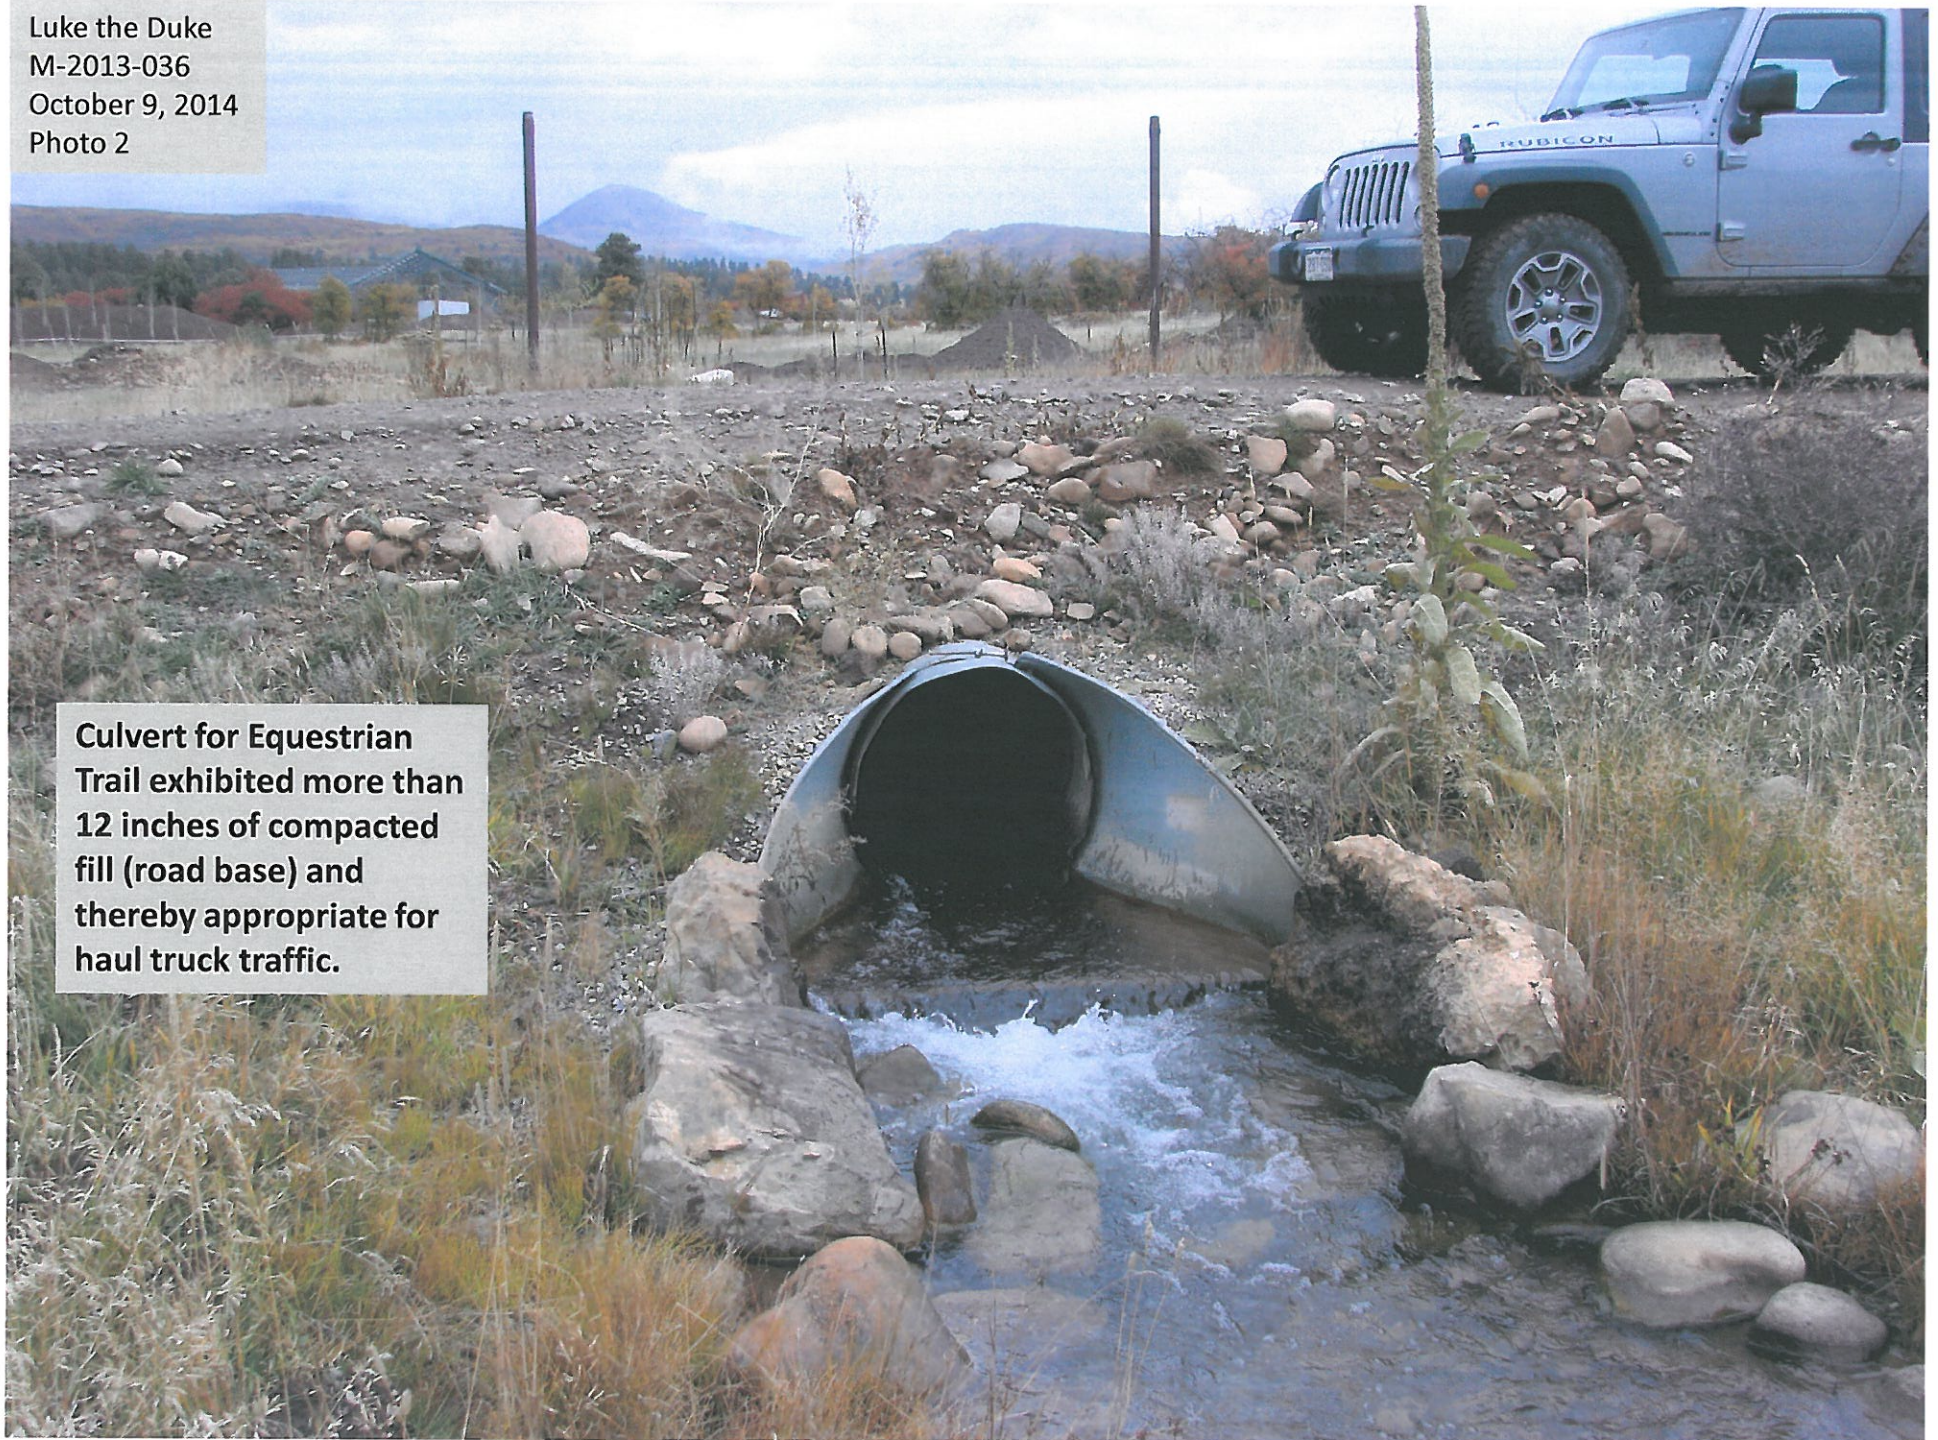
Luke the Duke
M-2013-036
October 9, 2014
Photo 2

Culvert for Equestrian Trail exhibited more than 12 inches of compacted fill (road base) and thereby appropriate for haul truck traffic.

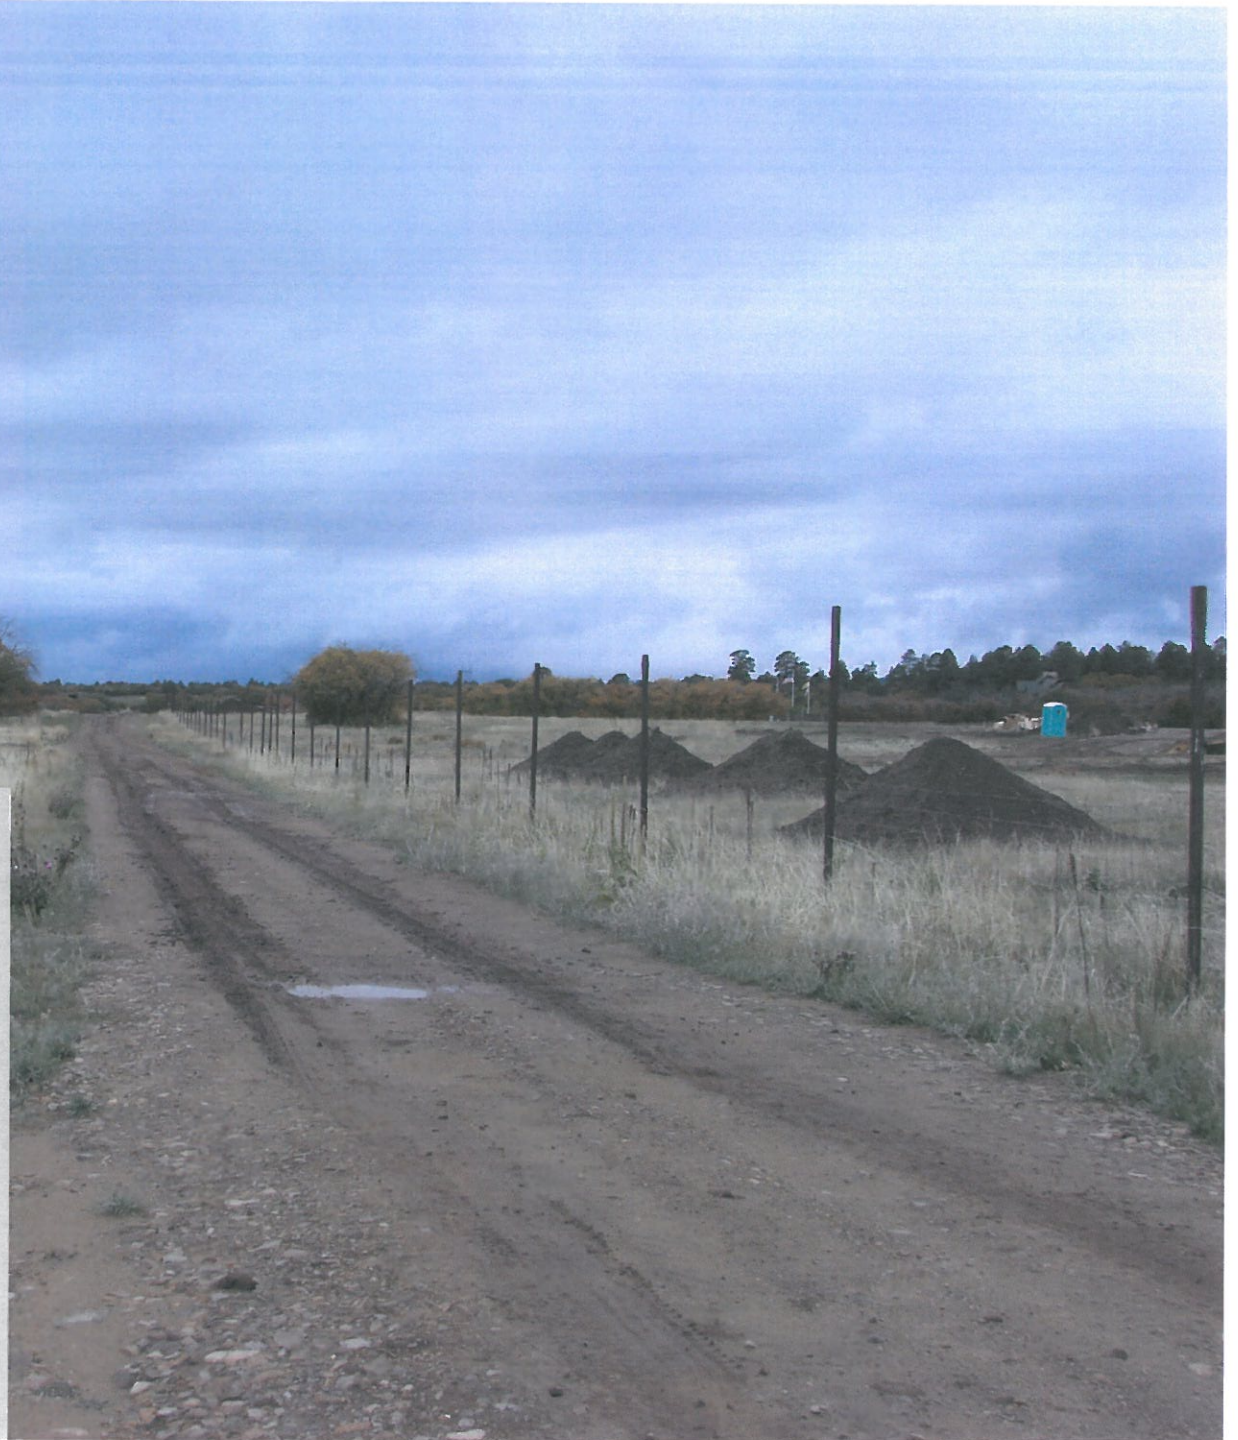
Luke the Duke
M-2013-036
October 9, 2014
Photo 3

View west, showing portions of Equestrian Trail located nearby the permit area and still under construction. Construction of the first 230 feet of Equestrian Trail, from the intersection of Cross Creek Road (Photo 1) to the culvert (Photo 2), appeared to be complete. However, the subsequent 1,230 feet of Equestrian Trail, from the culvert to the permit area, was established with three inch minus road base and did not yet exhibit a top coat of $\frac{3}{4}$ inch gravel. The Operator was constructing Equestrian Trail with materials excavated from the permit area.

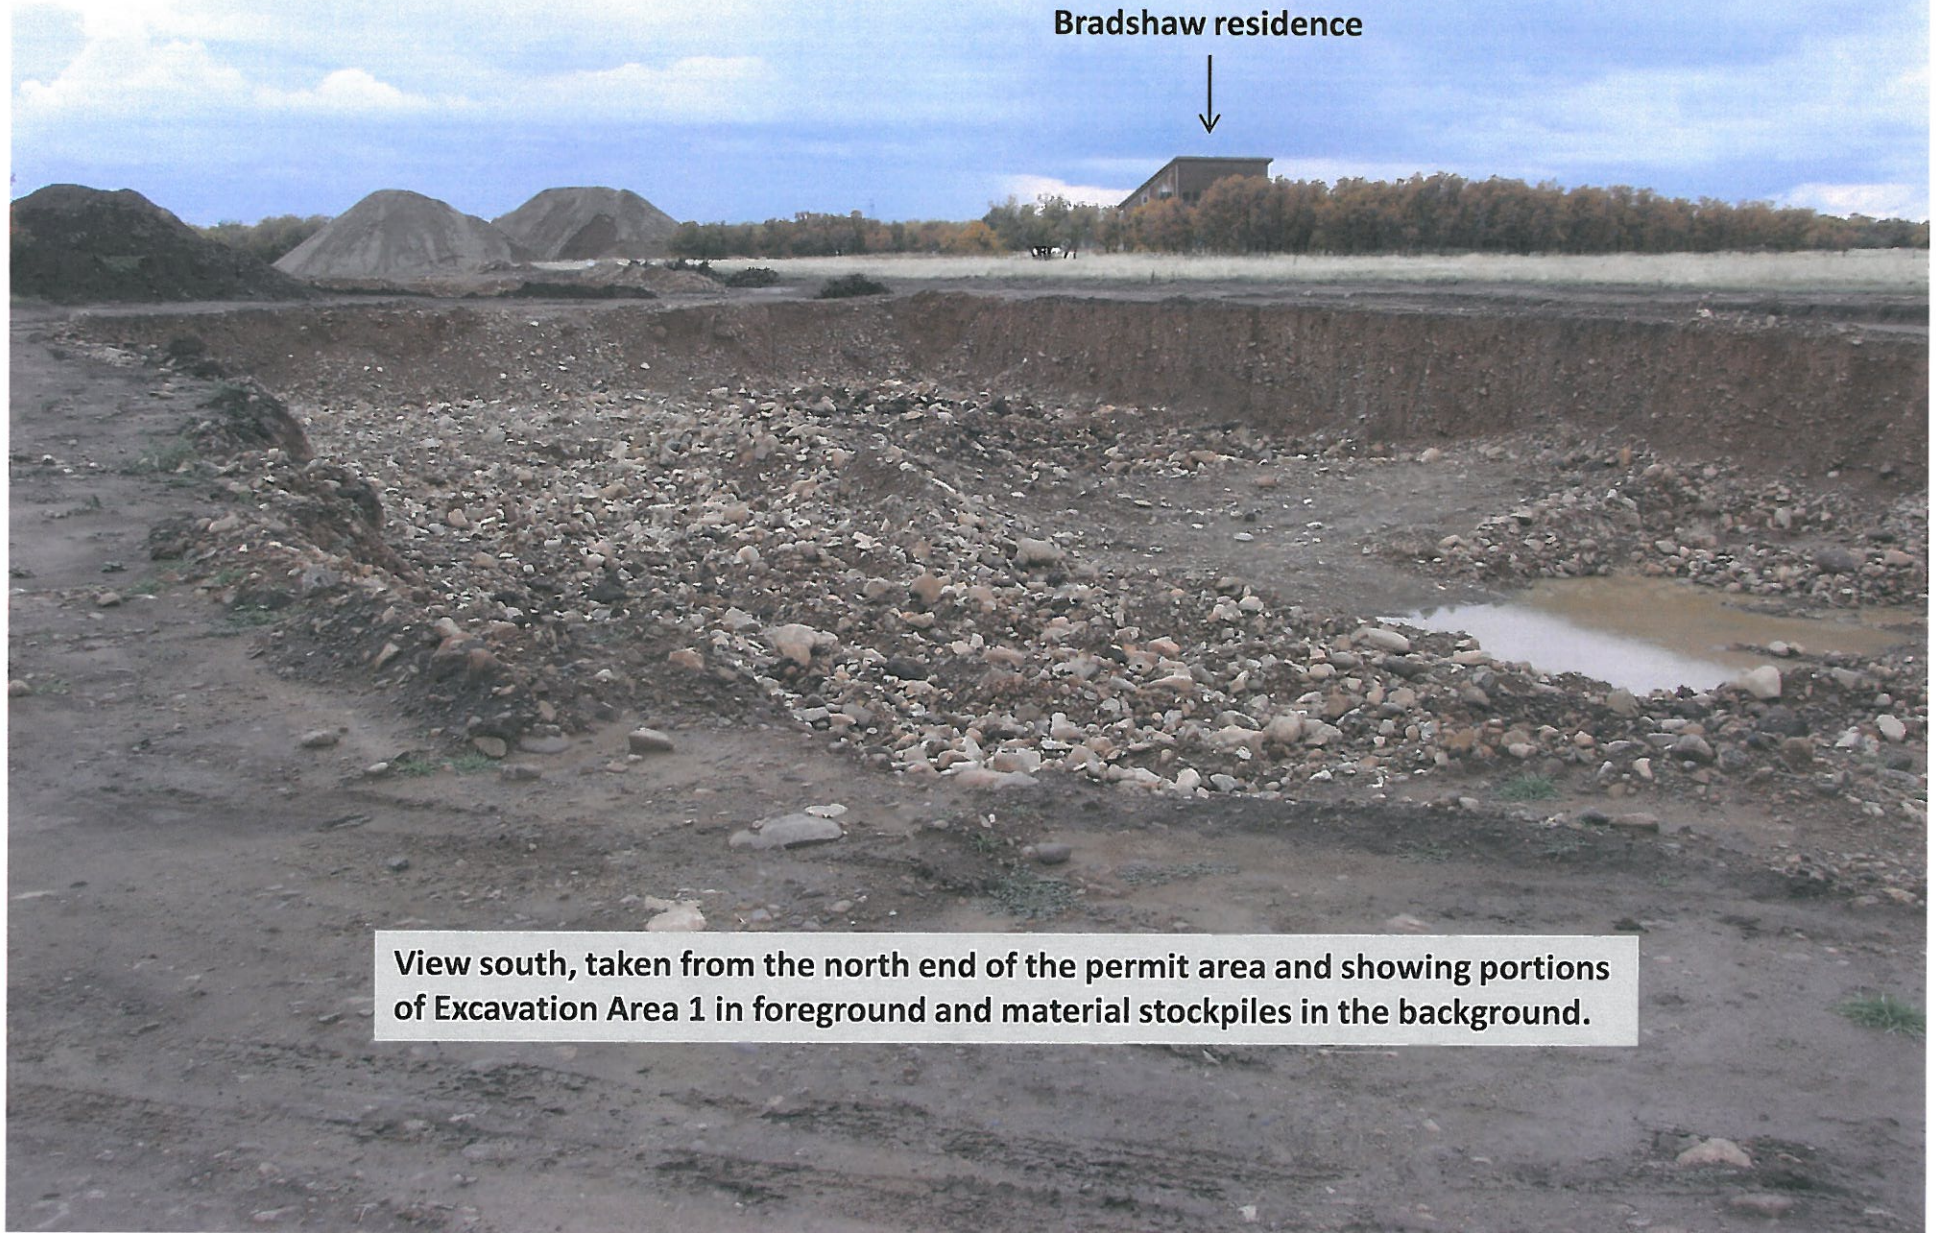
Luke the Duke
M-2013-036
October 9, 2014
Photo 4

View south, taken from the north end of the permit area and showing portions of Excavation Area 1 in foreground and material stockpiles in the background.

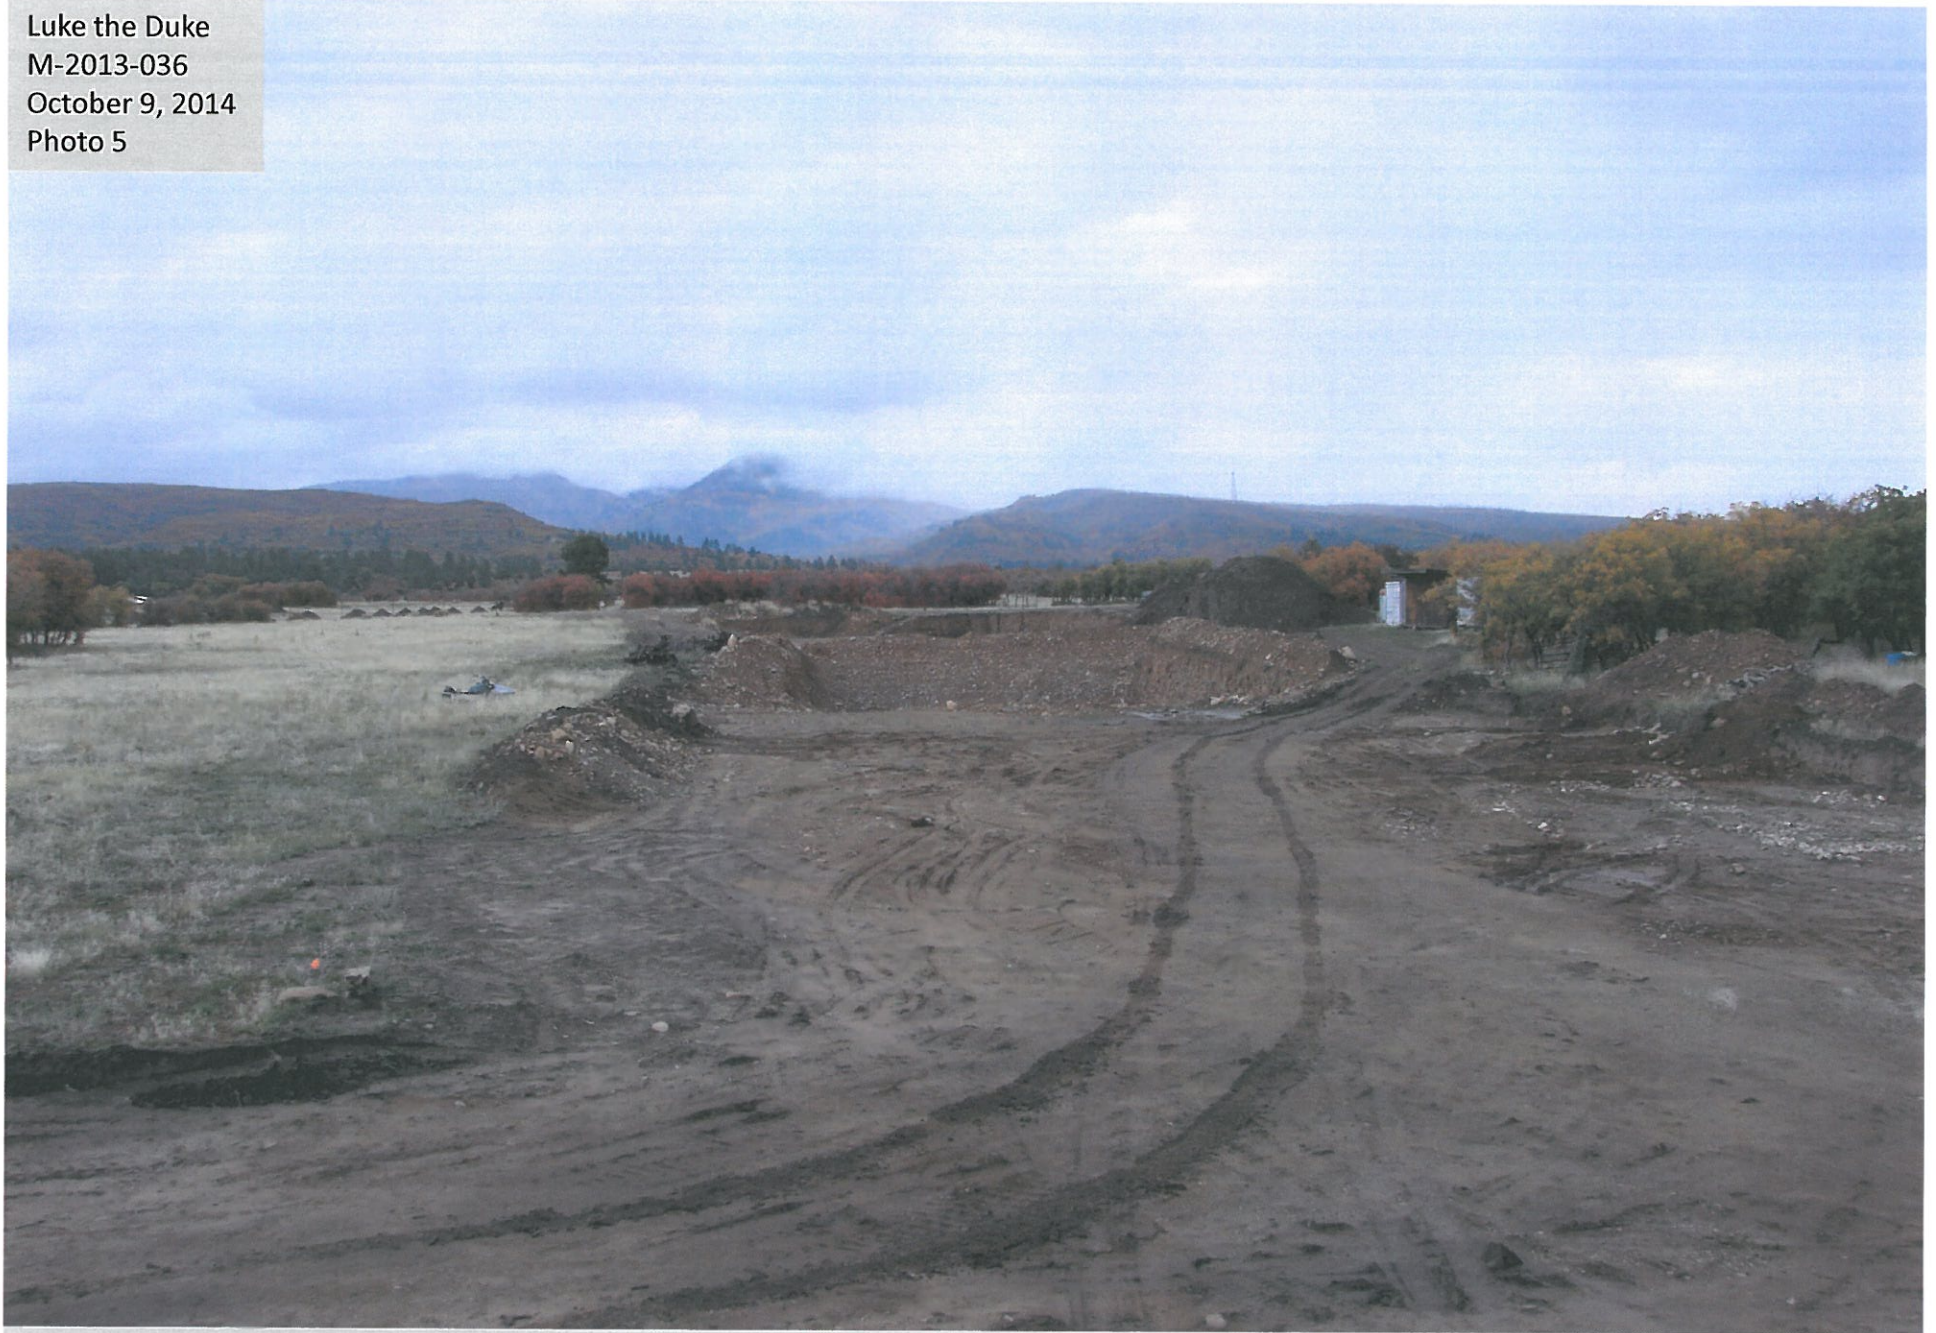
Luke the Duke
M-2013-036
October 9, 2014
Photo 5

View north, showing portions of the affected lands and an adjacent topsoil stockpile available for reclamation purposes. A second topsoil stockpile was located at the south end of the permit area (see Google Earth image for location).
