CRIPPLE CREEK & VICTOR GOLD MINING Co.
Squaw Gulch (VLF), HWY 67 Realignment Field Monitoring Summary Weekly Report

Owner:	Cripple Creek & Victor Gold Mining Co.	Project Number:	74201125N0. ****. ****	Date	04.27.2013
Project:	Squaw Gulch (VLF), Hwy 67 Realignment				
Location:	Cripple Creek & Victor Gold Mine, Colorado				
Contractor:	Ames Construction Co. Inc.

Reporting Period: 04.21.13 thru 04.27.13

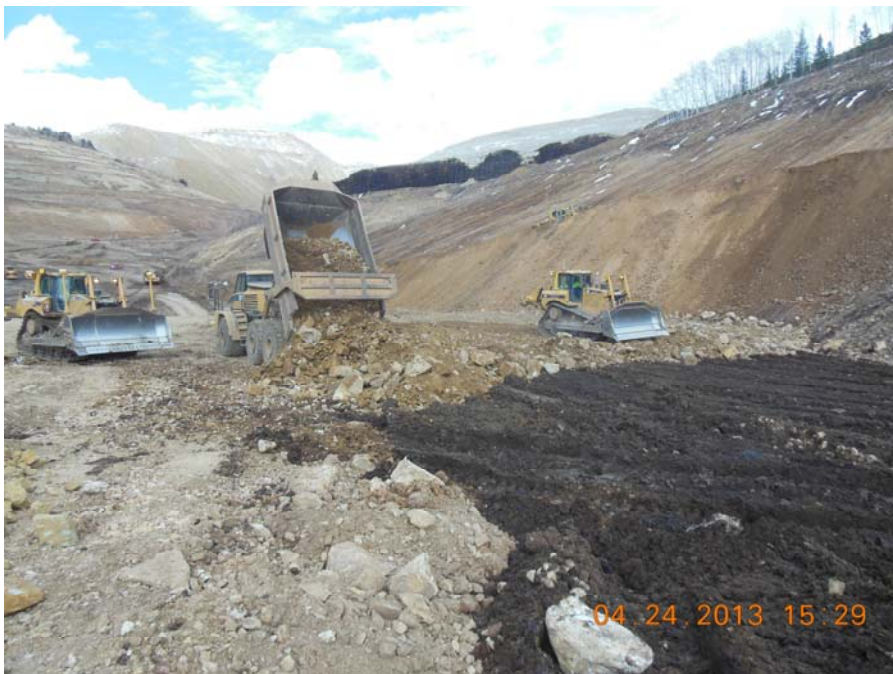
On Thursday the 25th at approximately 0800hrs, An Amec field representative observed slight deflection on the lift 4 feet above the oversaturated materials and it was then determined it would take between 5 and 6 feet of rock fill to bridge the 1 foot of oversaturated materials.

Photo No.2; Unsuitable material use, Test Pad construction

Amec recommended that the oversaturated materials not be placed in the fill unless proper drying of the materials were performed. CC&V Projects determined that the materials, as excavated should be hauled to a designated stockpile and not placed within the structural fill at this time.

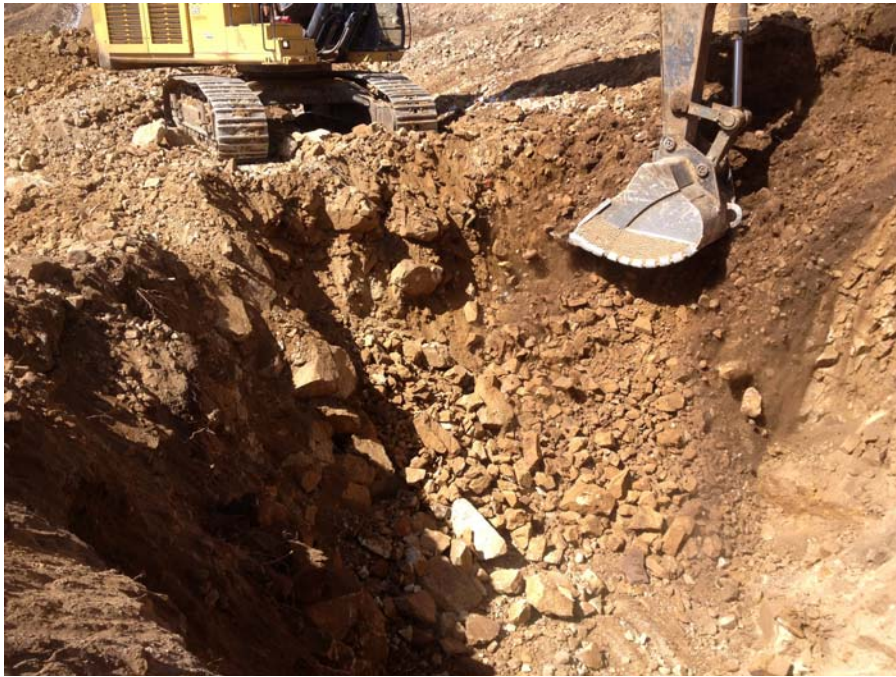
Photo No.3; UG #6018: Removing the shot rock to expose the working

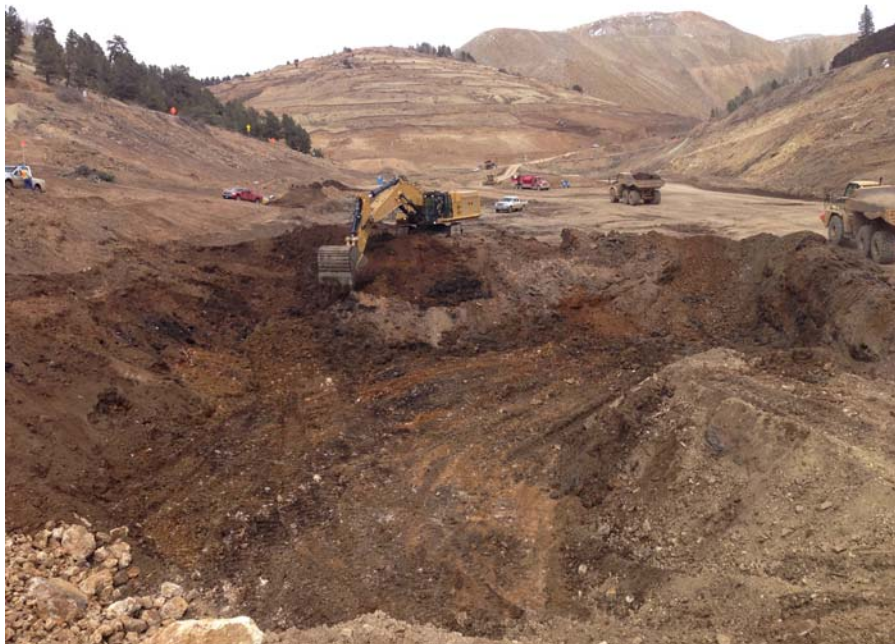
Photo No.4; Unsuitable material removal

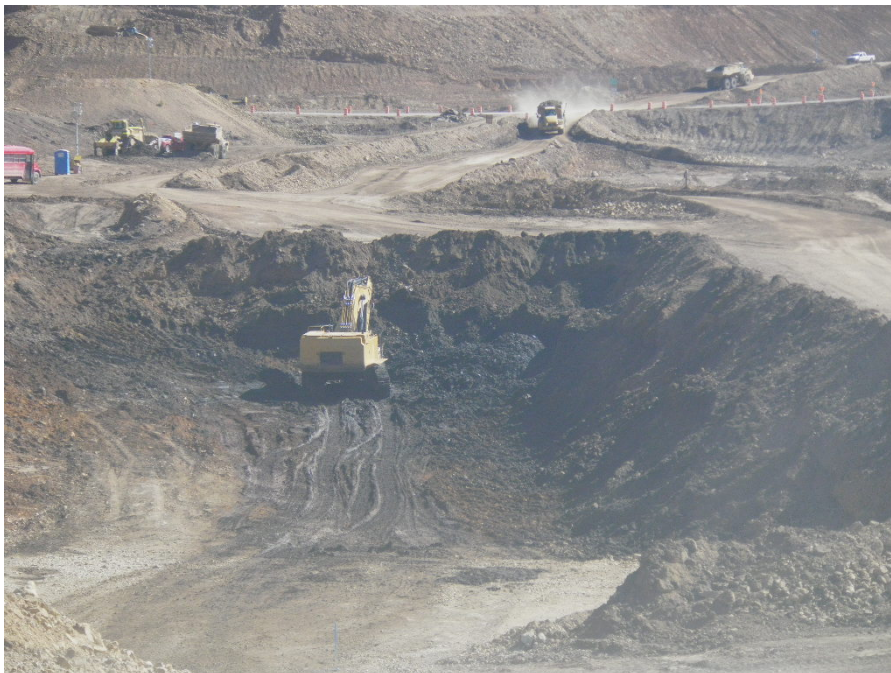
Photo No. 4; Unsuitable material removal.

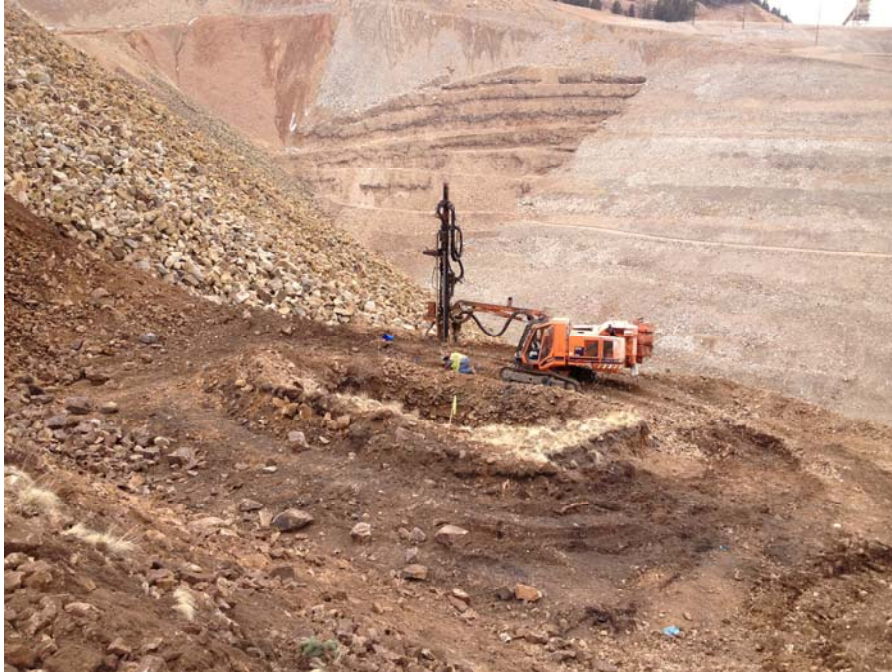
Photo No. 1; UG #U6122: Confirmatory drilling of working

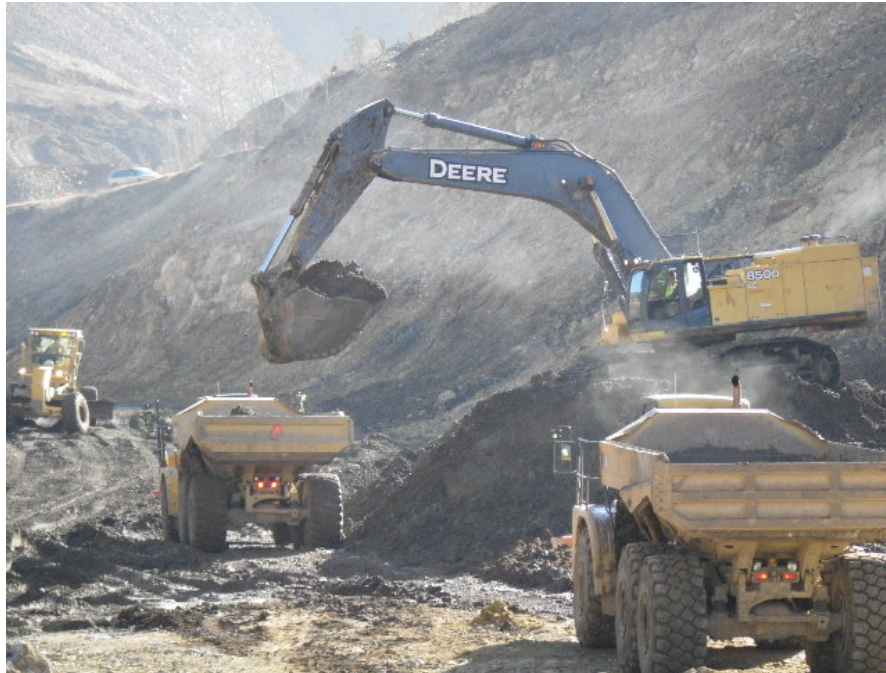
Photo 3; Unsuitable material removal

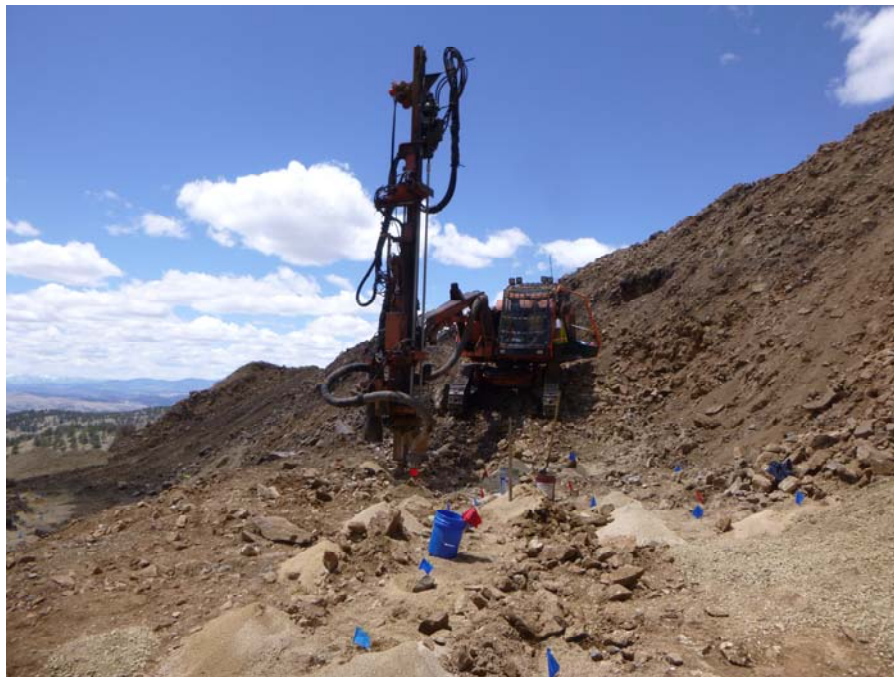
Photo 4; Continued confirmatory drilling on UG #U6136 (Unknown)

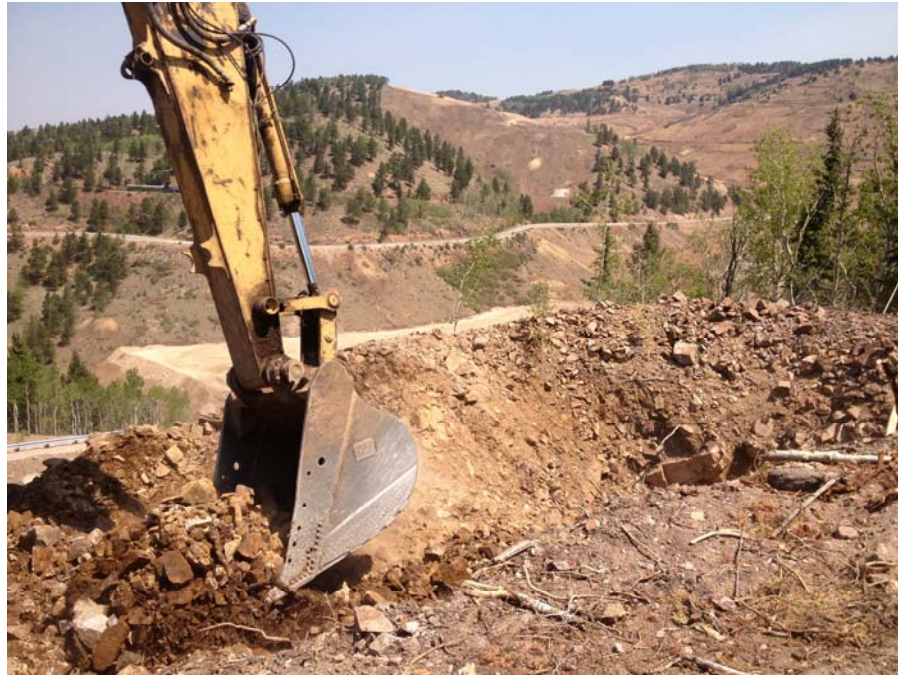
During this reporting period remediation efforts were performed and completed on UG working No. U6035, No. U6037, No. U6160, No. U6162, No. U6163, No. U6164 and No U6165. Sites listed were excavated to practical refusal into rock varying depths depending on the working remediated. The site for each working was then backfilled in 2 foot loose lifts to approximate planned subgrade elevation using the onsite structural fill (excavated material) and "bucket tamped" with the back of the CAT 330 excavator bucket. All backfill material was free of organic material, ice and snow and are considered remediated as specified

Photo 1: UG #U6130, Shallow shaft remediation
