**AMEC - 2013 CQA Field Staff Schedule MLE2**

**CRIPPLE CREEK & VICTOR GOLD MINING Co.**  
**Squaw Gulch (VLF), HWY 67 Realignment Field Monitoring Summary Weekly Report**

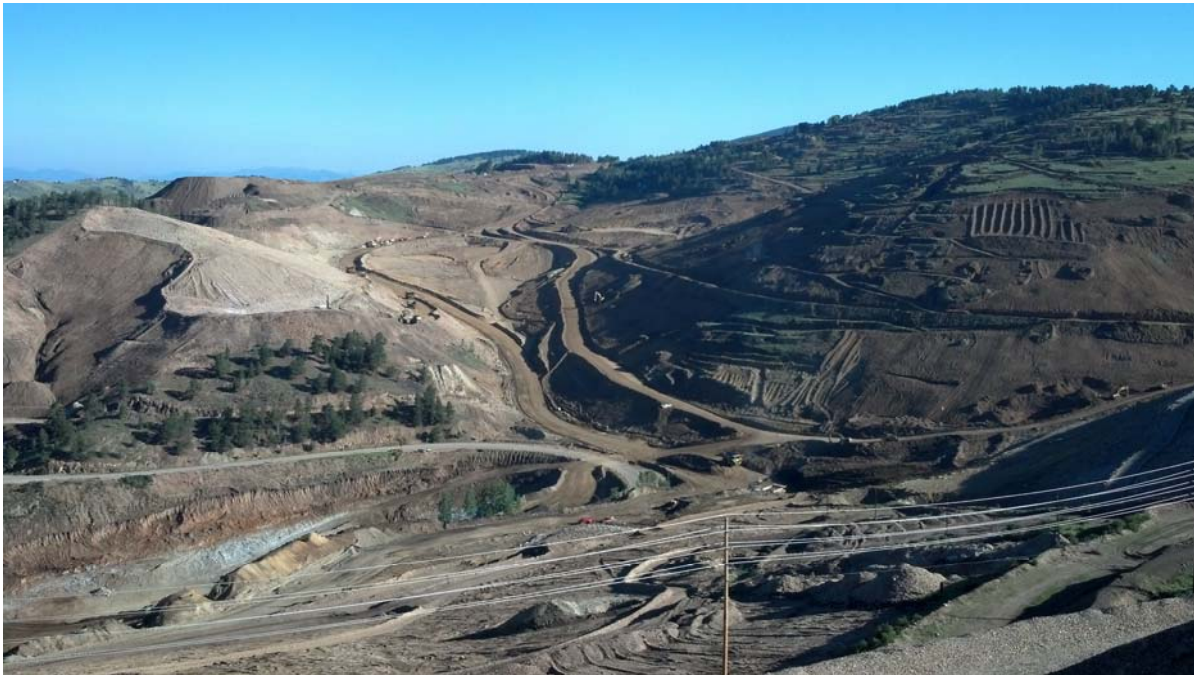
**Photo 1:** VLF site Overview

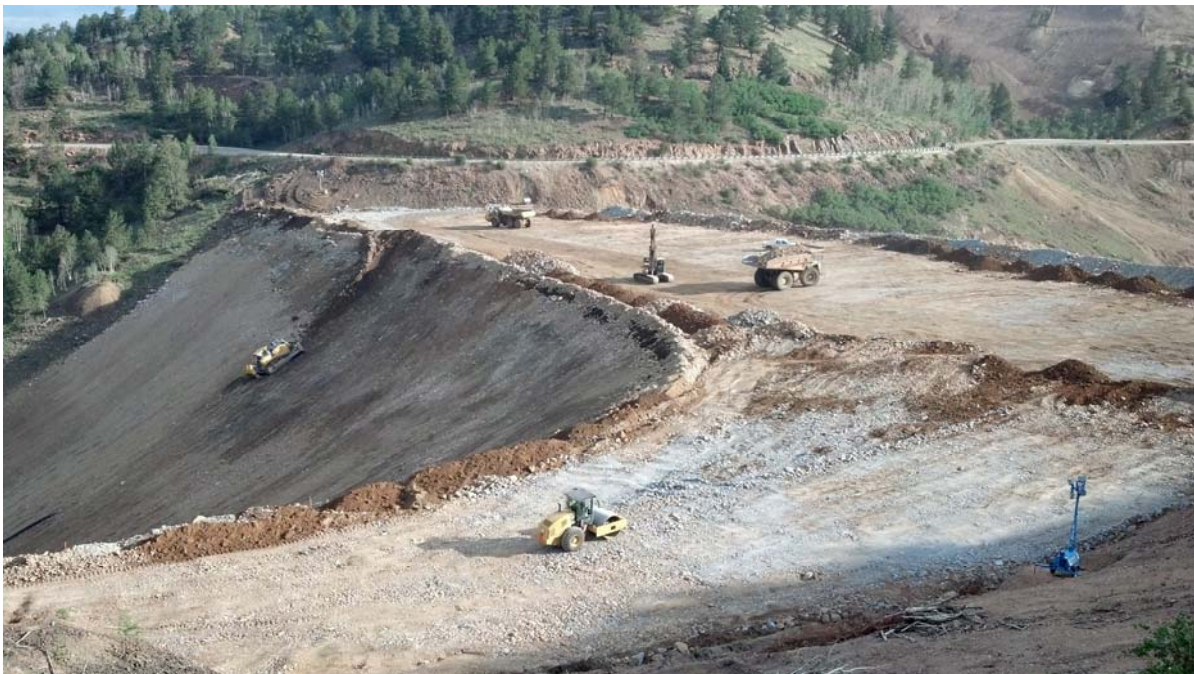
**Photo 2:** Hwy 67 embankment – Structural fill placement, compaction and slope contouring

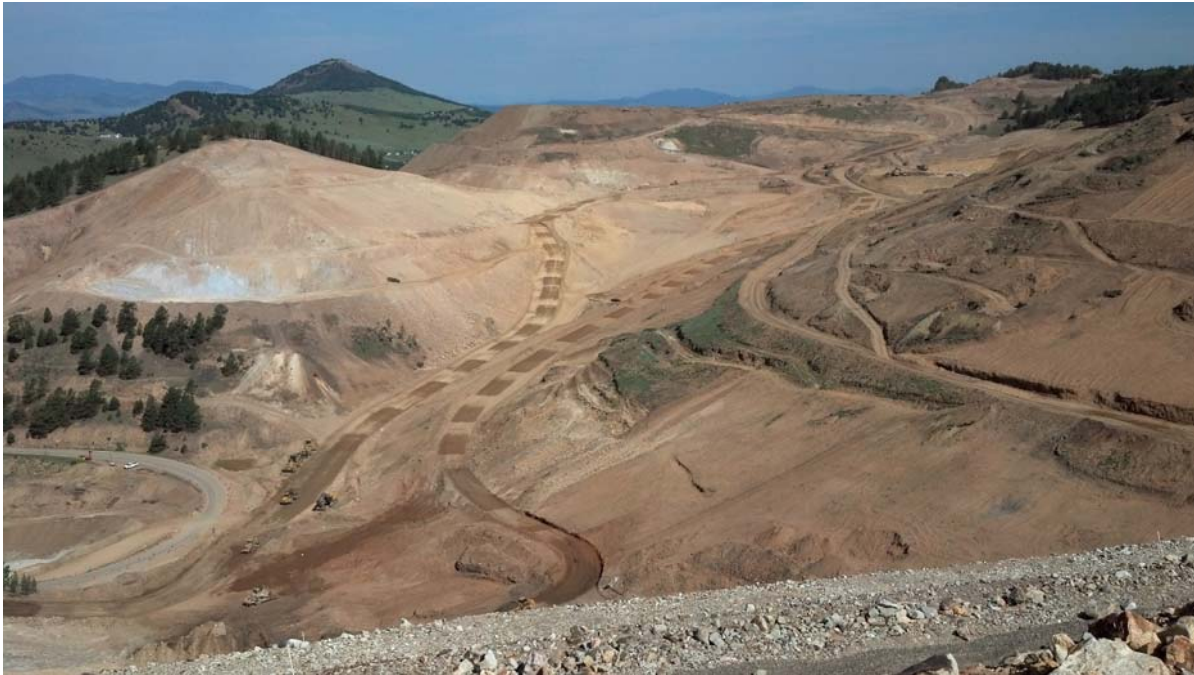
***Photo 1: VLF site Overview***

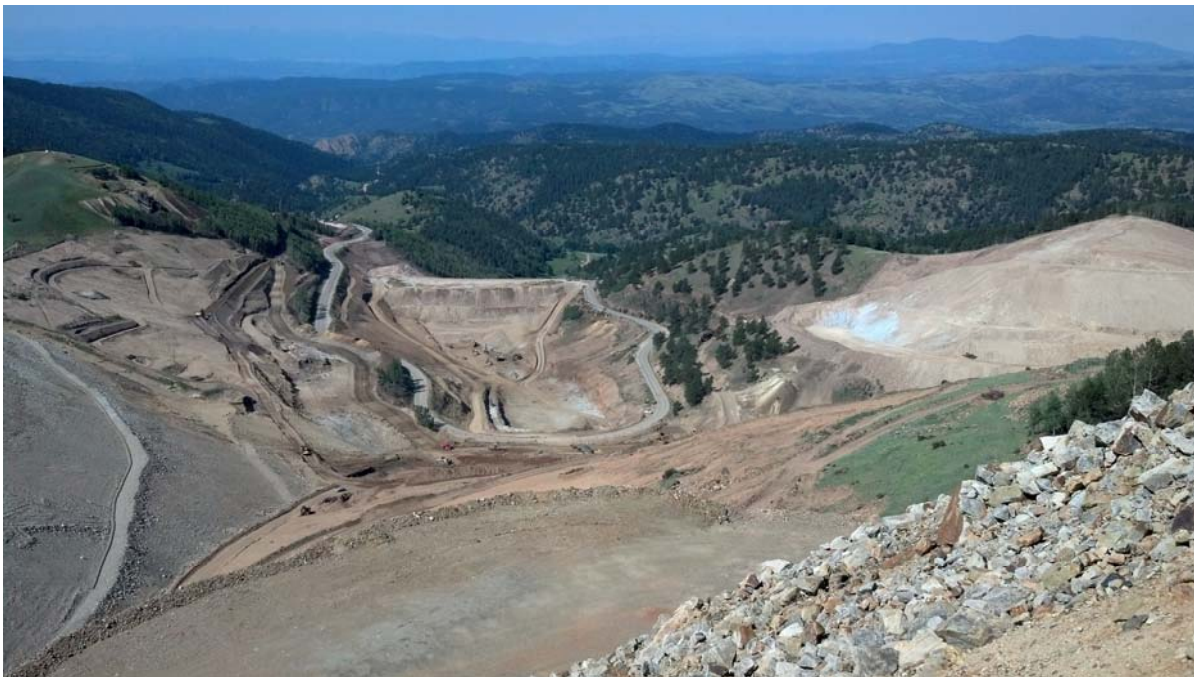
***Photo 2: Site Overview Hwy 67/PSSA embankment***

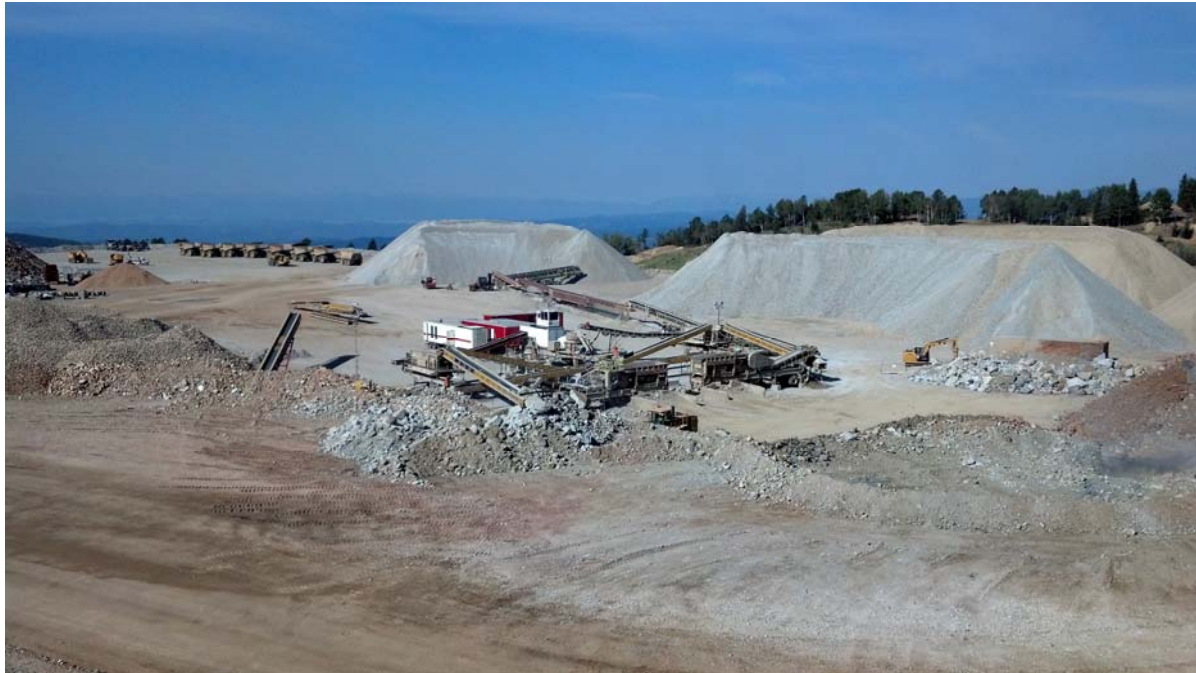
**Photo 3:** Crusher operations

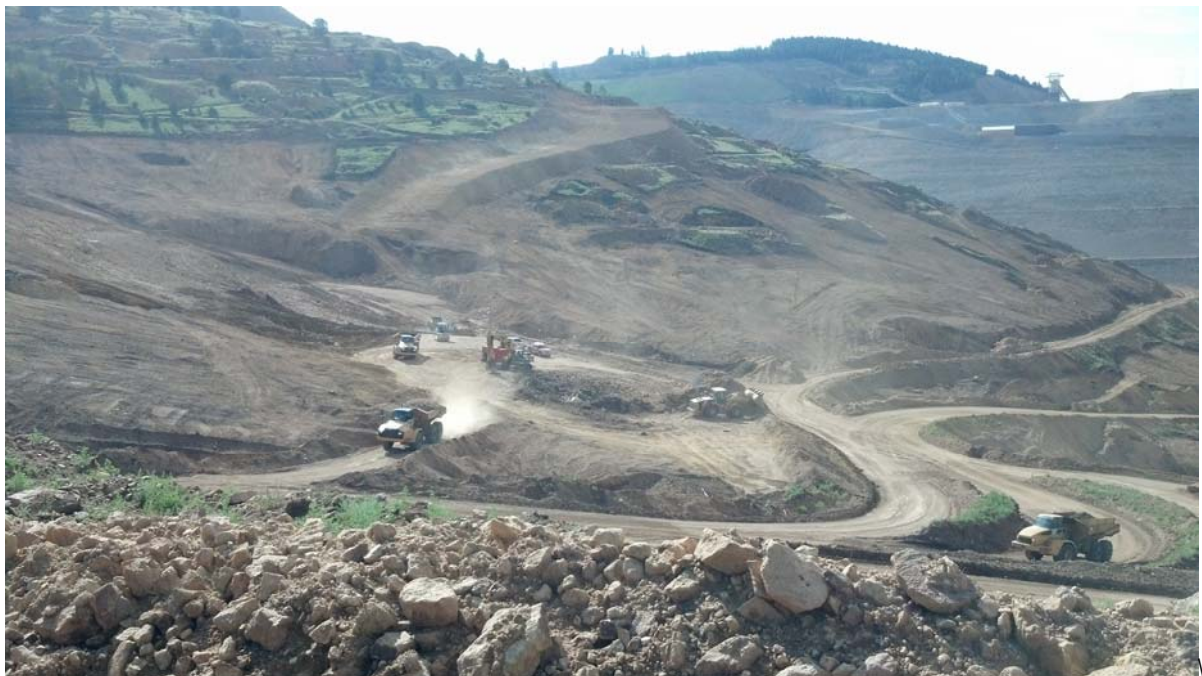
**Photo 4:** Midway – ADR Haul road fill placement

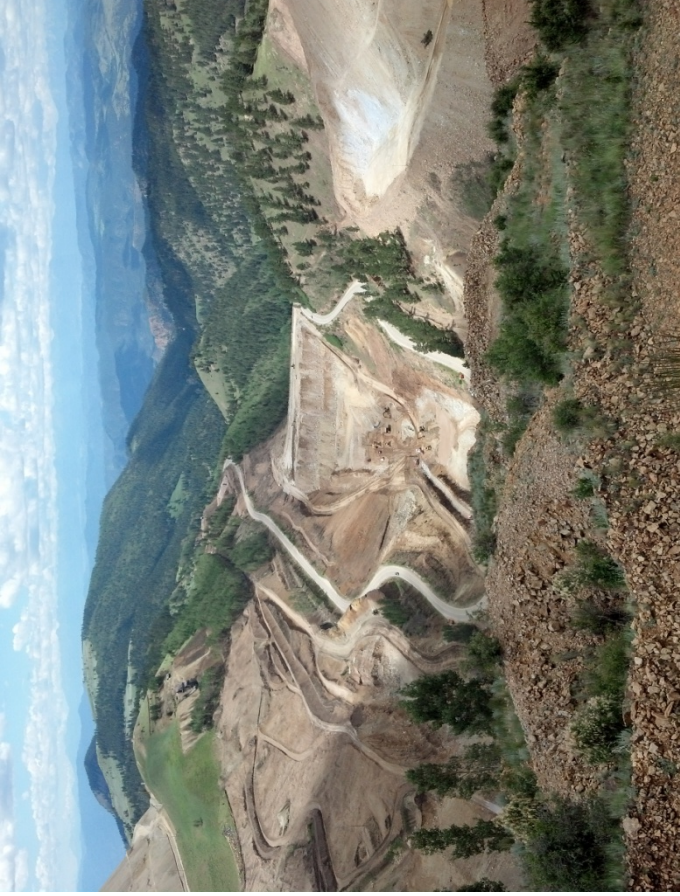
**Photo 1:** Site Overview Hwy 67/PSSA embankment

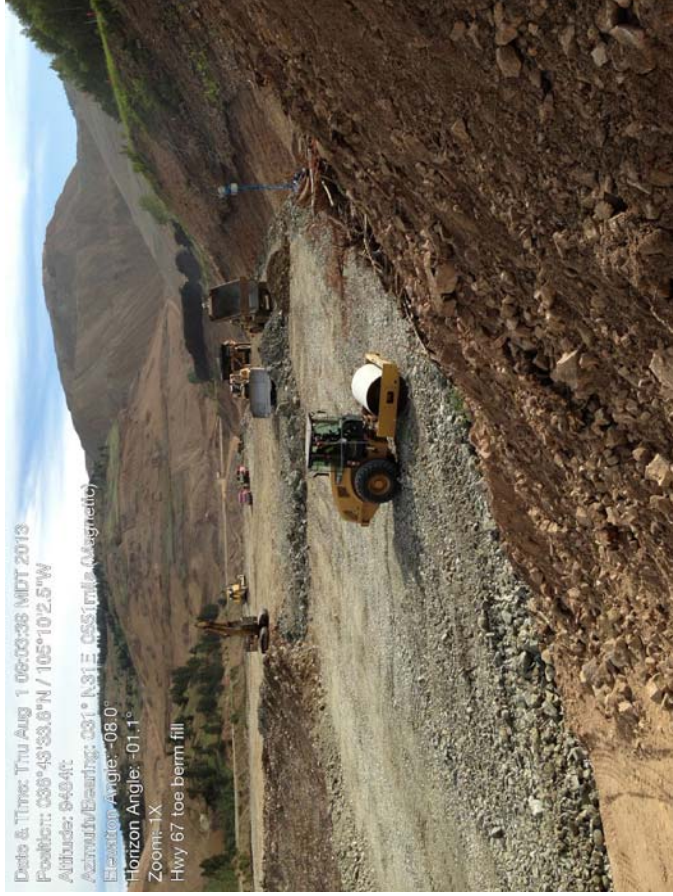
**Photo 2:** Hwy 67 Embankment compaction and structural fill placement

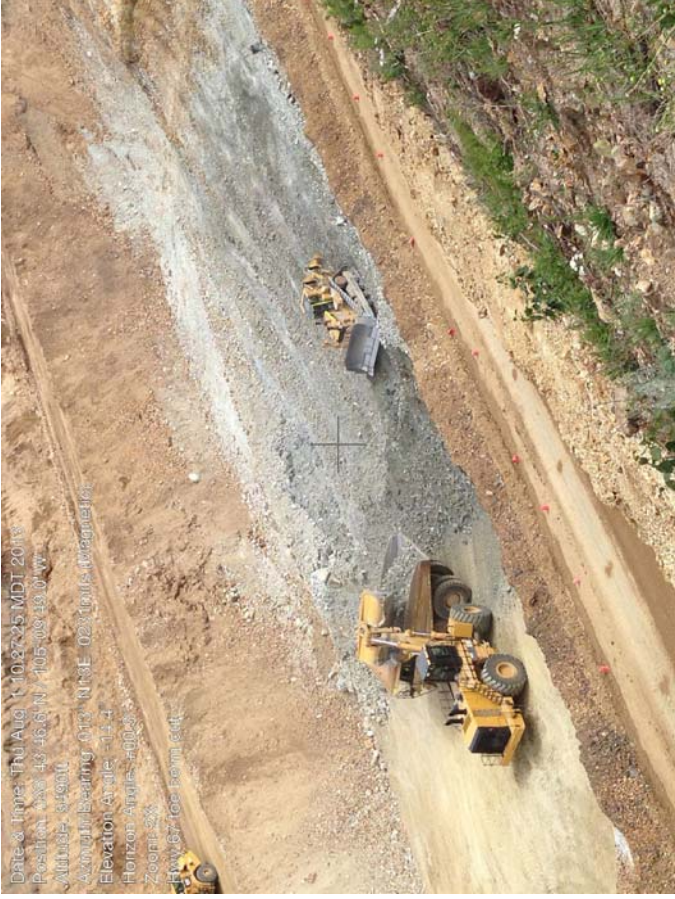
**Photo 3:** Generated Structural Fill (PSSA Floor)

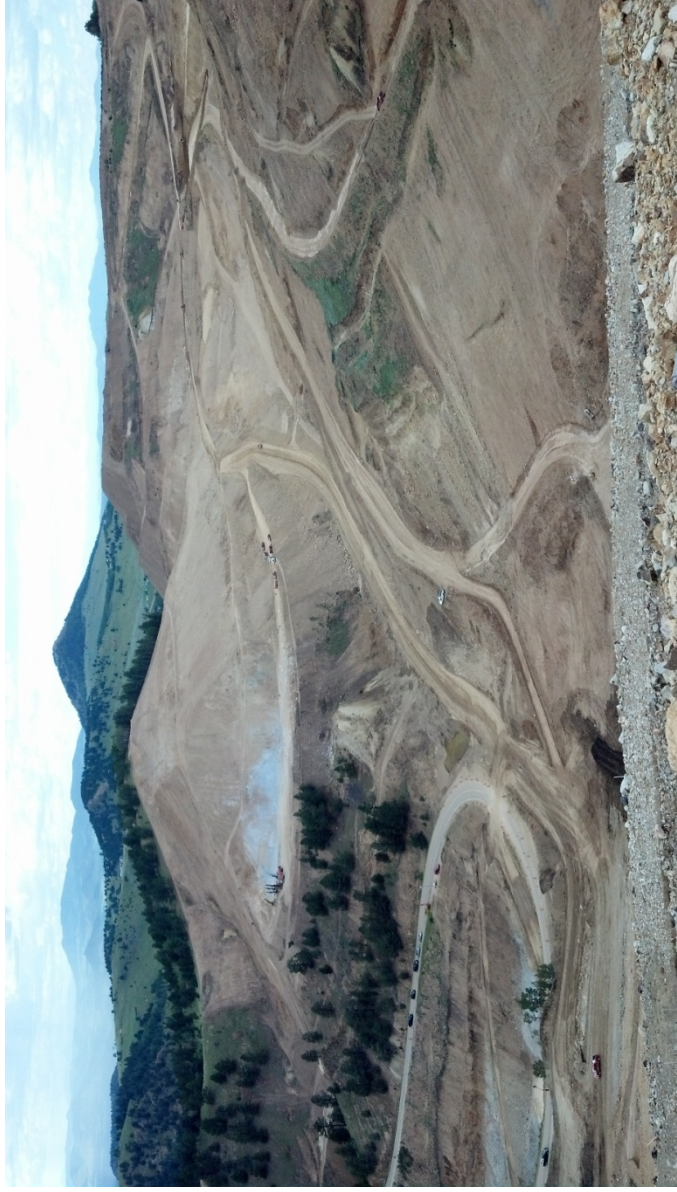
**Photo 4:** Site overview VLF

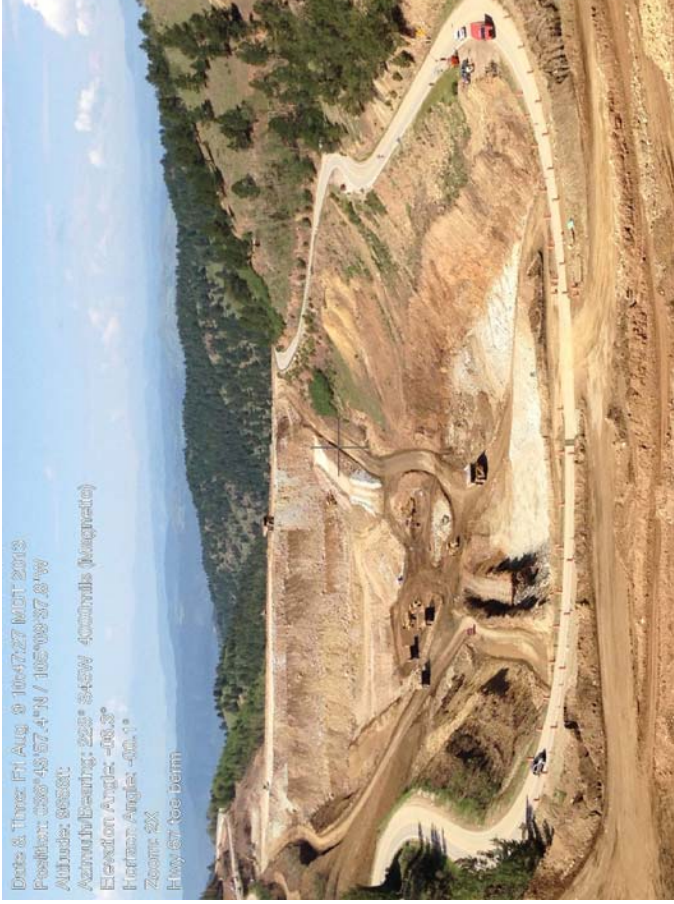
**Photo 1:** Site Overview Hwy 67/PSSA embankment

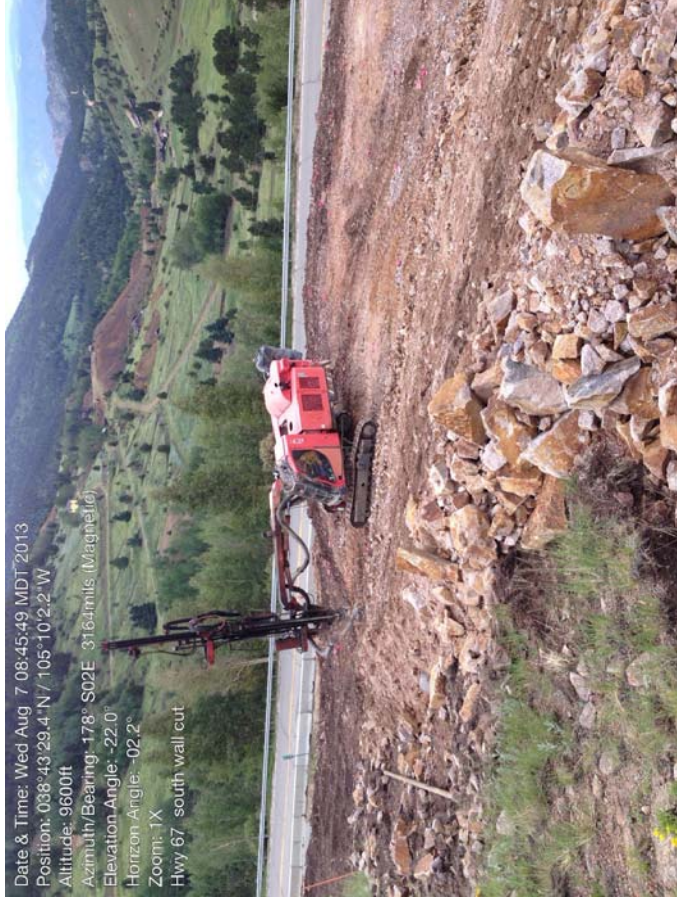
**Photo 2:** South Crib Wall – Production Drilling

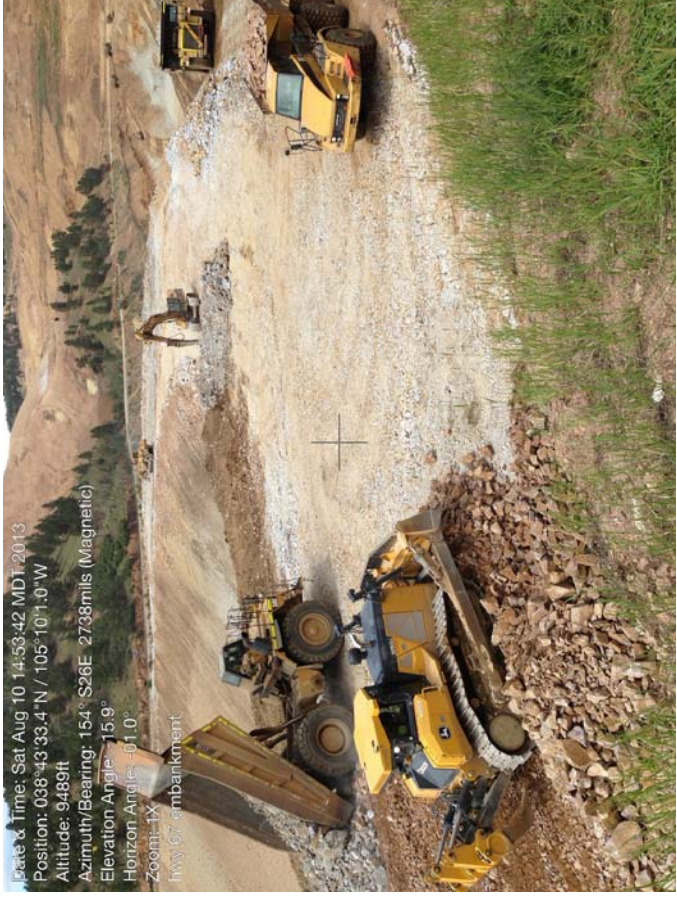
**Photo 3:** Hwy 67 Embankment Structural Fill Placement

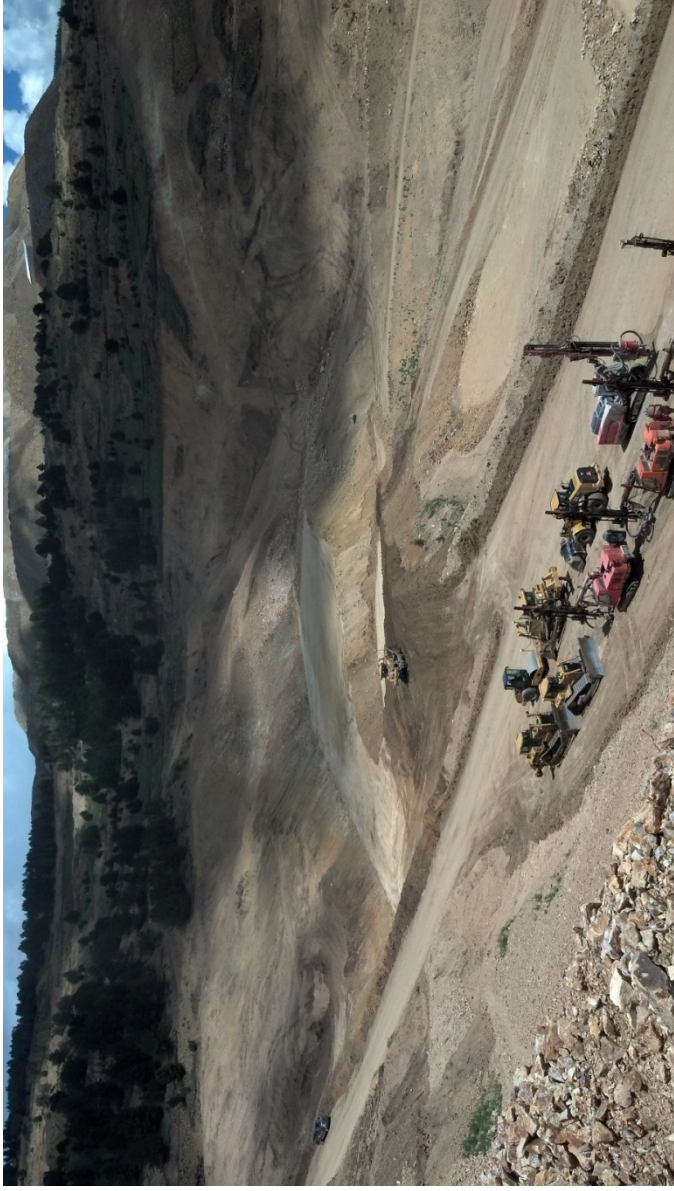
**Photo 4:** ADR HR - Midway Cut to Fill

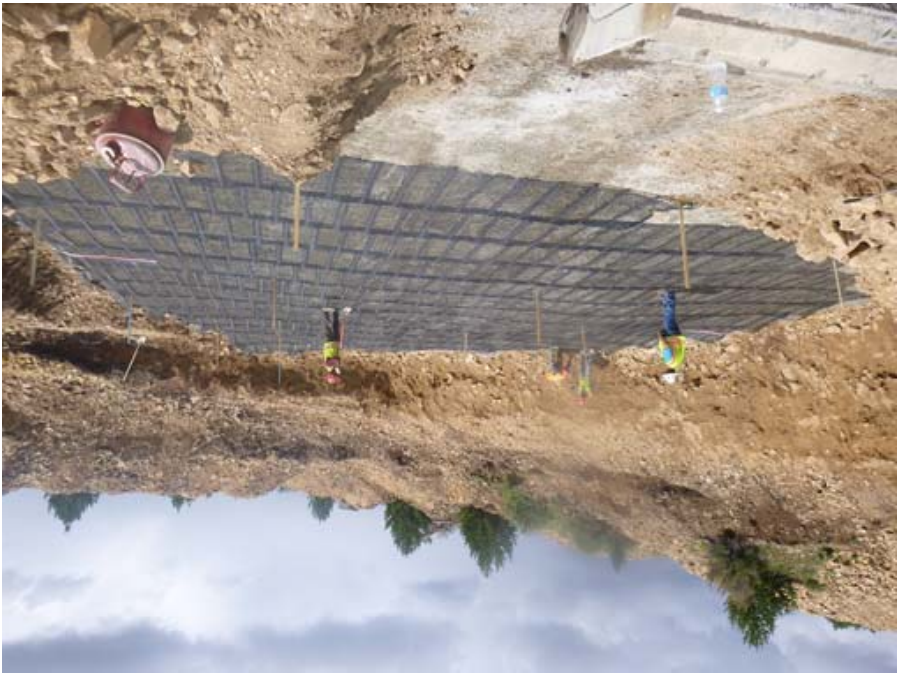
**Photo 4:** Geogrid placement, Underground Working UG #6239

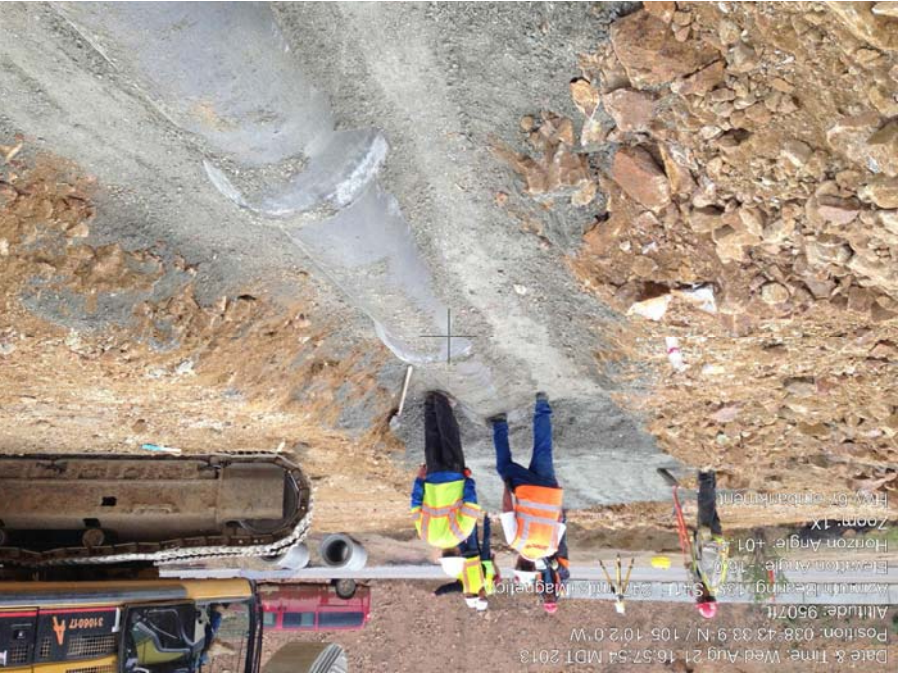
**Photo 3:** RCP and fill placement, Highway 67 Realignment Embankment

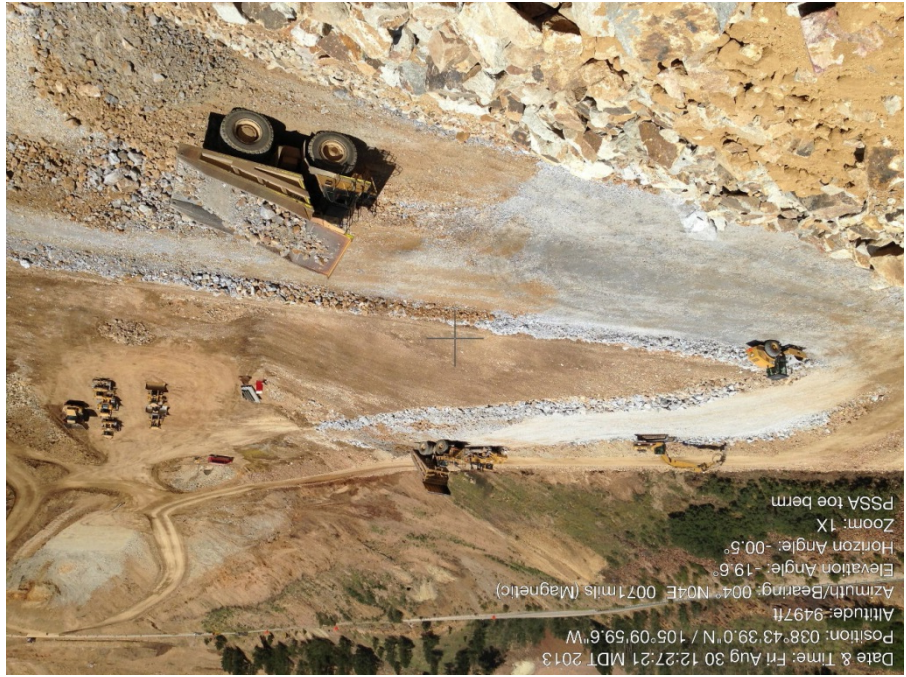
**Photo 1:** Structural fill placement - PSSA Toe Berm

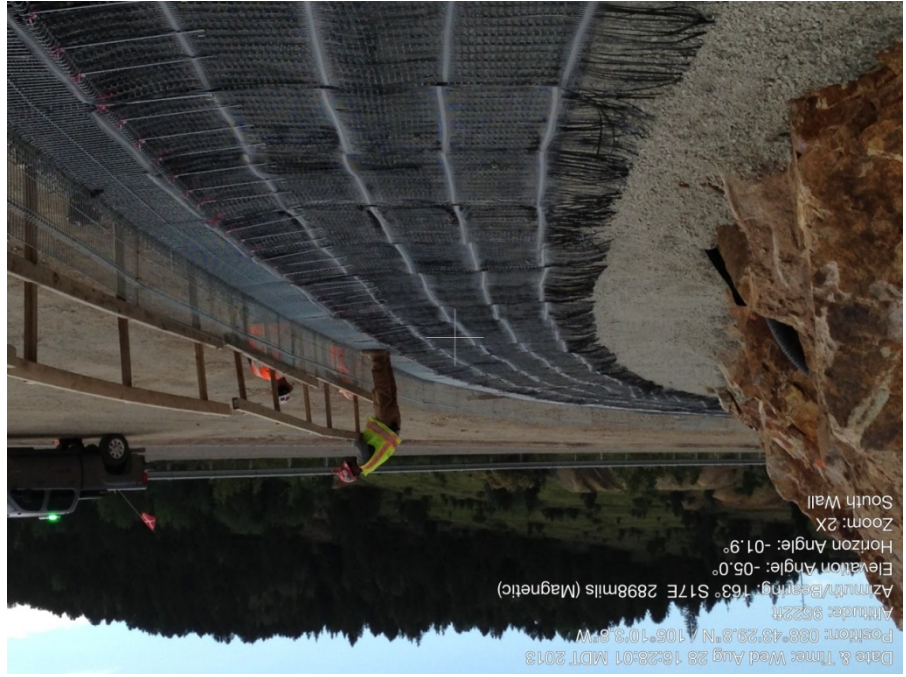
**Photo 2:** South Crib Wall - Geo-grid and basket placement.

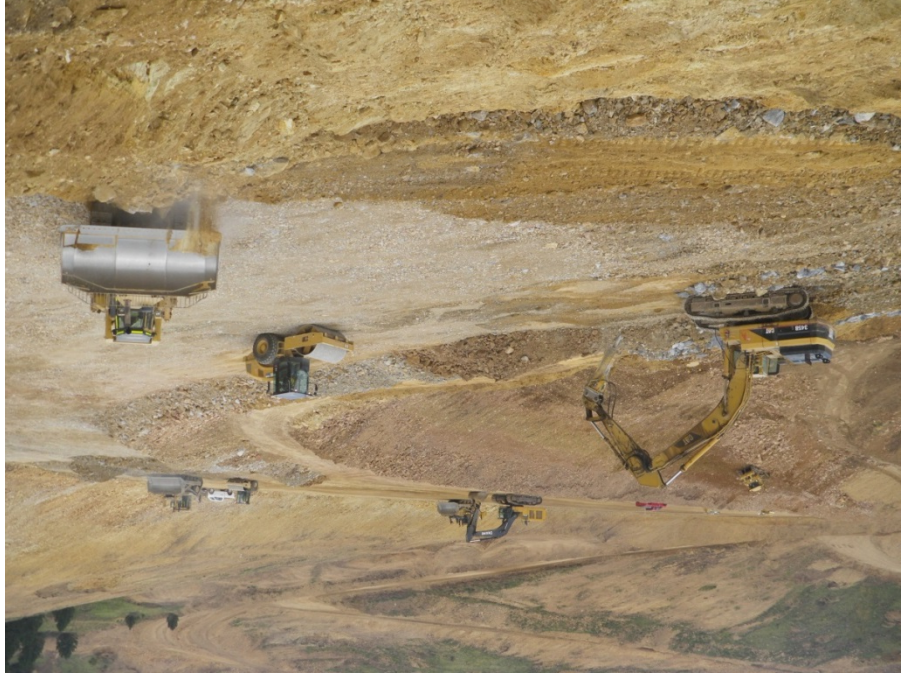
**Photo 1:** Structural fill placement – Midway ADR Haul Road

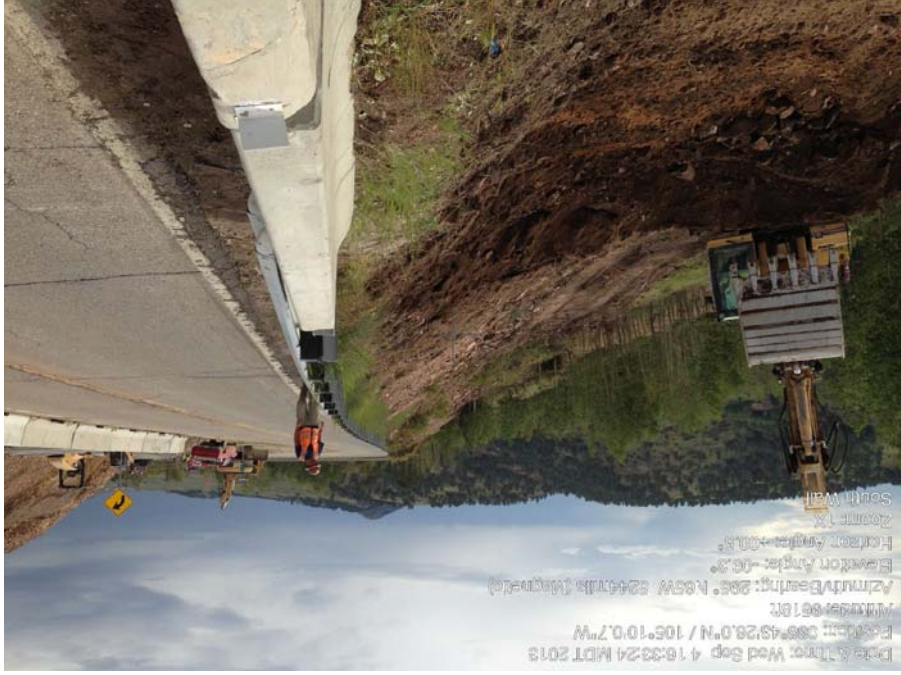
**Photo 2:** Clearing and Grubbing – HWY 67, Prep for Silver Fill Placement.

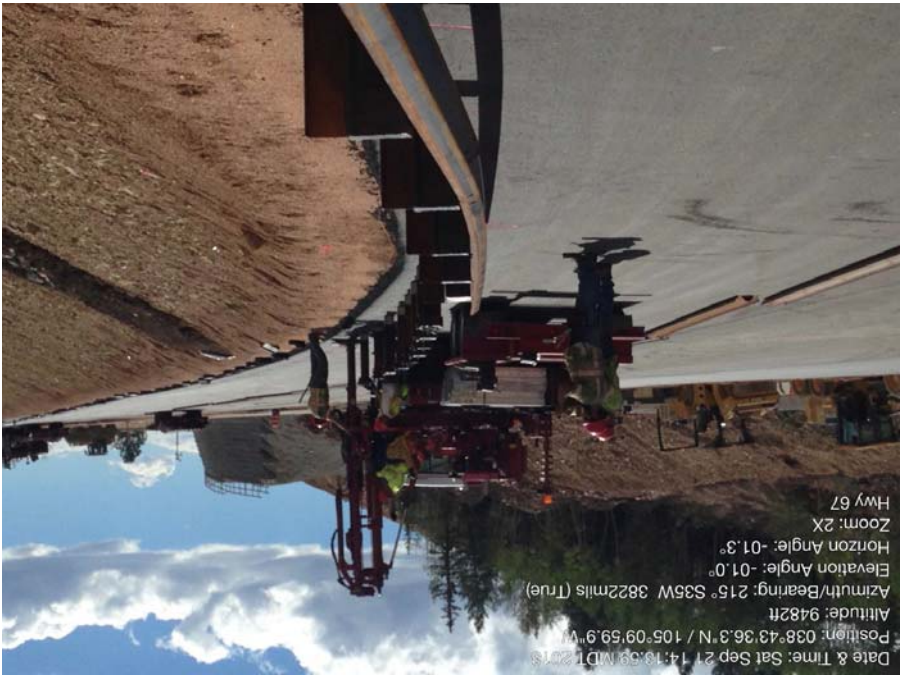
Photo 4: Guardrail Installation – HWY 67

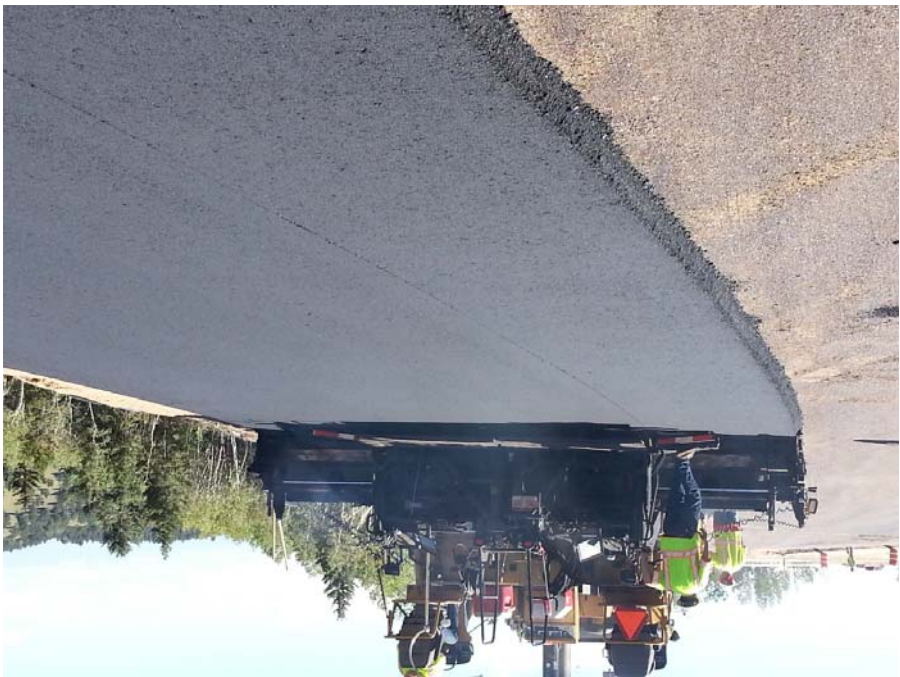
Photo 3: HWY 67 Embankment Paving Bottom 3 inch Mat

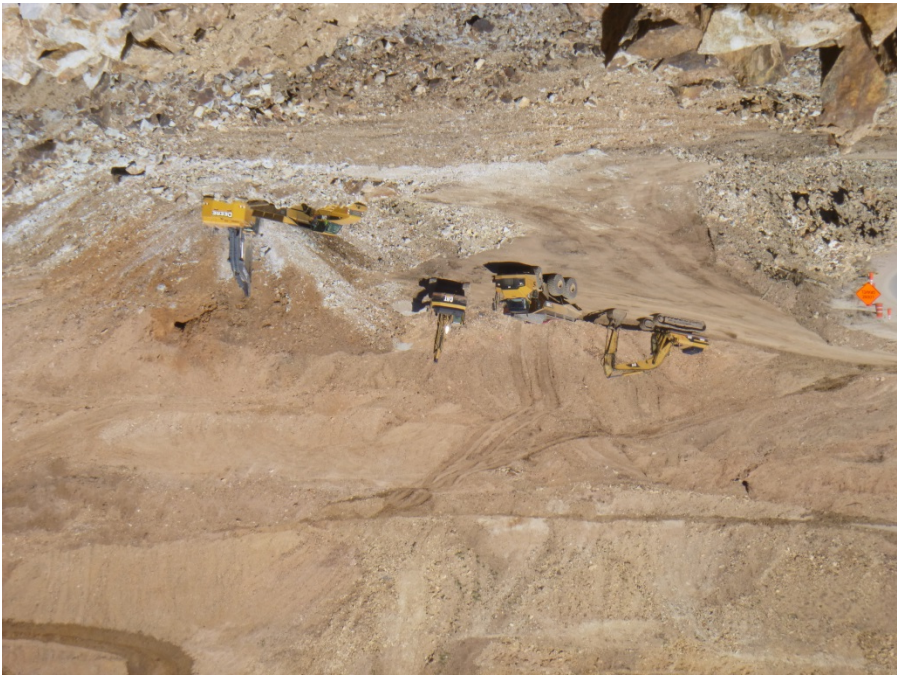
**Photo 3:** Underground Workings UG#6167 and UG#U6273 – Shot rock removal

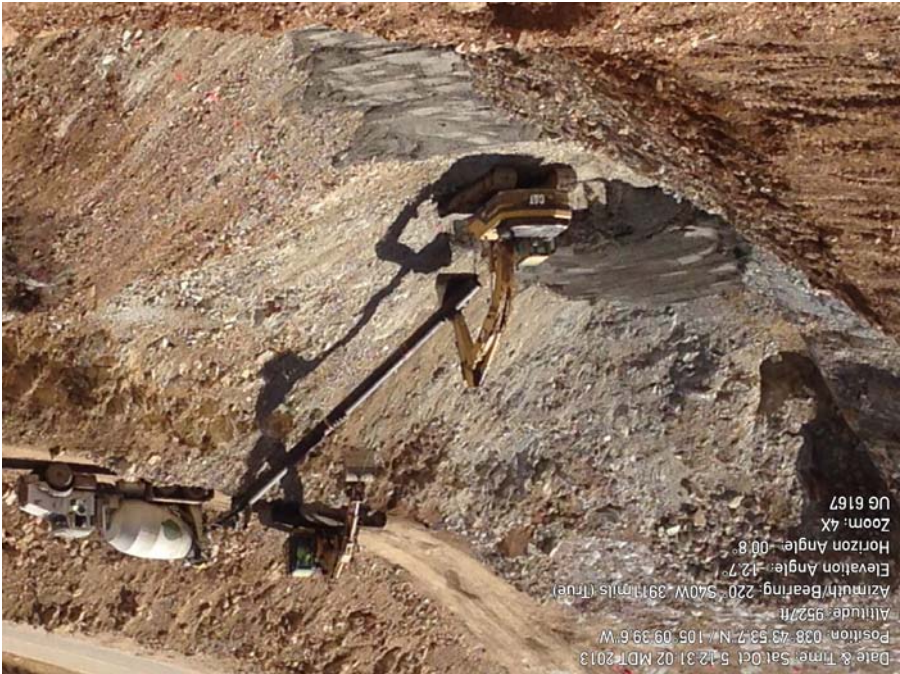
Photo 4: Concrete placement UG6167

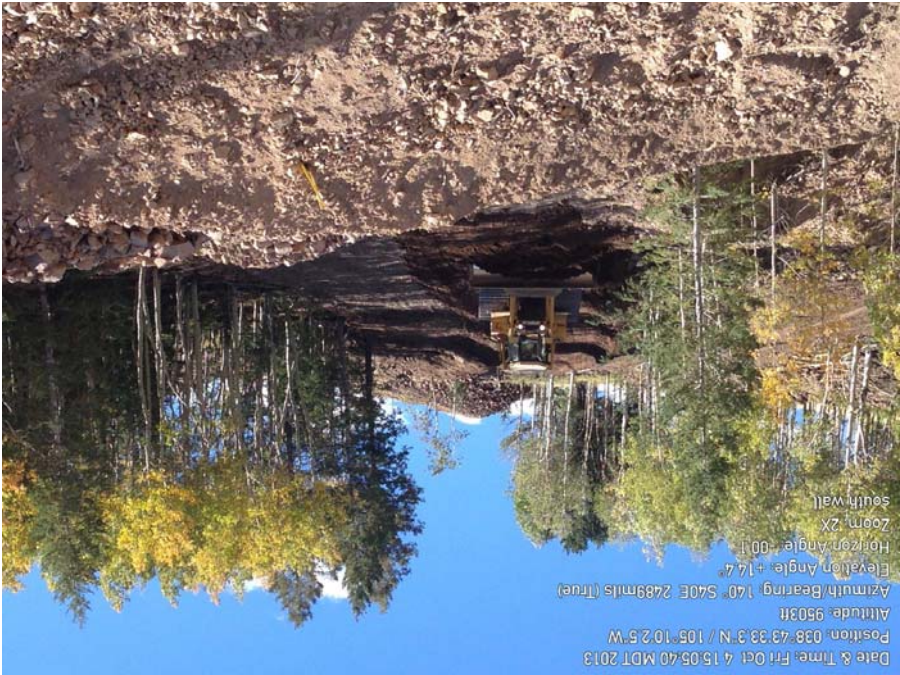
Photo 3: Topsoil placement (Natural Gas Line ROW)

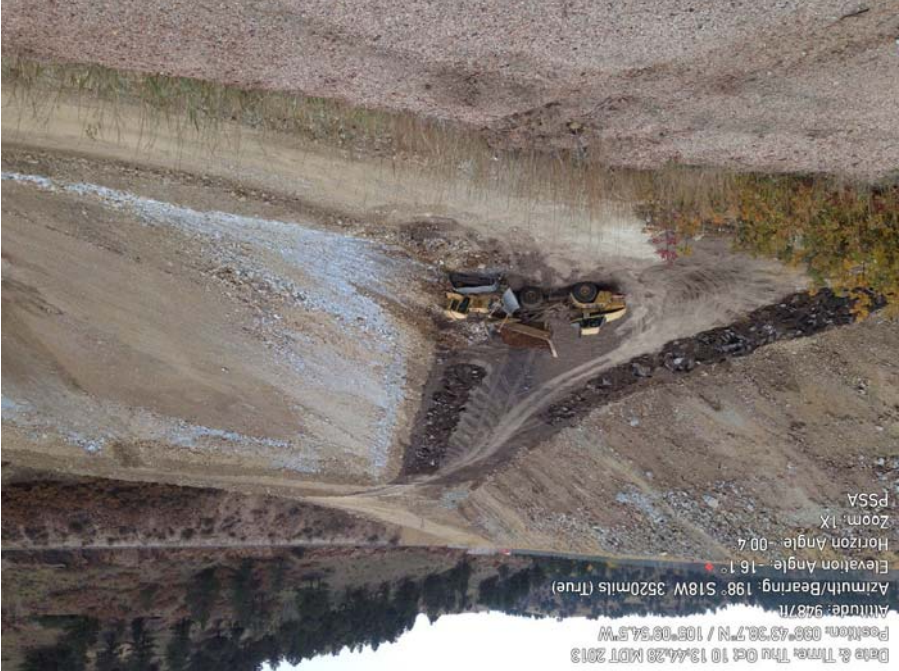
Photo 1: PSSA Toe berm fill placement

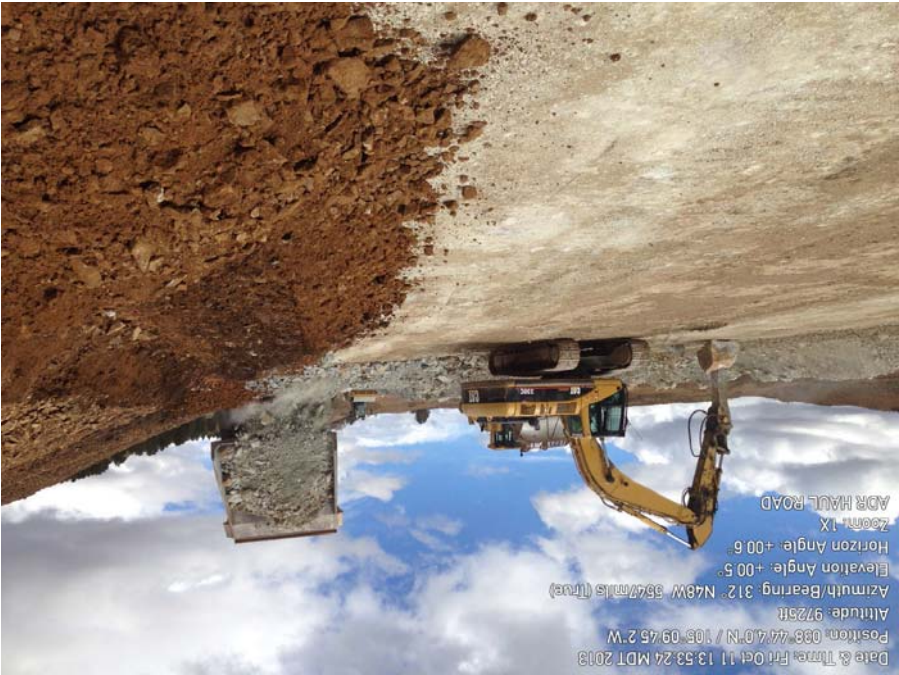
Photo 2: ADR Haul Road fill placement

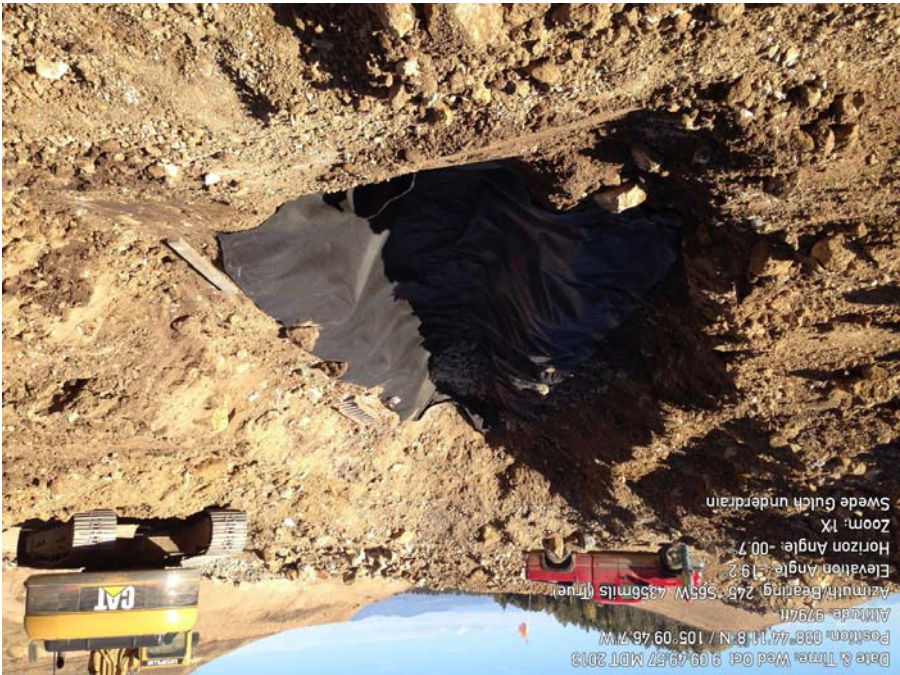
Photo 3: Secondary Underdrain construction
