**H CRIPPLE CREEK & VICTOR GOLD MINING Co.**  
**Squaw Gulch (VLF), HWY 67 Realignment Field Monitoring Summary Weekly Report**

<b>Owner:</b>	Cripple Creek & Victor Gold Mining Co.	<b>Project Number:</b>	74201125N0. ****. ****	<b>Date</b>	10.26.2013
<b>Project:</b>	Squaw Gulch (VLF), Hwy 67 Realignment				
<b>Location:</b>	Cripple Creek & Victor Gold Mine, Colorado				
<b>Contractor:</b>	Ames Construction Co. Inc.

**Reporting Period: 10.20.13 thru 10.26.13**

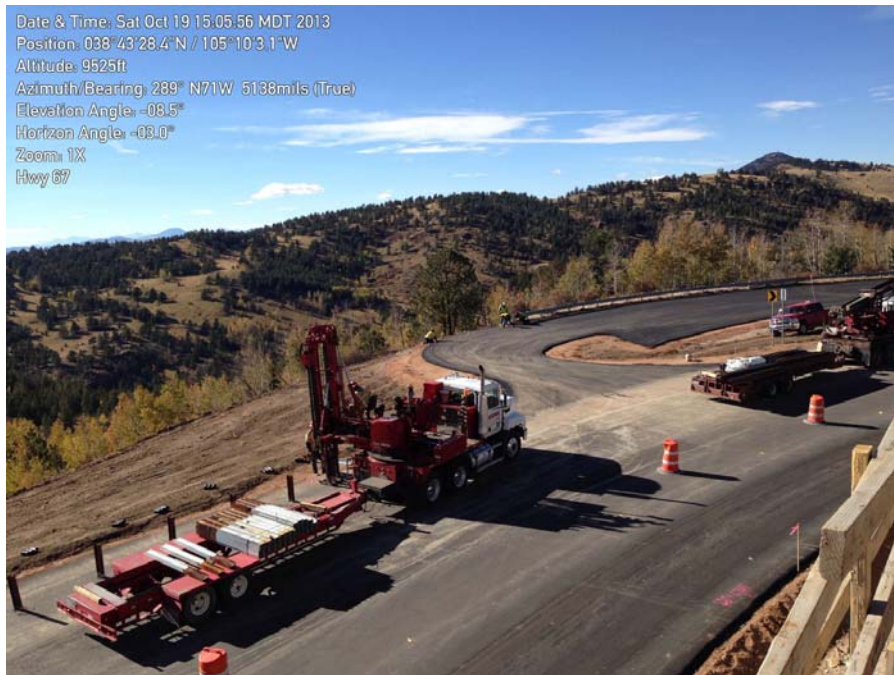
**Photo 1:** Guardrail installation at overlook

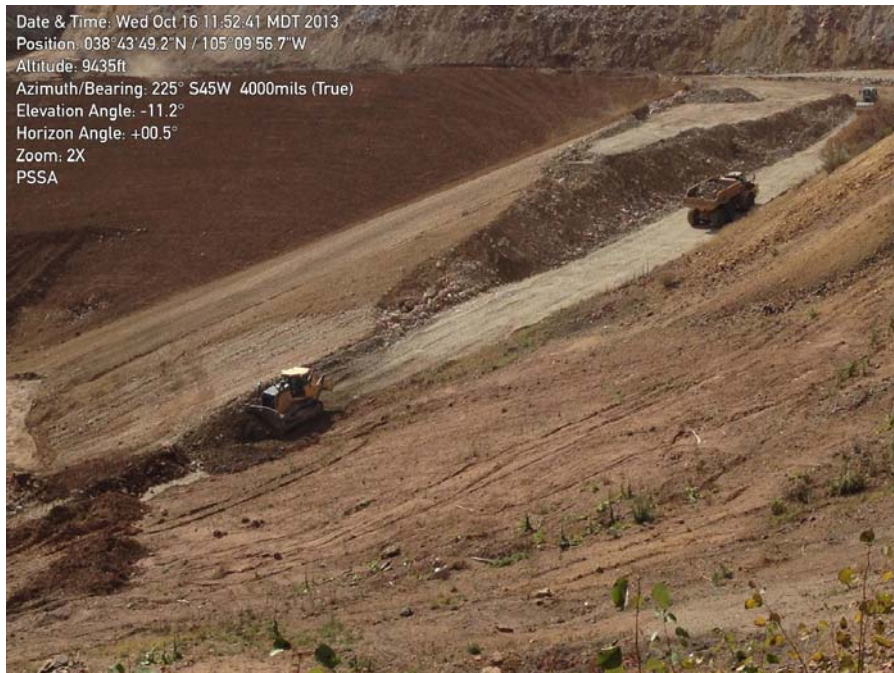
**Photo 2:** PSSA fill placement

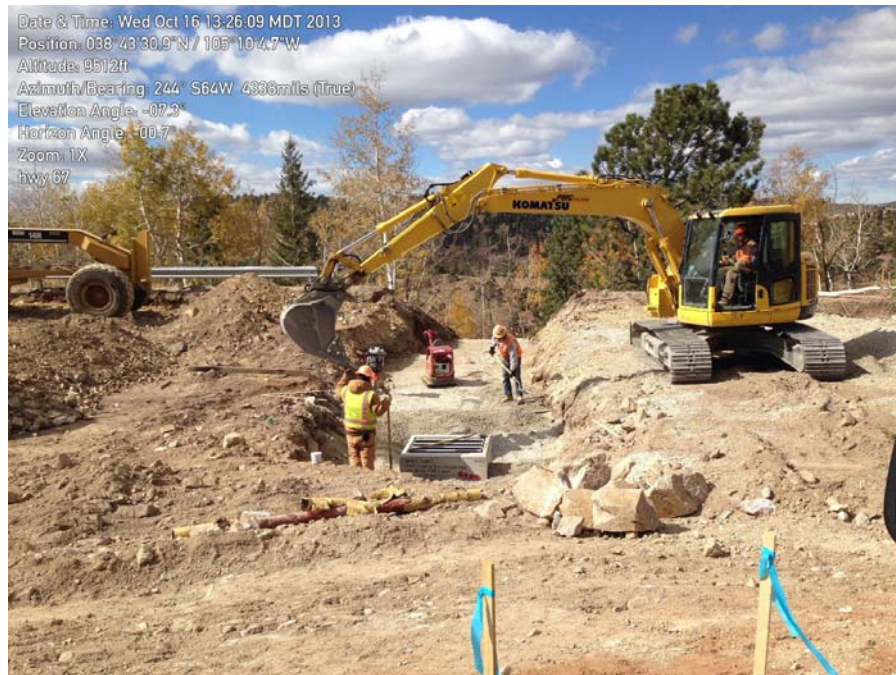
**Photo 3:** Culvert Installation at the overlook

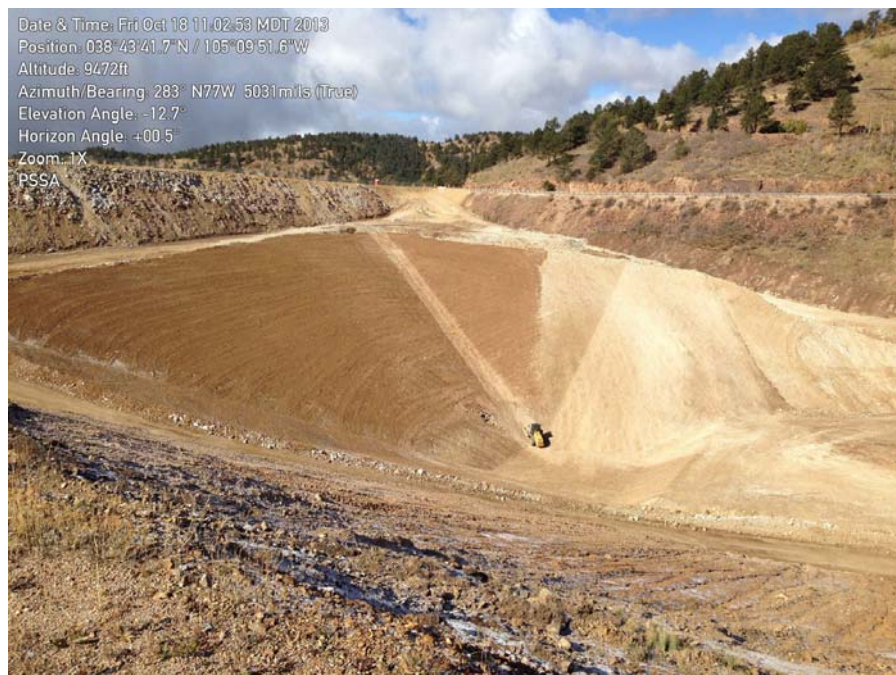
**Photo 4:** PSSA Subgrade compaction

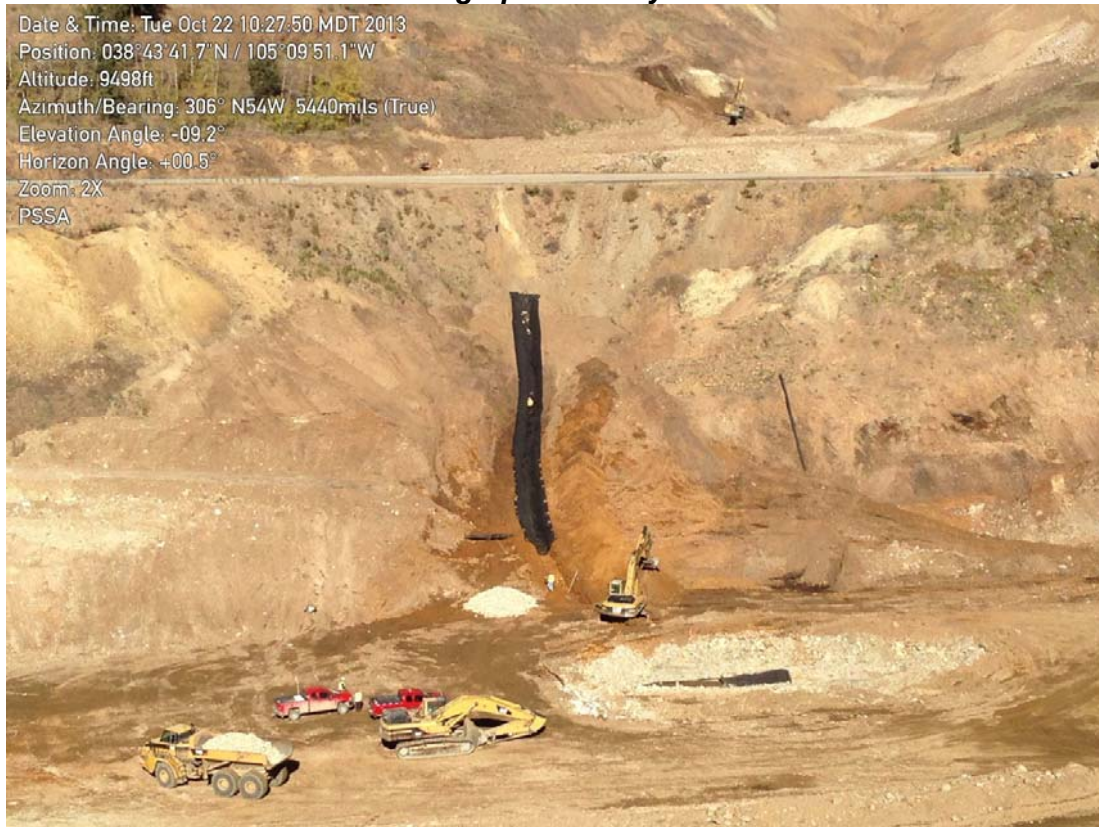
**Meetings and Discussions:** Continued groundwater seepage was noted entering into the draw on the northern slope of the PSSA after the removal of saturated material. On October 21<sup>st</sup> 2013, discussions were held between AMEC, CC&V, and Ames personnel resulting in a decision to place additional secondary underdrain extending from the primary underdrain in the PSSA floor to the former Hwy 67 roadway in the draw where the seepage was encountered. The possible need for tertiary underdrain placement higher up in the draw will be evaluated at a later time.

**Photo 1** Secondary underdrain construction in the PSSA area.

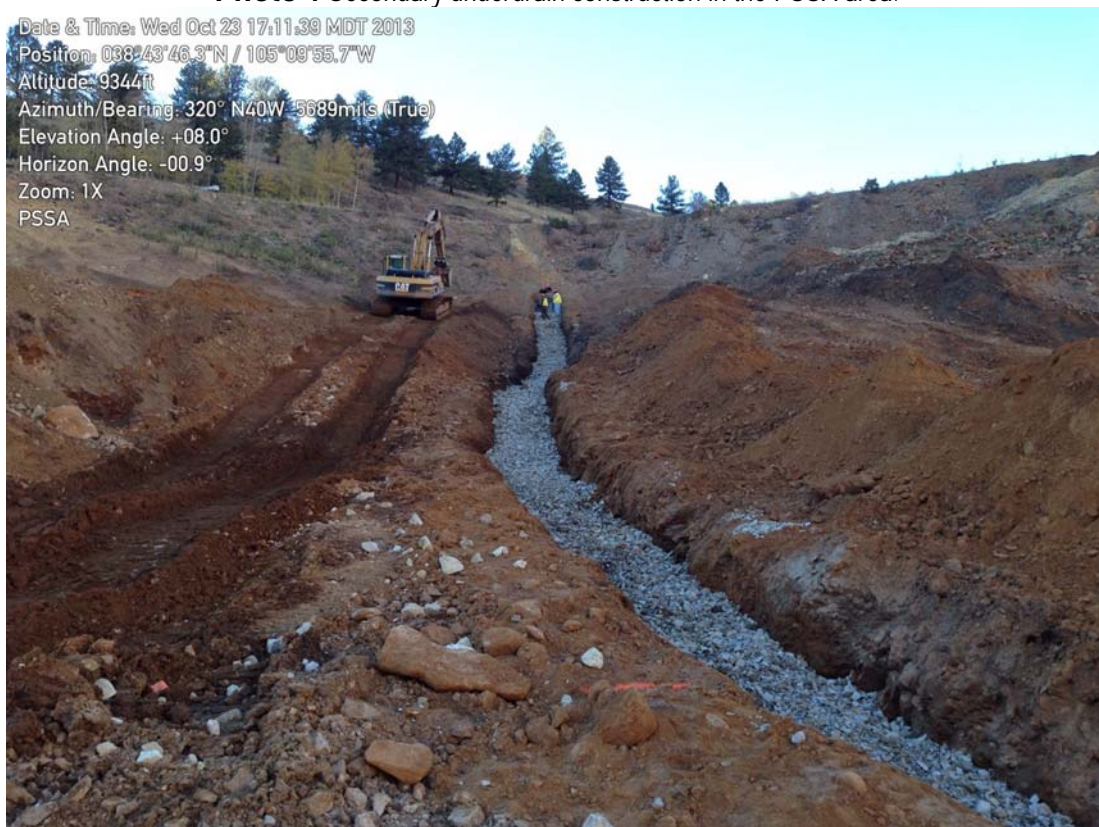
**Photo 2:** Secondary underdrain construction in the PSSA area.

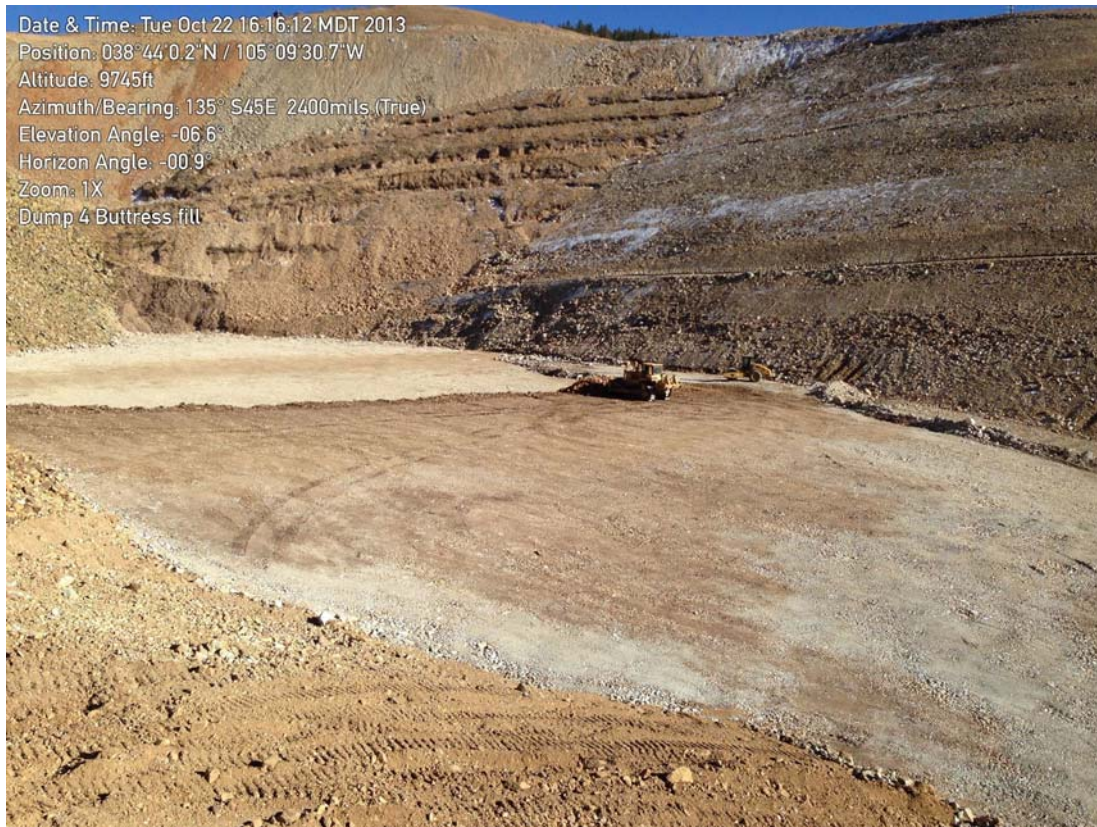
Structural fill materials were placed and compacted at the buttress fill below Dump 4. A Cat D8T was used to spread the loose lifts and compaction was achieved utilizing a Cat CS56 smooth drum roller by method specification.

**Photo 3:** The buttress fill below Dump 4.

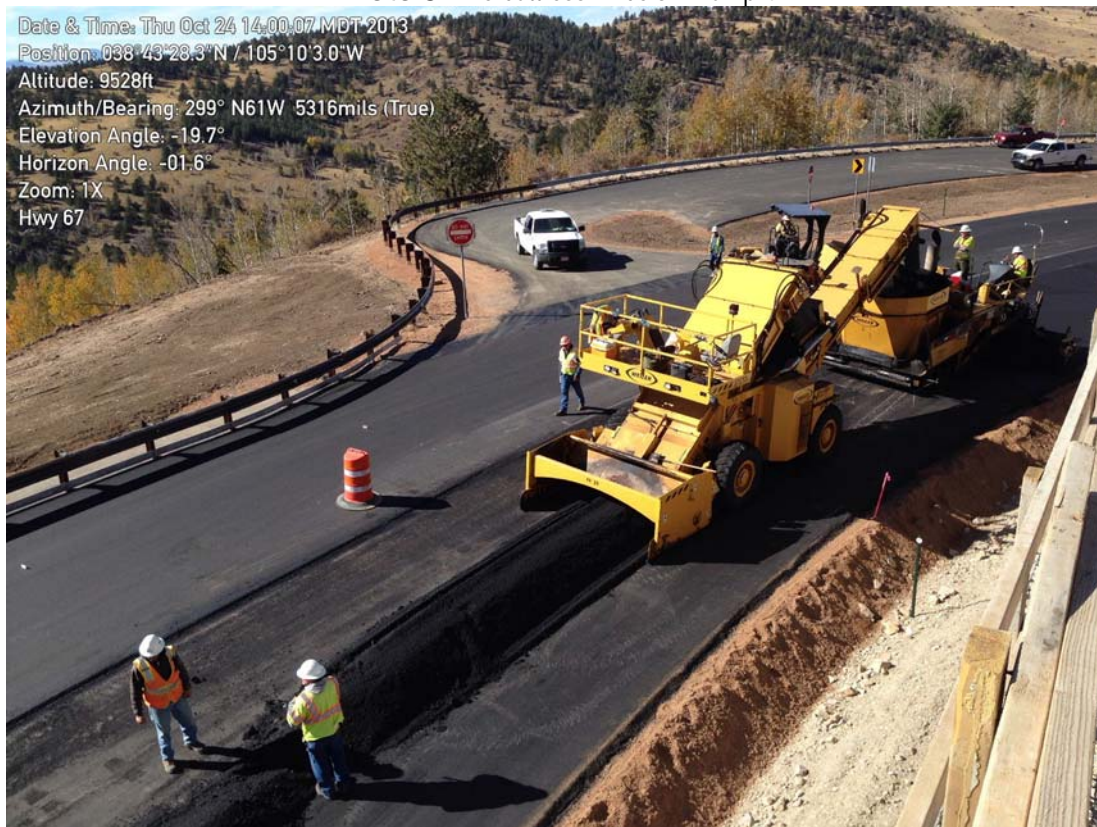
**Photo 4:** Paving operations adjacent to the South MSE Wall on the Hwy 67 Realignment.

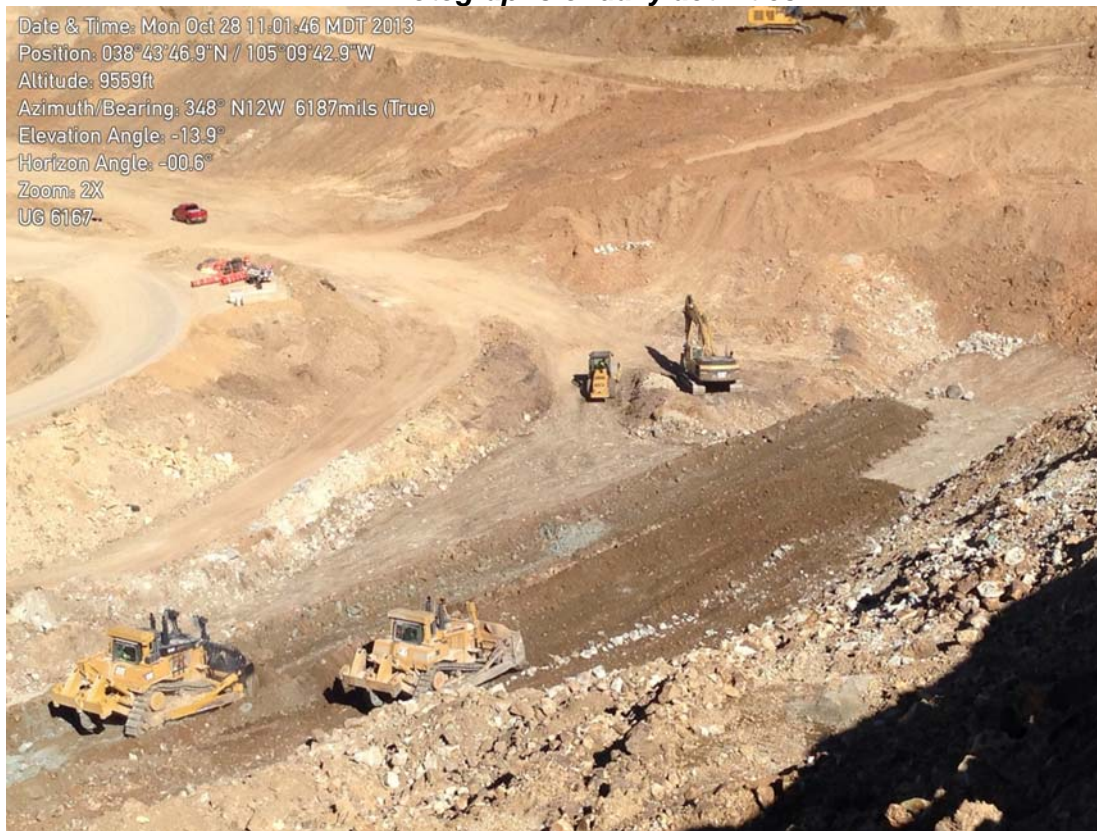
Structural fill materials were placed and compacted at UG workings 6167/U6273. A Cat D10T was used to spread the loose lifts and compaction was achieved utilizing a Cat CS56 smooth drum roller by method specification.

**Photo 1** Fill placement at UG 6167 and UG U6273.

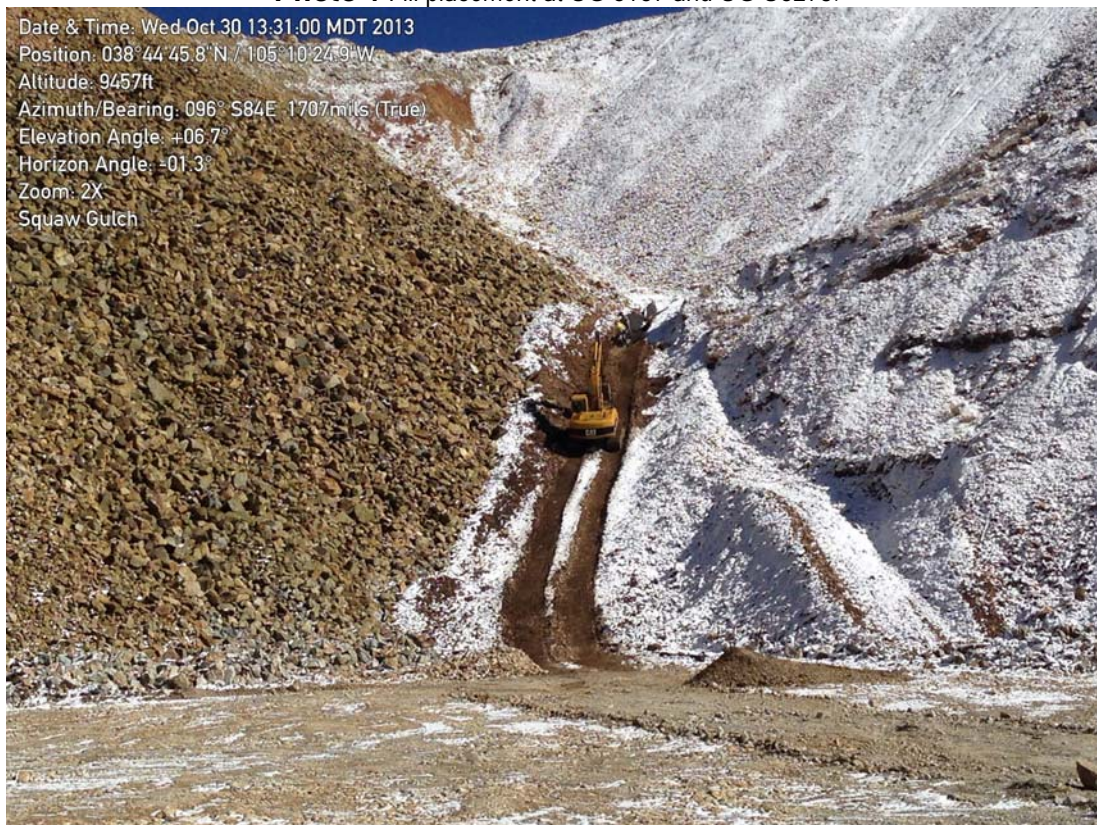
**Photo 2:** Secondary underdrain construction at Squaw gulch.

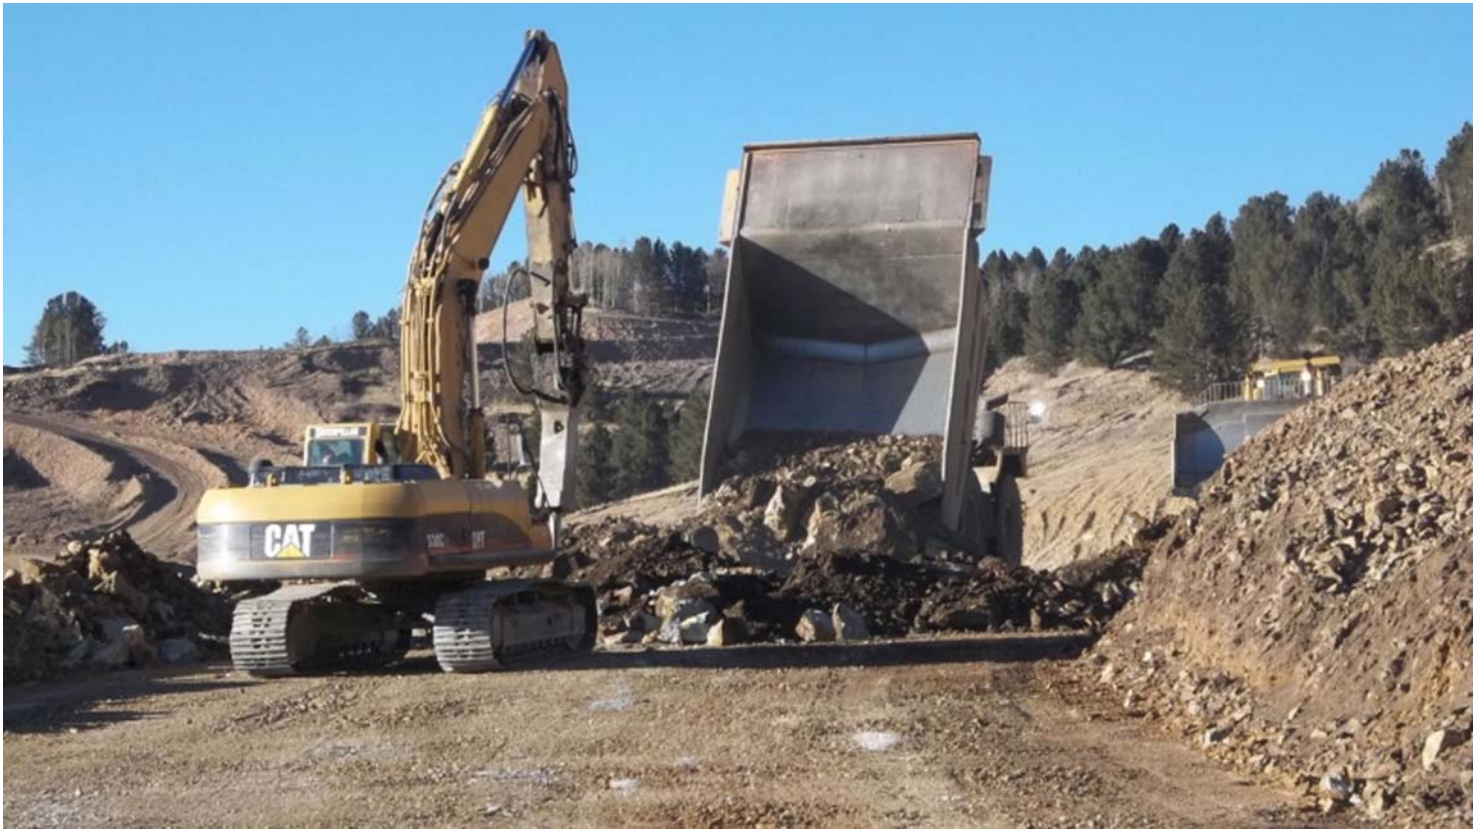
Structural fill materials were placed and compacted for the ADR haul road. A Cat D9T was used to spread the loose lifts and compaction was achieved utilizing a Cat CS56 smooth drum roller by method specification and any oversized material was broken with a Cat excavator hammer-hoe.

**Photo 3:** ADR haul road fill operations.

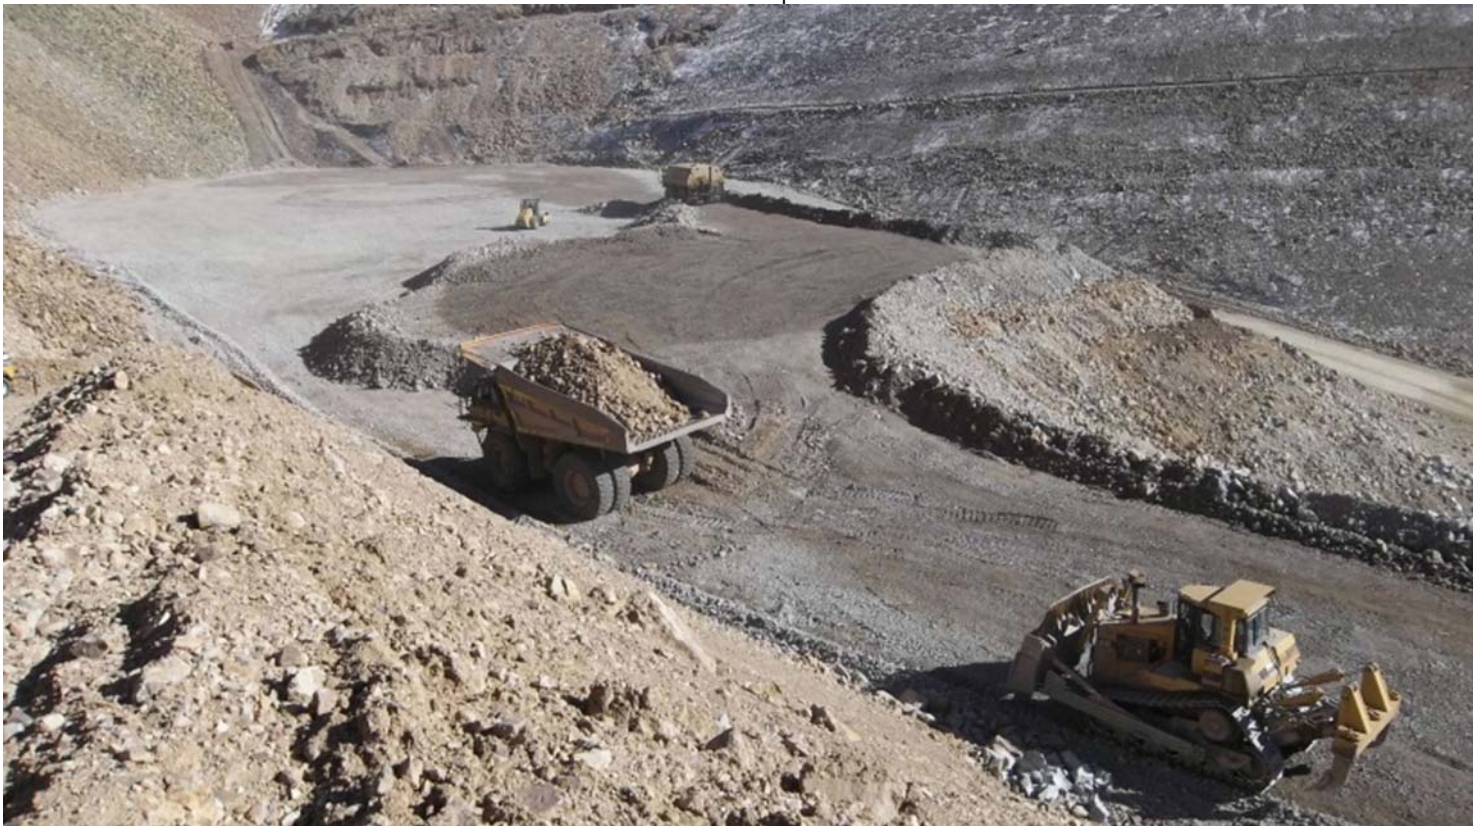
Structural fill materials were placed and compacted at the buttress fill below Dump 4. A Cat D8T was used to spread the loose lifts and compaction was achieved utilizing a Cat CS56 smooth drum roller by method specification.

**Photo 4:** Buttress fill operations below Dump 4.

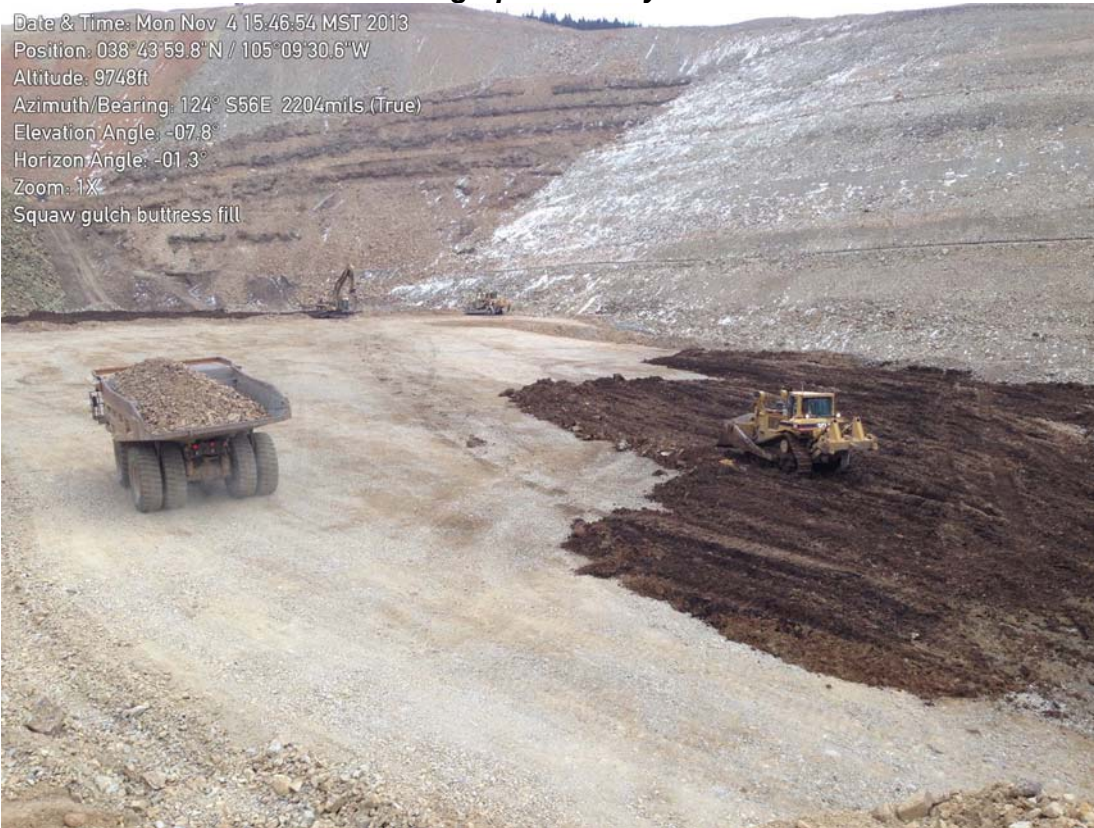
Structural fill materials were placed and compacted at the buttress fill below Dump 4 near Bench H. A Cat D8R and D9R dozer were used to spread the loose lifts and compaction was achieved utilizing a Cat CS56 smooth drum roller by method specification. Any oversized material was broken by a Cat 345 excavator hammer-hoe.

**Photo 1** Fill placement at the Buttress fill below Dump 4.

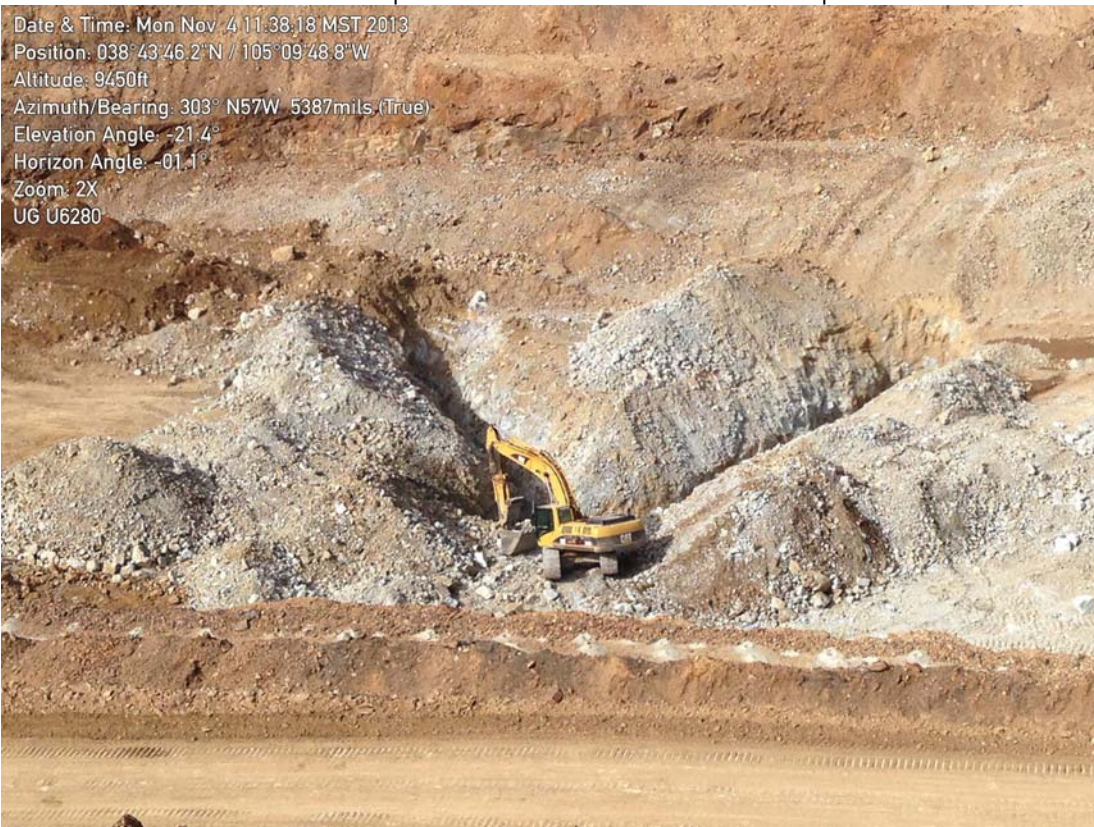
**Photo 2:** Fill placement at UG U6280.

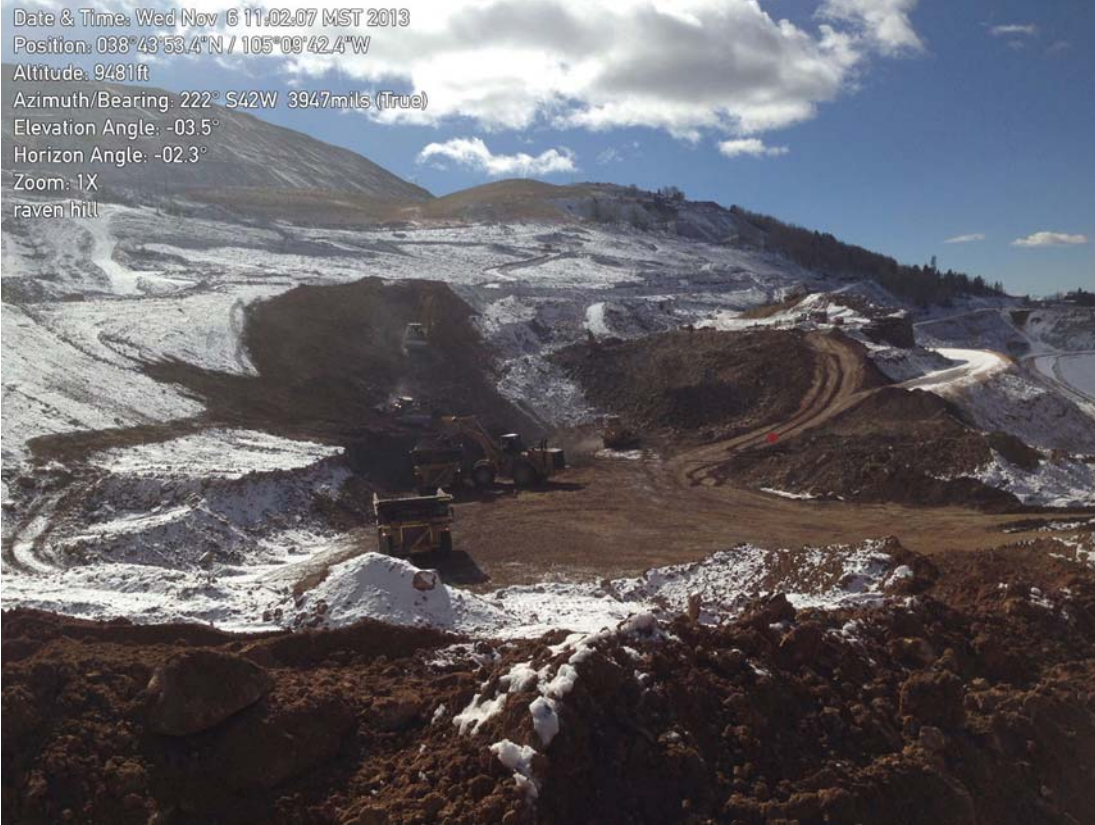
**Photo 3:** Cut activities at the Raven Hill / Crib Wall area.

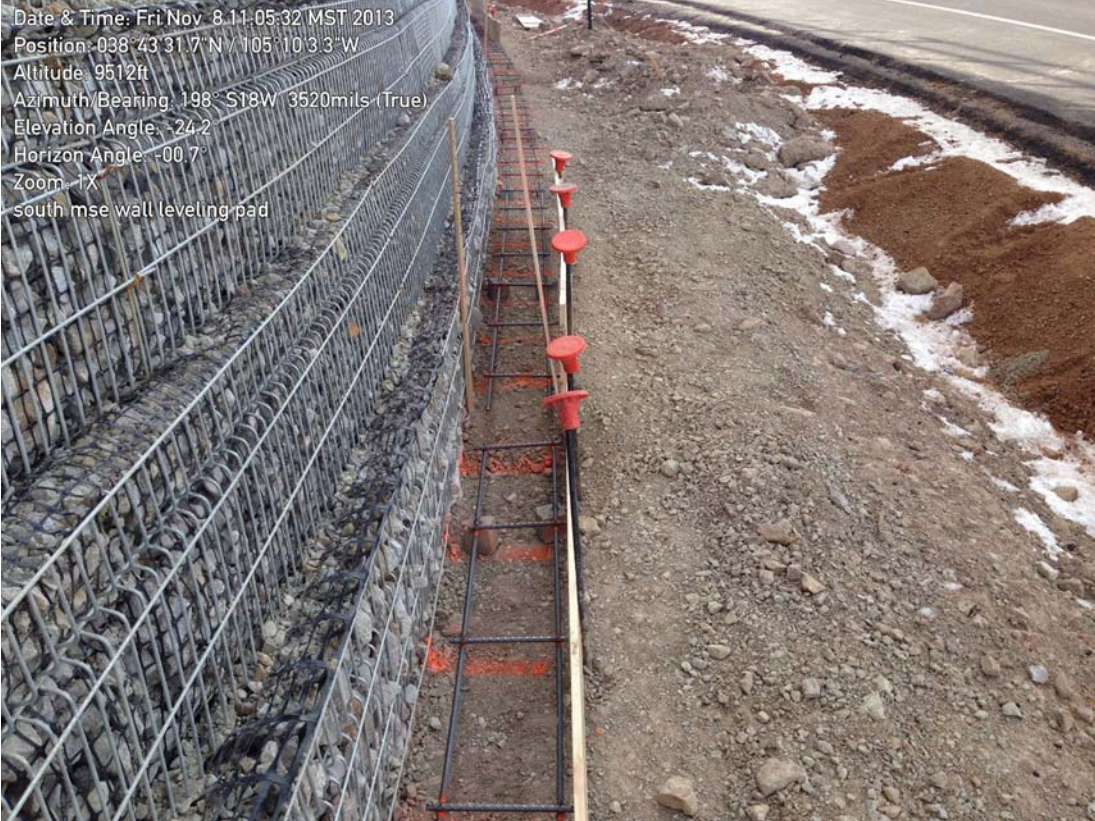
**Photo 4:** Rebar and concrete formwork for the leveling pad along the base of the South MSE wall.

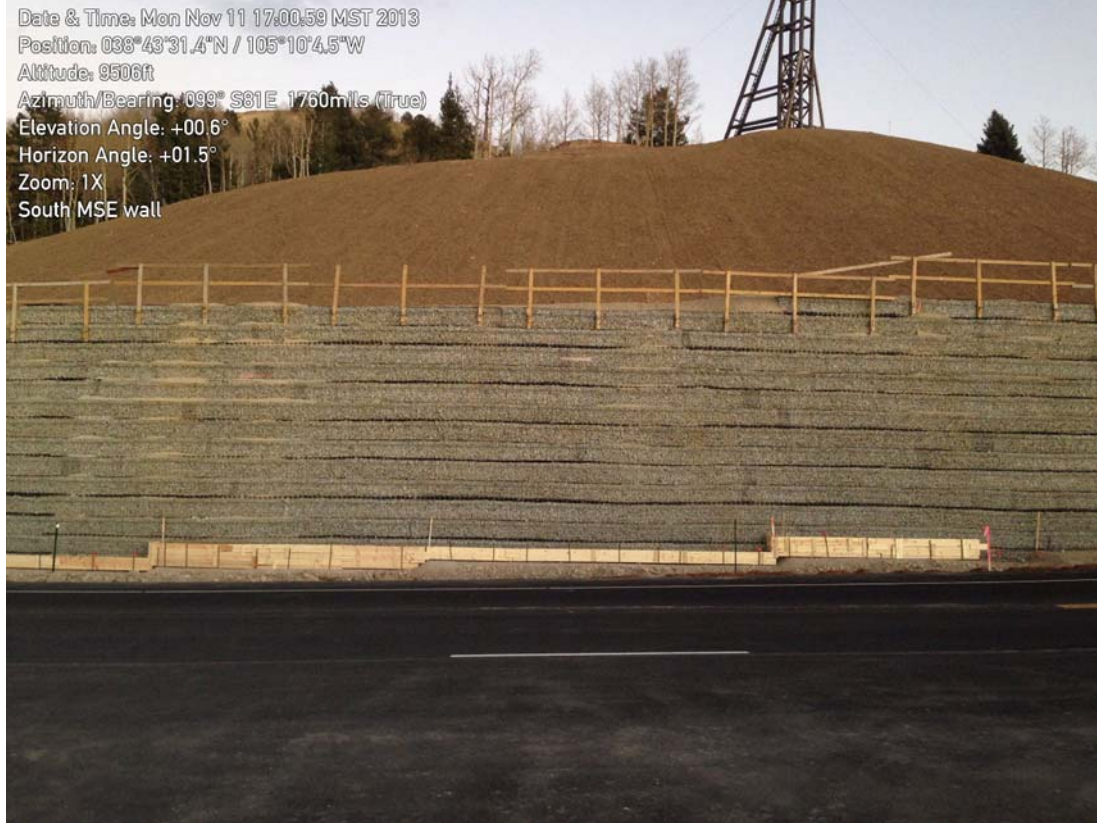
**Photo 1** Form work at the base of the South MSE Wall.

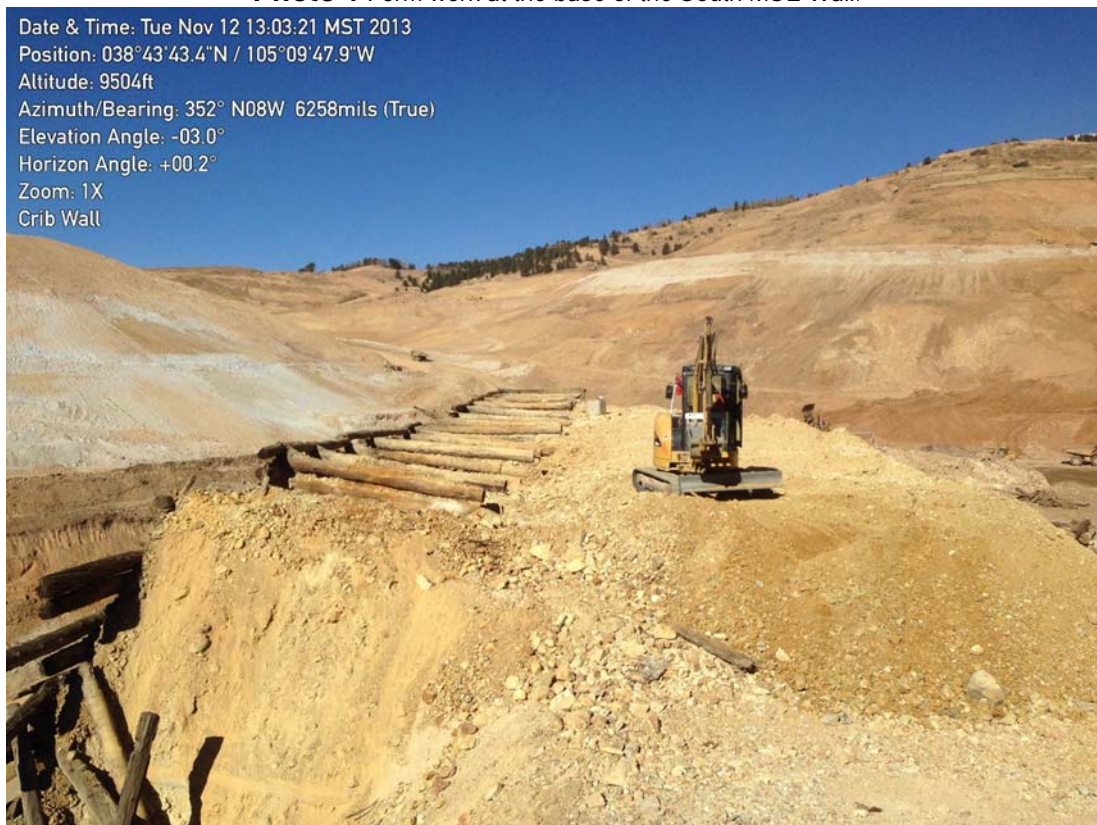
A Cat 302 mini excavator was observed removing tailings from behind the Crib Wall to expose the timbers for use on the South MSE Wall facade.

**Photo 2:** Crib wall removal.

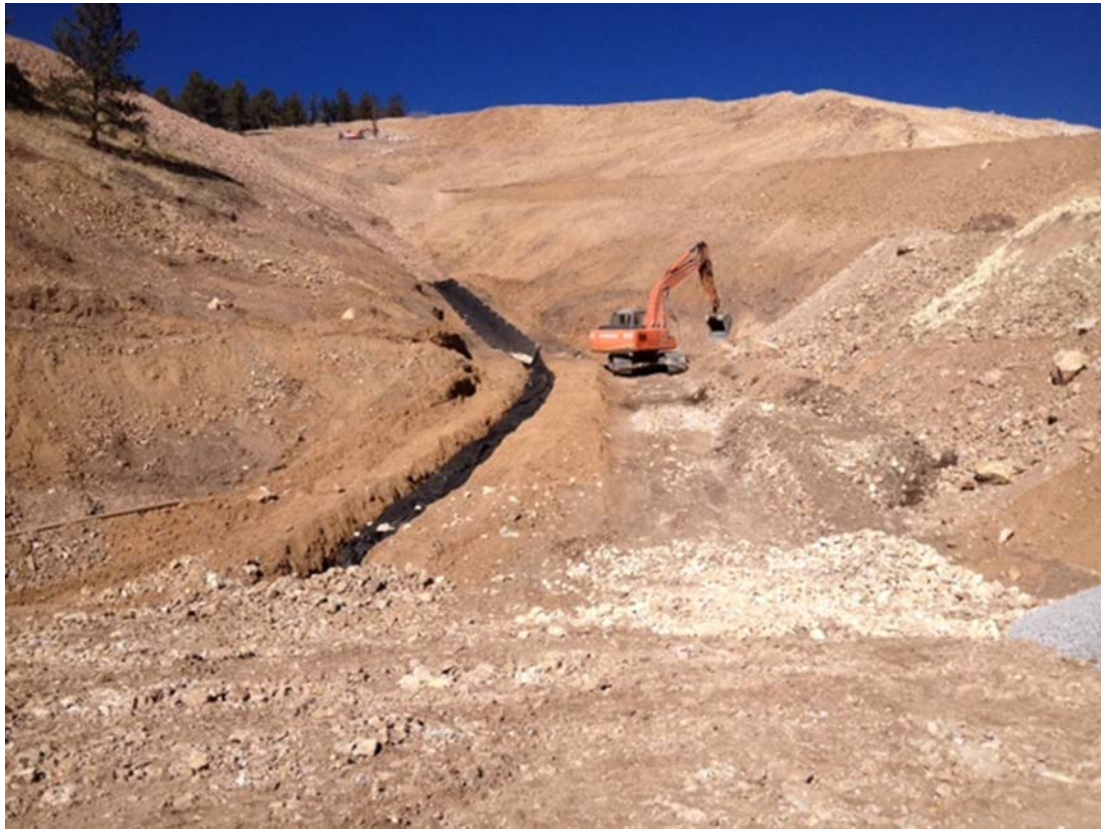
**Photo 3:** Secondary Underdrain installation near station A6+00.

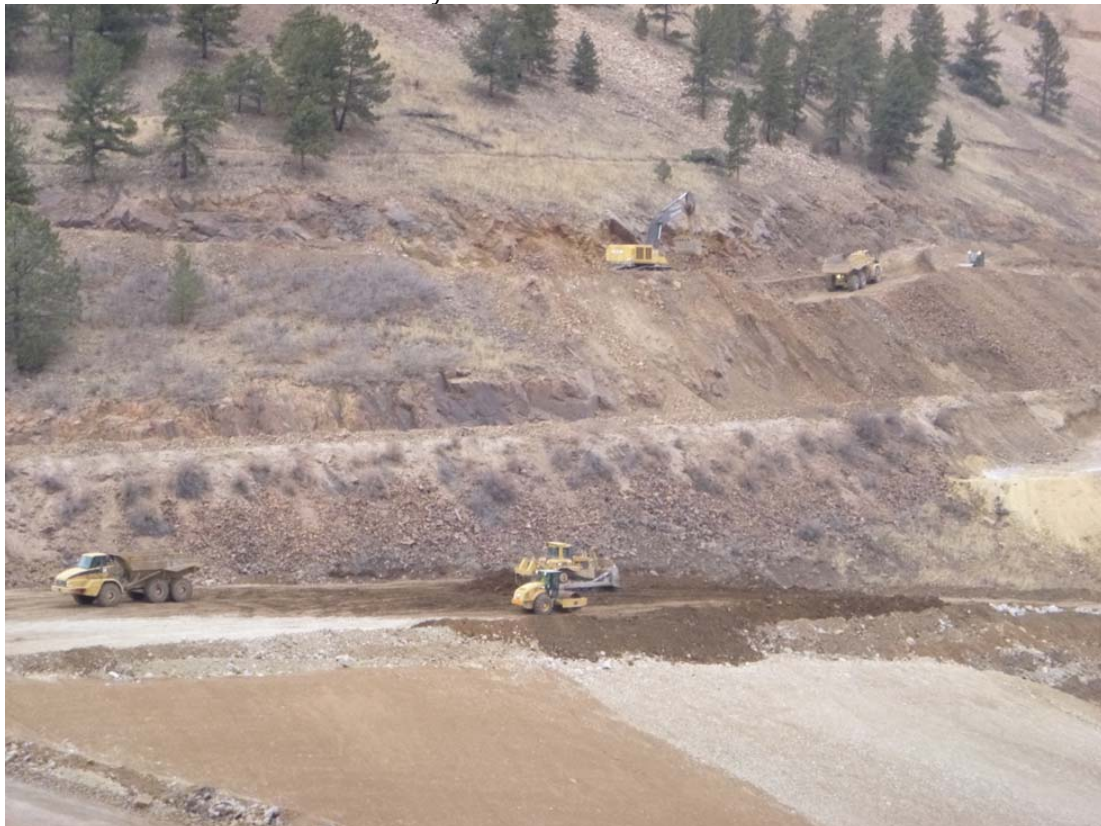
**Photo 4:** Fill Placement at the PSSA (lower) and cut and fill operations near stations A4+00 to A6+00(upper).

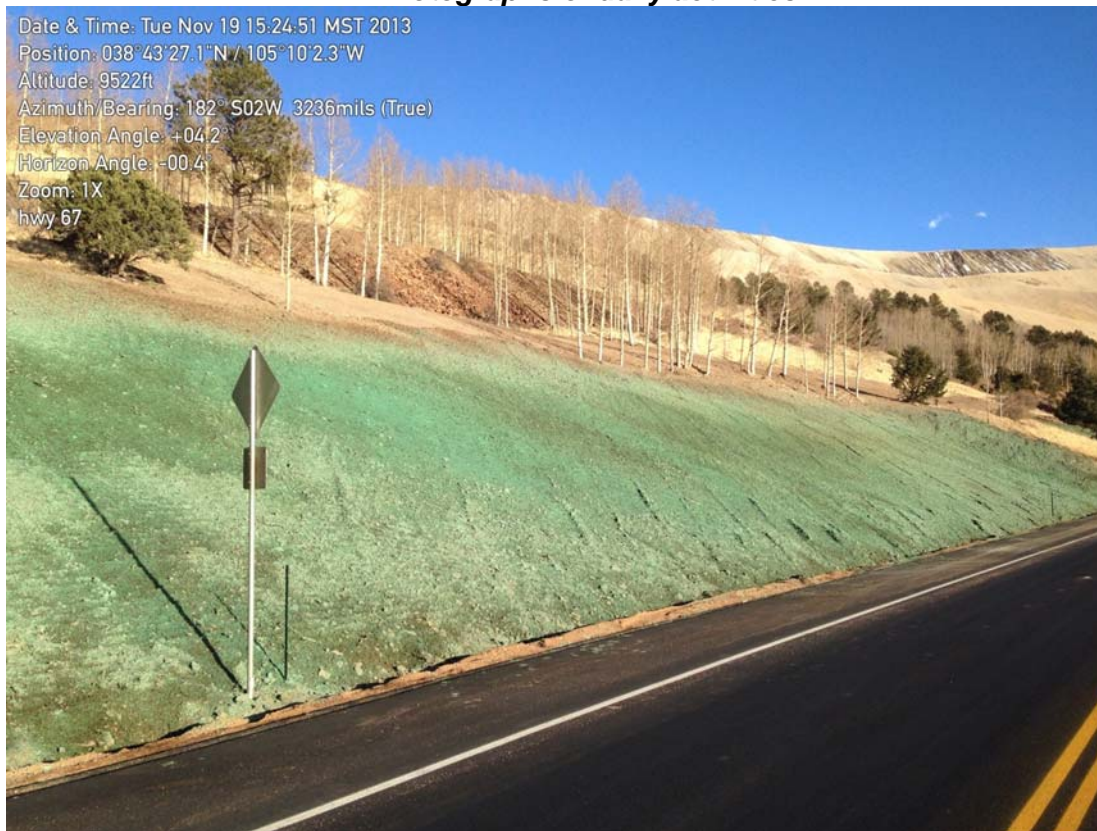
**Photo 1:** Hydro-seeding southeast of the South MSE Wall.

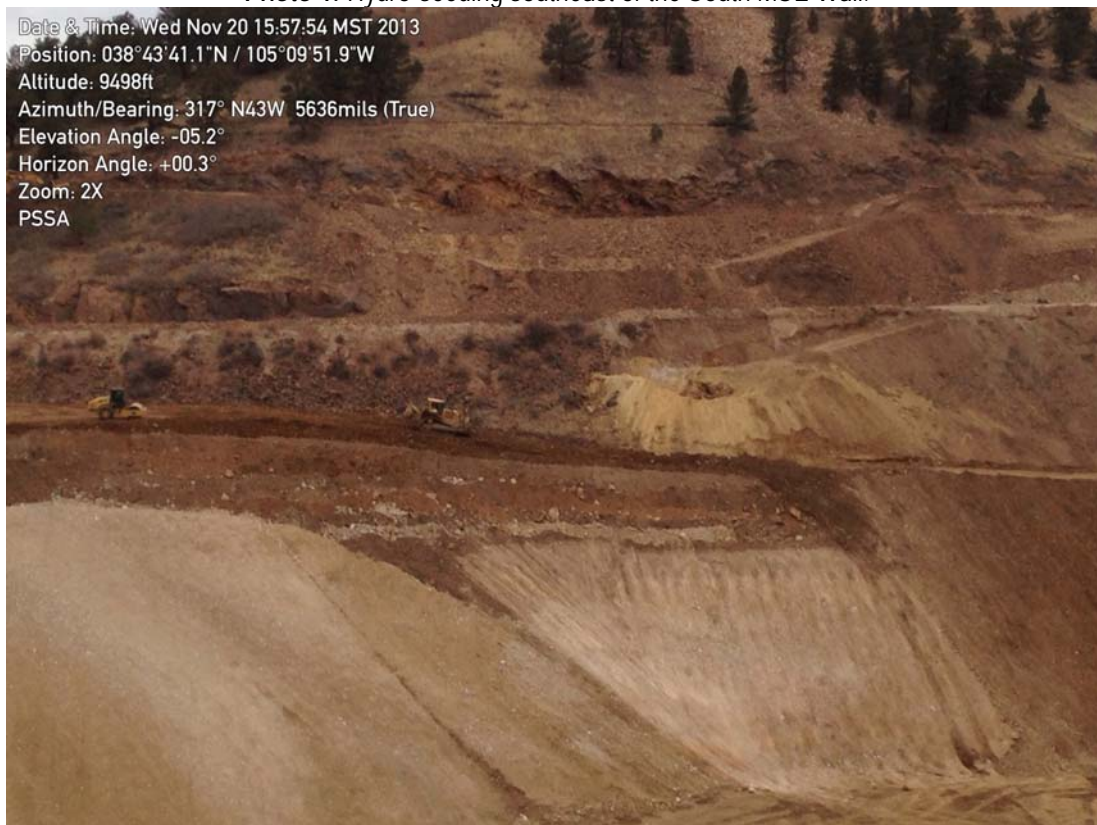
Structural fill materials were placed and compacted at the PSSA toe berm. A Cat D8T was used to spread the loose lifts and compaction was achieved utilizing a Cat CS56 smooth drum roller by method specification.

**Photo 2:** Fill placement at the PSSA Toe Berm.

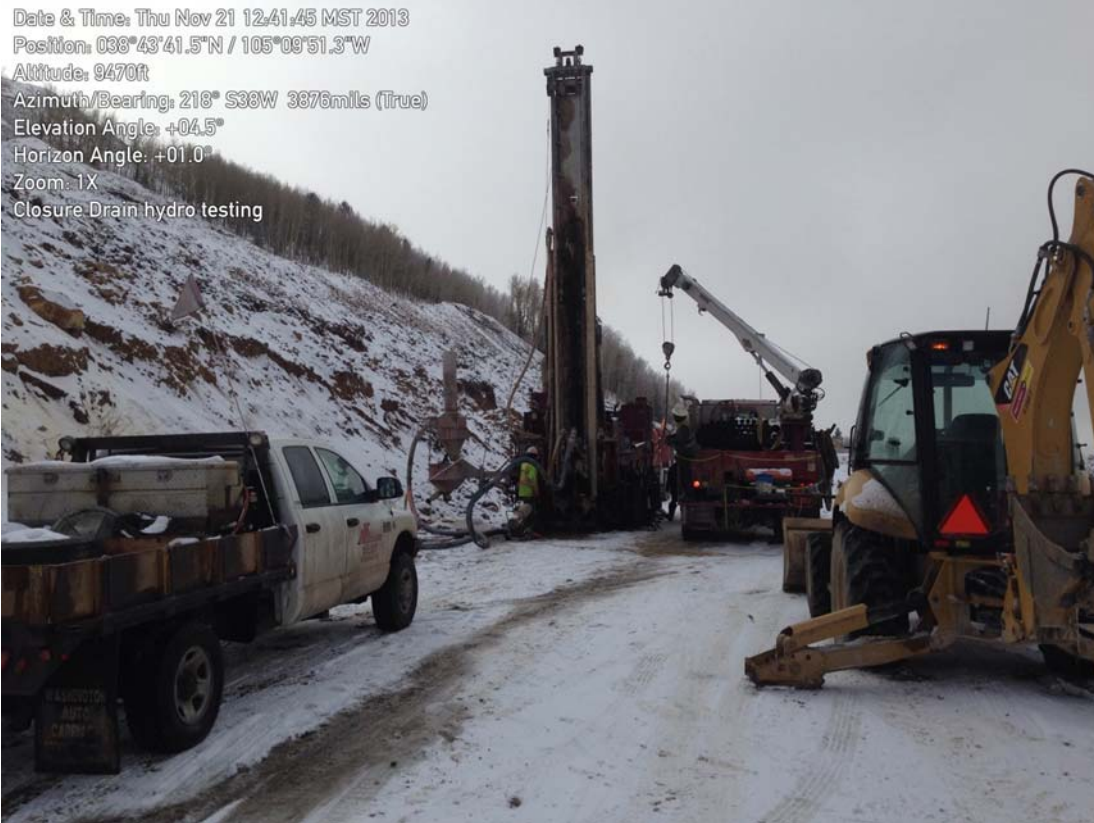
**Photo 3:** Closure Drain hydro testing borehole abandonment (Borehole #1).

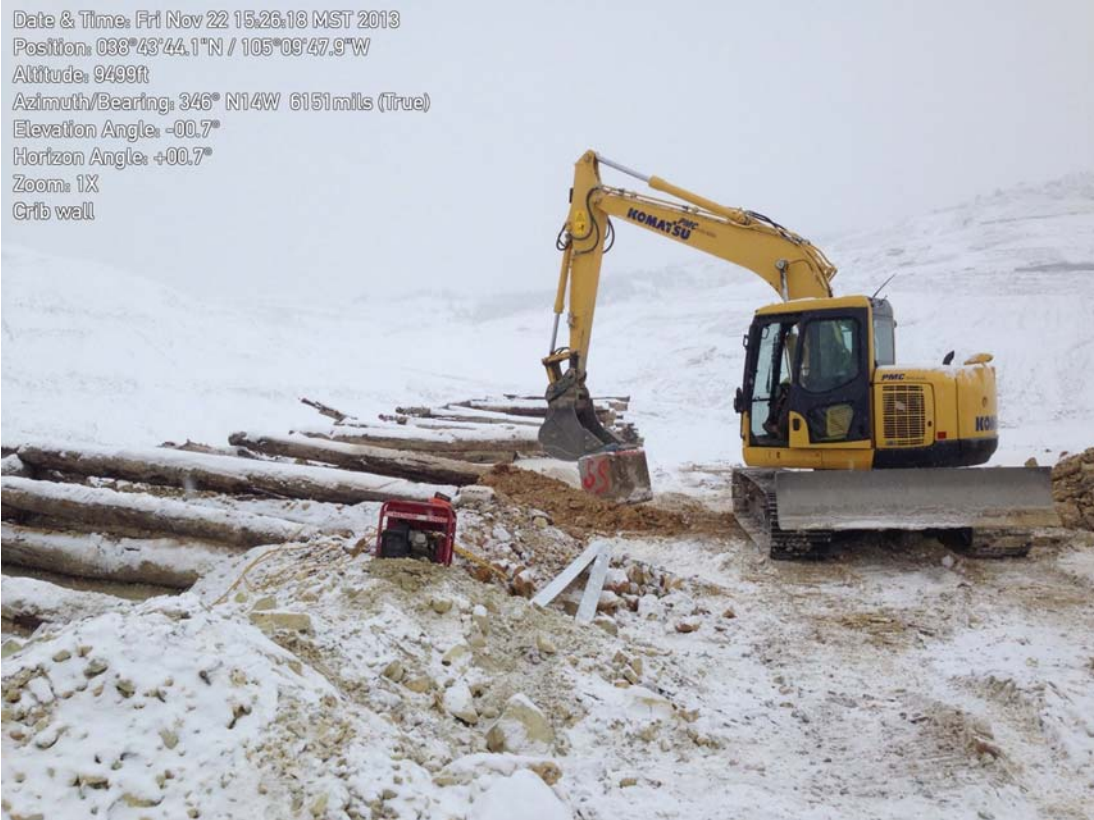
A Komatsu mini excavator was observed removing tailings from behind the Crib Wall to expose the timbers for use on the South MSE Wall facade.

**Photo 4:** Tailings removal behind the Crib Wall.

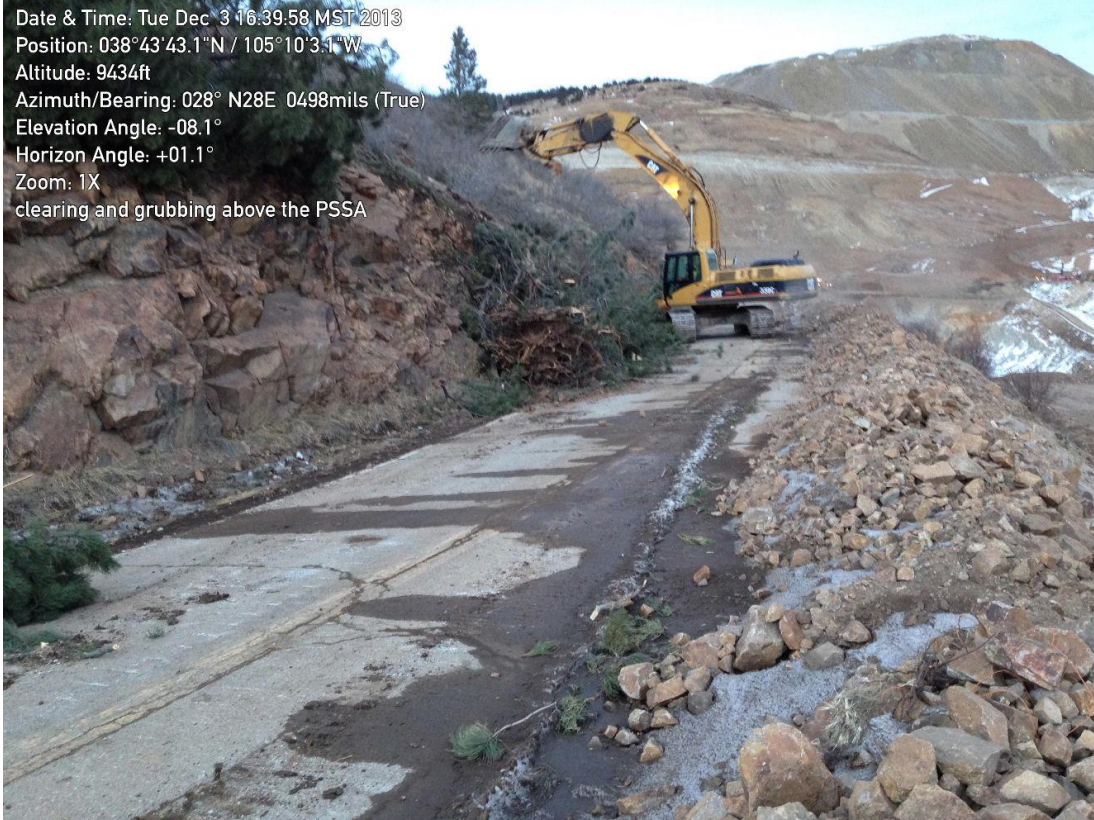
A Cat 330 was observed clearing and grubbing near station A0+00 above the former Hwy 67 roadway and the PSSA Toe Berm.

**Photo 1:** Clearing and grubbing above the PSSA Toe Berm near station A0+00.
