**H CRIPPLE CREEK & VICTOR GOLD MINING Co.**  
**Squaw Gulch (VLF), HWY 67 Realignment Field Monitoring Summary Weekly Report**

<b>Owner:</b>	Cripple Creek & Victor Gold Mining Co.	<b>Project Number:</b>	74201125N0. ****. ****	<b>Date</b>	10.26.2013
<b>Project:</b>	Squaw Gulch (VLF), Hwy 67 Realignment				
<b>Location:</b>	Cripple Creek & Victor Gold Mine, Colorado				
<b>Contractor:</b>	Ames Construction Co. Inc.

**Reporting Period: 10.20.13 thru 10.26.13**

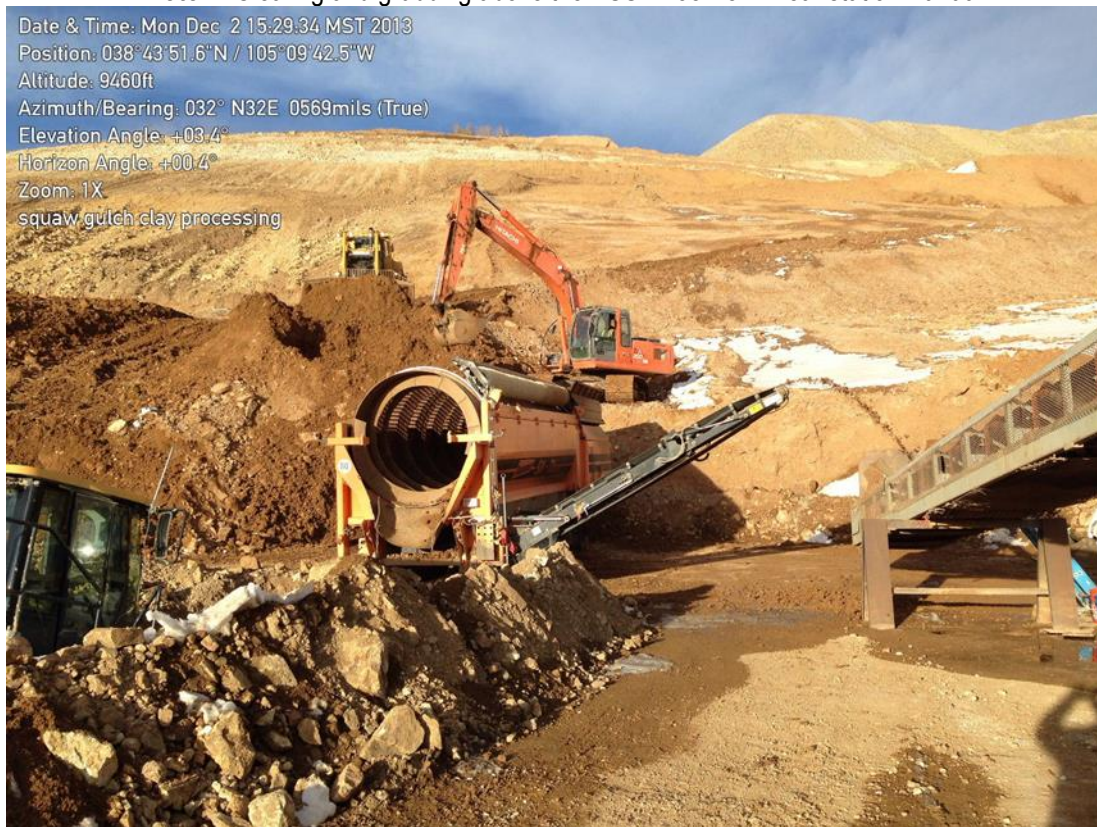
**Photo 2:** Clay processing at Squaw Gulch.

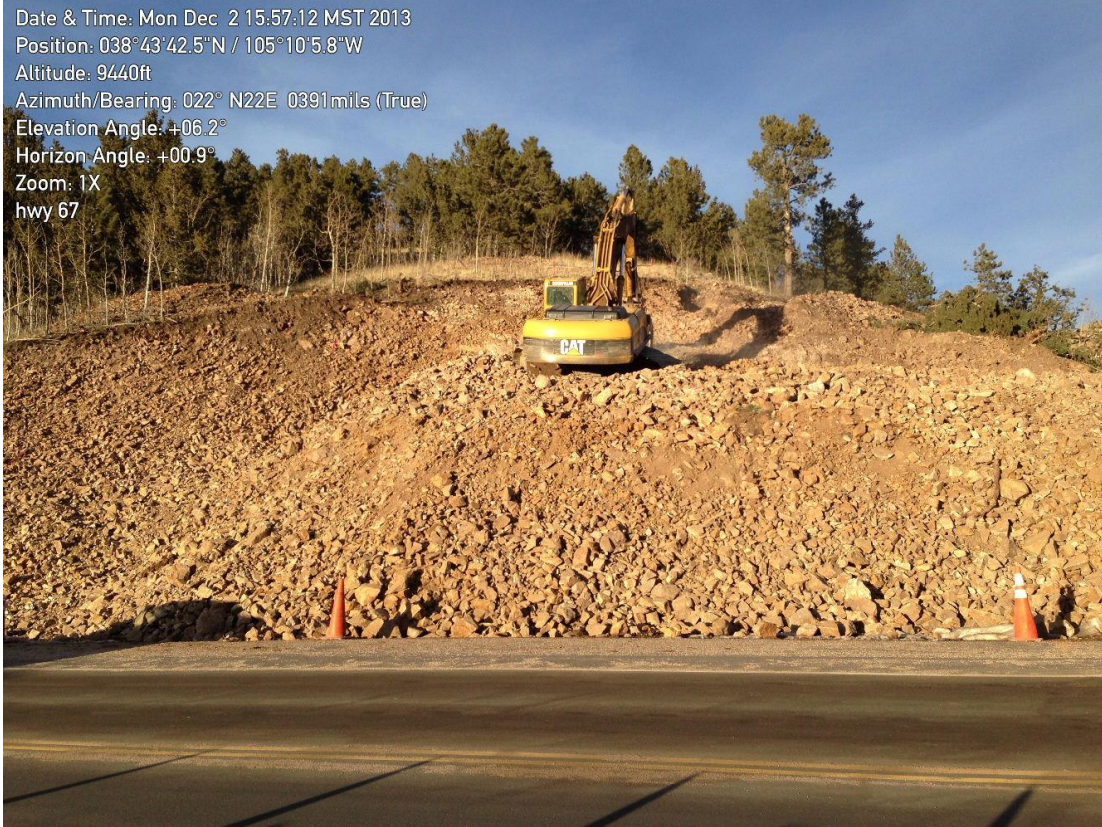
**Photo 3:** Slope grading near the Cripple Creek tie-in above Hwy 67.

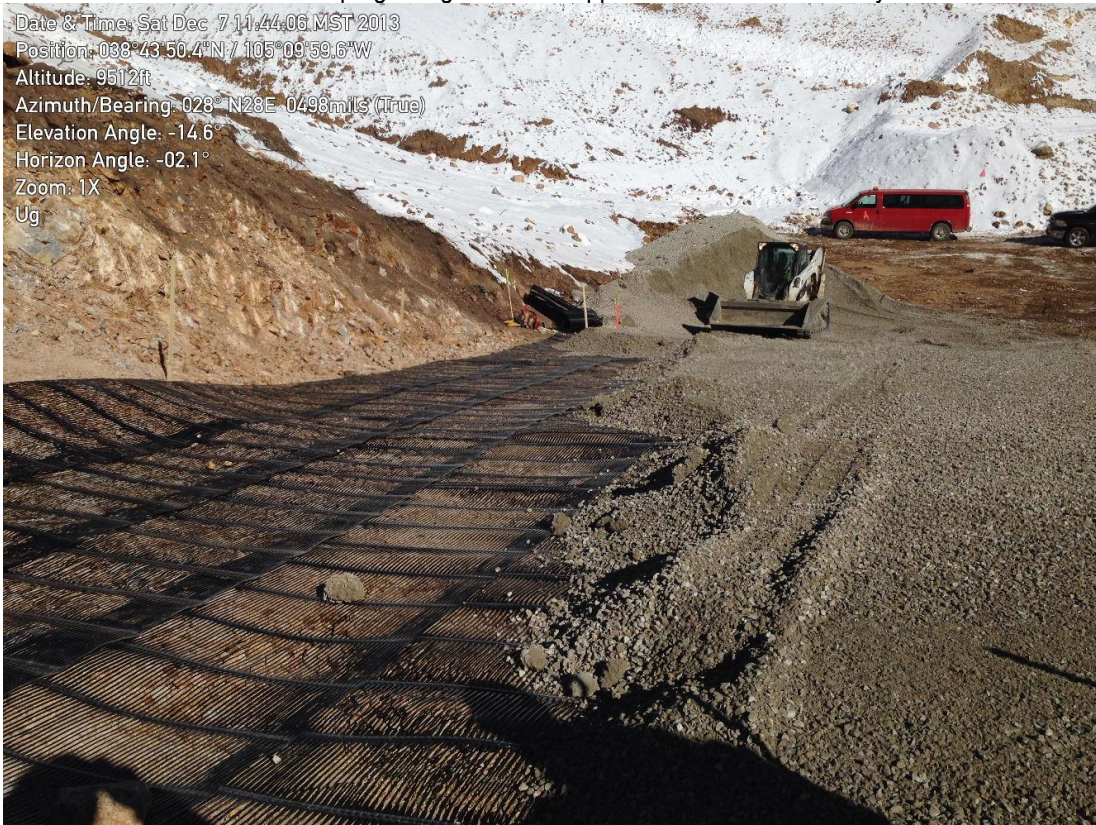
**Photo 4:** Geogrid placement and fill covering at UG6304.

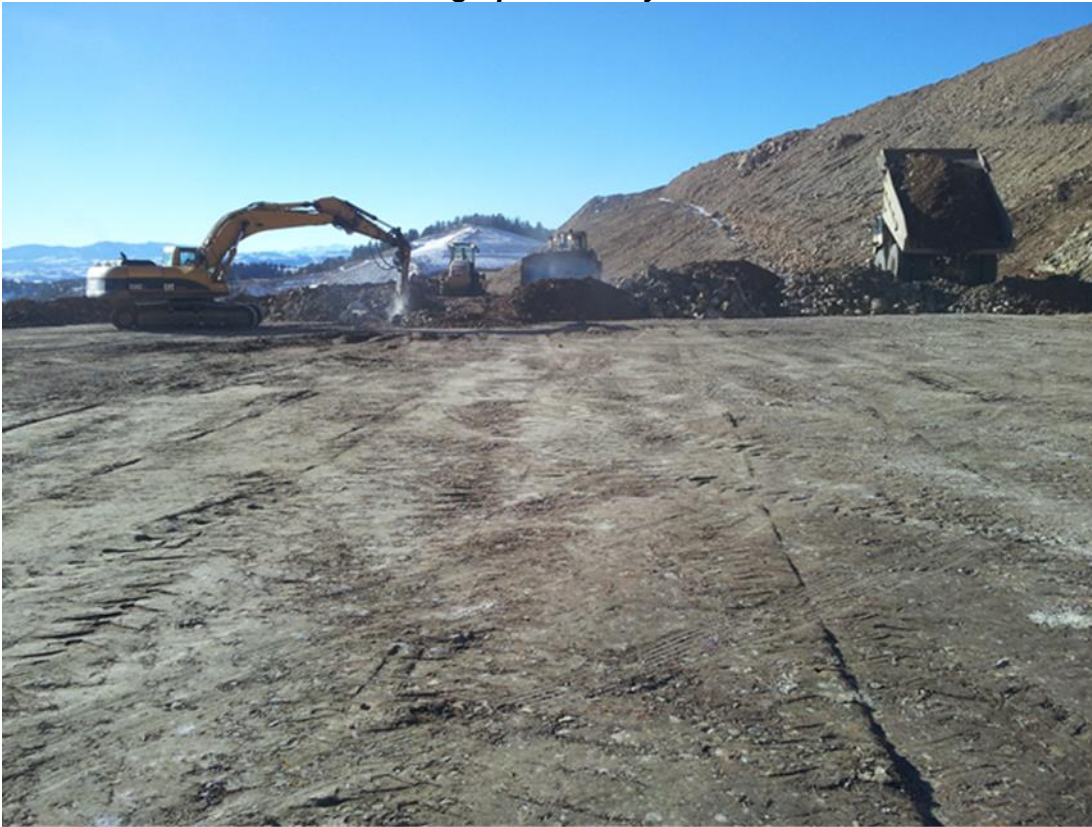
**Photo 1:** Placing, compacting and breaking oversize rocks at the buttress fill area.

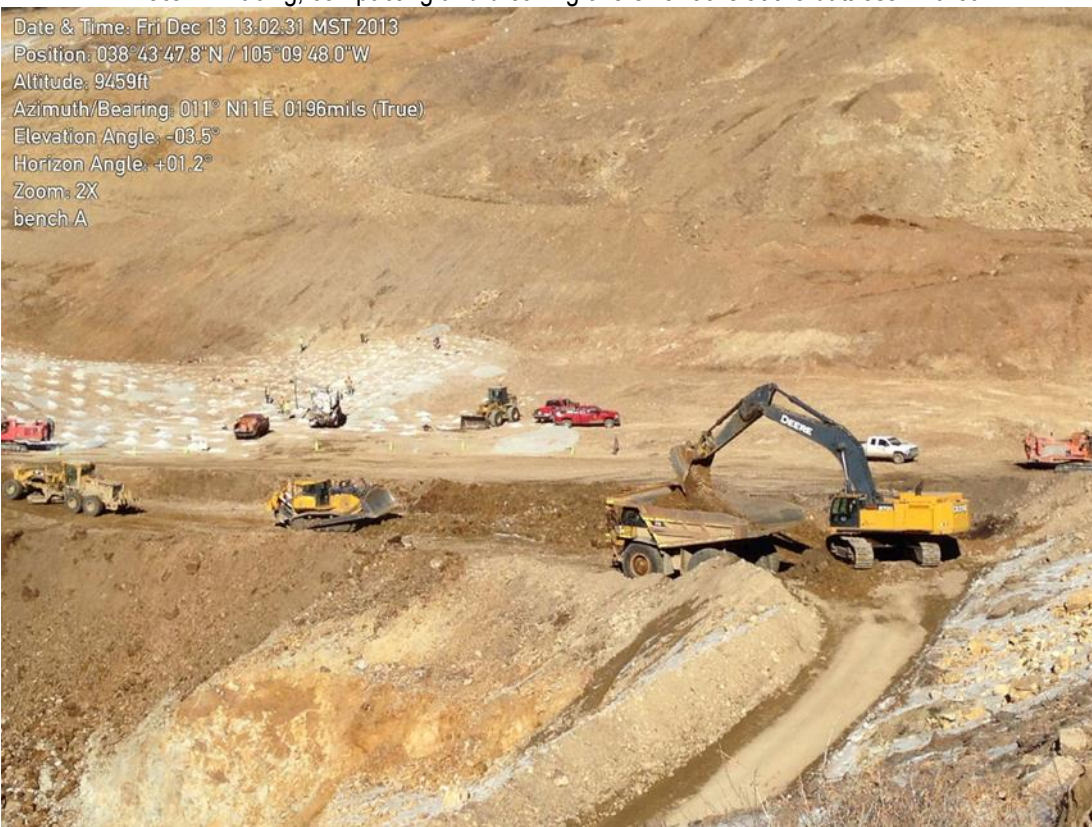
**Photo 2:** Production drilling near Station A16+00 and cut removal near station A18+00.

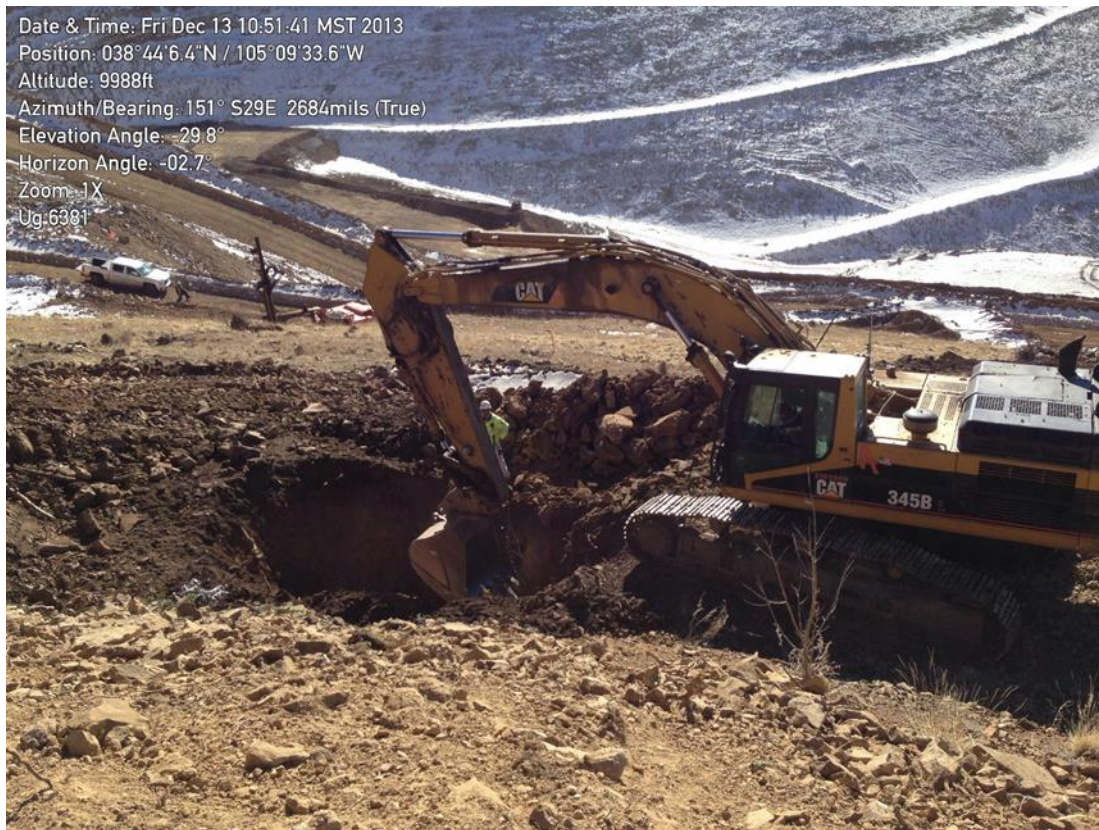
**Photo 3:** Excavating UG #6381-northwest side of the working.

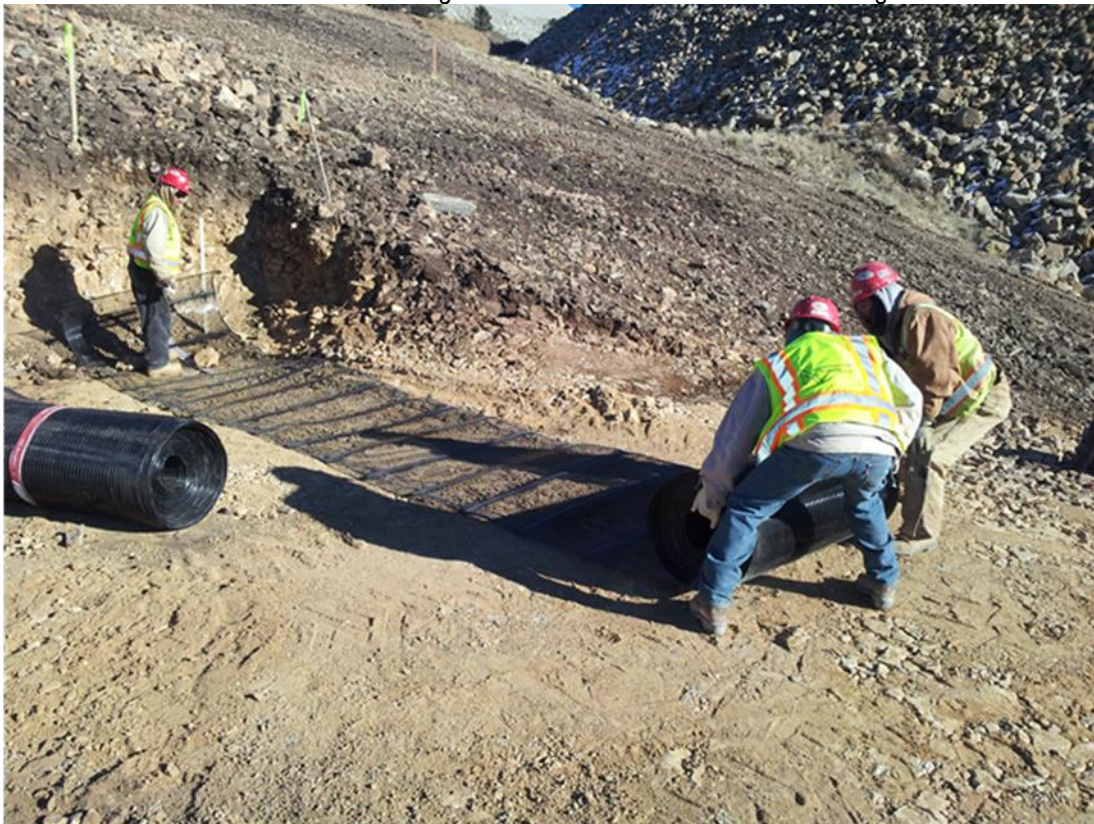
**Photo 4:** Geogrid installation on UG #6372.

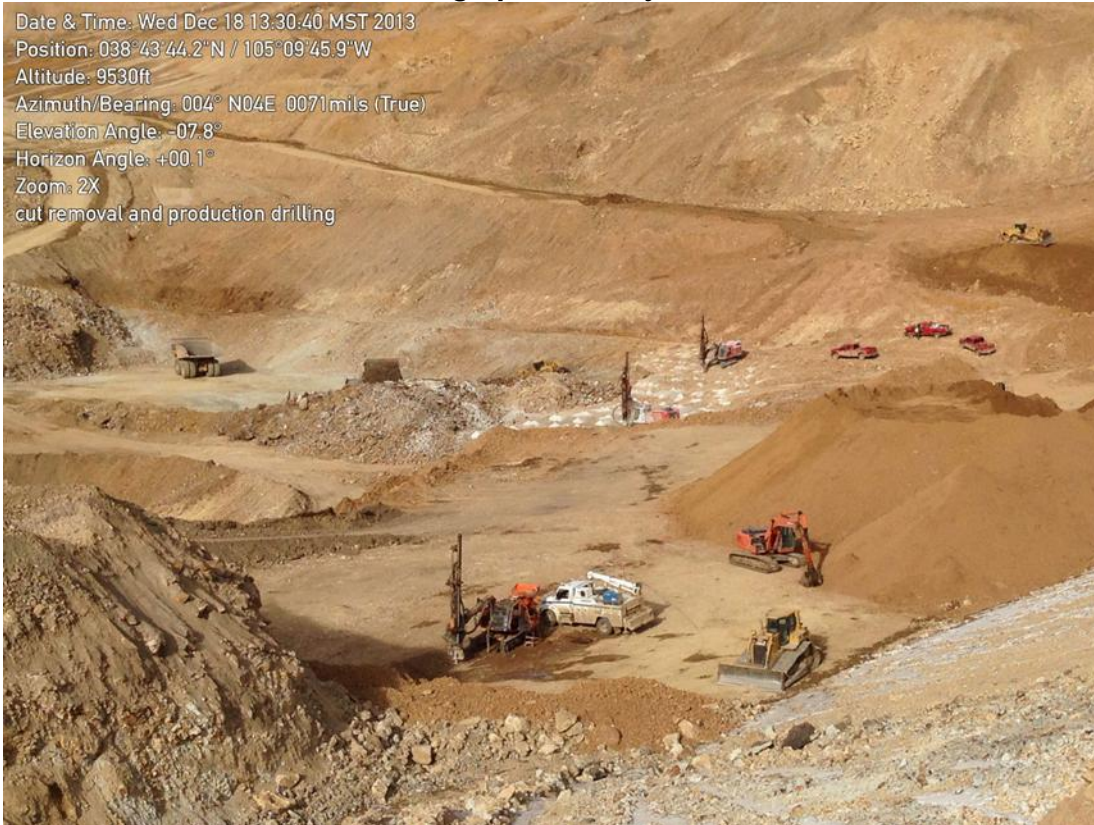
**Photo 1:** Cut removal and production drilling along Bench A.

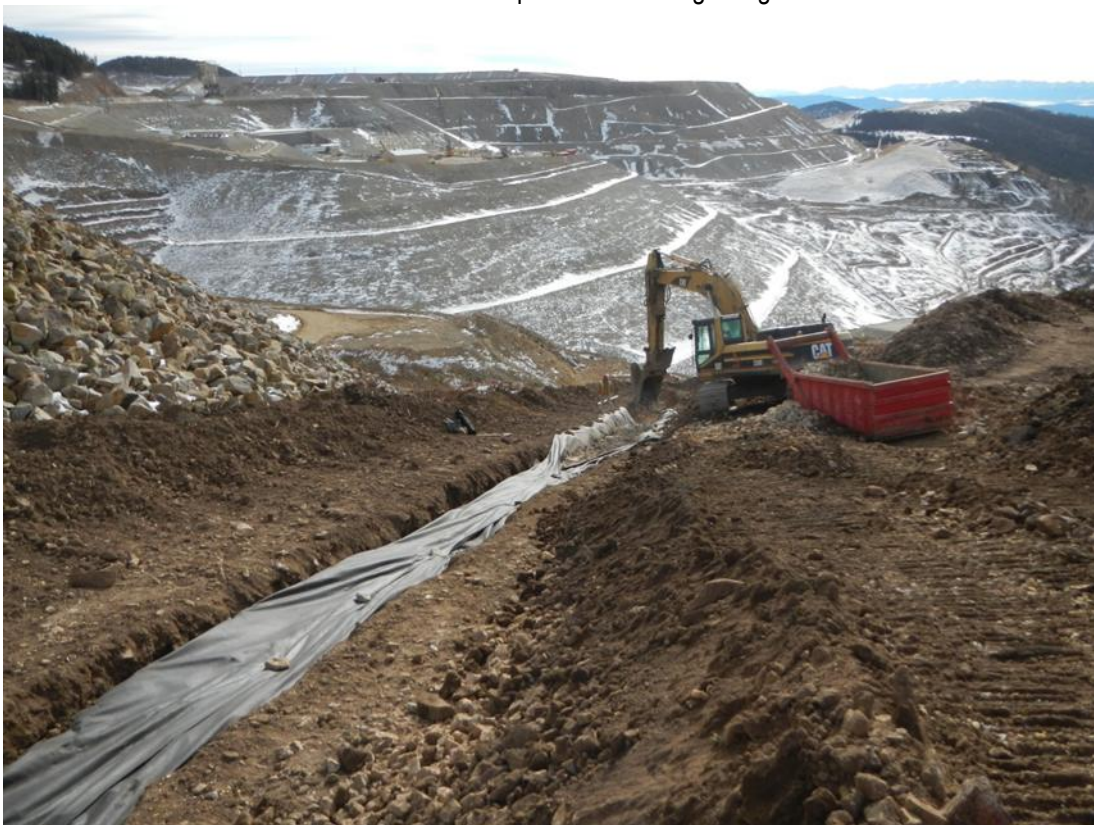
**Photo 2:** Secondary underdrain installation near the Phase 2 Diversion Channel.

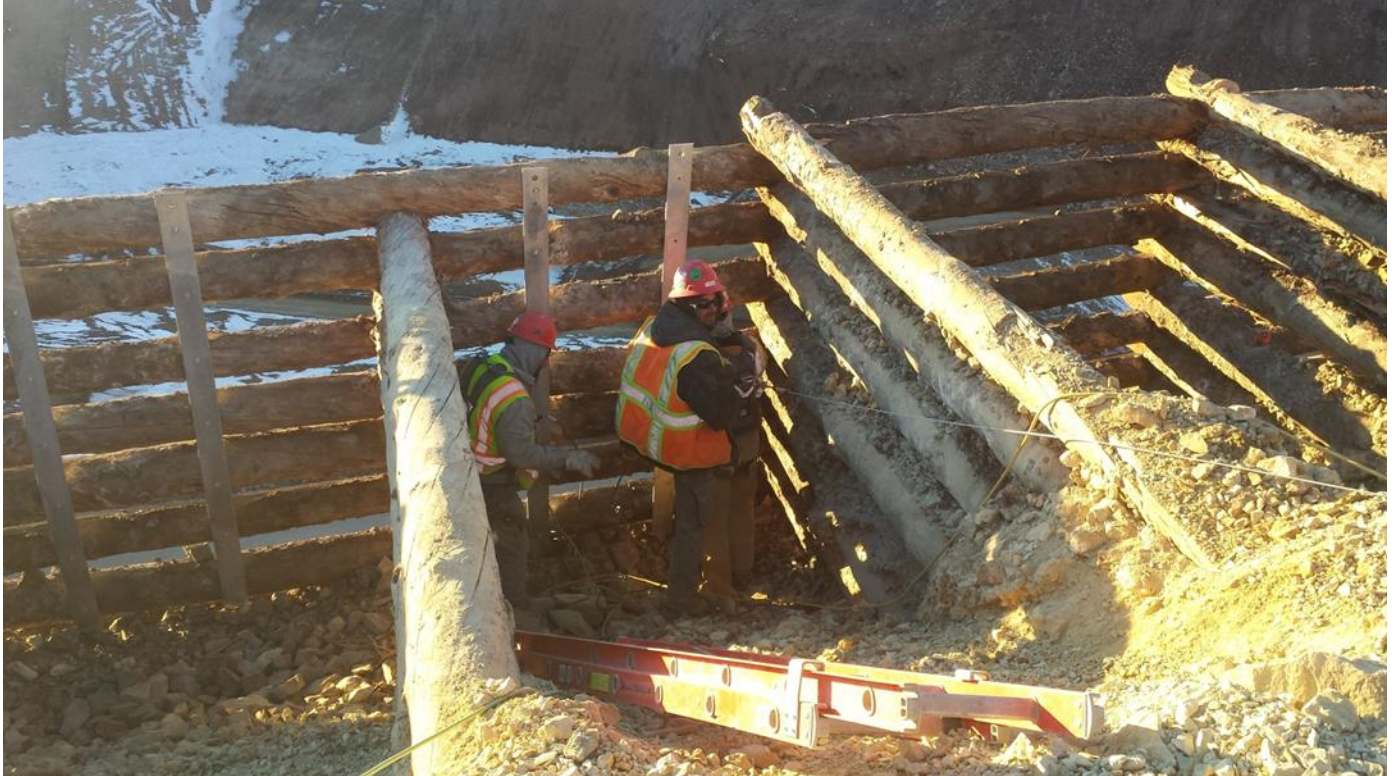
**Photo 3:** Preparation for timber removal at the Crib Wall

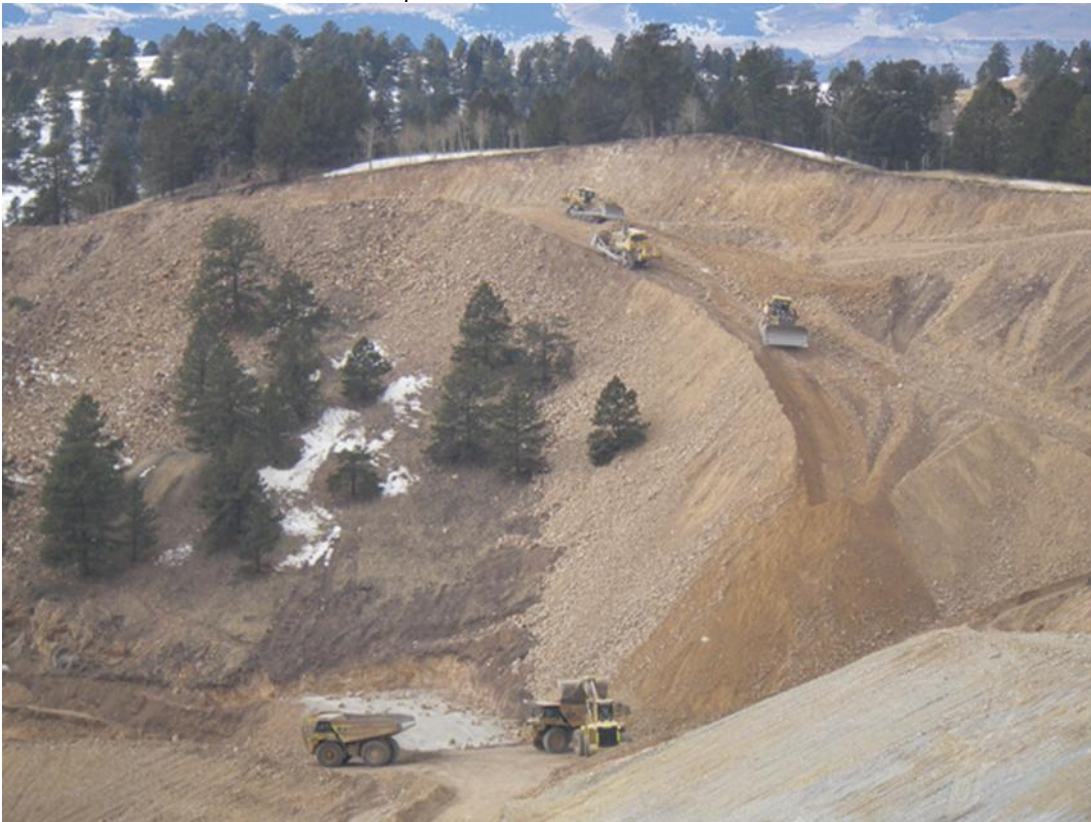
**Photo 4:** Cut operations between stations Q6+00 and A6+00.

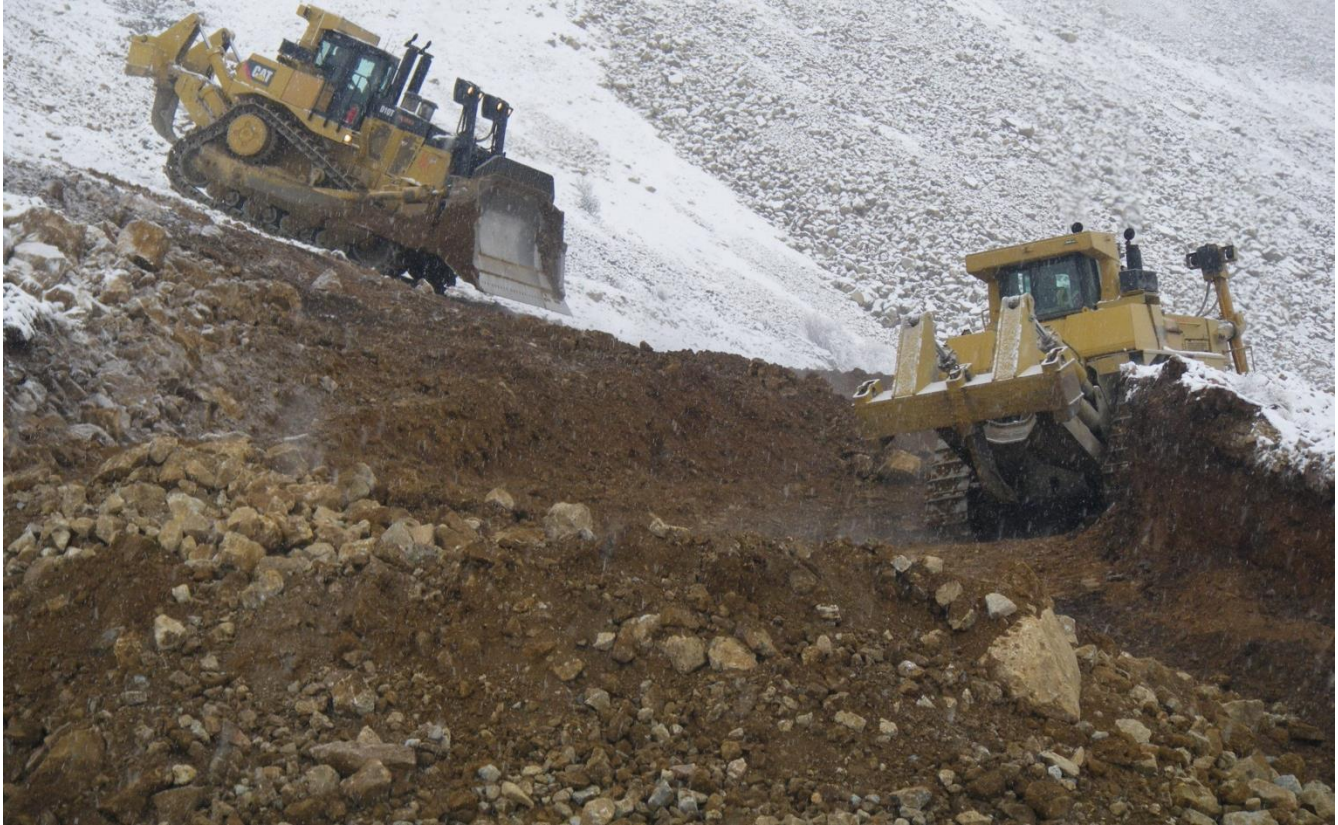
**Photo :** Dozers pushing material downslope near station Q6+00.

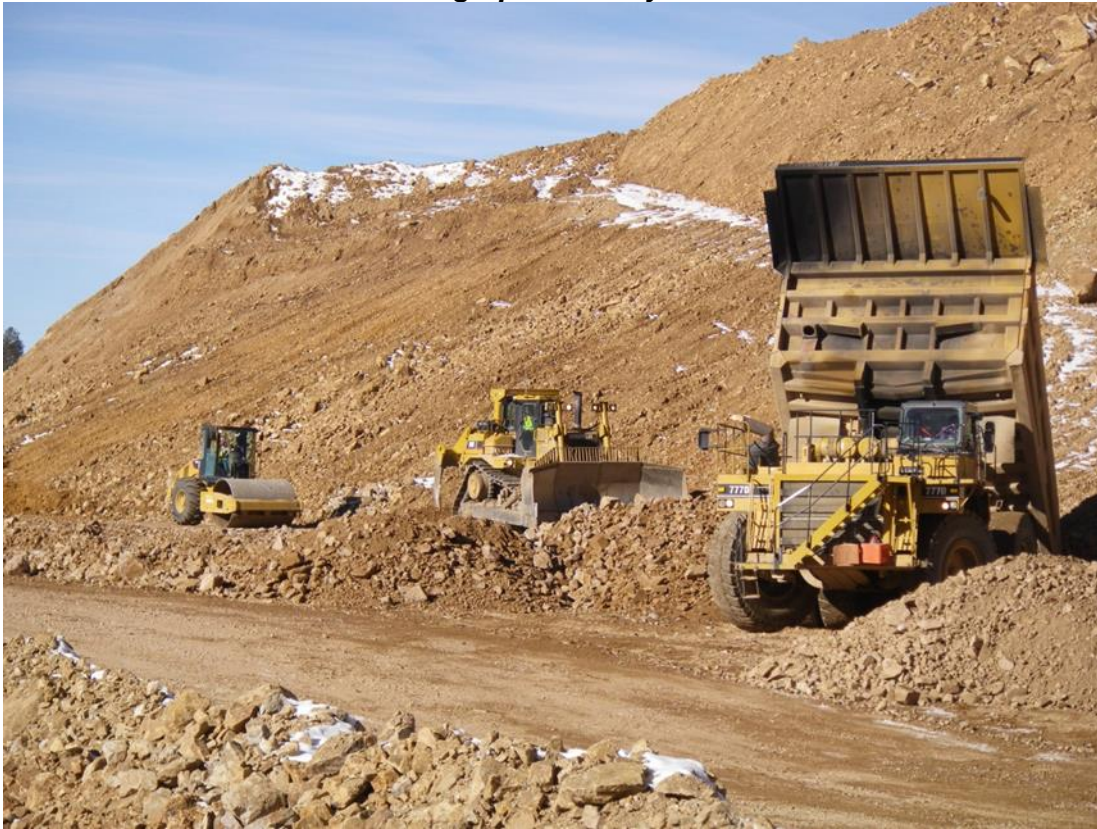
**Photo 1:** Fill placement at the ADR road.

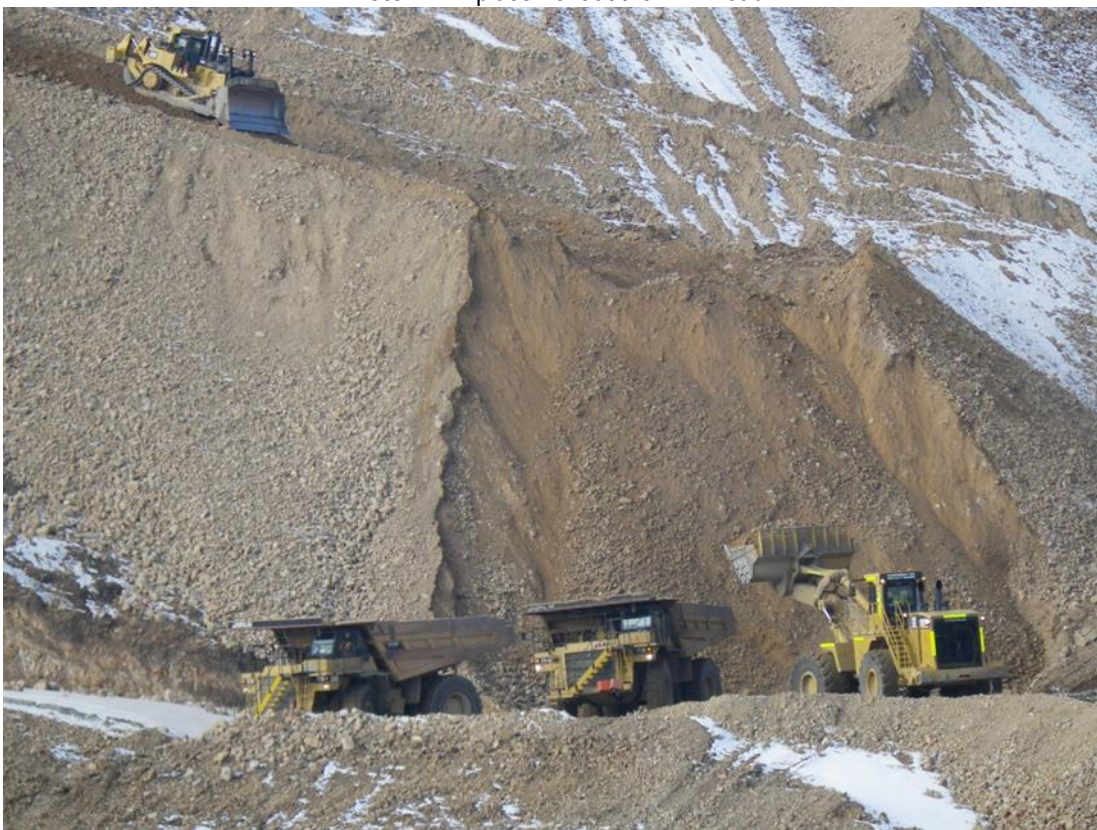
**Photo 2:** Cut operations between stations Q6+00 and A6+00.

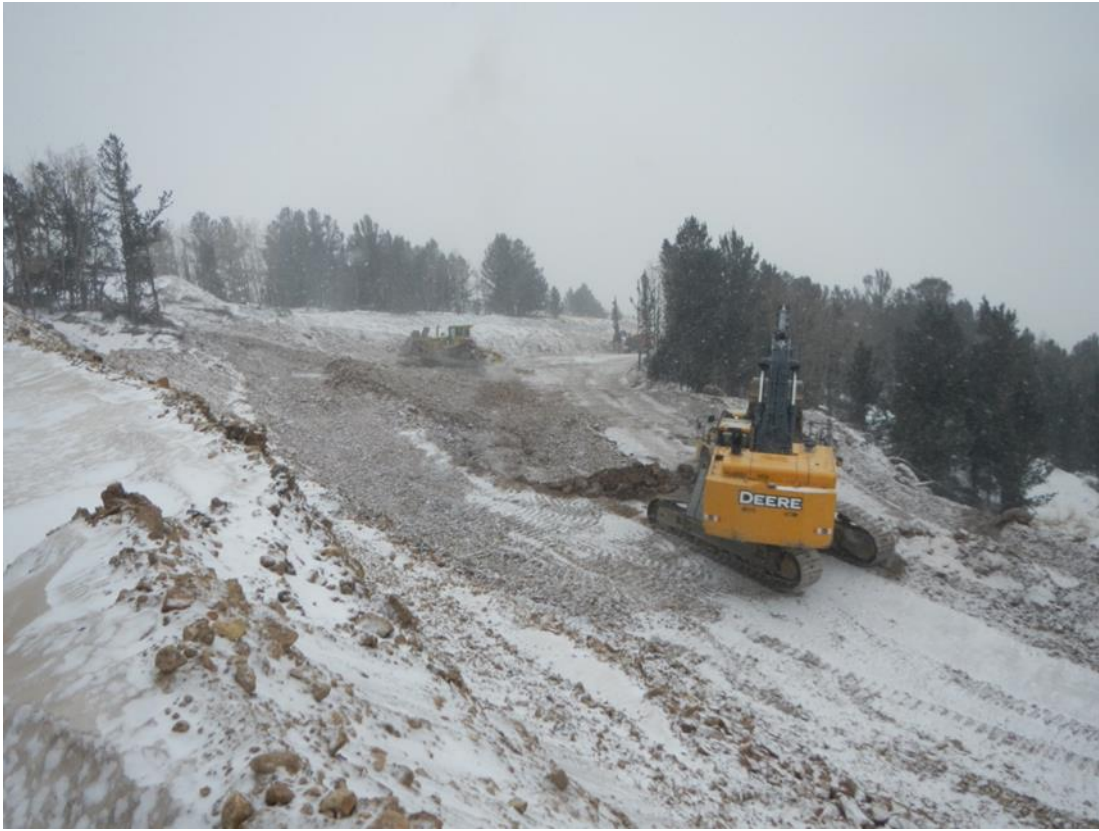
**Photo 3:** Cut operations in the Phase 2 Diversion Channel area.

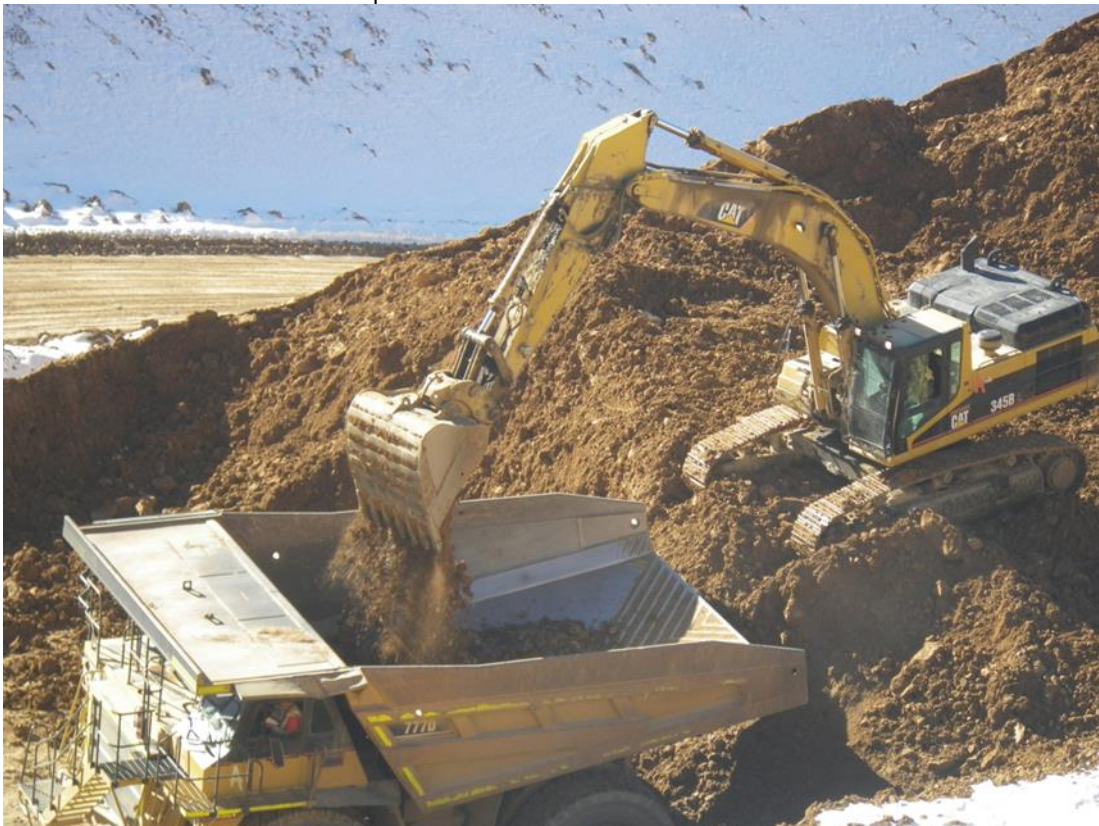
**Photo 4:** Loading out clay till for the Squaw Gulch clay processing plant.

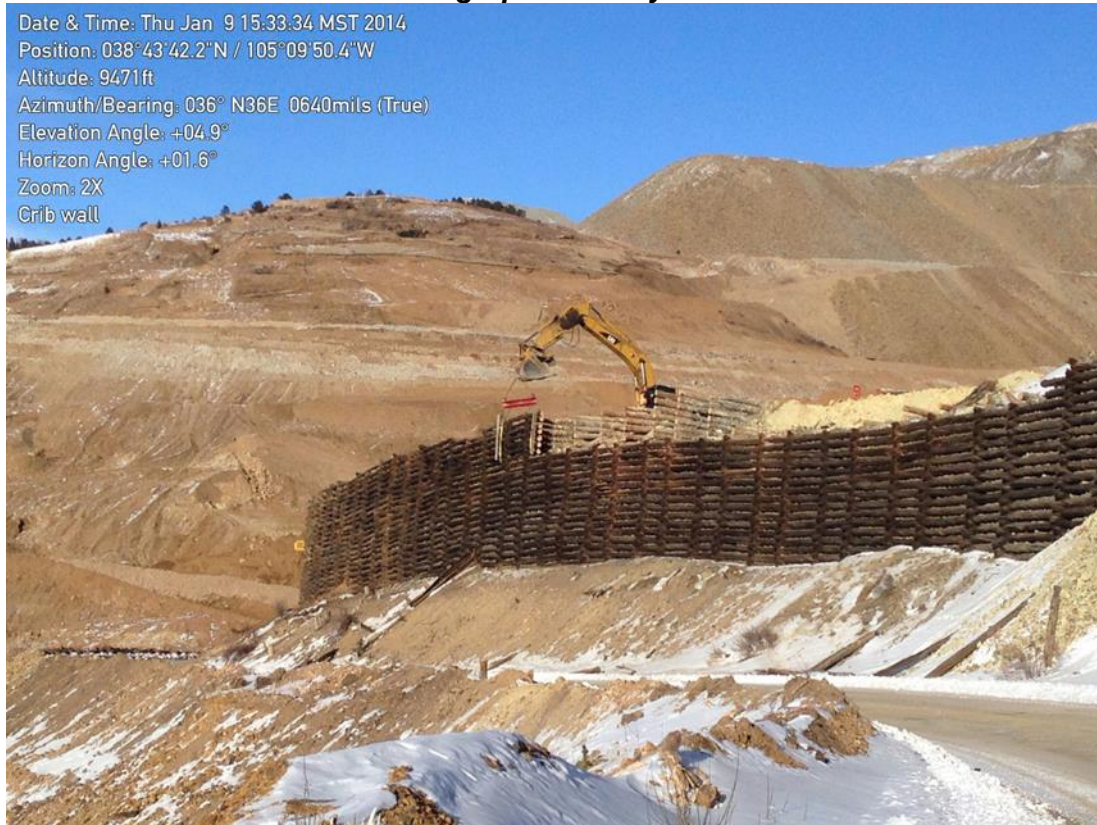
**Photo 1:** Historical Crib Wall dismantling.

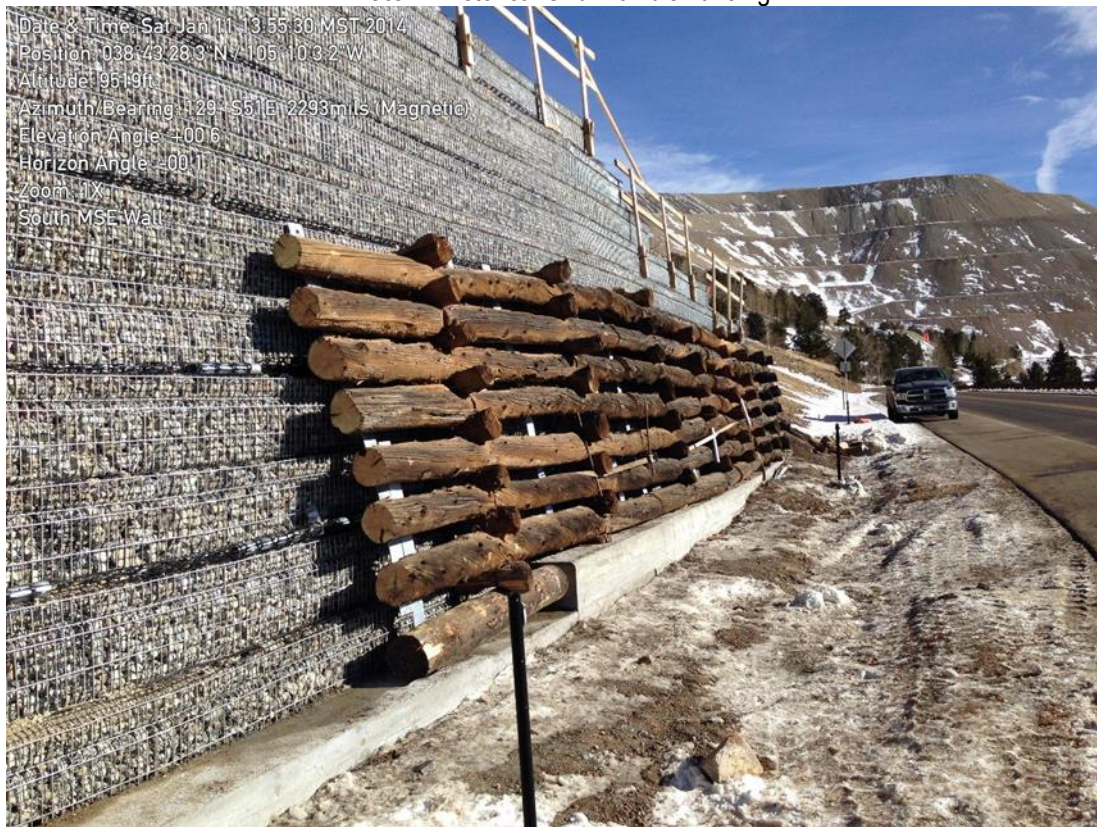
**Photo 2:** Installed timber panels at the South MSE Wall..

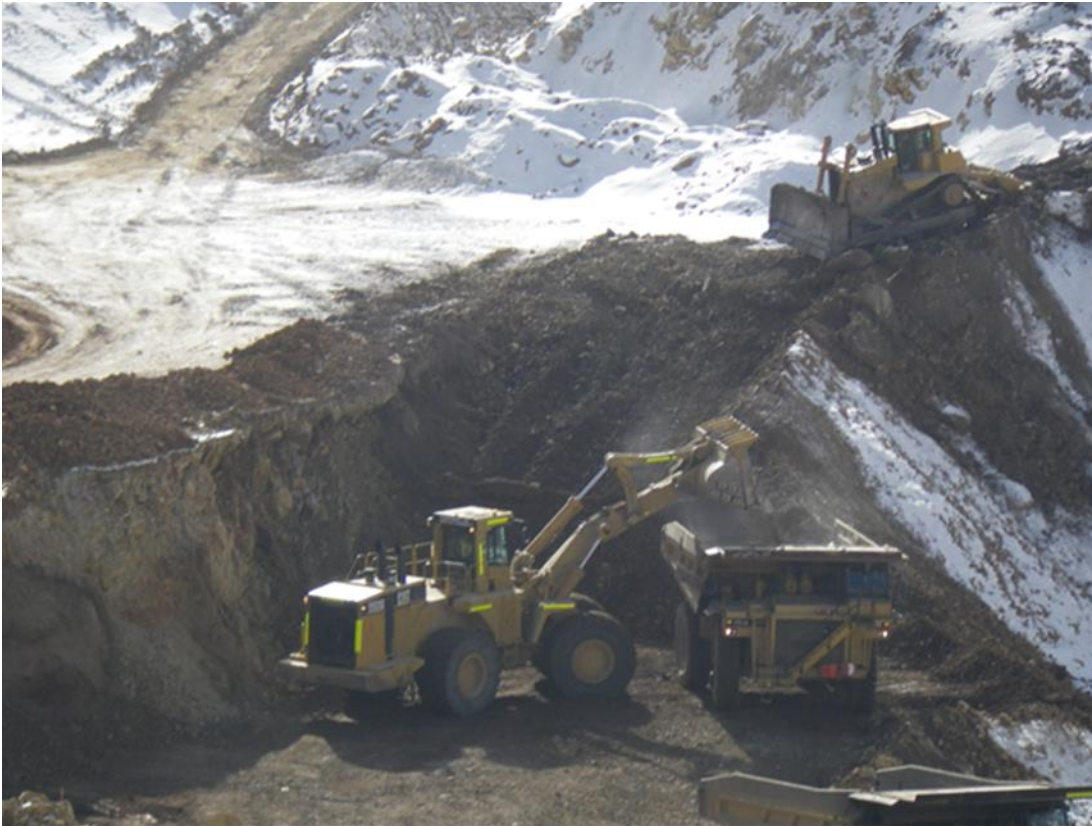
**Photo 3:** Cut operations near station A20+00.

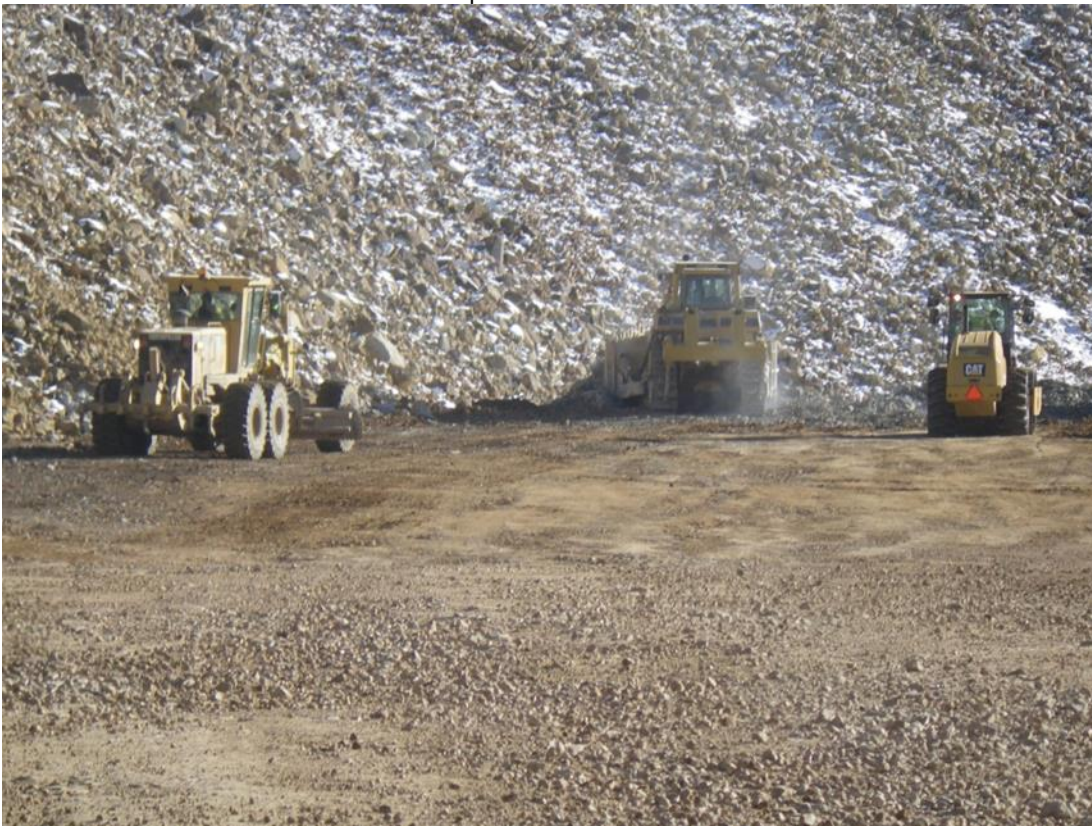
**Photo 4:** Fill placement at the Butress Fill area.
