# CRIPPLE CREEK & VICTOR GOLD MINING Co. Squaw Gulch (VLF), HWY 67 Realignment Field Monitoring Summary Weekly Report

**Owner:** Cripple Creek & Victor Gold Mining Co.

**Project:** Squaw Gulch (VLF), Hwy 67 Realignment

**Location:** Cripple Creek & Victor Gold Mine, Colorado

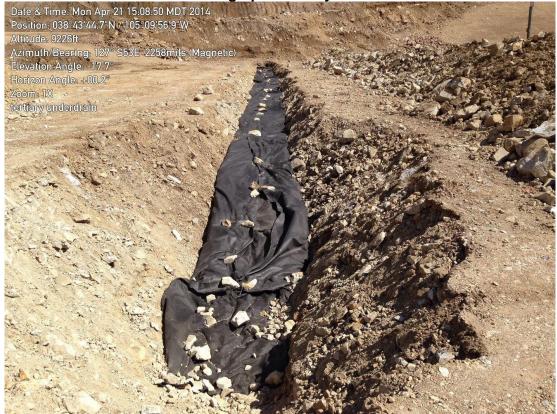
Photo 1: Tertiary underdrain on the PSSA floor.

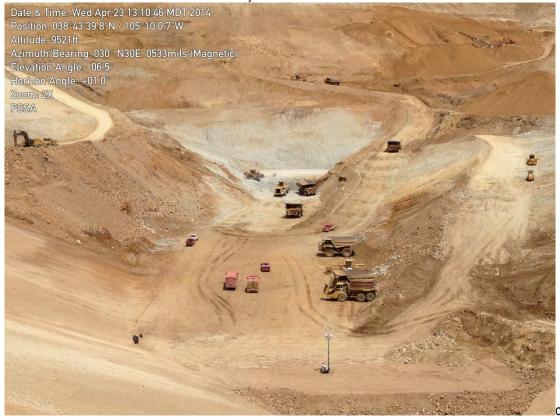
Photo 2: PSSA Area.

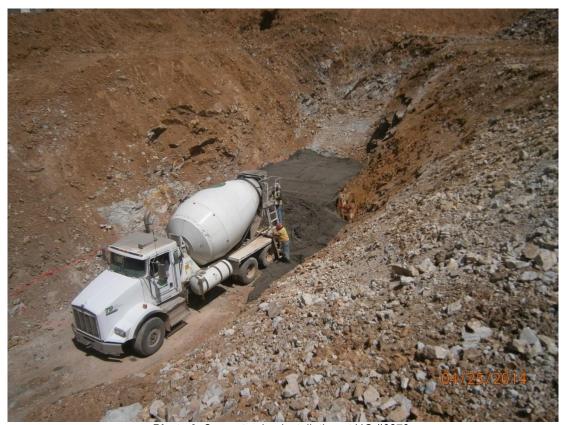
Photo 3: Concrete plug installation at UG #6273.

Approximately 200 yds<sup>3</sup> of 4,000 PSI concrete was placed in underground working #U6273. Concrete physical property testing occurred and concrete cylinders were cast for laboratory determination of compressive strength. Additional remediation is required.

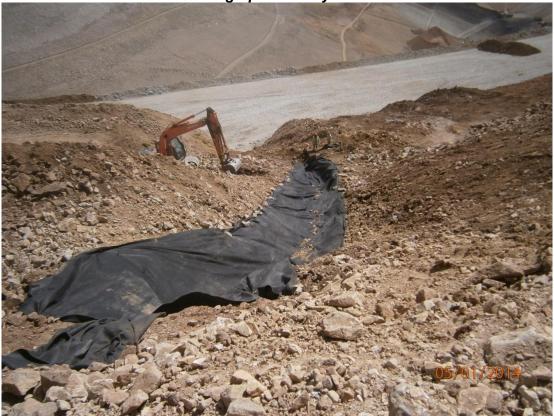
Photo 1: Secondary underdrain installation adjacent to Dump 4.

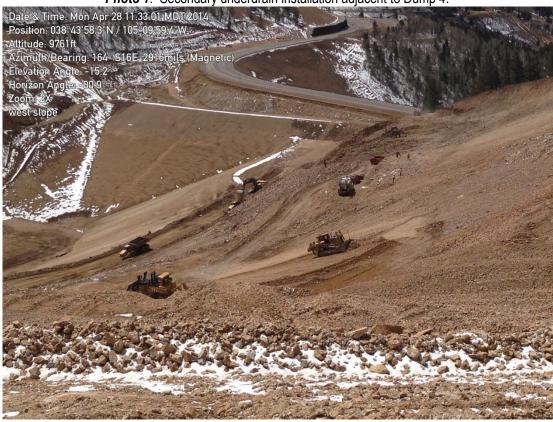
**Photo 2**: Fill placement, cut activities, and blasting preparation at the western VLF slope between the C and E benches.

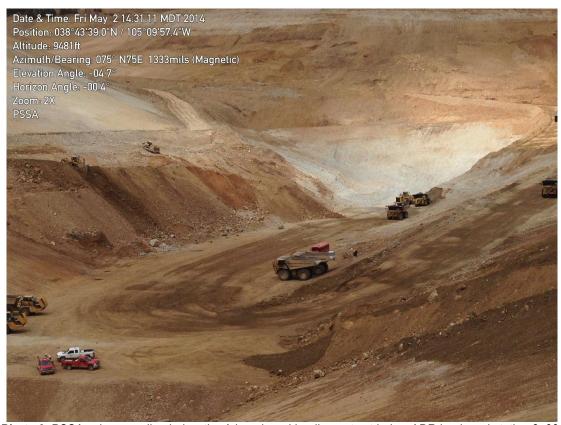
Photo 3: PSSA: slope grading below the A bench and loading out cut below ADR haul road station 8+00.

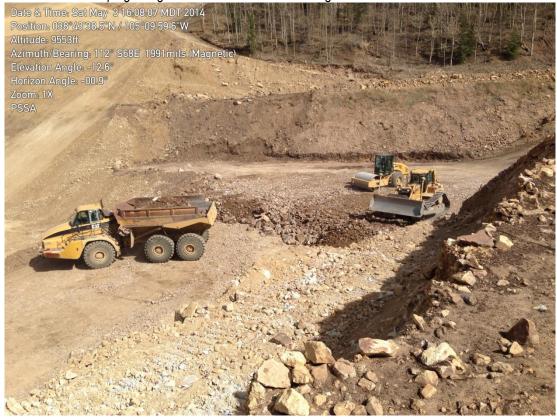
**Photo 4**: Fill placement at the PSSA Embankment.

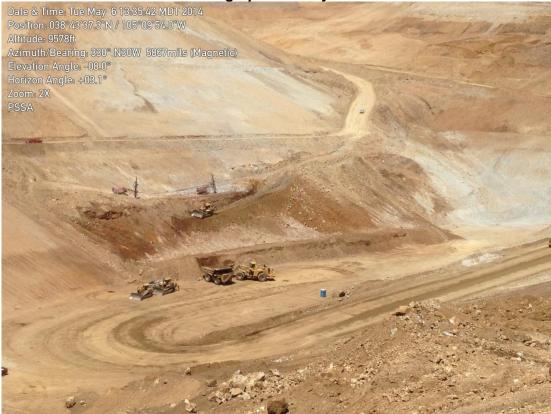
**Photo 1**: Slope grading, production drilling, and cut removal downslope of stations A7+00 to A12+00.

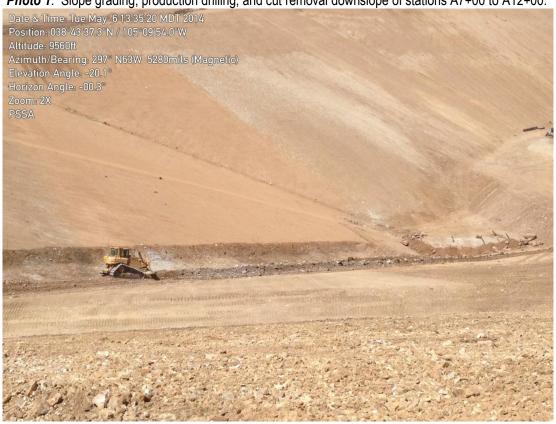
Photo 2: A Cat GPS D6 dozer shaping the trench for the Low Volume Solution Collection (LVSC) riser piping in the PSSA.

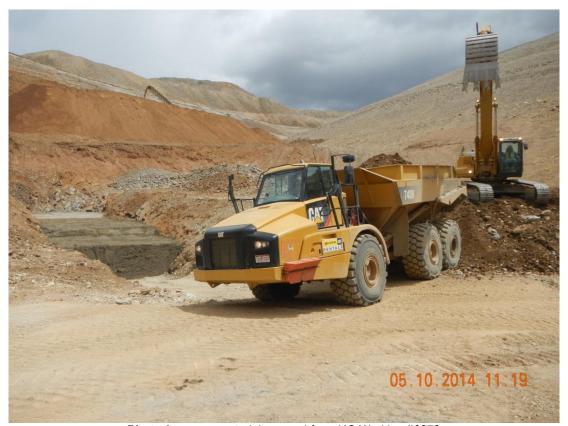
Photo 3: excess material removal from UG Working #6273

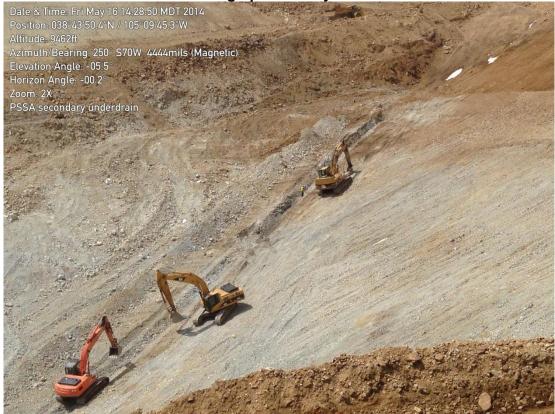
Photo 1: Trenching for secondary underdrain below station A14+00 in the PSSA.

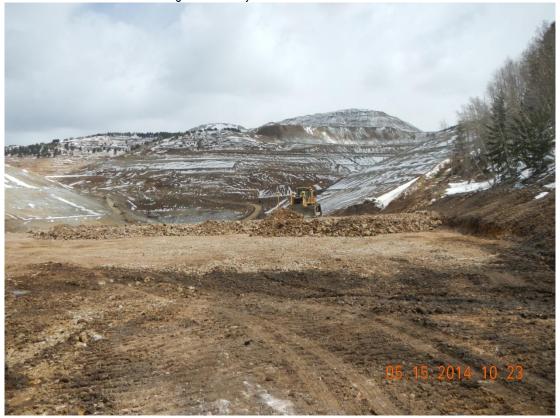
Photo 2: Fill placement at PSSA embankment fill area.

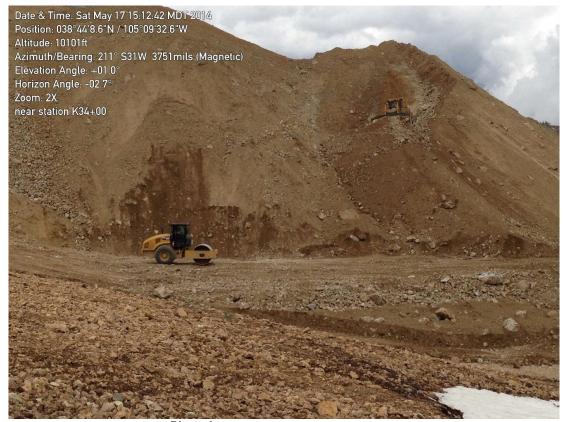
Photo 3: Fill compaction near station K34+00.

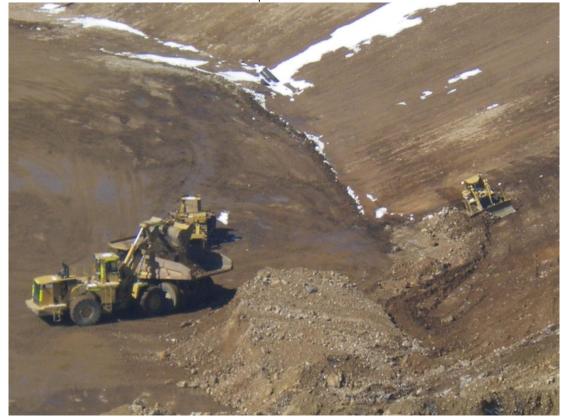
Photo 4: Cut removal below stations A5+00 to A10+00 on the PSSA floor.

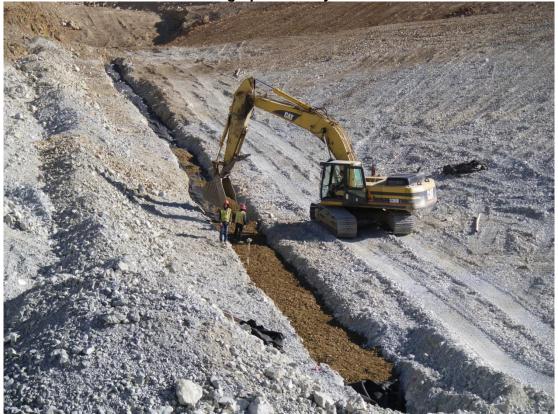
**Photo 1**: Secondary underdrain installation below station A14+50.

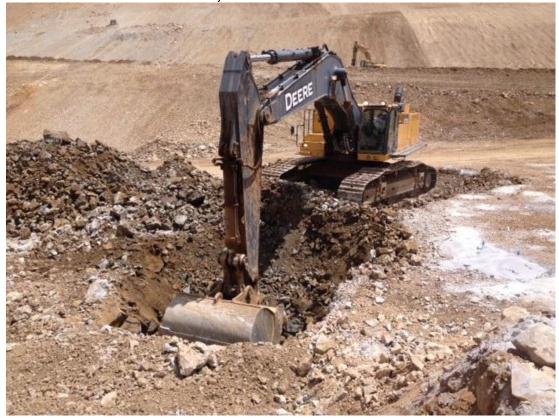
Photo 2: Excavating the shot rock from underground working #6280 on the PSSA floor.

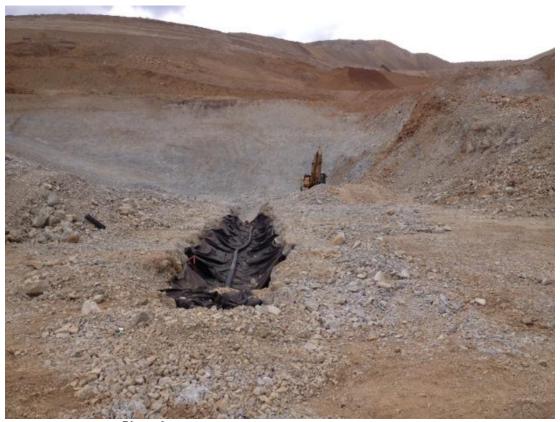
Photo 3: Primary underdrain installation on the north PSSA floor

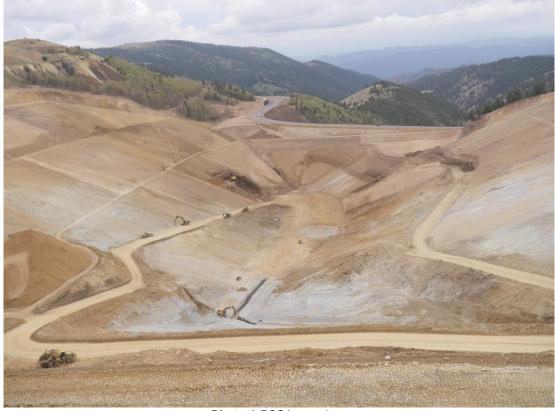
Photo 4: PSSA overview.

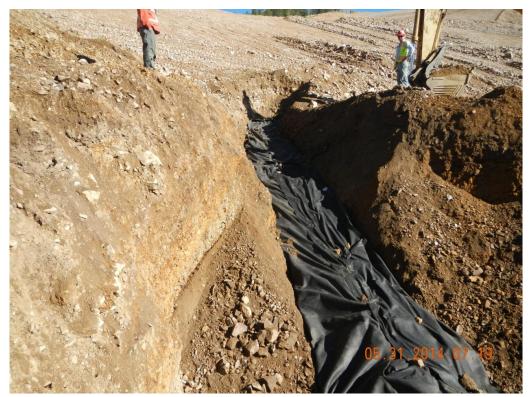
Photo 1 Secondary Underdrain Installation near Station A6+00

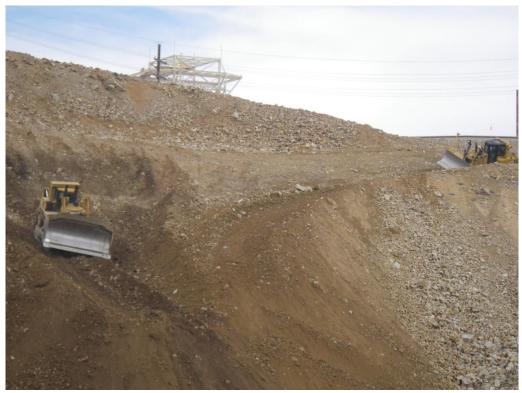
Photo 2 Slope Grading Below the Ball Mill Platform

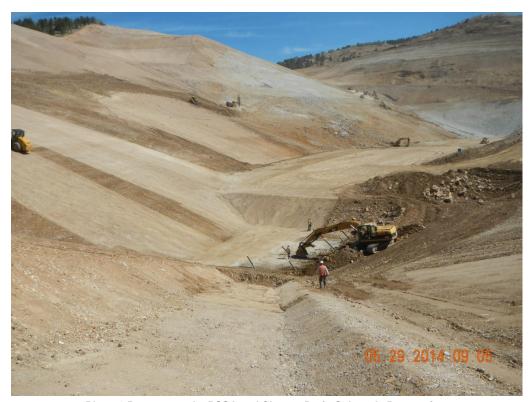
Photo 3 Progress at the PSSA and Closure Drain Subgrade Preparation

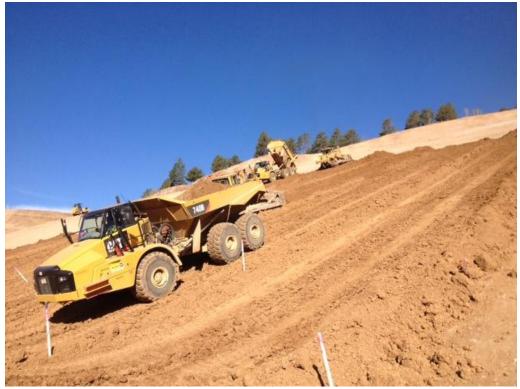
Photo 1: Soil Liner Fill Placement on the PSSA Slopes.

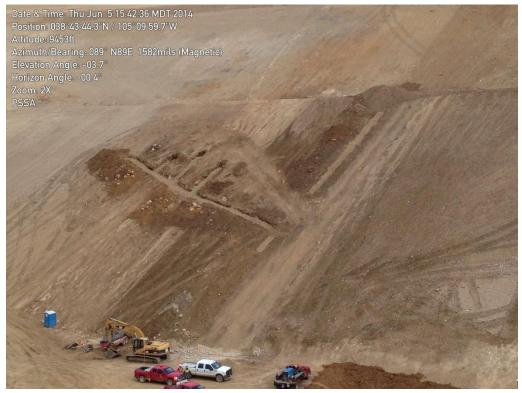
Photo 2: Tertiary Underdrain, Spurs, and Laterals on the East Slope of the PSSA.

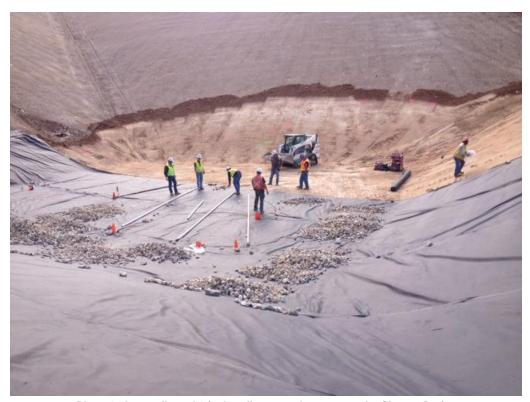
Photo 3: Geotextile and 2-inch well screen placement at the Closure Drain.

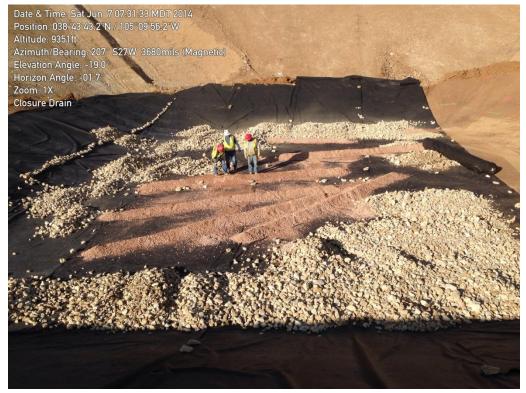
Photo 4: Drain Cover Fill Placement over the Leak Detection Fill and Geotextile in the Closure Drain Area

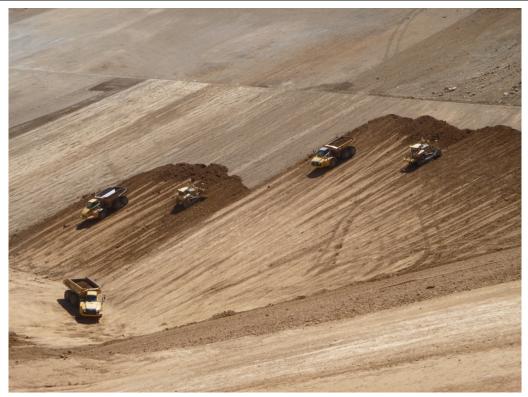
Photo 1: Soil Liner Fill Placement on the PSSA Slopes.

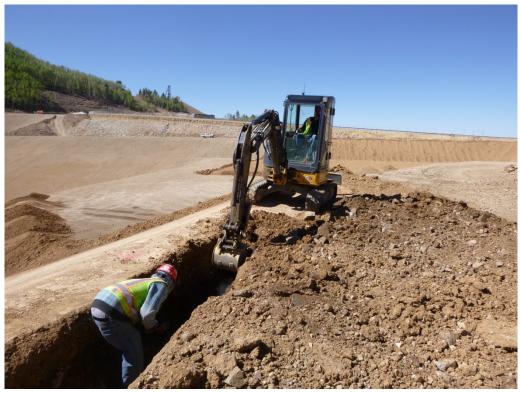
Photo 2: Excavating anchor trench.

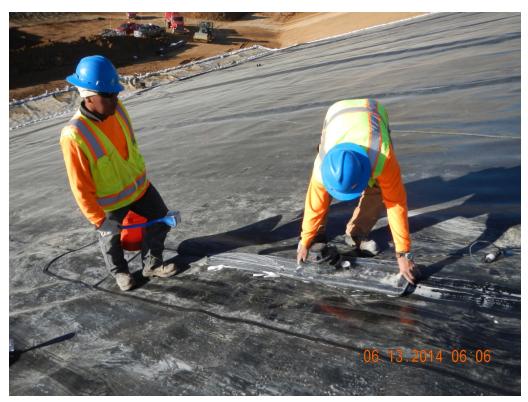
Photo 3: Vacuum testing extrusion weld during liner repairs.

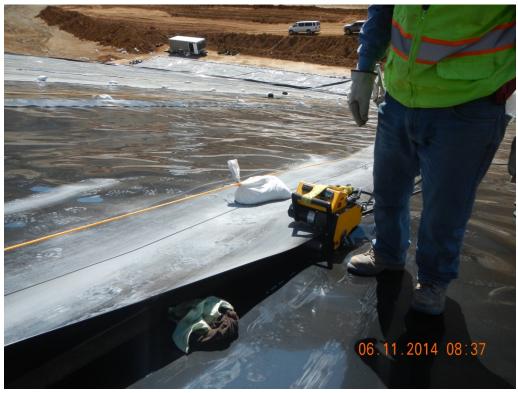
Photo 4: Fusion welding geomembrane seams.

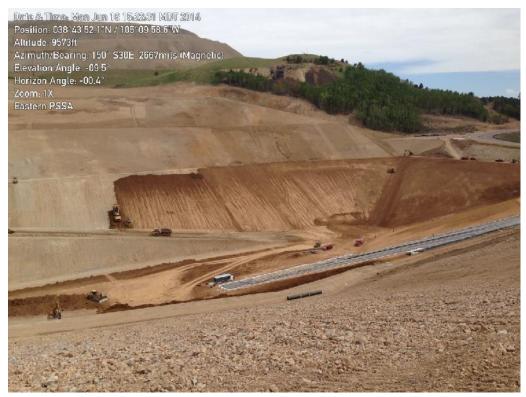
Photo 1: Soil Liner Fill Placement on the PSSA Slopes.

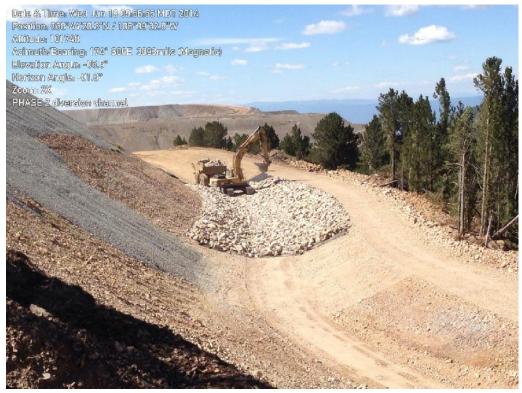
Photo 2: Rip rap placement in the Phase 2 diversion channel.

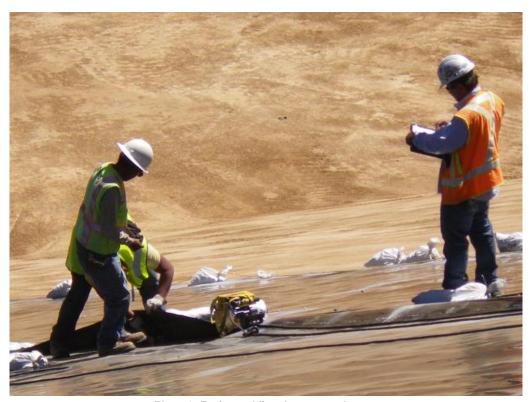
Photo 3: Fusion welding the geomembrane.

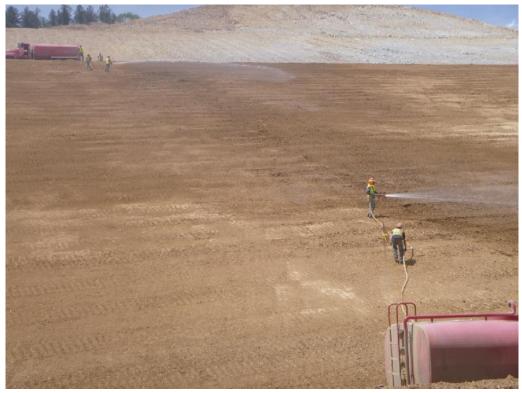
Photo 4: Moisture conditioning clay lined slopes.

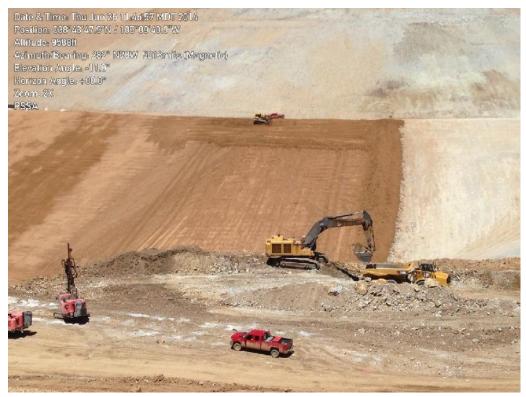
Photo 1: Blast zone and SLF placement.

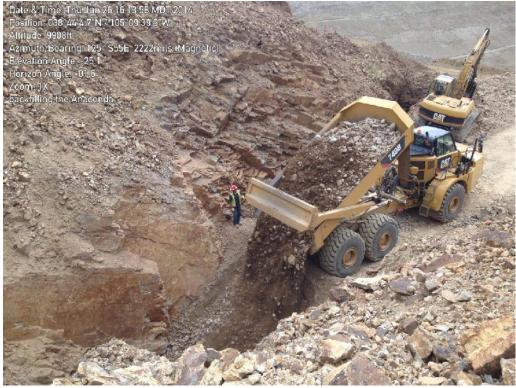
Photo 2: UG#6446, backfilling shaft with coarse shaft backfill.

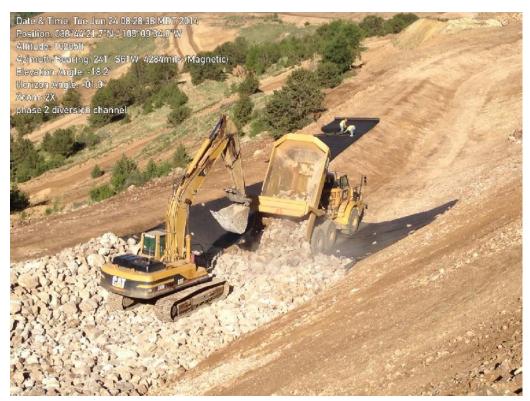
Photo 3: Placing rip rap in the Phase 2 diversion channel.

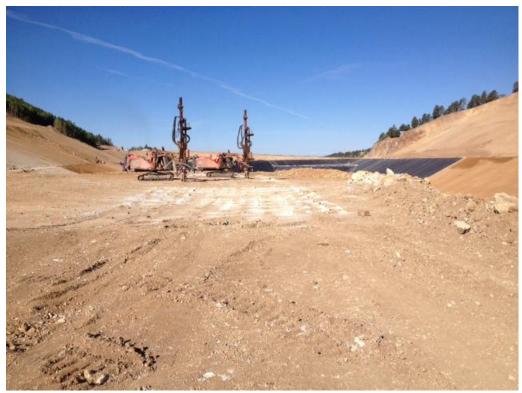
Photo 4: Production drilling near B16+00.

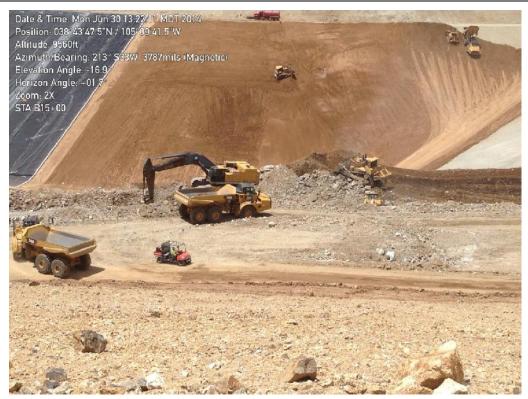
Photo 1: Blast zone cut in foreground and SLF placement in background.

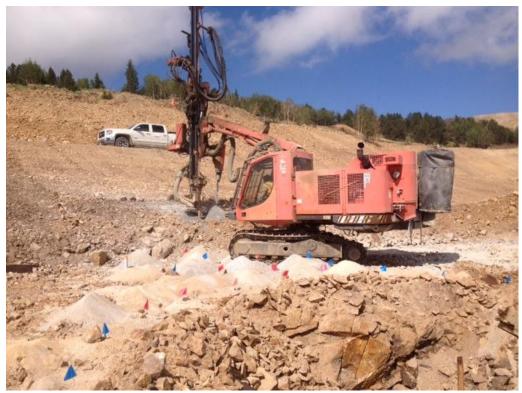
Photo 2: UG# 6579, confirmatory drilling.

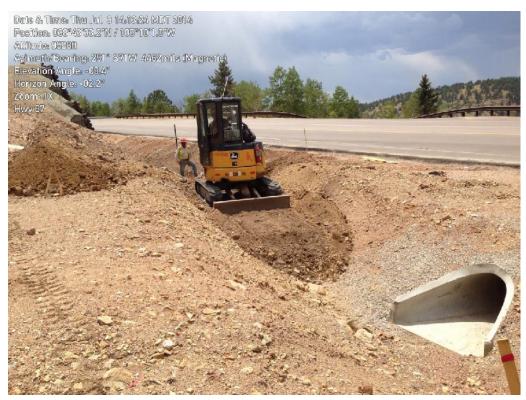
Photo 3: Highway 67 drainage channel preparation.

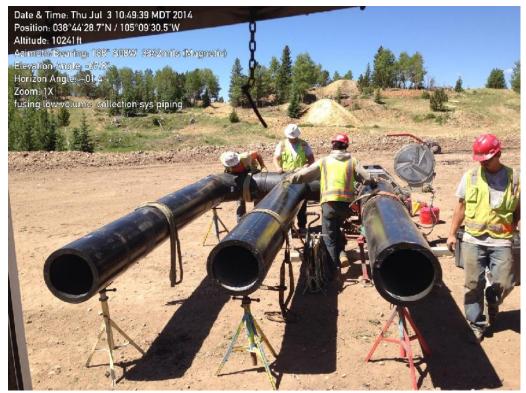
Photo 4: Low Volume Solution Collection System Manifold HDPE pipe butt fusion.

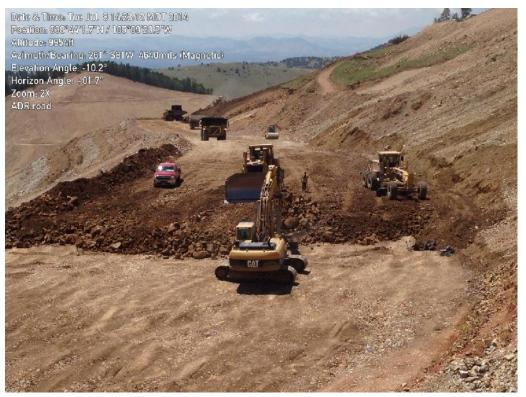
Photo 1: Structural Fill on ADR haul road.

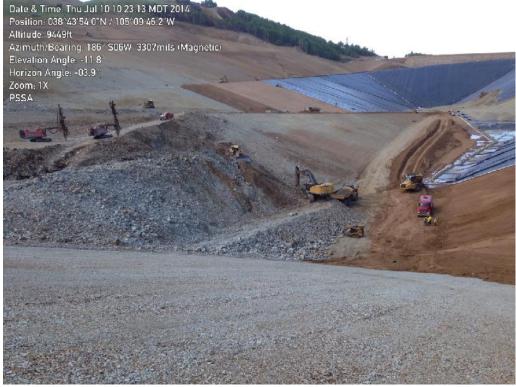
Photo 2: Production drilling and shot rock removal.

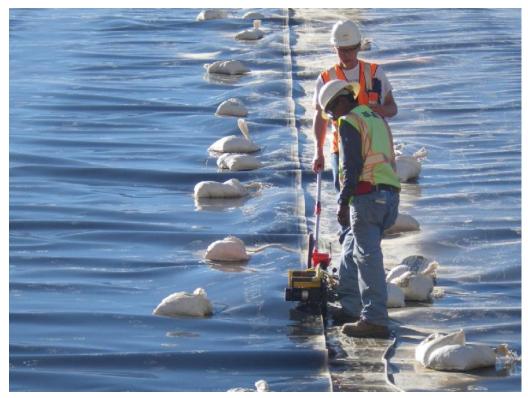
Photo 3: Geomembrane fusion welding.

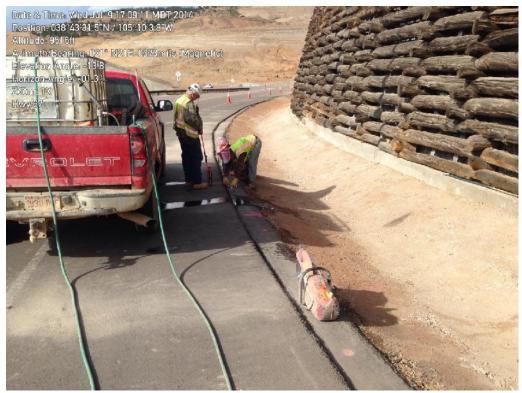
Photo 4: Preparing Highway 67 drainage channel.
