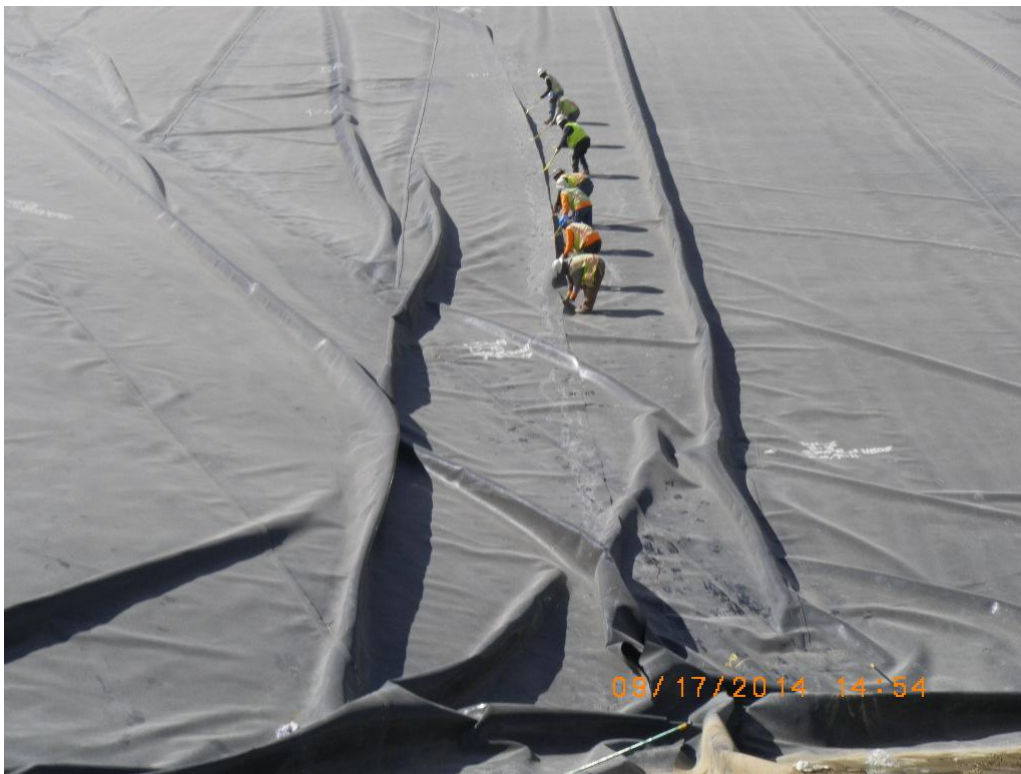
Photo 2: Removing a Wrinkle on the Primary Liner

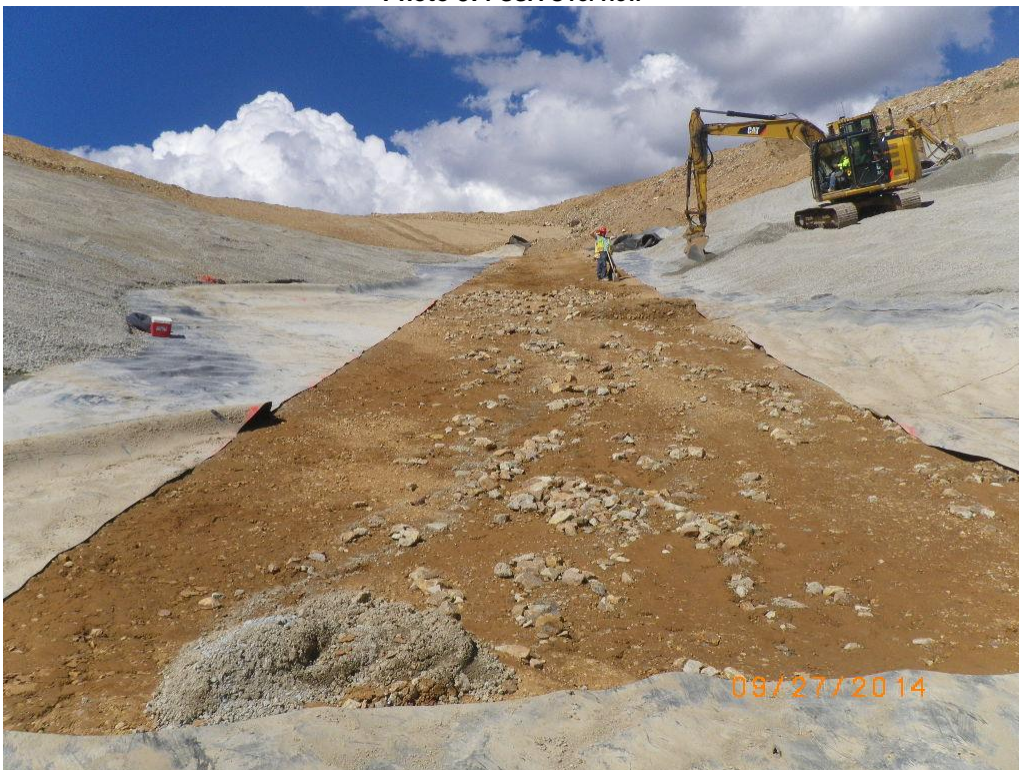
A rain event on the evening of September 20, 2014 washed out a small section of the ADR road and slope into the northwest corner of the PSSA; subsequently, causing washout of finished LVSCF, tearing, and damage of underlying secondary geomembrane and SLF material. The damaged secondary liner was removed during the course of this reporting period from the northwest corner of the PSSA to expose the underlining soil liner fill for repair, re-compaction, and reconditioning.

Photo 4: Secondary Liner Cut Back for Removal of Deleterious Material, SLF Removal and Reconditioning, and Finish Grading

ECA repaired the secondary 100-mil LLDPE single-side textured geomembrane in the PSSA. The geomembrane was damaged from a rain event that washed material onto the liner on the northwest corner. Damaged geomembrane was removed and replaced using 100-mil LLDPE single-side textured geomembrane on 20 Sep 2014. Panels S-398 through S-409 were deployed on accepted soil liner fill, panels installed replaced existing panels S-251A through S-255A and S-259 and S-260 were removed and partial panels of S-250A, S-250 through S-256 and S-261 through S-275 were removed during the replacement of the damaged liner. One full roll and multiple partial rolls of 100-mil LLDPE single-side textured geomembrane were deployed yielding 968 lineal feet of fusion welds for an approximate installed weekly total of 9,695 square feet. Quality control was performed using two extrusion guns. All seams were fusion welded per project technical specifications. All work performed was observed by AMEC QA personnel. All secondary liner within the PSSA including the aforementioned liner repair work was accepted for drain cover fill.

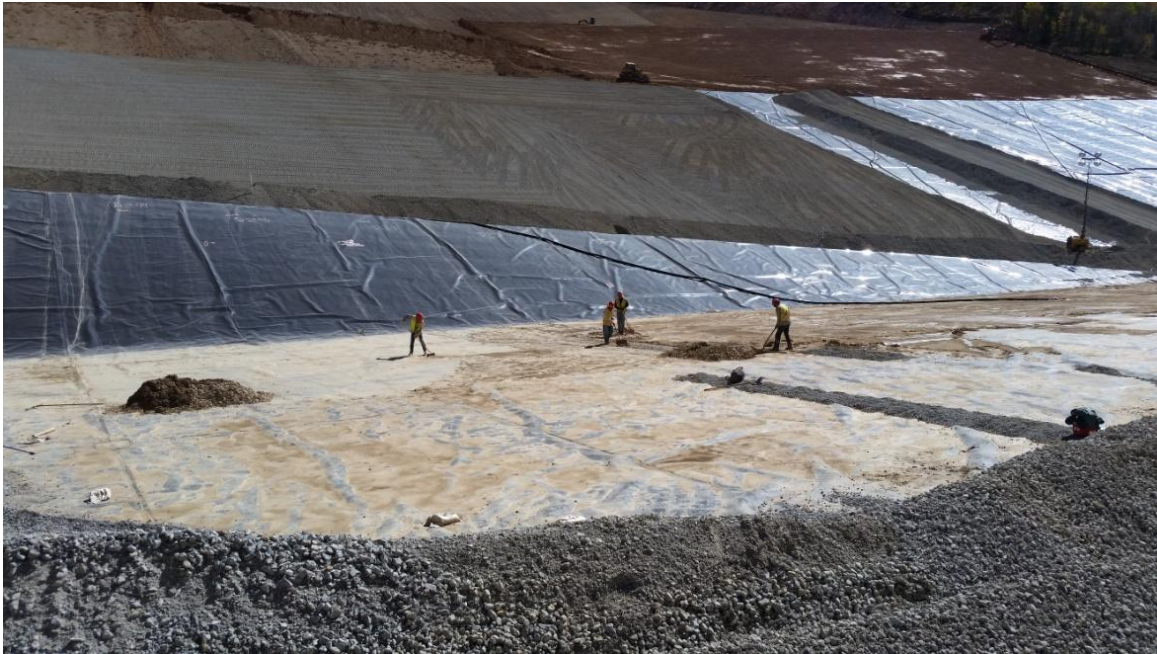
Areas of previously accepted primary geomembrane that were silted over on the floor of the PSSA were washed and swept. AMEC inspectors confirmed that there was no damage to the primary liner prior to overliner placement.

Photo 1: Primary Liner Silt Cleanup on the PSSA Floor

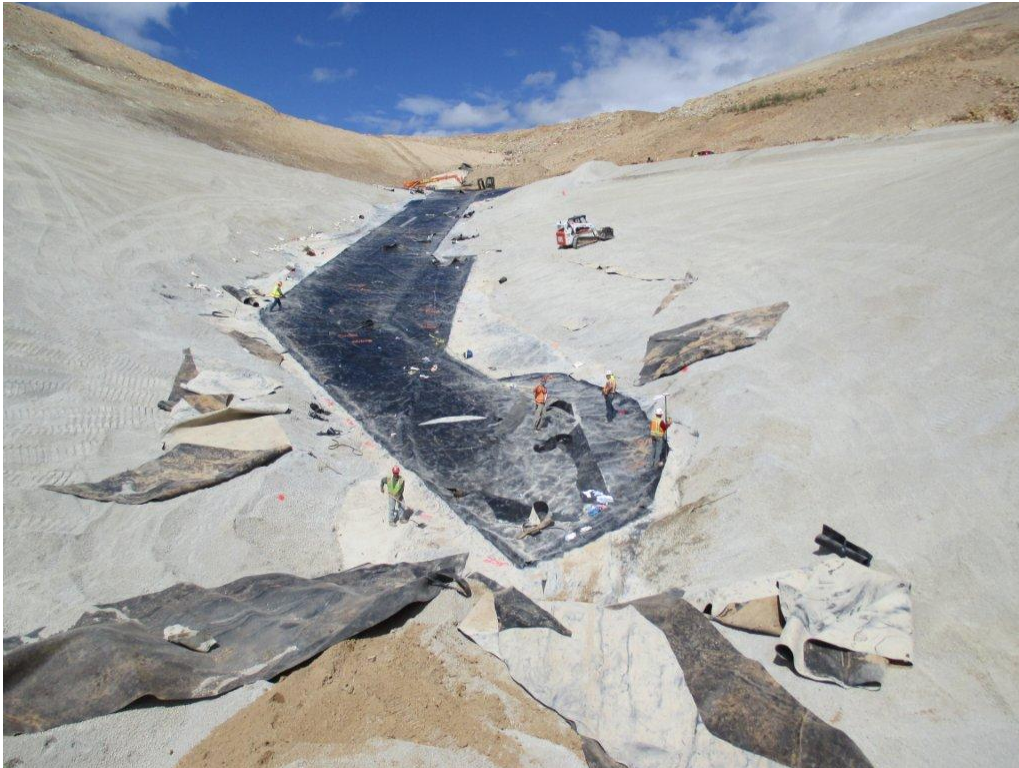
Photo 4: Secondary Liner Repair

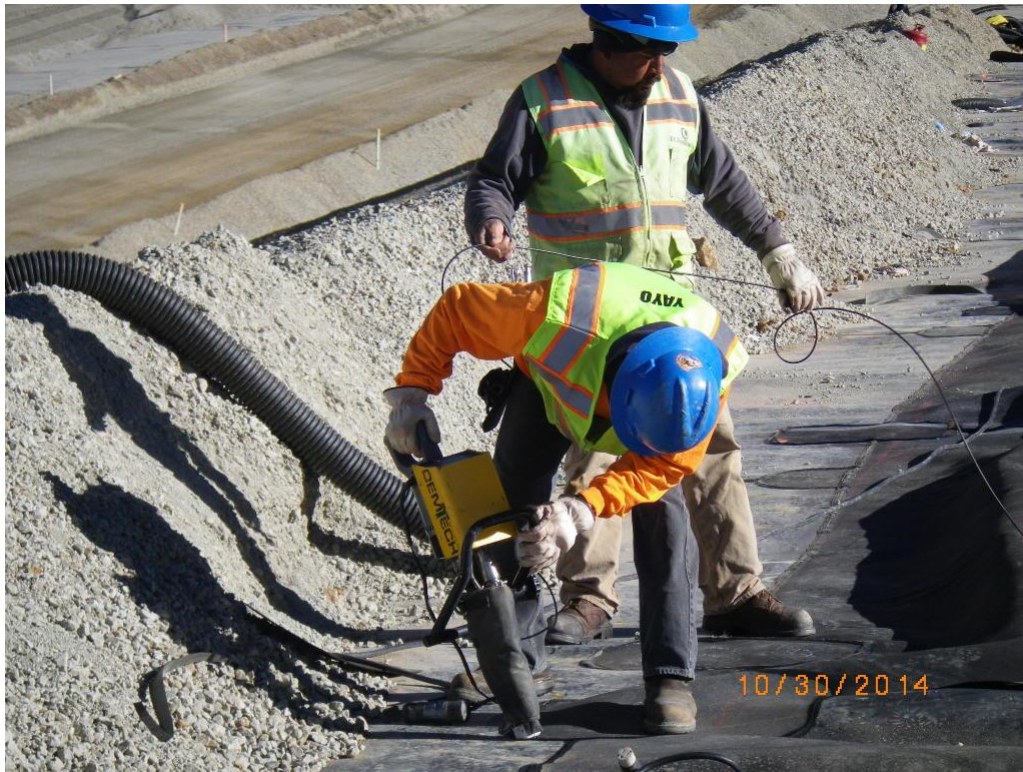
Photo 1: Geomembrane Repairs at the PSSA to Phase 1 Tie-in

100-mil liner in the PSSA was exposed in various places along the backfilled anchor trench on Bench A, the Highway 67 embankment, and SGVLF pad for repairs.
