COLORADO DIVISION OF RECLAMATION, MINING AND SAFETY
MINERALS PROGRAM INSPECTION REPORT
PHONE: (303) 866-3567

MINE NAME: Lily Mines	MINE/PROSPECTING ID#: M-1987-028	MINERAL: Marble	COUNTY: Chaffee
INSPECTION TYPE: Monitoring	INSPECTOR(S): Dustin M. Czapla	INSP. DATE: September 10, 2014	INSP. TIME: 12:30
OPERATOR: Monarch Mountain Minerals and Aggregates,	OPERATOR REPRESENTATIVE: None	TYPE OF OPERATION: 112c - Construction Regular Operation

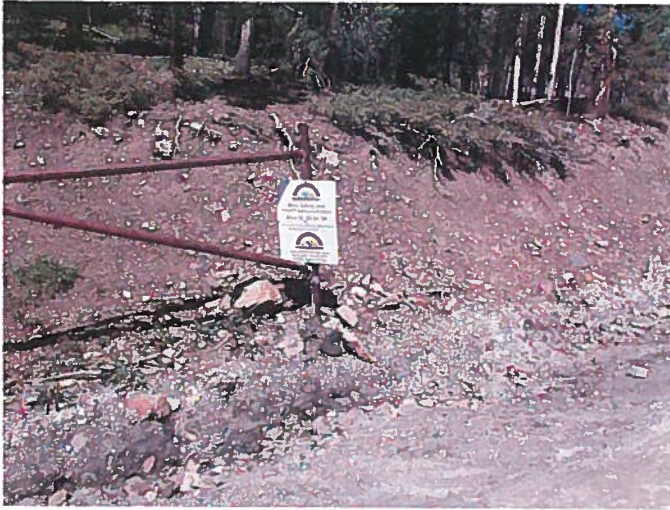
Adequate mine identification signage was noted at the entrance to the site.

Figure 1: Mine ID sign at entrance

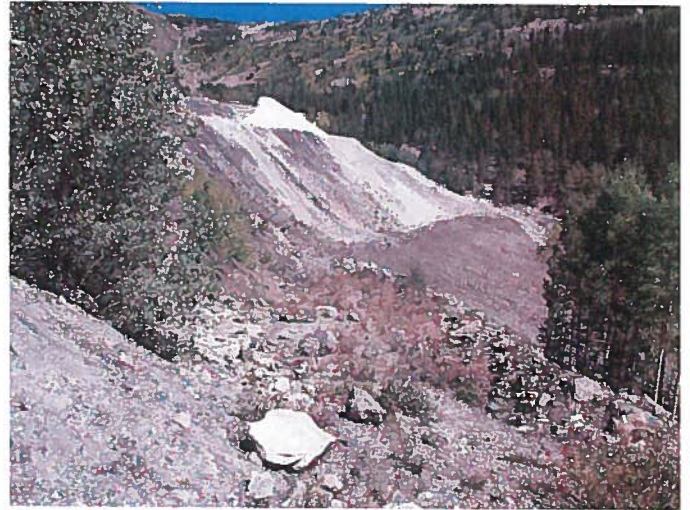
Vegetation on the reclaimed slope in the south permit area adjacent to Taylor Gulch is becoming well established. Rills or gullies were not observed on the slope.

Figure 2: Reclaimed slope at foot of waste pile

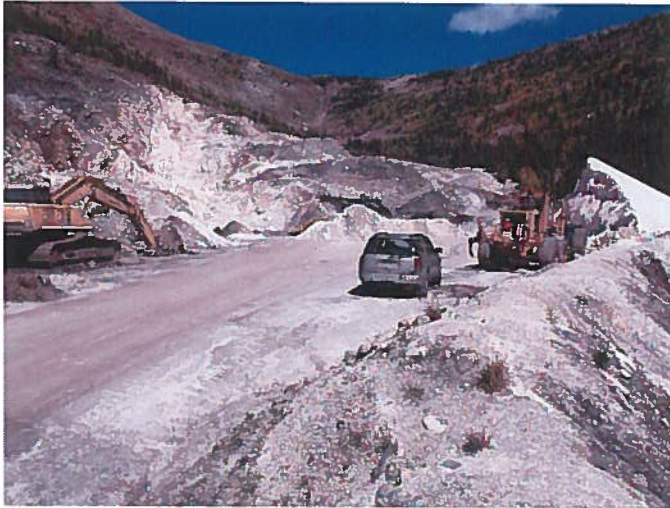
Figure 3: Mine bench and stockpile area

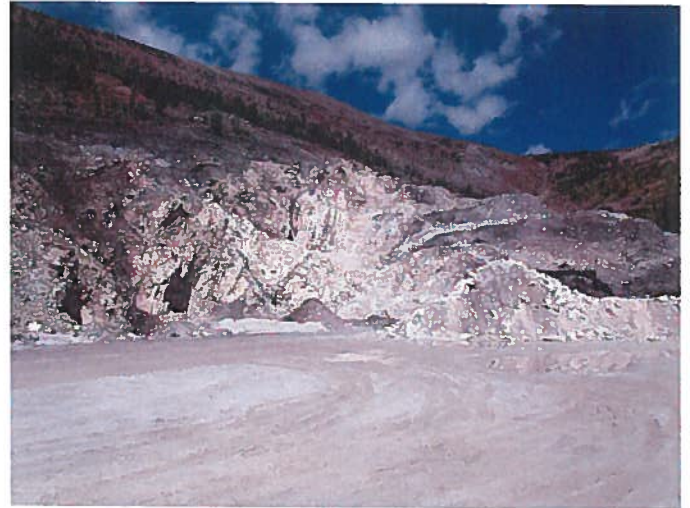
The east facing highwall spans approximately 1,000 linear feet up to heights of 40-60 feet. A condition of the permit requires the operator to include a report describing geotechnical conditions related to construction of the highwalls with their annual report each year. A review of the permit file found that this condition has not been complied with. This has been noted as a problem.

Figure 4: South highwall area

CORRECTIVE ACTIONS: Submit the required geotechnical reporting information.

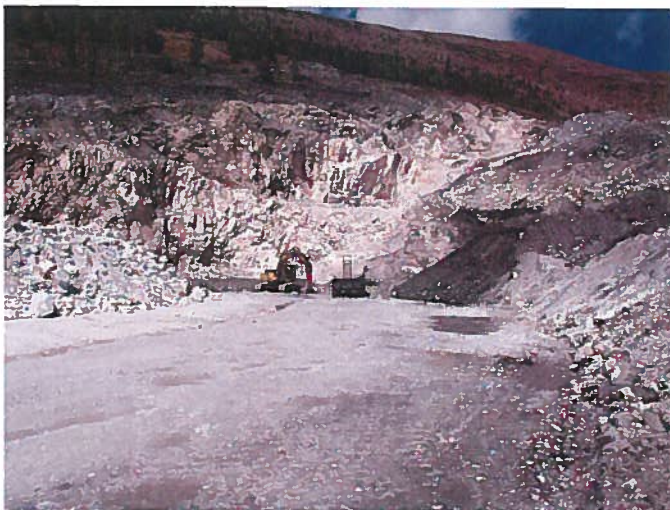
Figure 5: South highwall area

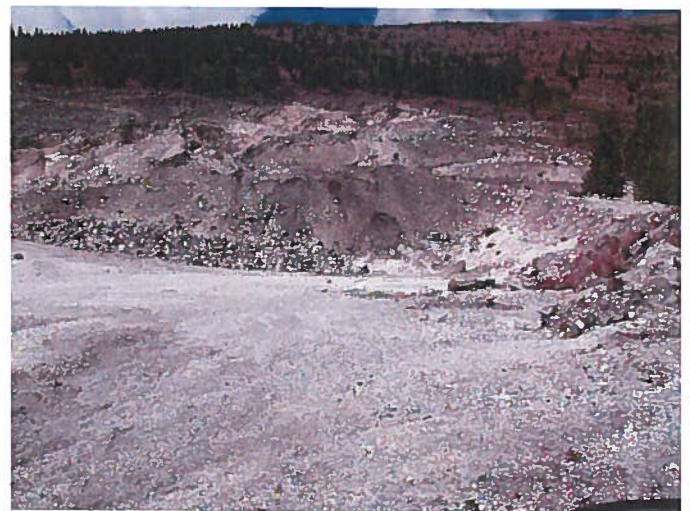
Figure 6: North highwall area
