Underground Working Observations

Appendix O.1 – Underground Workings Summary and Figures

Cripple Creek & Victor Gold Mining Company
Squaw Gulch VLF Pregnant Solution Storage Area
Underground Workings Remediation Summary

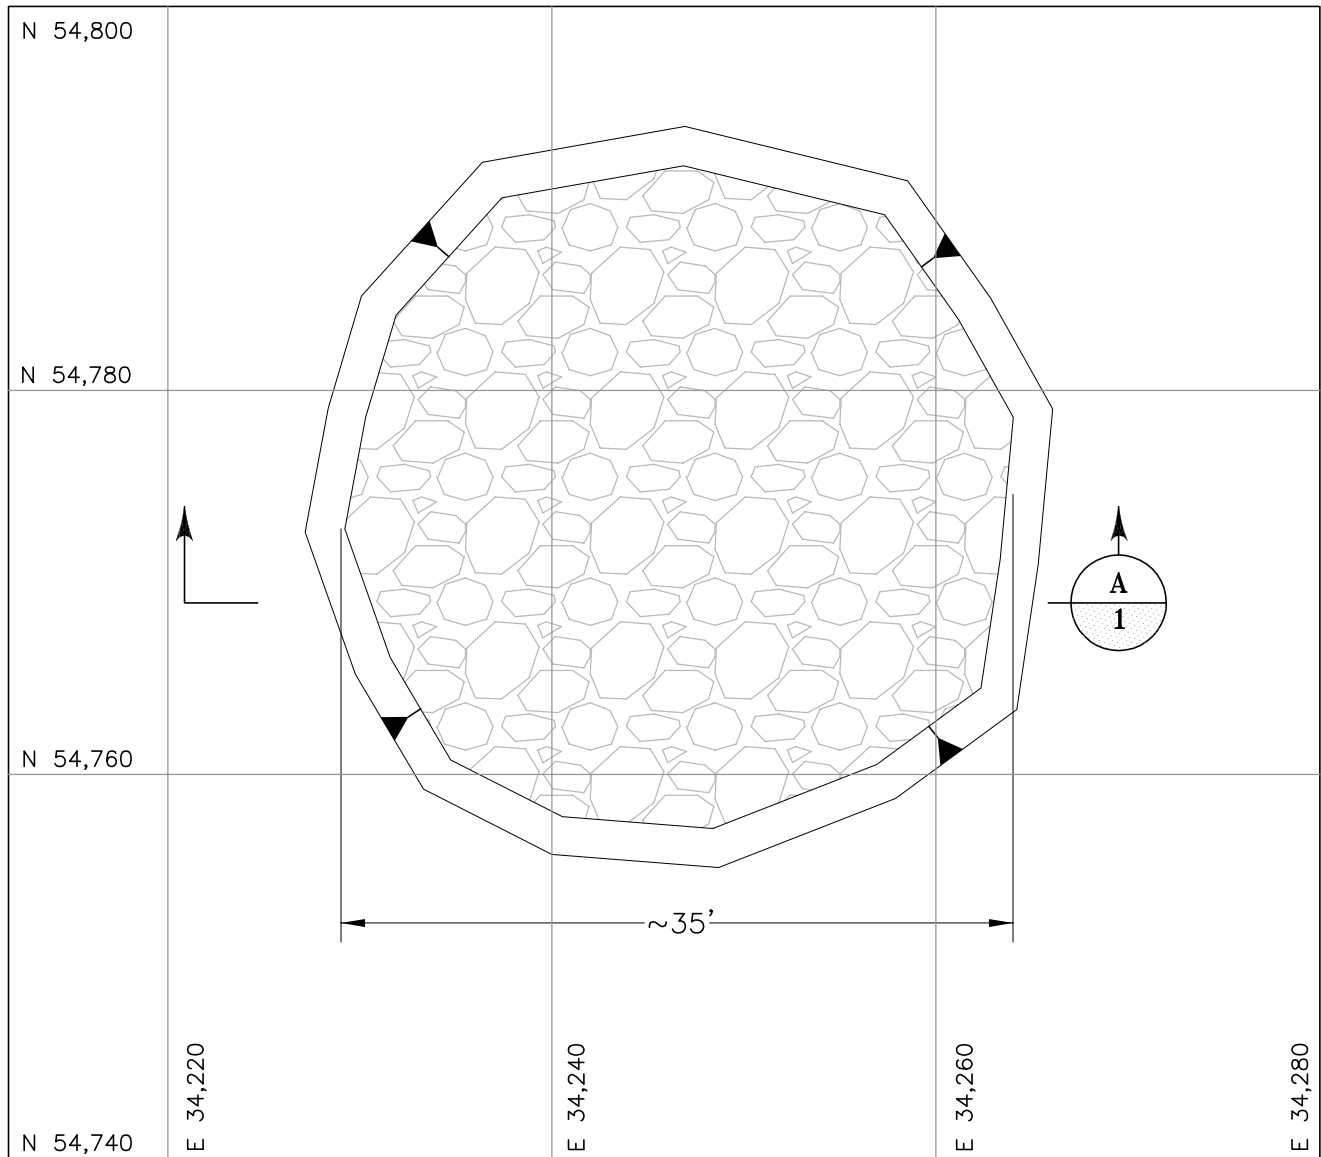
- 92 YD³ – COARSE SHAFT BACKFILL
- 118 YD³ – STRUCTURAL FILL
- 10 YD³ – CONCRETE
- 126 YD³ – CEMENTED ROCK FILL

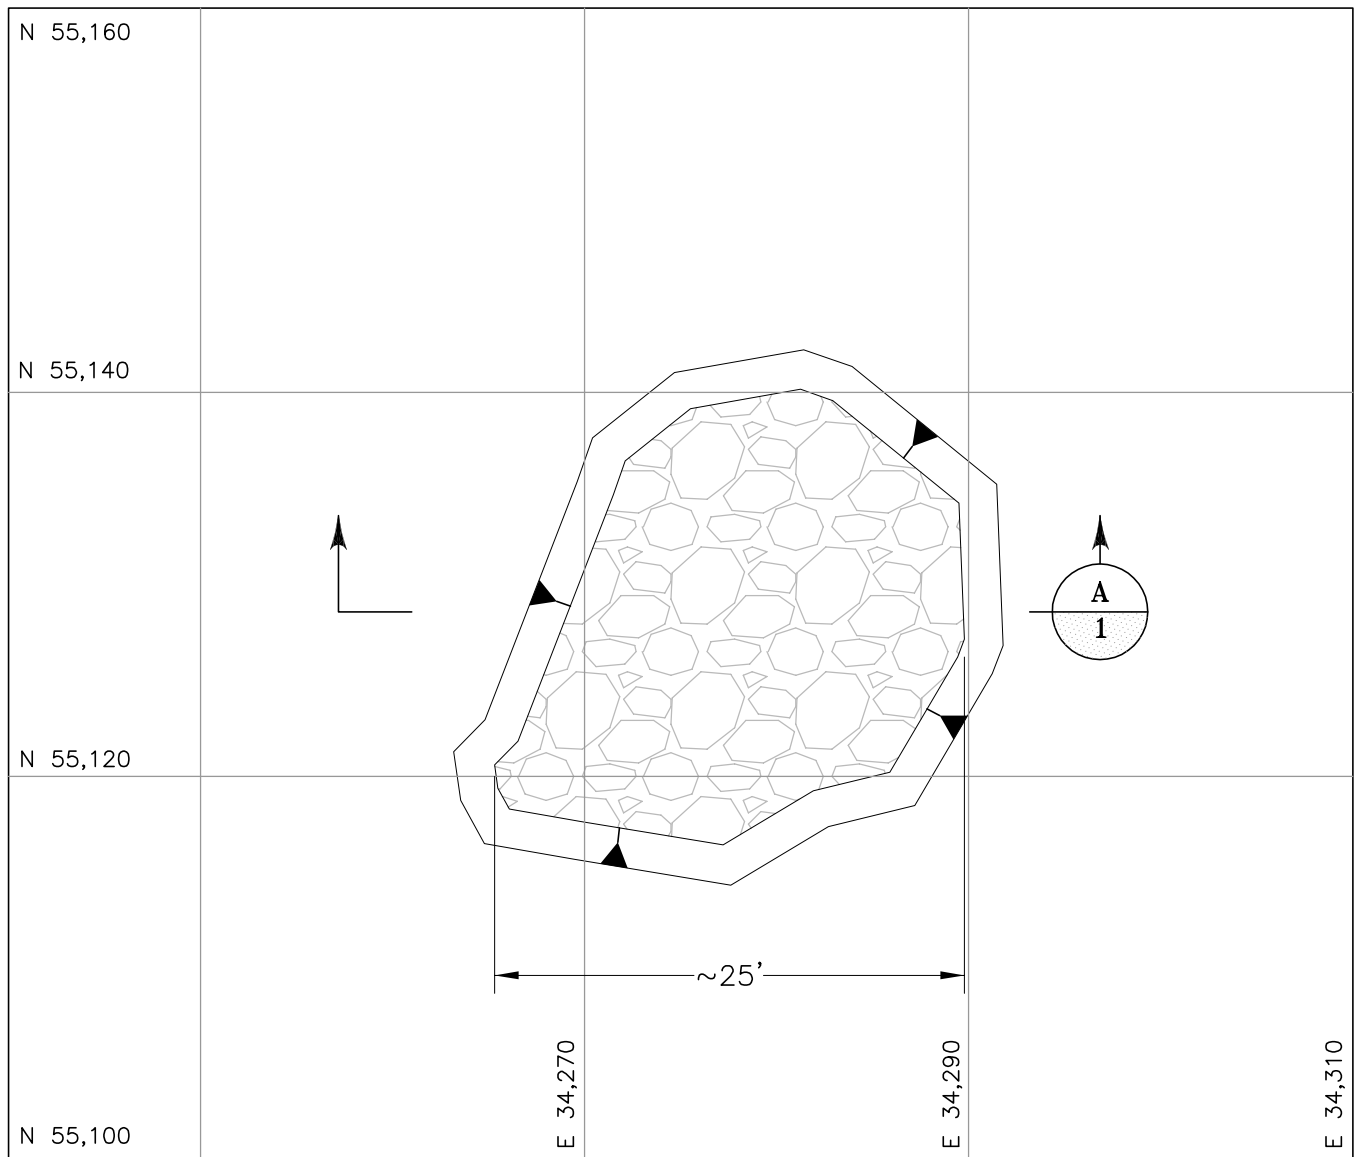
10 YD³ — CONCRETE

55 YD³ — CEMENTED ROCK FILL

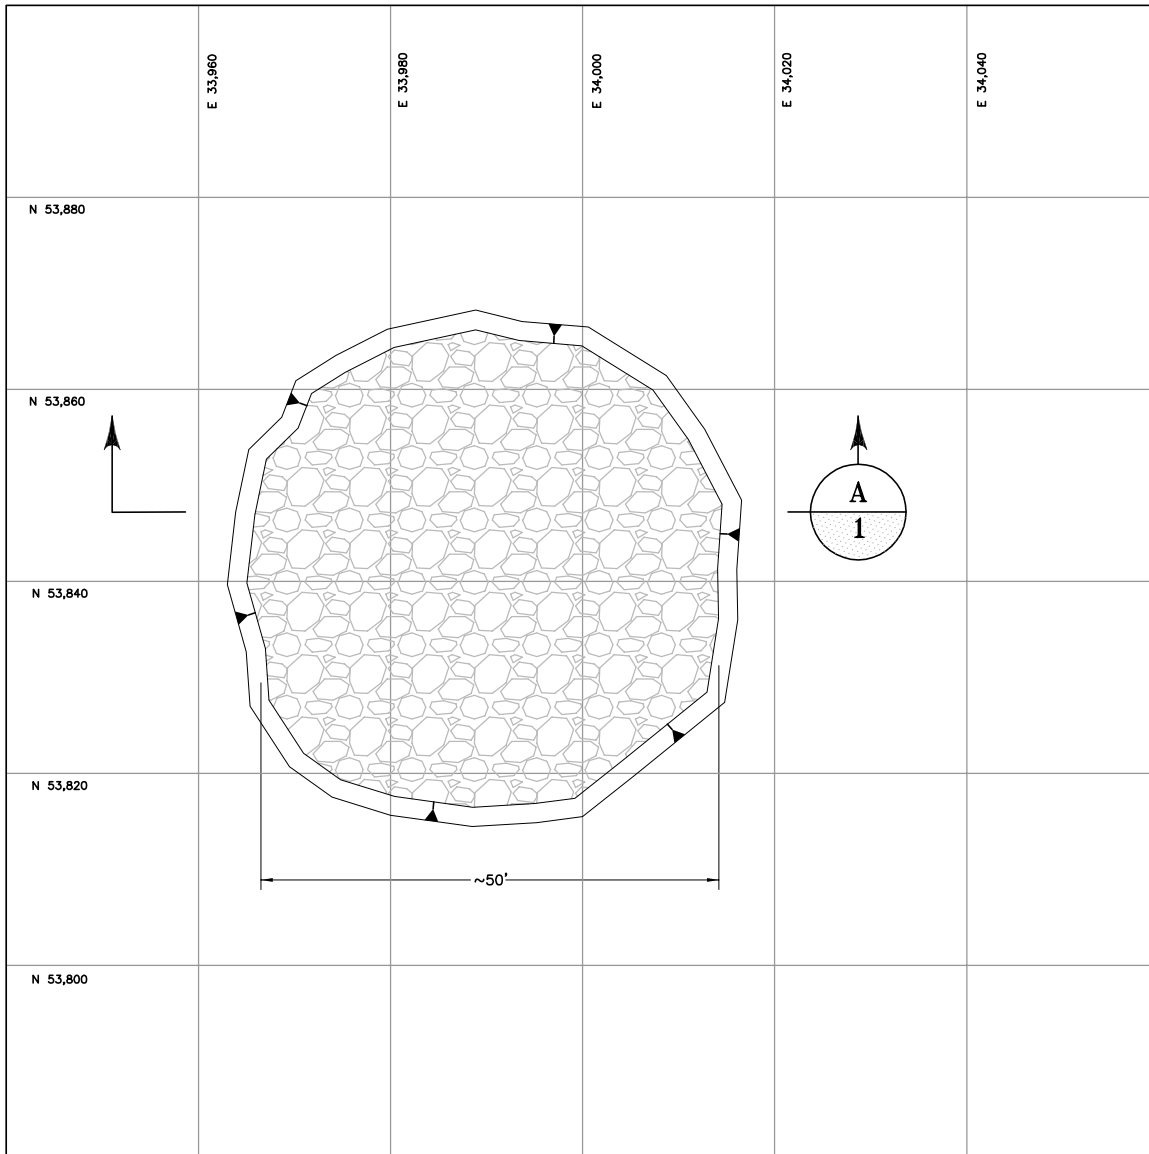
- 0 YD³ – STRUCTURAL FILL (SEE NOTE #2)
- 5 YD³ – CONCRETE
- 70 YD³ – CEMENTED ROCK FILL

1. SLOPE = 0.5H:1V MINIMUM.
2. EMBANKMENT FILL USED AS STRUCTURAL FILL IN REMEDIATION EFFORT.

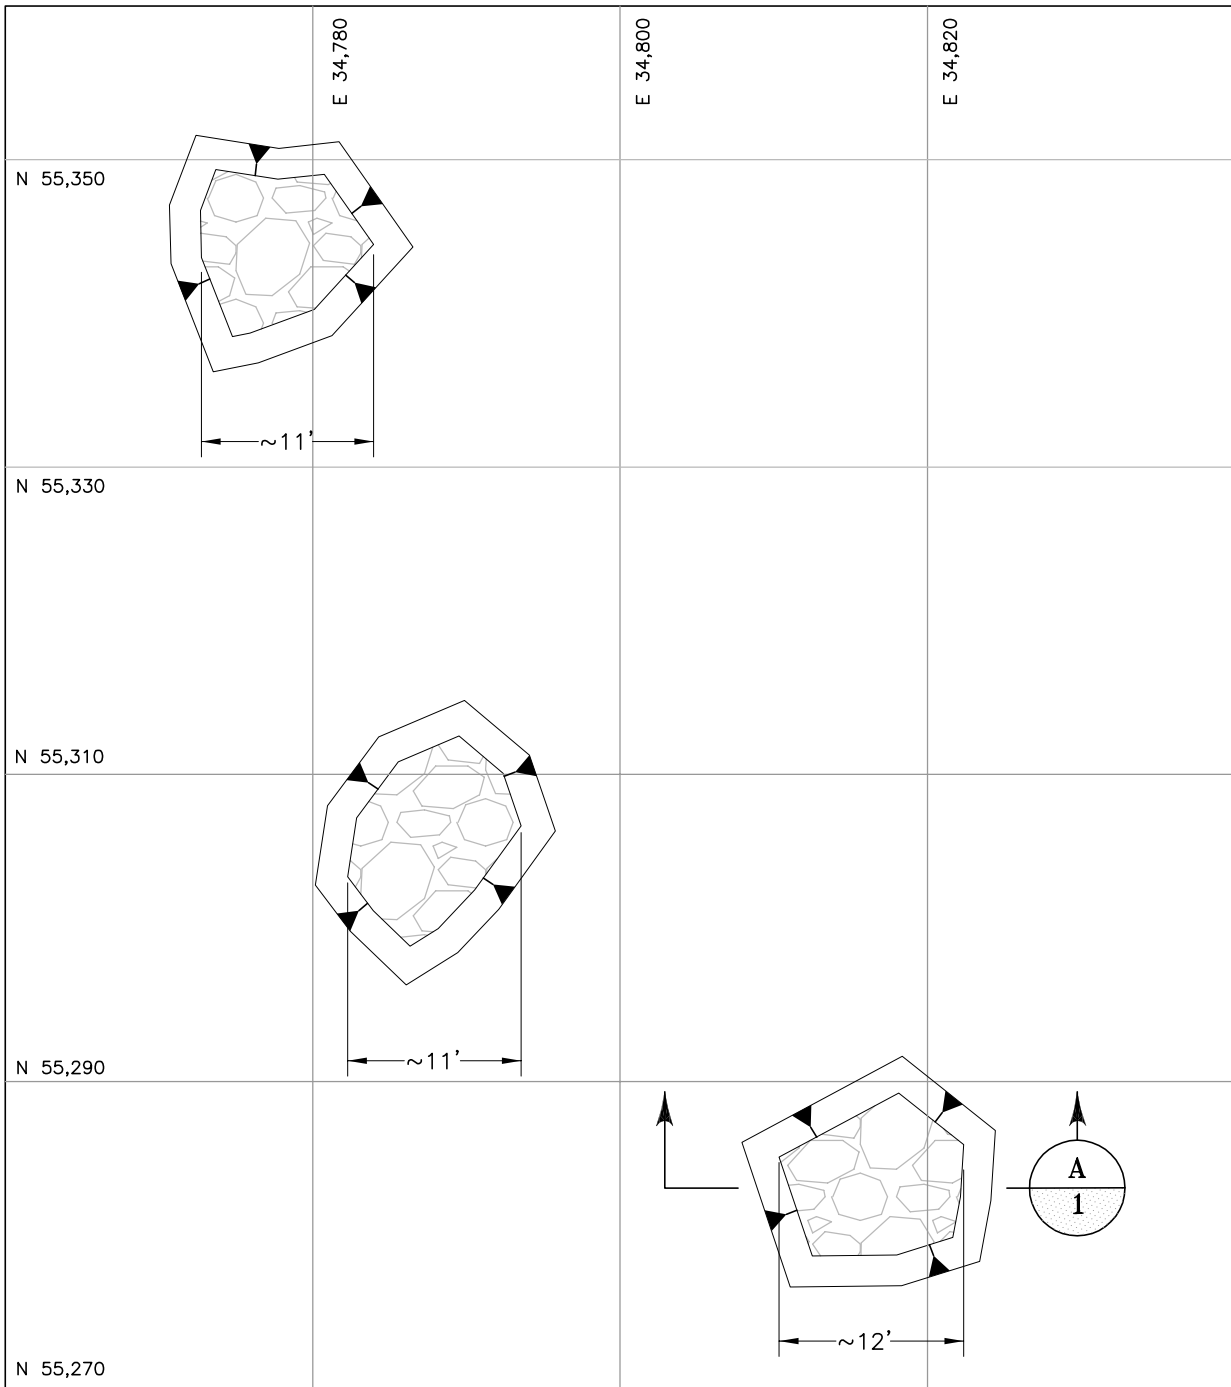
3,060 YD³ – STRUCTURAL FILL

35 YD³ – CONCRETE

430 YD³ – CEMENTED ROCK FILL

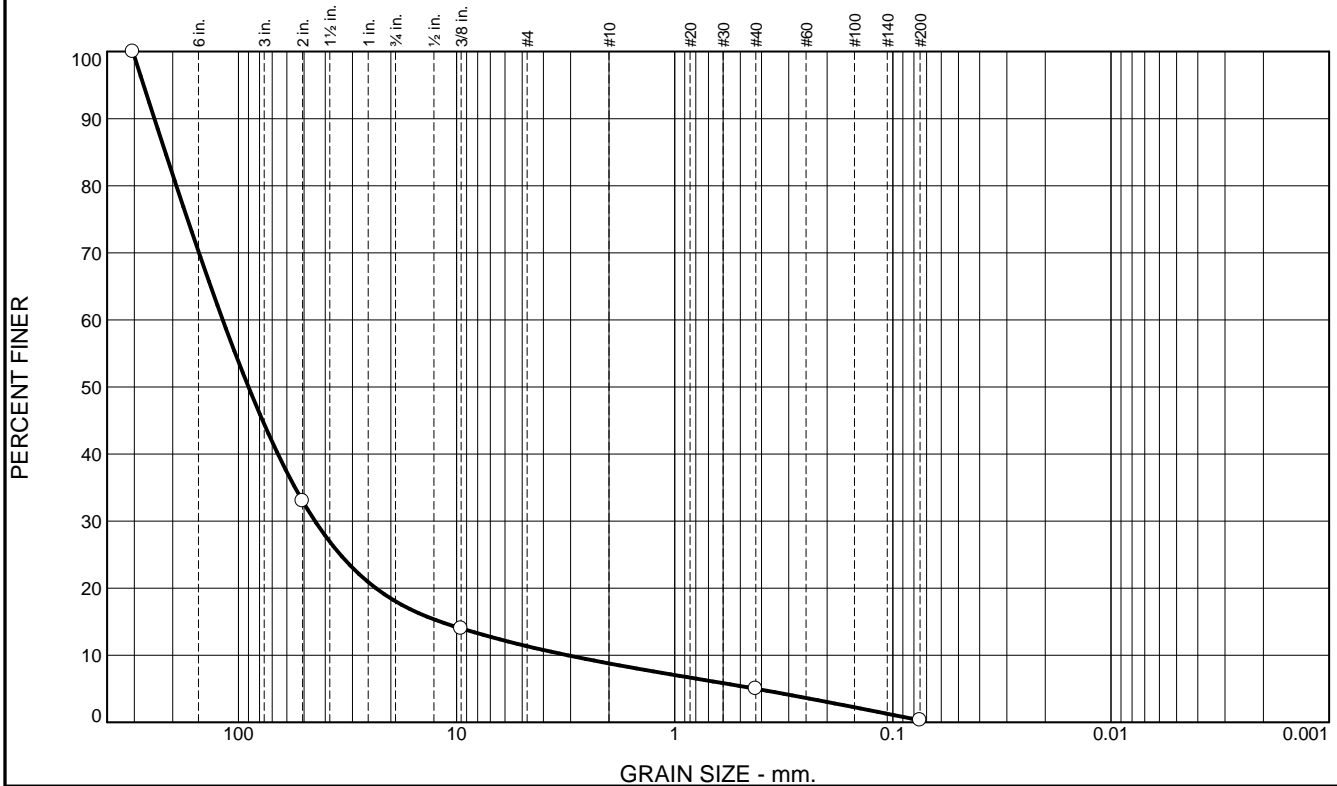
Figure CSB-1-R

Brown poorly graded gravel with sand

USCS= GP AASHTO= A-1-a

Sample obtained from UG#6320

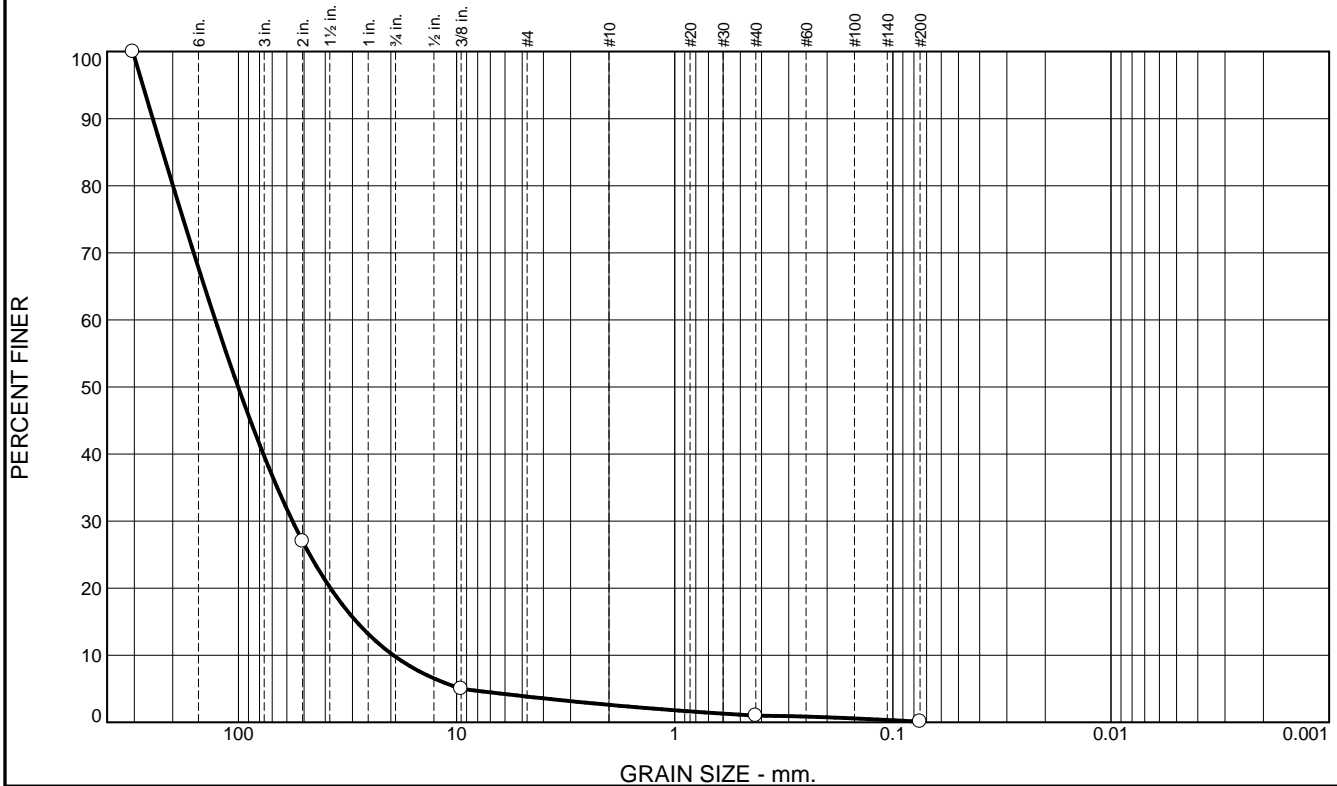
Figure CSB-2-R

Brown well-graded gravel

USCS= GW

Sample obtained from UG#6320
