**COLORADO DIVISION OF RECLAMATION, MINING AND SAFETY**  
**MINERALS PROGRAM INSPECTION REPORT**  
**PHONE: (303) 866-3567**

<b>MINE NAME:</b> Monogram Mines	<b>MINE/PROSPECTING ID#:</b> M-1978-222-UG	<b>MINERAL:</b> Uranium and vanadium	<b>COUNTY:</b> Montrose
<b>INSPECTION TYPE:</b> Monitoring	<b>INSPECTOR(S):</b> Dustin M. Czapla	<b>INSP. DATE:</b> November 12, 2014	<b>INSP. TIME:</b> 11:00
<b>OPERATOR:</b> Nuvemco, LLC	<b>OPERATOR REPRESENTATIVE:</b> Paul Szilagyi	<b>TYPE OF OPERATION:</b> 112d-1 - Designated Mining Operation

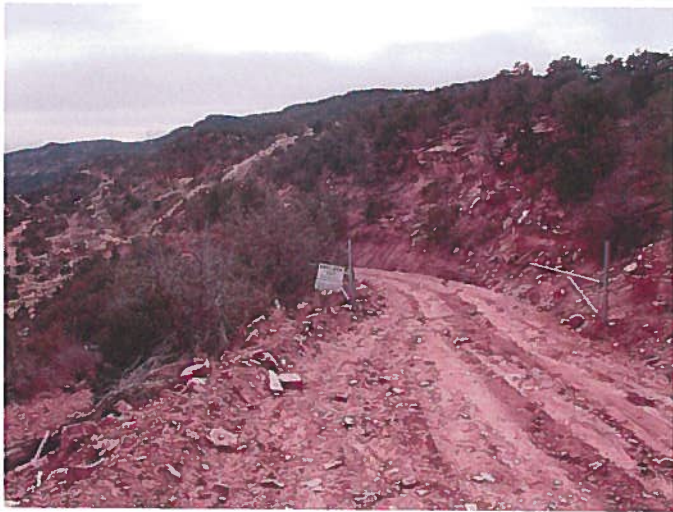
Adequate mine identification signage was noted on the gate at the entrance to the site.

Figure 1: Mine entrance

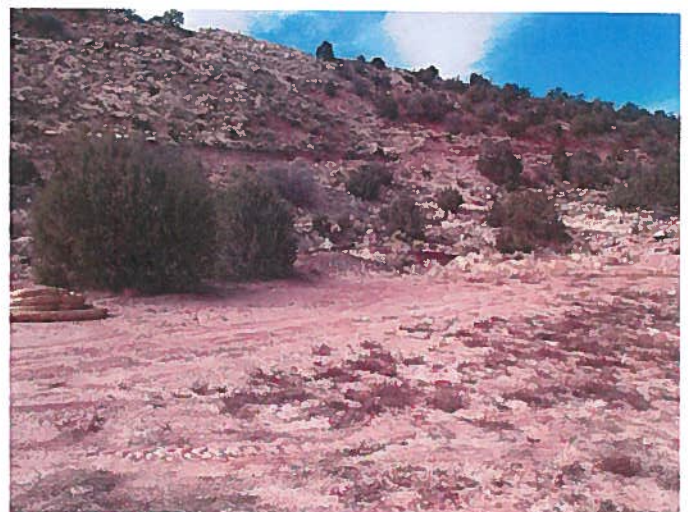
The ore bins are not yet constructed. Mining has not commenced and no ore or waste rock has been generated.

Figure 2: Staging area looking toward future ore bin location

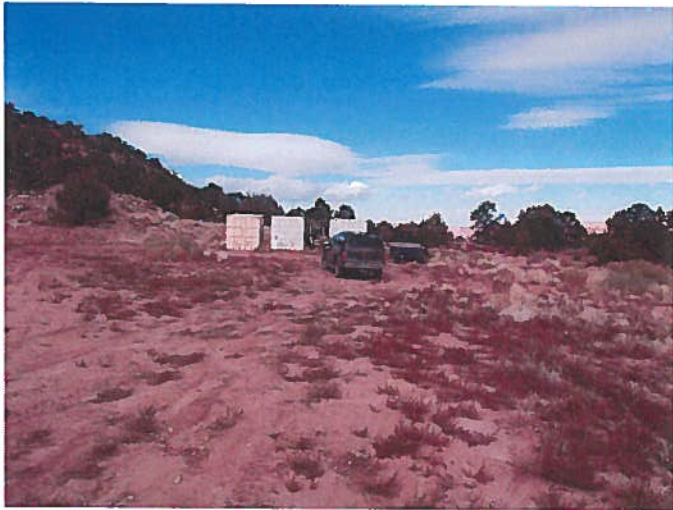
Figure 3: Staging area

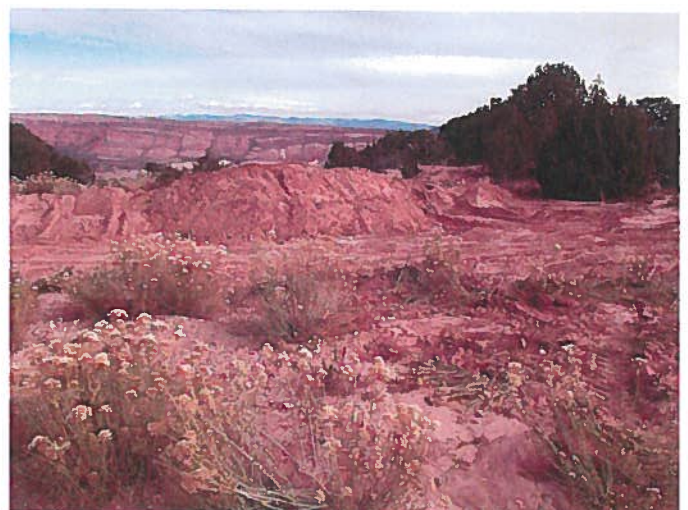
Site stormwater controls have been constructed to direct flow around the staging area to the location of the approved retention basin. The retention basin has not been constructed yet. An earthen berm has been constructed at the north end of the staging area to retain stormwater until the approved stormwater controls are constructed. These temporary stormwater controls appear to be effective.

Figure 4: Earthen berm at north end of staging area

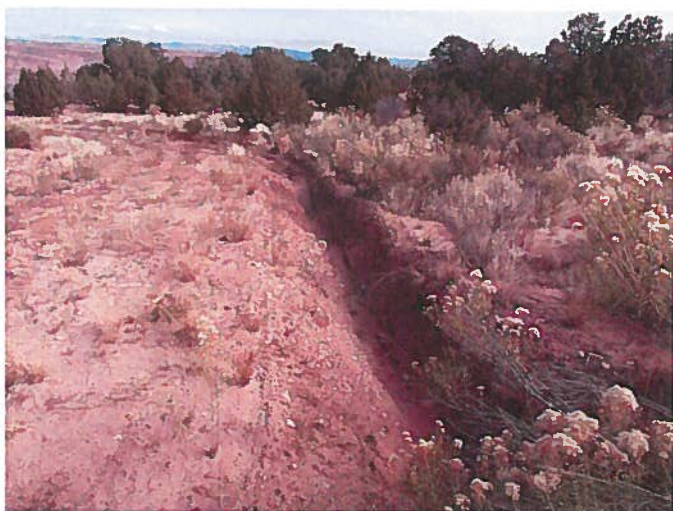
Figure 5: Diversion ditch constructed around staging area

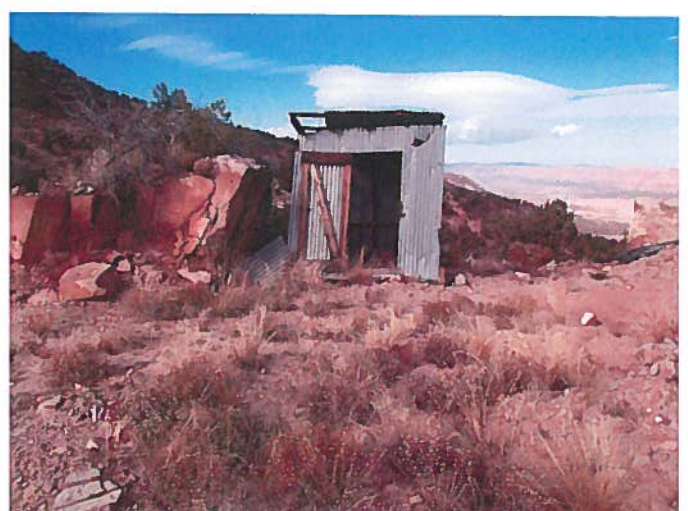
Figure 6: Future area of surface mining

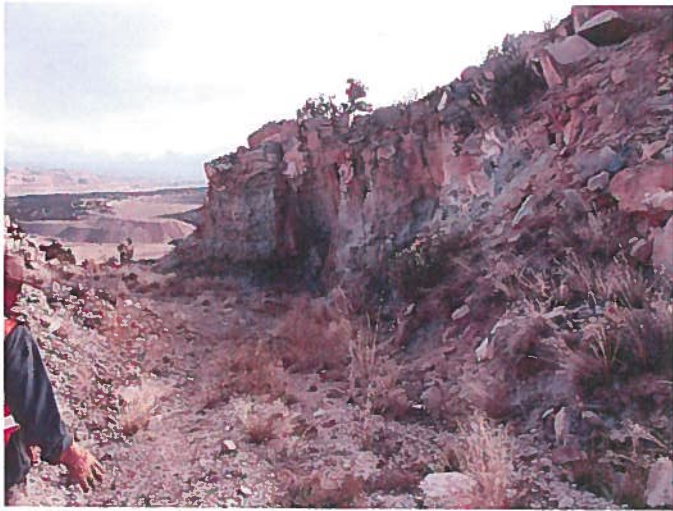
Figure 7: Future area of surface mining

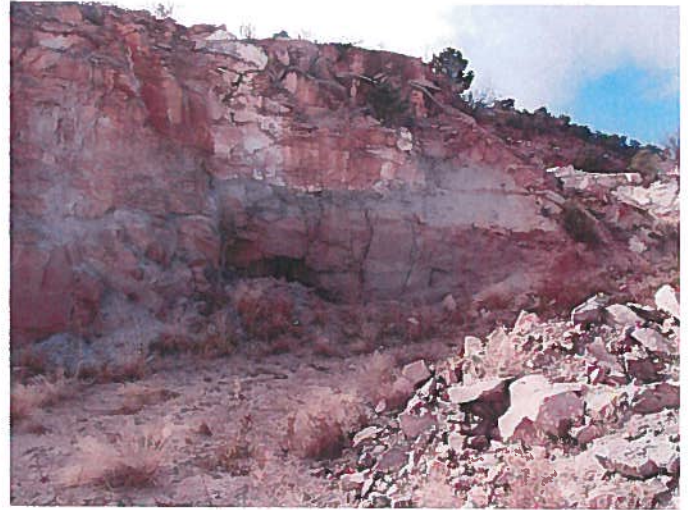
Figure 8: Future area of surface mining
