COLORADO DIVISION OF RECLAMATION, MINING AND SAFETY
MINERALS PROGRAM INSPECTION REPORT
PHONE: (303) 866-3567

MINE NAME: Pit No 1	MINE/PROSPECTING ID#: M-1977-020	MINERAL: Sand and gravel	COUNTY: Delta
INSPECTION TYPE: Monitoring	INSPECTOR(S): Dustin M. Czaplá	INSP. DATE: November 14, 2014	INSP. TIME: 10:00
OPERATOR: Keys Blue Haven LLC	OPERATOR REPRESENTATIVE: Bill St. James	TYPE OF OPERATION: 112c - Construction Regular Operation

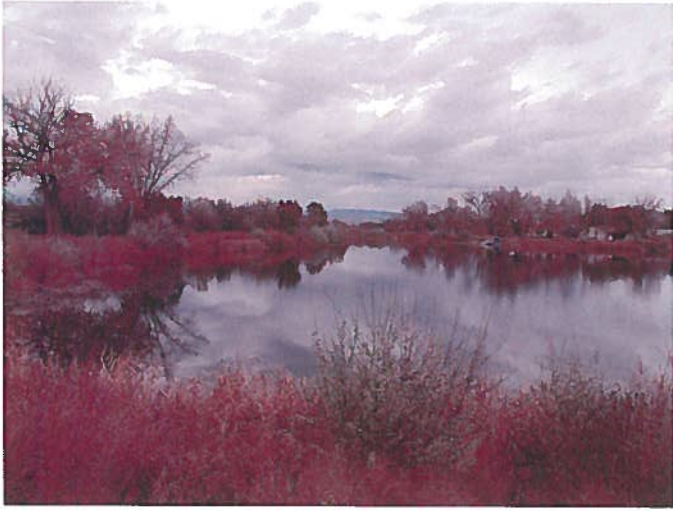
Figure 1: Northeast lake from west side

Grading appears adequate and the banks are well vegetated, although there is a heavy infestation of tamarisk and Russian olive. Remaining reclamation in this area consists of weed control and vegetation of the access road areas.

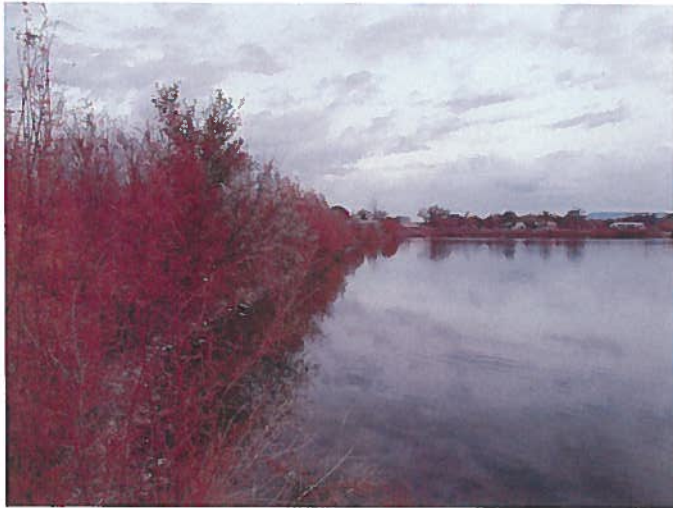
Figure 3: North bank of the southeast lake from northwest corner

Grading appears adequate and the banks are mostly well vegetated, although there is a heavy infestation of tamarisk and Russian olive. Remaining reclamation in this area consists of weed control and vegetation of the access road areas and the west and south slopes.

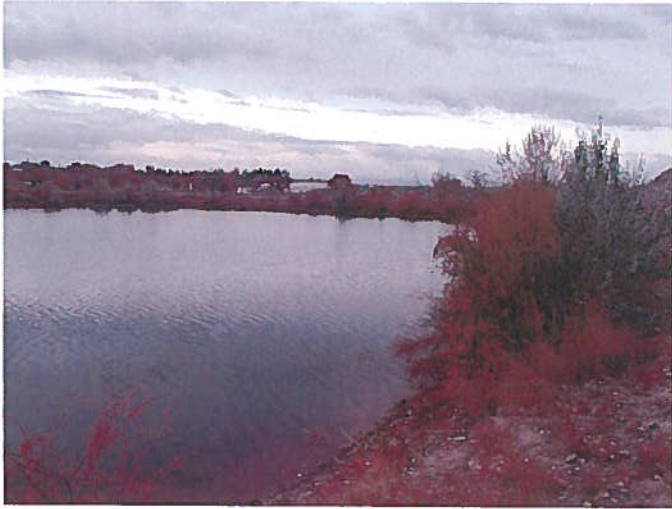
Figure 7: View from north bank of the west lake, facing west

Slopes below the water line appeared to be adequately graded. Several areas of the banks above water line, along the north and east banks, will require additional grading to reduce the slopes to the required grade 3H:1V grade. Most of the south and east bank will require slope reduction. Tamarisk and Russian olive have infested this area as well.
