COLORADO DIVISION OF RECLAMATION, MINING AND SAFETY
MINERALS PROGRAM INSPECTION REPORT
PHONE: (303) 866-3567

MINE NAME: Last Chance #3 & #4	MINE/PROSPECTING ID#: M-2008-012	MINERAL: Uranium and vanadium	COUNTY: Montrose
INSPECTION TYPE: Monitoring	INSPECTOR(S): Dustin M. Czapla	INSP. DATE: November 12, 2014	INSP. TIME: 12:00
OPERATOR: Nuvemco, LLC	OPERATOR REPRESENTATIVE: Paul Szilagyi	TYPE OF OPERATION: 112d-1 - Designated Mining Operation

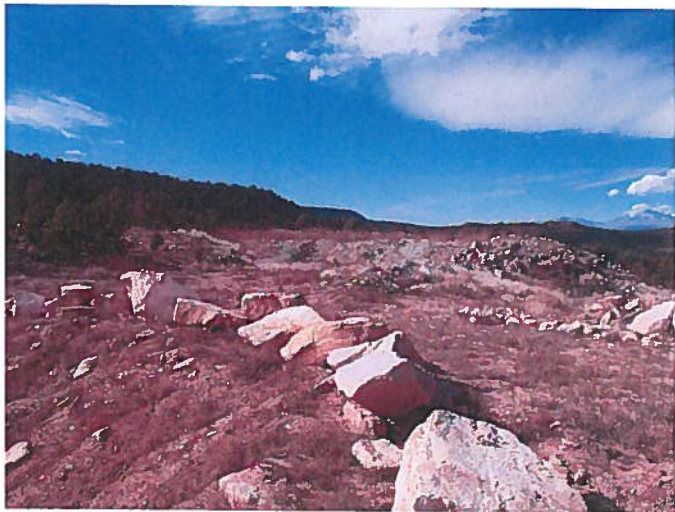
No erosion issues were noted around the waste rock piles.

Figure 3: Waste rock area

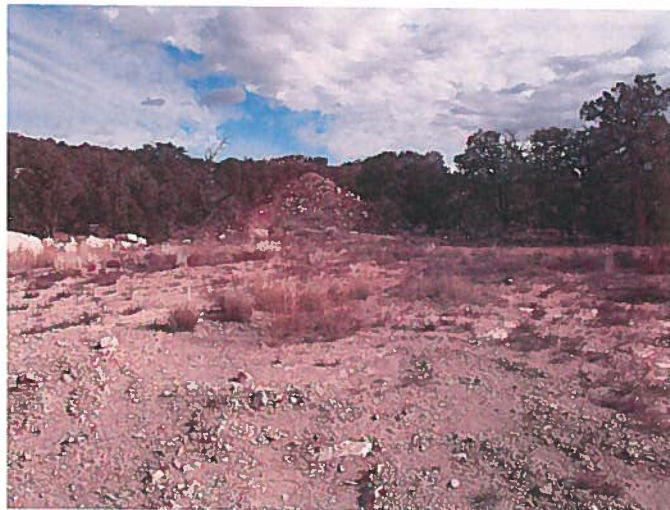
Topsoil material is stockpiled northwest of Pond 2. The stockpile appears stable and protected from disturbance.

Figure 4: Soil stockpile

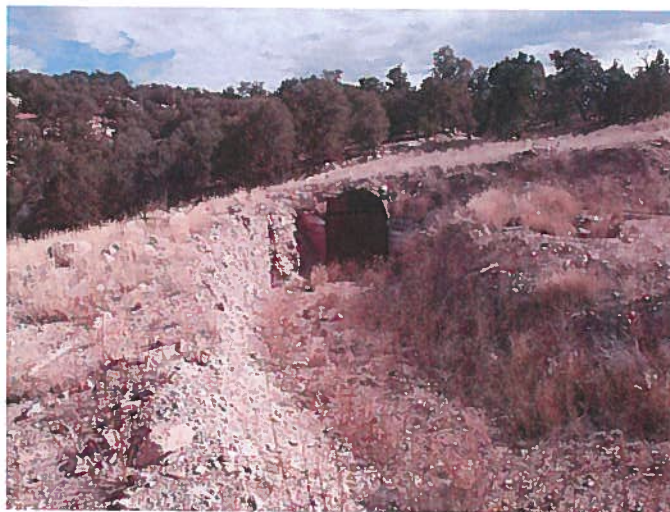
The mine portal is secured with a locked steel gate.

Figure 6: Mine portal

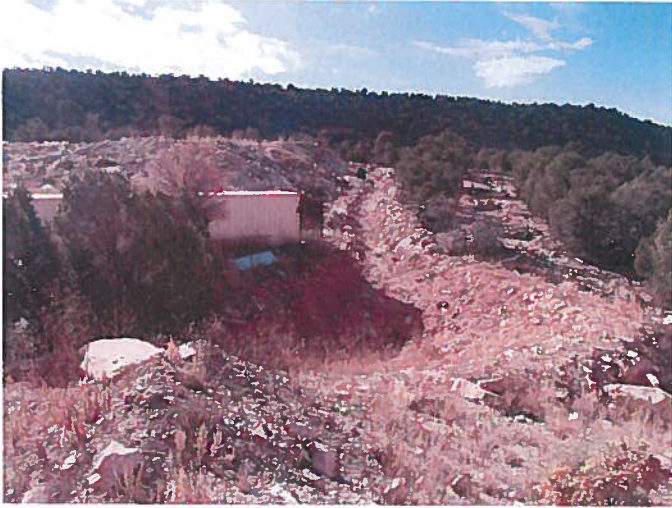
Underground mining operations have been inactive since 2010. Other than site maintenance and weed control, the last mining activity occurred in 2012, and consisted of construction of stormwater control structures. The stormwater control structures appeared to be effective.

Figure 7: Constructed diversion ditch
