**COLORADO DIVISION OF RECLAMATION, MINING AND SAFETY**  
**MINERALS PROGRAM INSPECTION REPORT**  
**PHONE: (303) 866-3567**

<b>MINE NAME:</b> Kunau Site	<b>MINE/PROSPECTING ID#:</b> M-2008-025	<b>MINERAL:</b> Gravel	<b>COUNTY:</b> El Paso
<b>INSPECTION TYPE:</b> Monitoring	<b>INSPECTOR(S):</b> Timothy A. Cazier	<b>INSP. DATE:</b> March 4, 2014	<b>INSP. TIME:</b> 09:30
<b>OPERATOR:</b> Tim Kunau	<b>OPERATOR REPRESENTATIVE:</b> Red Kunau	<b>TYPE OF OPERATION:</b> 110c - Construction Limited Impact

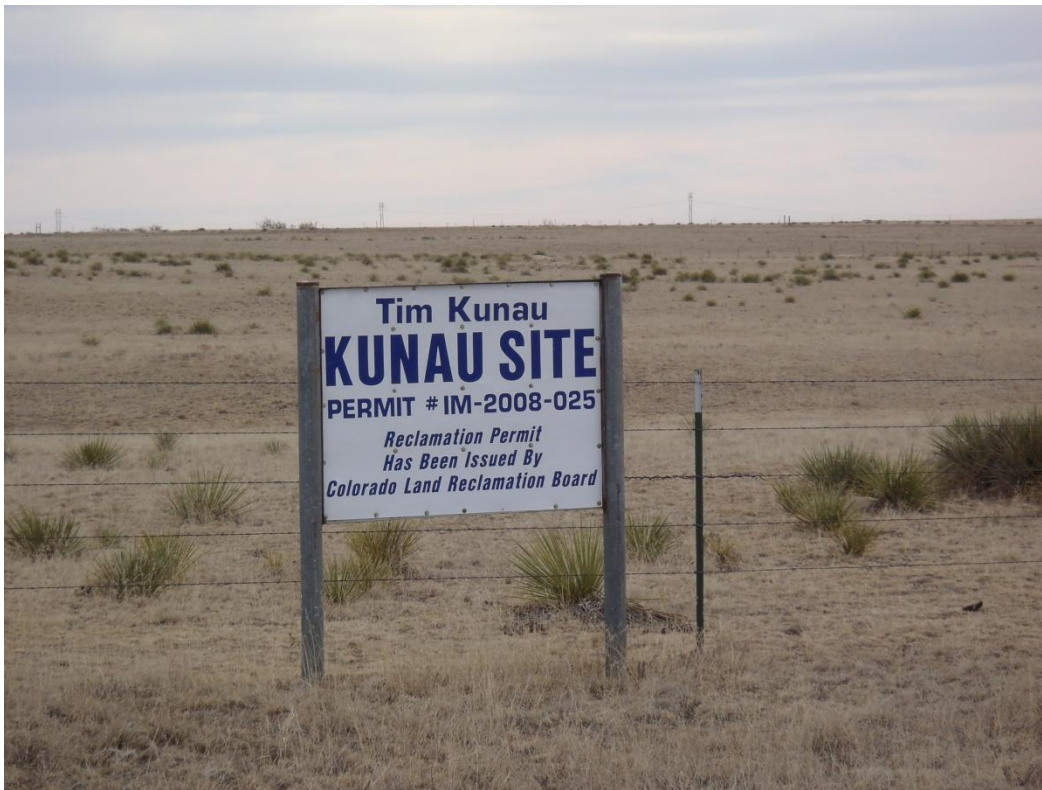
A permit sign was displayed at the site entrance (see **Photo 1**). The site is rectangular with the four corners marked with PVC posts (see **Photo 2**).

Photo 1. Required posted permit sign.

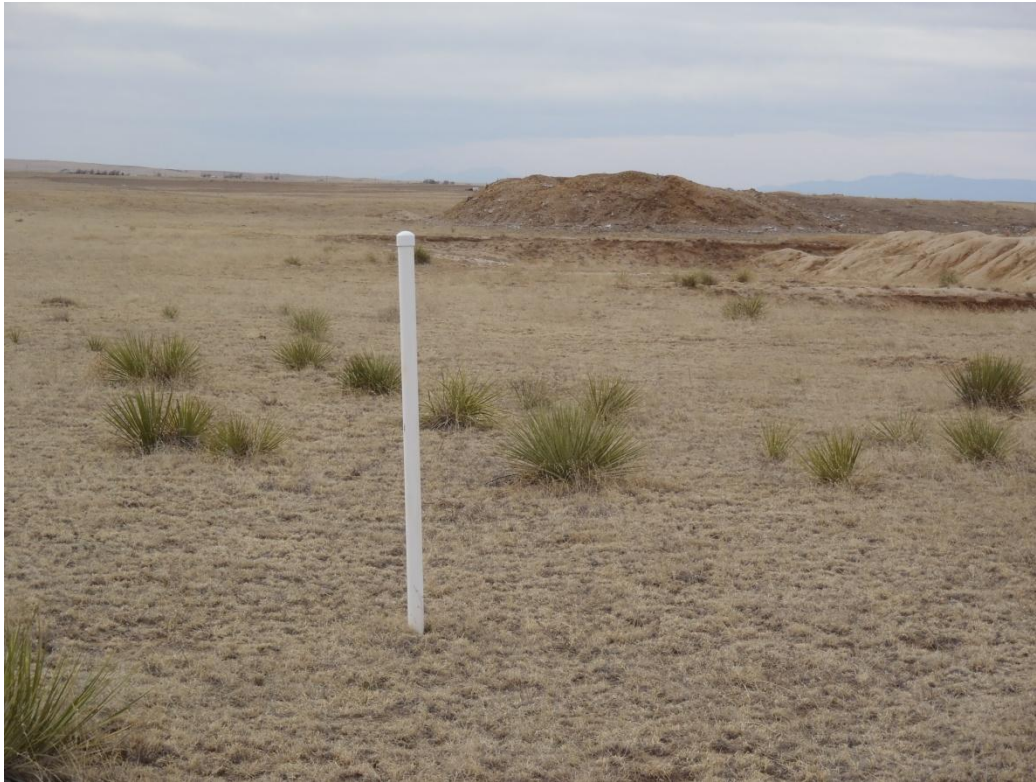
Photo 2. Typical PVC permit boundary corner post.

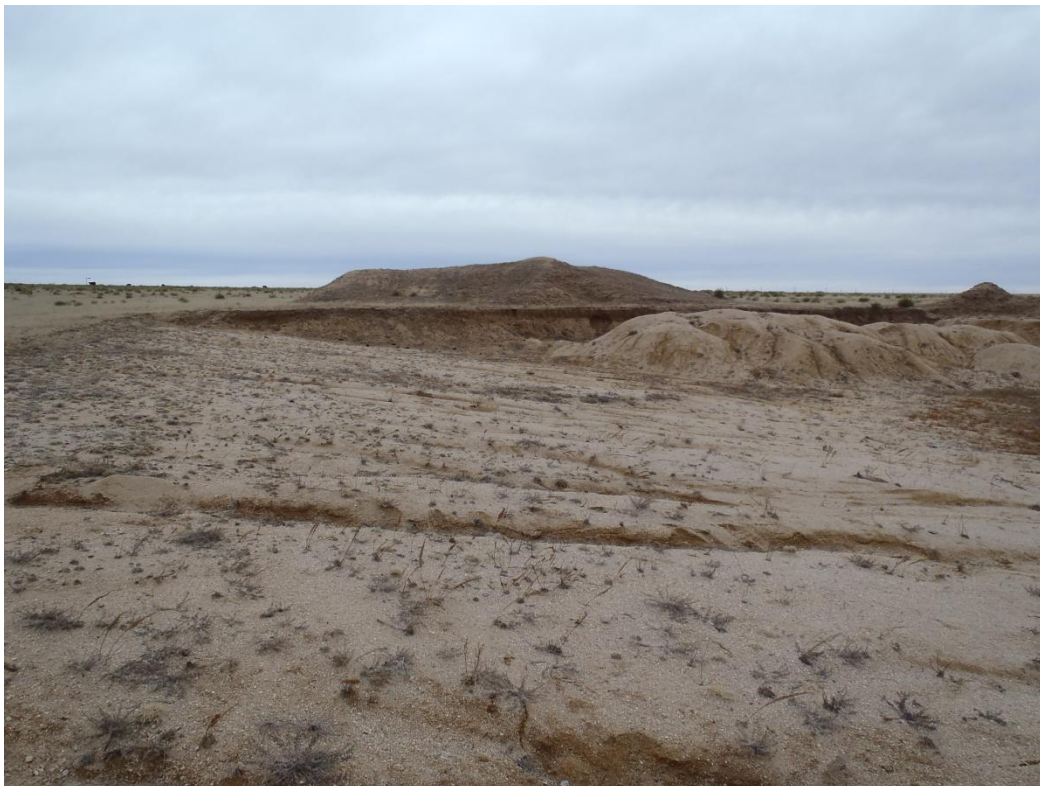
This inspector walked the perimeter of the site with Mr. Kunau. Highwalls, estimated to be approximately 10 feet high, existed on the north and south edges of the pit. The west (see **Photo 3**) and east side of the pit are at a much shallower grade (estimated to be between 7H:1V and 10H:1V). Material was stockpiled in the bottom of the pit (see **Photo 4**). A topsoil stockpile was observed on the north side of the pit as designated in the approved permit (see **Photo 5**). A wood mulch pile was observed on the south side of the pit (see **Photo 6**). Mr. Kunau indicated the mulch pile was originally intended for wood burning, but they will keep it for mulch now. It appeared that a few cubic yards of the topsoil stockpile appeared to be outside the permit boundary (see **Photo 7**). Mr. Kunau was urged to dress up the topsoil stockpile so that it is entirely within the permit boundary and check it regularly to be sure it is kept within the permit boundary. A smaller excavation (approximately 120 feet long and 30 feet wide) was observed on the northeast corner of the pit.

Photo 3. Shallow grade on west side of pit (looking north).

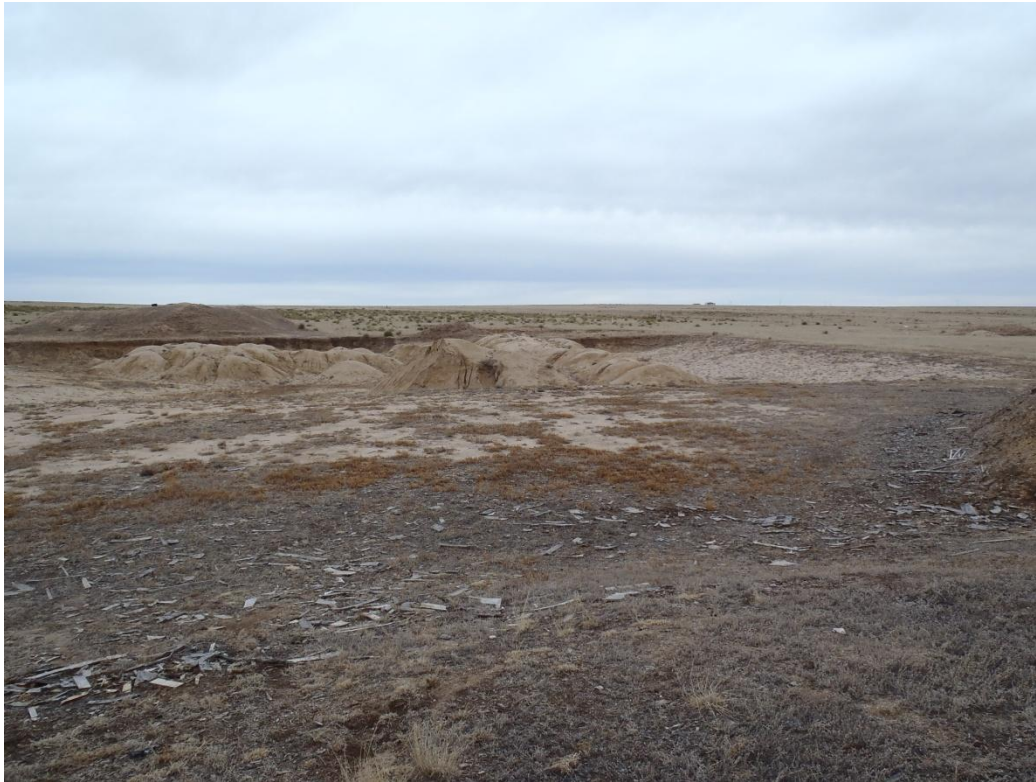
Photo 4. Stockpiled material in bottom of pit (looking NE).

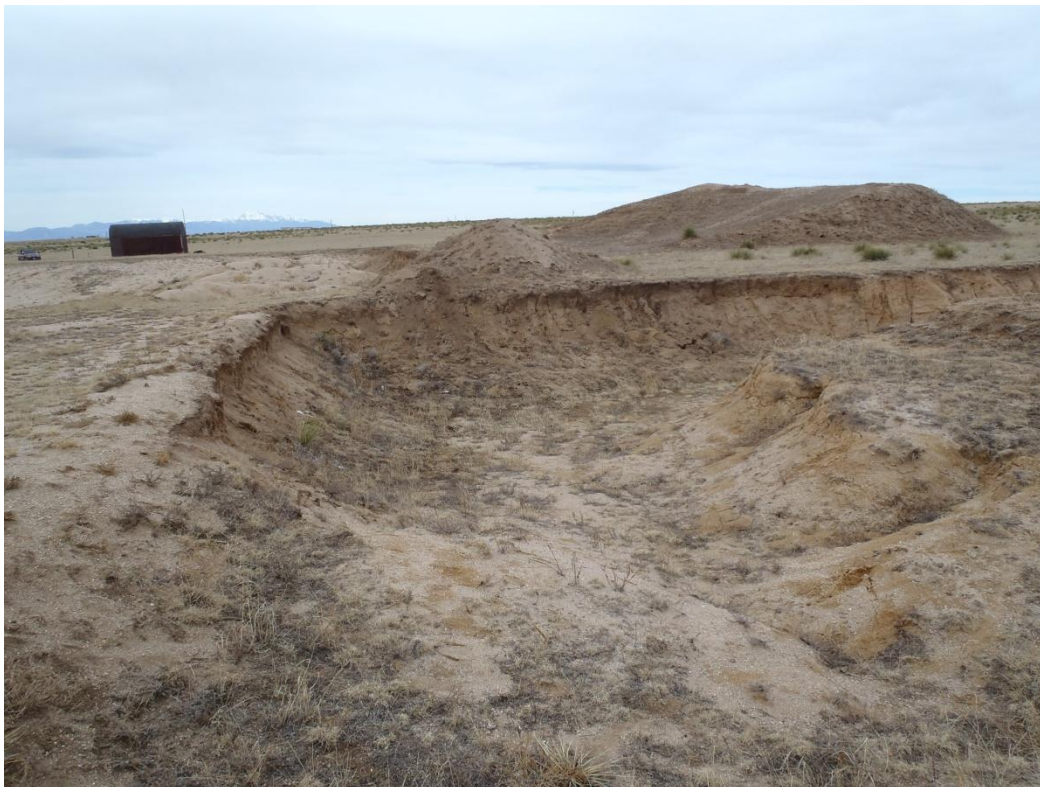
Photo 5. Topsoil stockpile (looking north).

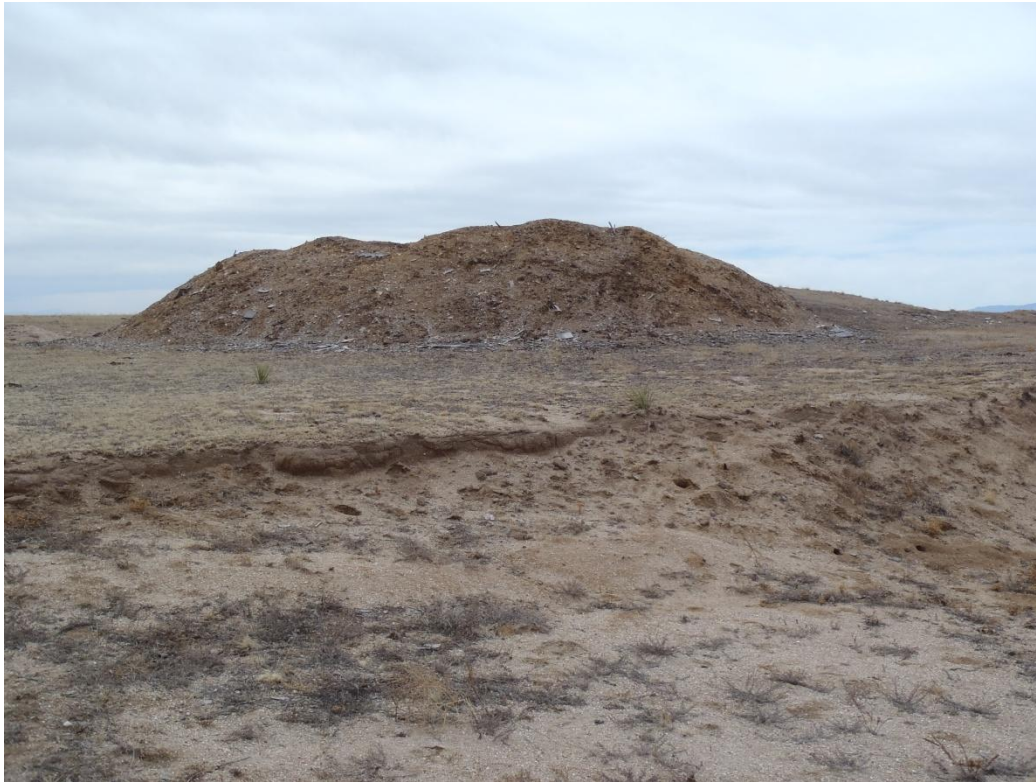
Photo 6. Wood mulch stockpile (looking south).

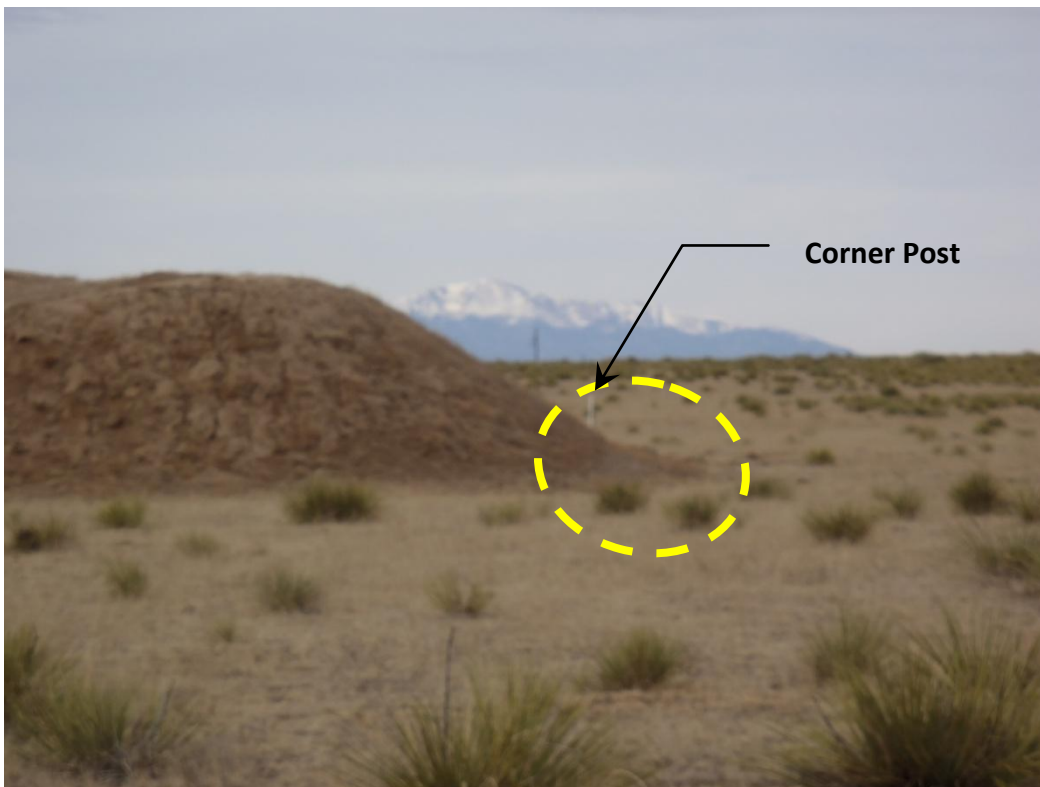
Photo 7. Topsoil stockpile outside permit boundary (looking west).

1. The Operator needs to dress up and check the topsoil stockpile frequently to be sure it is maintained within the permit boundary.
2. Please be aware there is a \$144 fee and a form (mailed on November 24, 2014) which must be submitted to the Division and approved by the Mined Land Reclamation Board to formally enter TC.
