COLORADO DIVISION OF RECLAMATION, MINING AND SAFETY
MINERALS PROGRAM INSPECTION REPORT
PHONE: (303) 866-3567

MINE NAME: Conger Harvesting Area	MINE/PROSPECTING ID#: M-1998-022	MINERAL: Stone	COUNTY: Gunnison
INSPECTION TYPE: Monitoring	INSPECTOR(S): Dustin M. Czaplá	INSP. DATE: December 11, 2014	INSP. TIME: 11:00
OPERATOR: The Gallegos Corporation	OPERATOR REPRESENTATIVE: Frank Gutierrez	TYPE OF OPERATION: 112c - Construction Regular Operation

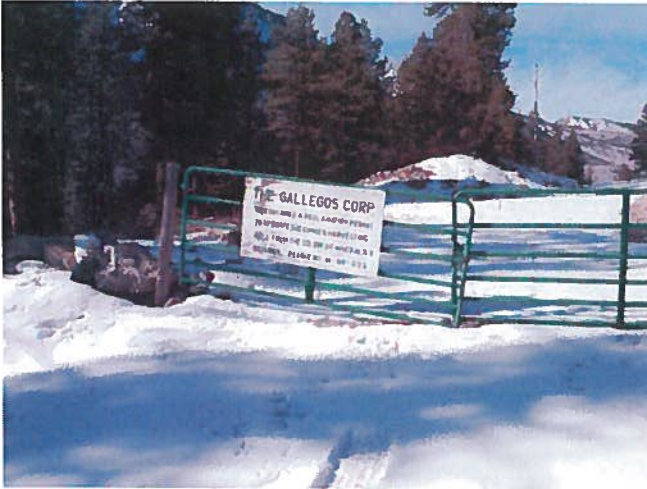
Adequate mine identification signage was noted on the gate at the entrance to the site.

Figure 1: Permit area entrance to the private land

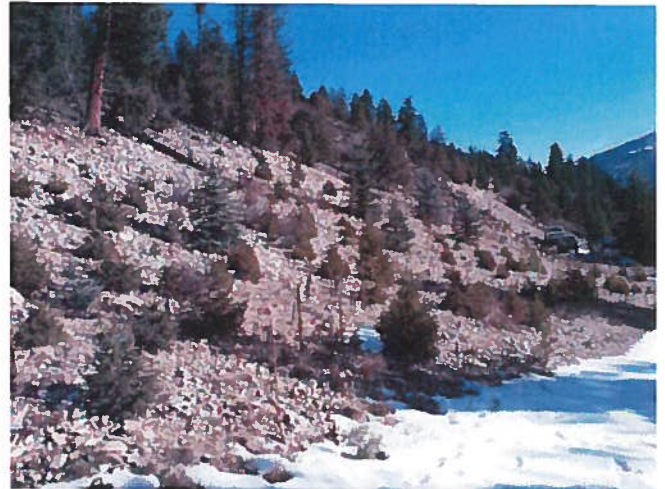
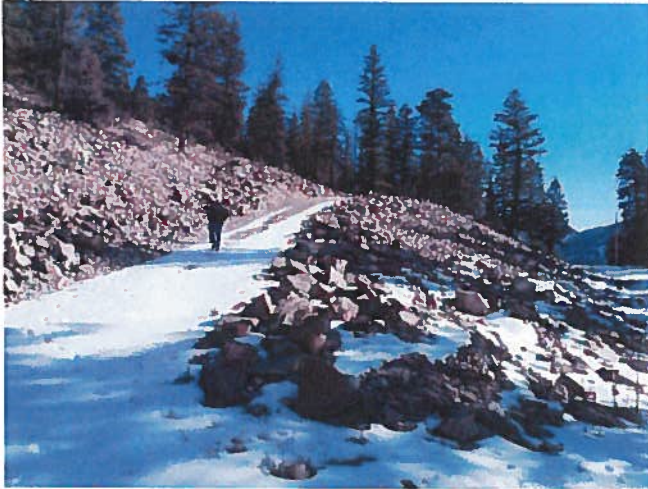
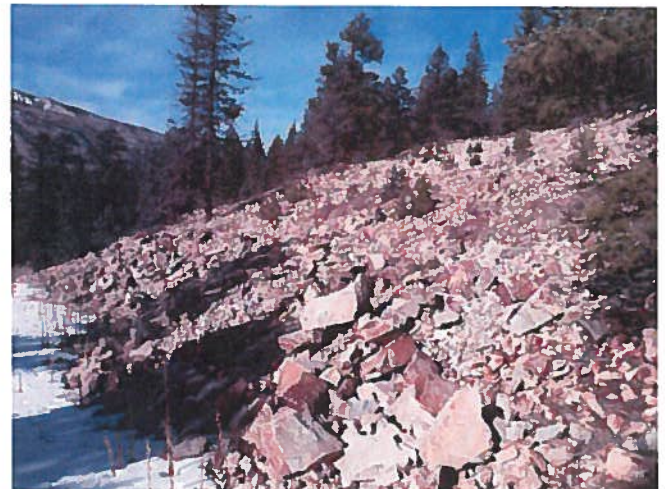
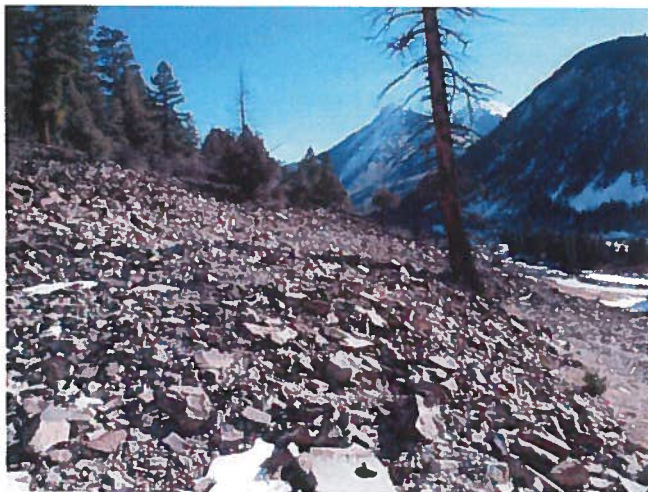
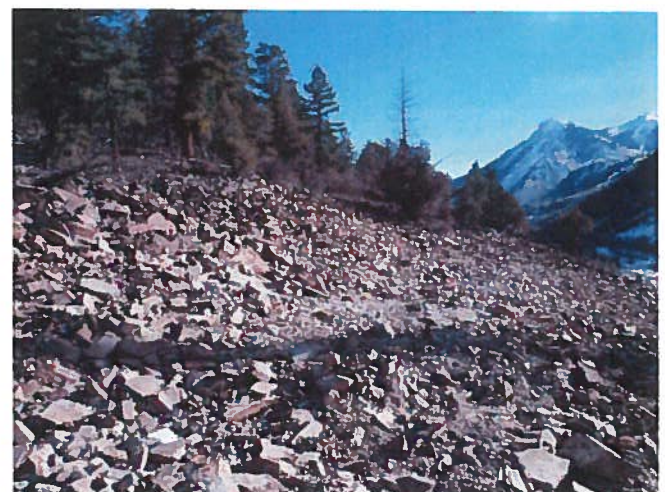
Mining and reclamation are completed in the private land portion of the permit area. Mined slopes have been graded to blend with the surrounding area and appear stable. Where soil exists vegetation is becoming well established. No potential problems were noted in this area.

Figure 2: Reclaimed area on the private land

Figure 3: Reclaimed area on the private land

Figure 4: Reclaimed area on the private land

Figure 5: Reclaimed area on the private land

Figure 6: Reclaimed area on the private land

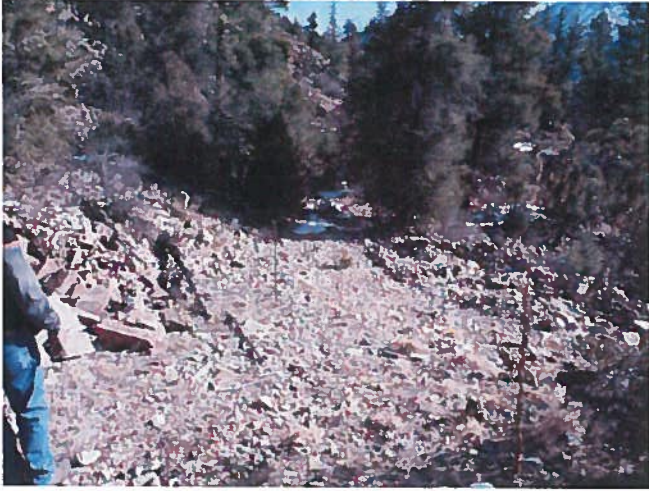
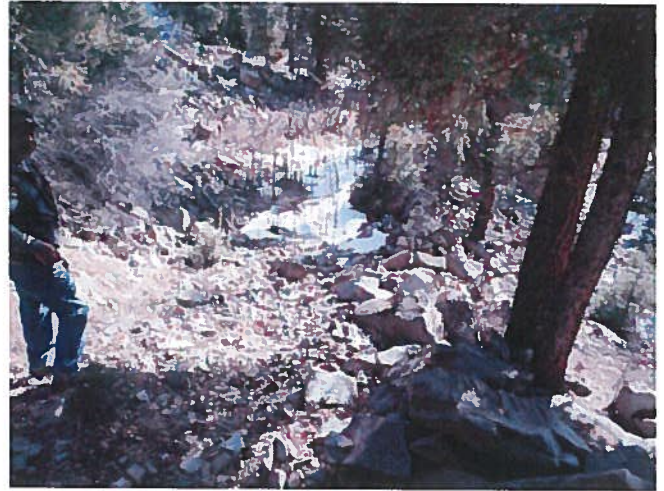
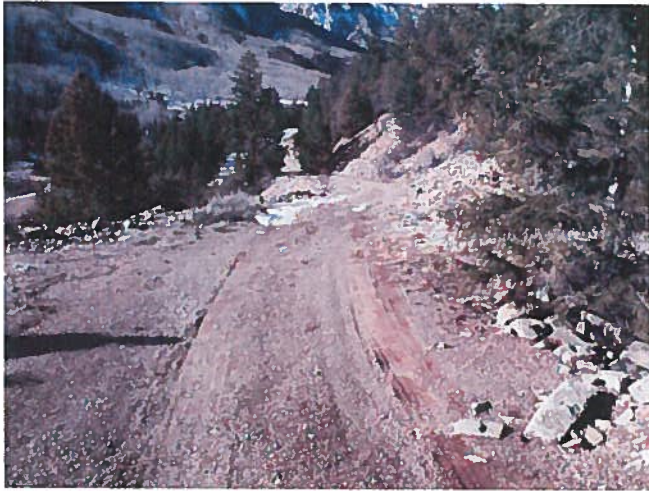
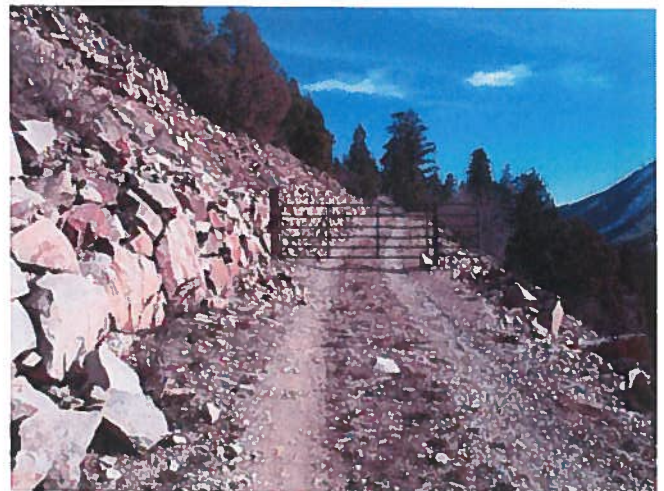
The operator anticipates revising the permit to relocate the access to the USFS property. The new access would utilize an existing road located on private property owned by Robert Raymond. The existing road terminates at the USFS property line. Before the road can be utilized maintenance will be necessary, but significant upgrades are not anticipated. It was determined that the existing road does not need to be included in the permit area.

Figure 7: Proposed new access road

Figure 8: Proposed new access road

Figure 9: Proposed new access road

Figure 10: Proposed new access road
