**COLORADO DIVISION OF RECLAMATION, MINING AND SAFETY
MINERALS PROGRAM INSPECTION REPORT
PHONE: (303) 866-3567**

MINE NAME: Bulldog Mine Operation	MINE/PROSPECTING ID#: M-1977-215	MINERAL: Lead and silver	COUNTY: Mineral
INSPECTION TYPE: Monitoring	INSPECTOR(S): Bob Oswald	INSP. DATE: November 18, 2014	INSP. TIME: 15:30
OPERATOR: Rio Grande Silver, Inc.	OPERATOR REPRESENTATIVE: Randy McClure	TYPE OF OPERATION: 112d-2 - Designated Mining Operation

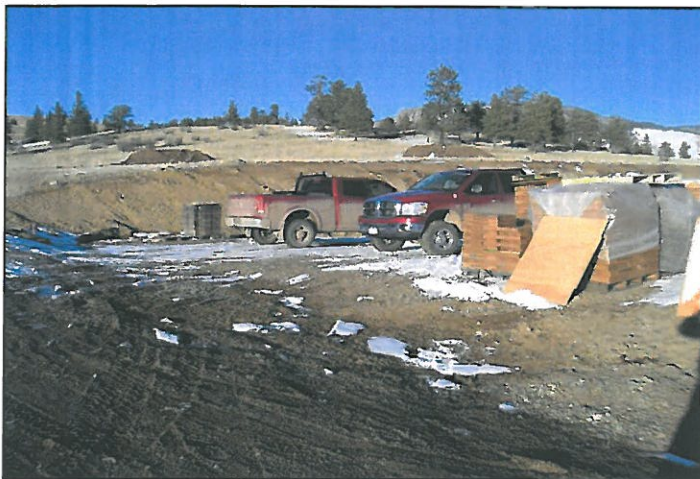
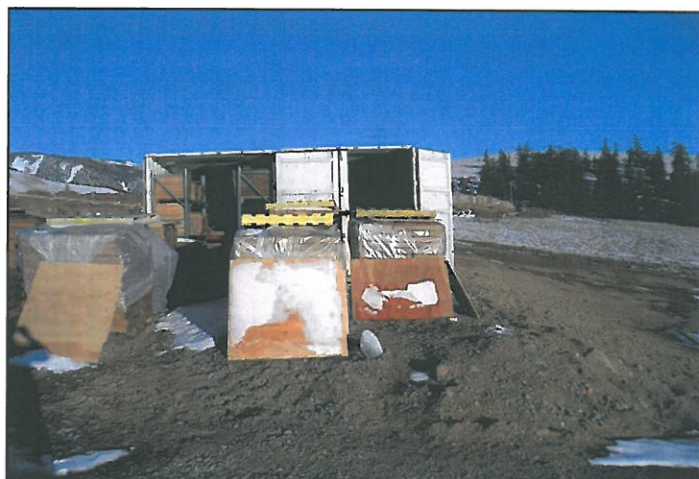
The new core storage area near TP2 was recently approved by the Division, and its development and use has begun. Wherever it was present, the operator stripped and stockpiled topsoil for later use. The topsoil must be monitored for erosion and weeds; it has been seeded to protect it while it is in stockpile. There are two separate pad areas for storing the pallets of drill core, each constructed by shallow cut and fill earthmoving. The larger pad to the NE already contained many pallets of boxed core, and there is still a lot of storage capacity left. The smaller storage pad is adjacent to the TP2 access road, and it contains two zircon storage containers. Jonathon Moore with RGS was moving and filing selected core boxes into the containers for secure storage. The storage pads were orderly and did not contain debris. The pad construction is new, however, and the operator must monitor the site for to control runoff and sediment that may be transported from the pads and slopes. All cut and fill slope surfaces were also seeded to stabilize them.

L and R, above: Lower (SW) core storage pad and zircon containers

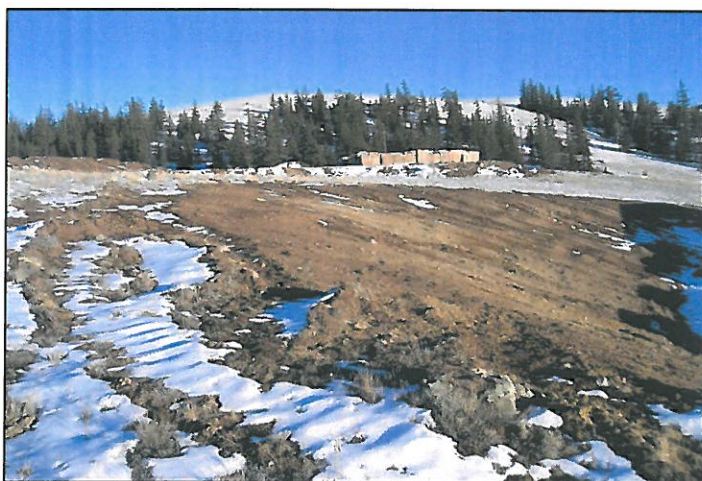
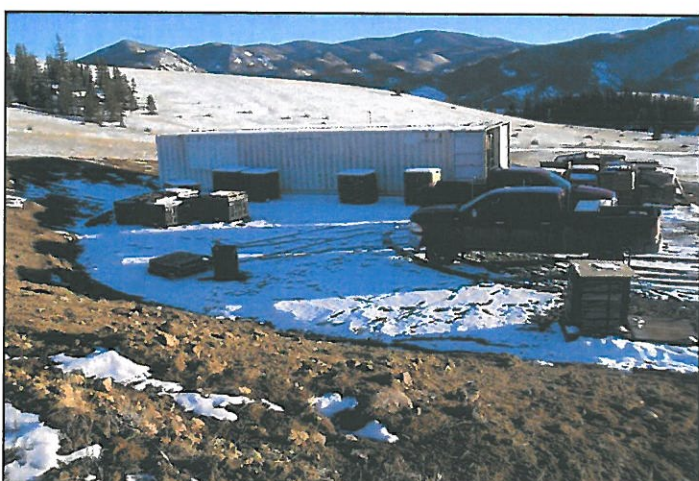
L and R, above: Earthwork to construct lower core storage pad

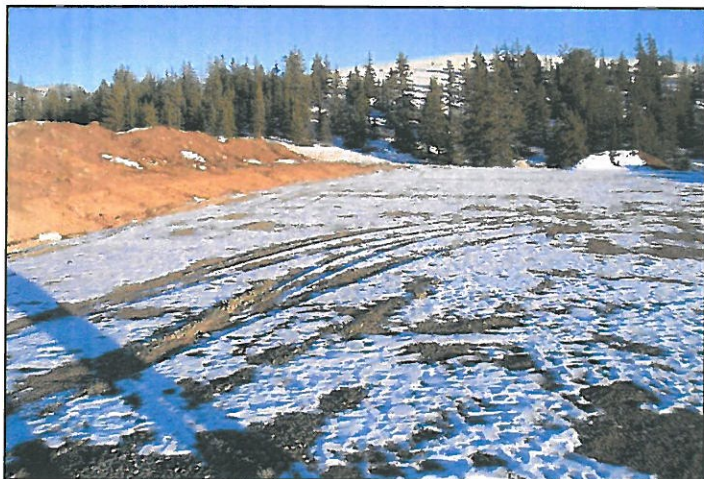
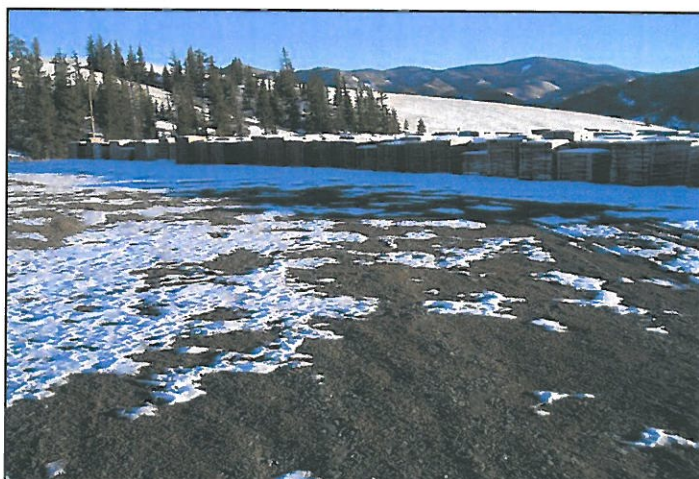
L and R, above: Upper (NE) core storage pad, note full pallets on right.

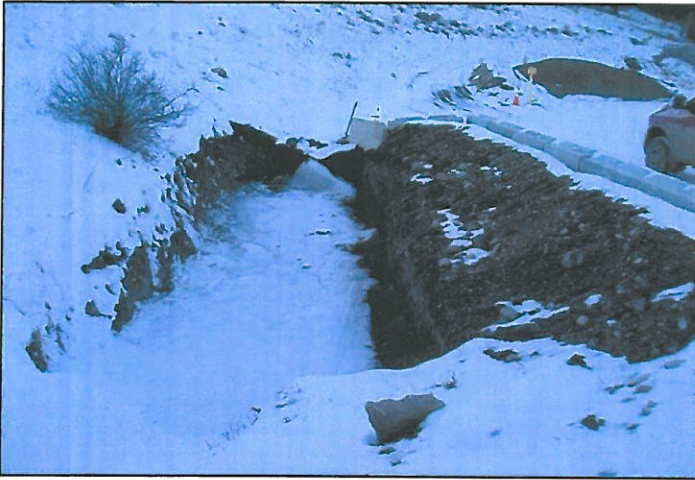
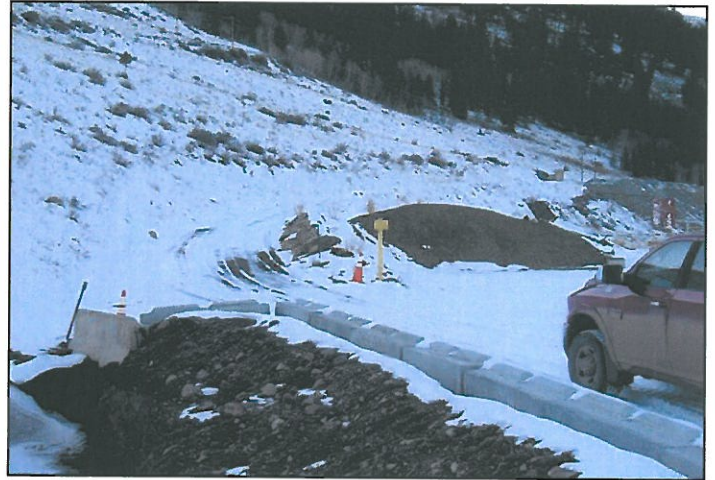
The road up to the 9400 level portal has a better drainage ditch and large capacity sump at the base, to handle all stormwater runoff from the road and upland areas. The runoff analysis included in the recent EPP shows this sump to be sufficient. All stormwater from the 9400 pad area is contained there by berms, and infiltrates into the pad itself. The runoff from the pad outslope reports to and is contained by other berms below the pad area. The 9400 level portal was secured against unauthorized entry.

L and R, above: Stormwater catchment sump at base of road up to 9400 level portal

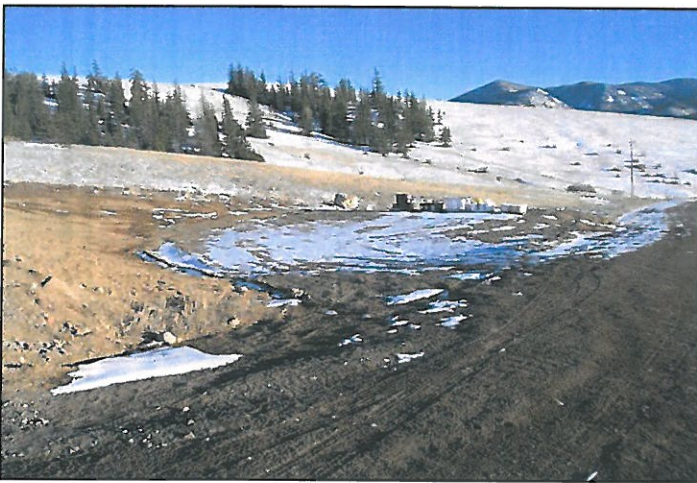
Above: Lowest portion of SW core storage pad
