COLORADO DIVISION OF RECLAMATION, MINING AND SAFETY
MINERALS PROGRAM INSPECTION REPORT
PHONE: (303) 866-3567

MINE NAME: 31 Road Pit	MINE/PROSPECTING ID#: M-1987-178	MINERAL: Sand and gravel	COUNTY: Mesa
INSPECTION TYPE: Monitoring	INSPECTOR(S): Travis H. Marshall and Lucas West	INSP. DATE: December 18, 2014	INSP. TIME: 09:00
OPERATOR: Parkerson Construction, Inc.	OPERATOR REPRESENTATIVE: Alan Parkerson	TYPE OF OPERATION: 112c - Construction Regular Operation

REASON FOR INSPECTION: Citizen Complaint	BOND CALCULATION TYPE: None	BOND AMOUNT: \$194,642.35
DATE OF COMPLAINT: 11/18/2014	POST INSP. CONTACTS: Local Government	JOINT INSP. AGENCY: Local Government
WEATHER: Cloudy	INSPECTOR'S SIGNATURE:

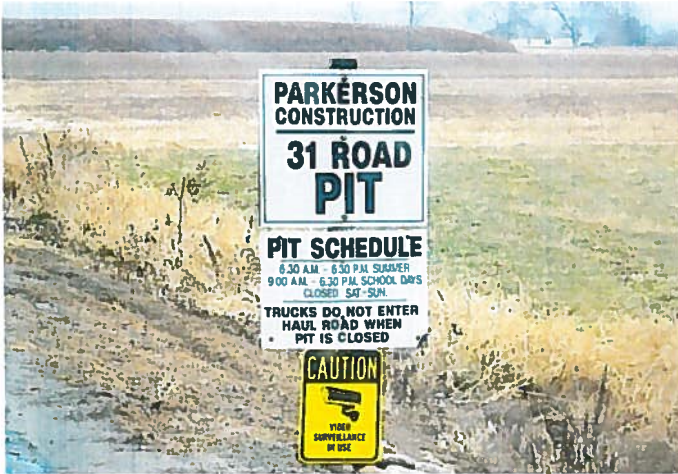
The mine identification sign and the affected area boundary markers are in place and in compliance with Rule 3.1.12. The sign is located on a post at the main entrance on the south side of the mine. The permit boundaries are comprised of fences and landscape barriers that are easily identifiable around the entire perimeter of the mine.

Mine identification sign at entrance

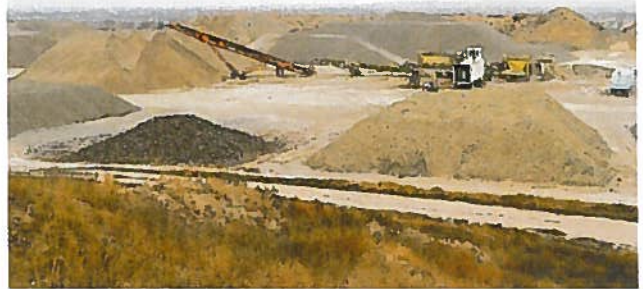
Mining operations looking north

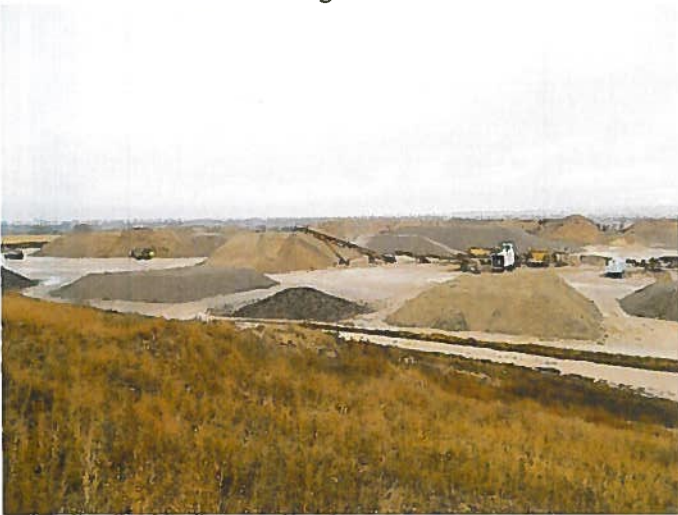
Mining operations looking northwest

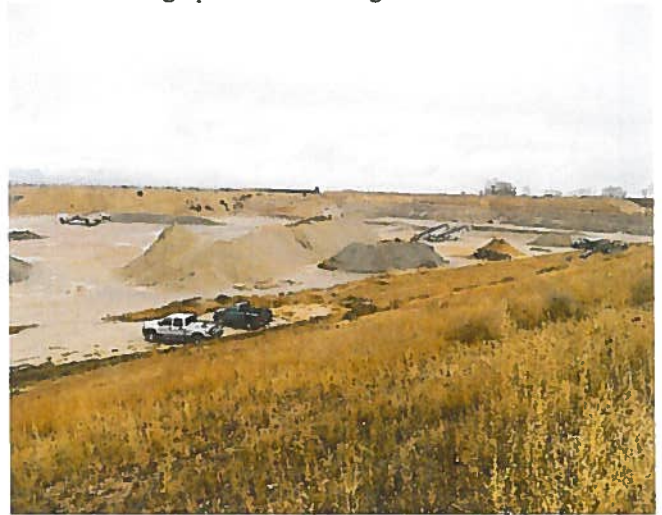
Mining operations looking northeast

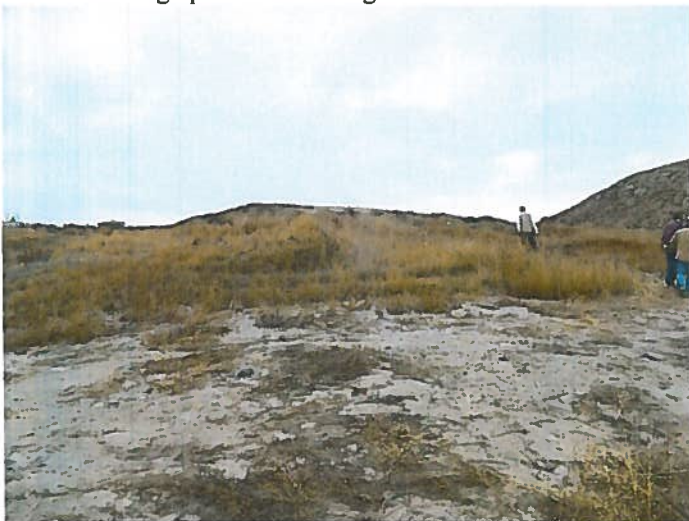
Topsoil and overburden were observed stockpiled at various locations of the mine. The topsoil stockpiles observed are estimated to be adequate to reclaim the site to the approved post mine land use of general agriculture. The topsoil stockpiles were free from erosional features and had adequate vegetation to assure protection and stability.

Topsoil stockpile with adequate vegetation

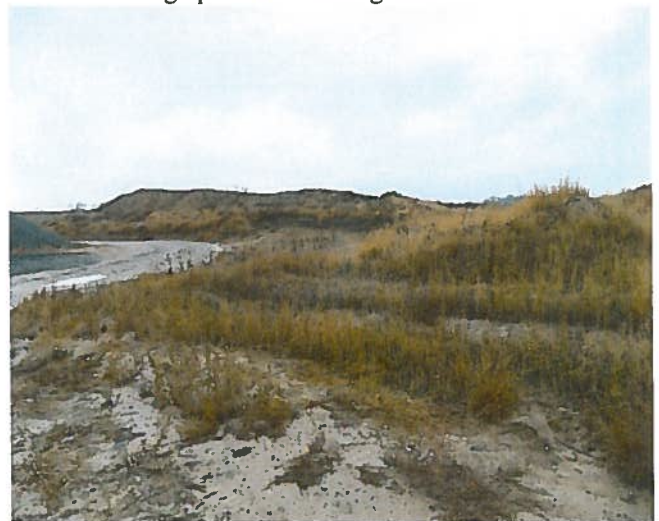
Topsoil stockpile with adequate vegetation

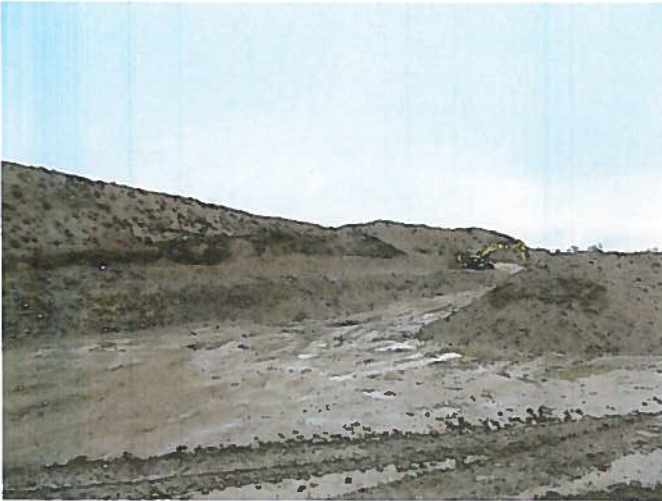
An excavator was observed removing overburden and gravel near the south end of the mine during the inspection. A loader and other miscellaneous mining equipment were observed during the inspection. Other equipment observed during the inspection included several conveyor belts, a scale and scale house located near the main entrance at the southern permit boundary.

Excavator removing overburden

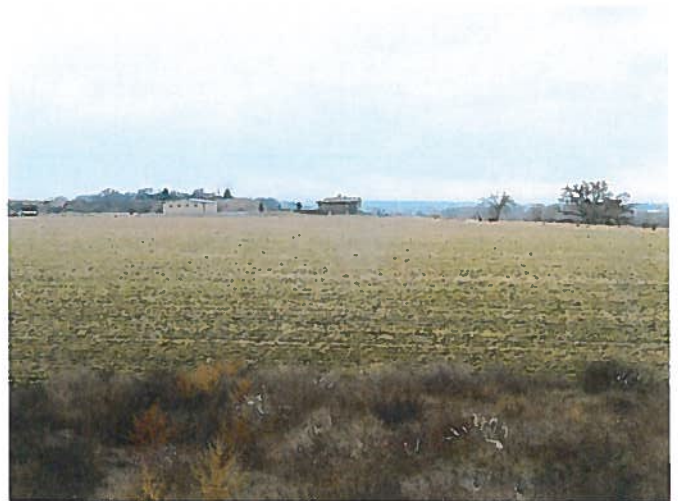
Reclamation of the western extent of the permit area has been completed and is functioning as irrigated cropland. The reclamation completed to date is in accordance with the approved reclamation plan. The reclaimed slopes along the southern permit boundary appeared to be no steeper than the required 3H:1V.

Reclaimed irrigated cropland

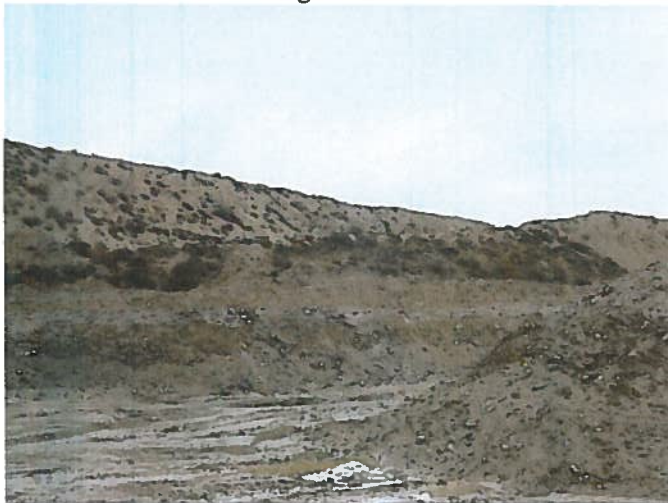
Overburden stockpiles

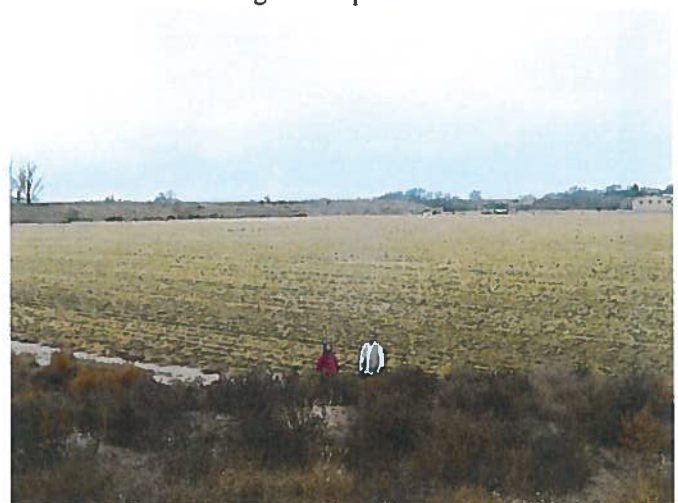
Reclaimed irrigated cropland
