COLORADO DIVISION OF RECLAMATION, MINING AND SAFETY
MINERALS PROGRAM INSPECTION REPORT
PHONE: (303) 866-3567

MINE NAME: Cresson Project	MINE/PROSPECTING ID#: M-1980-244	MINERAL: Gold	COUNTY: Teller
INSPECTION TYPE: Monitoring	INSPECTOR(S): Amy Eschberger	INSP. DATE: December 10, 2014	INSP. TIME: 09:45
OPERATOR: Cripple Creek & Victor Gold Mining Company	OPERATOR REPRESENTATIVE: Chris Hanks	TYPE OF OPERATION: 112d-3 - Designated Mining Operation

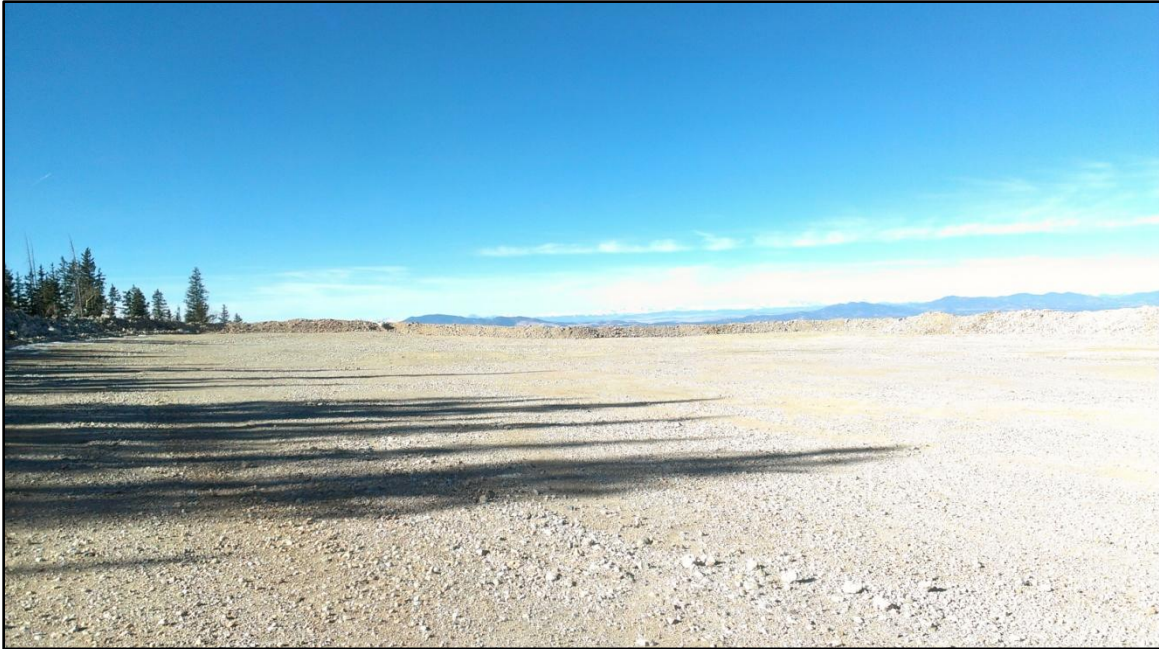
Photo 1. View looking northwest, showing alternate location for crushing stemming material located on existing West Blue Overburden Storage area.

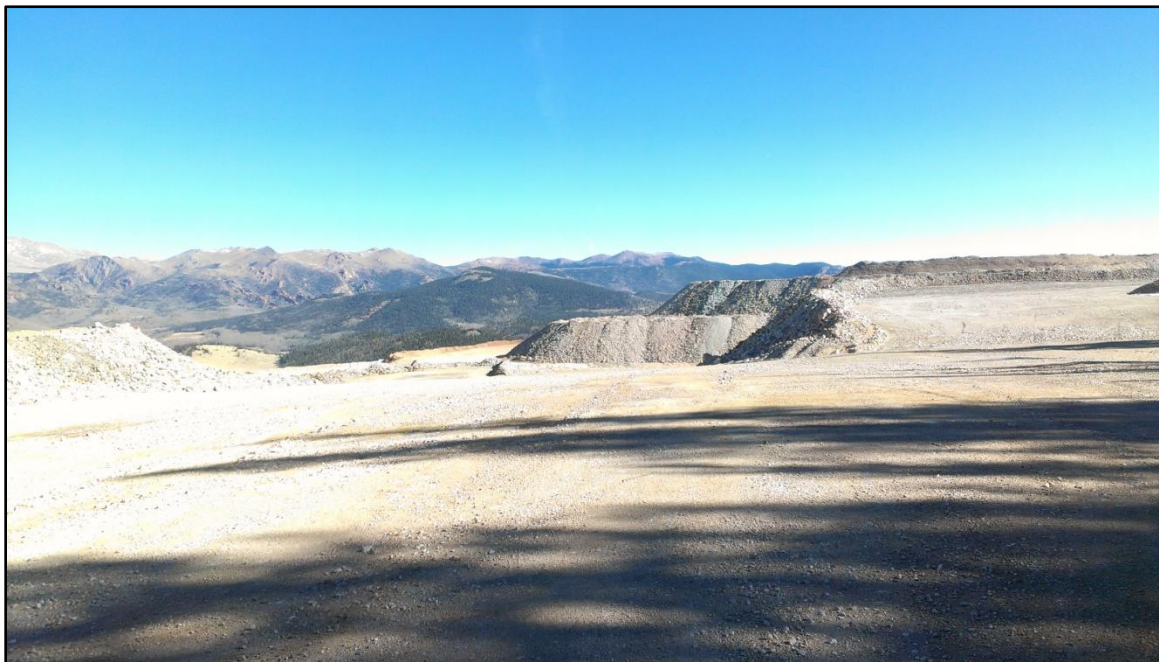
Photo 2. View looking east, showing haul road leading up to alternate location for crushing stemming material located on existing West Blue Overburden Storage area.

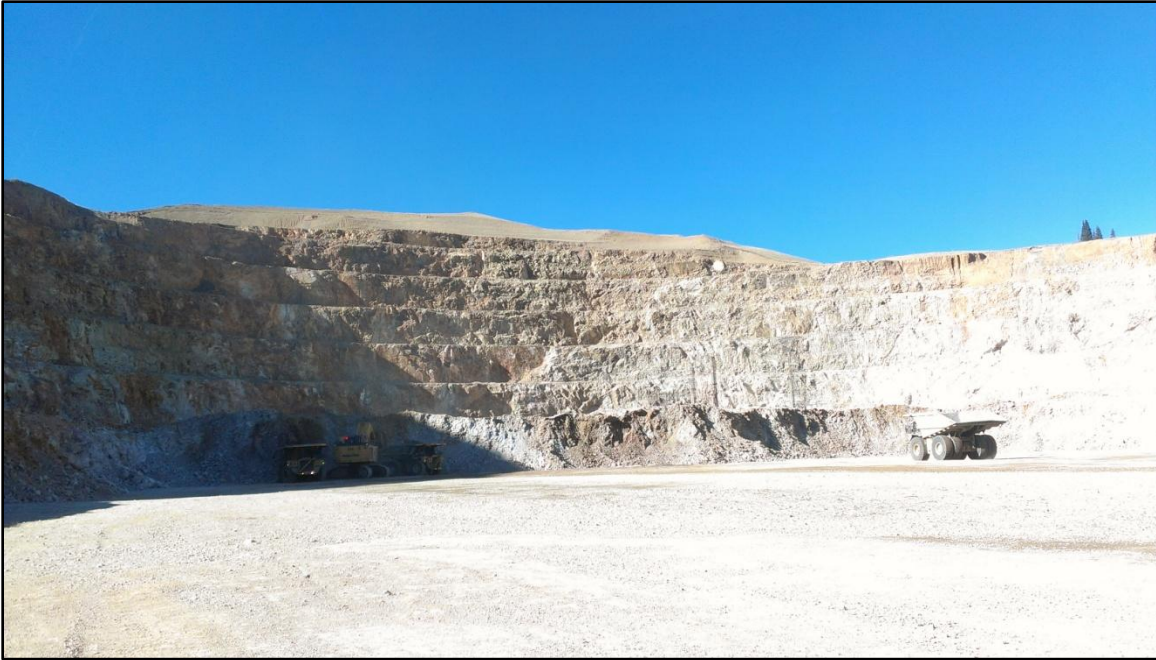
Photo 3. View looking southwest, showing active mining in WHEX pit.

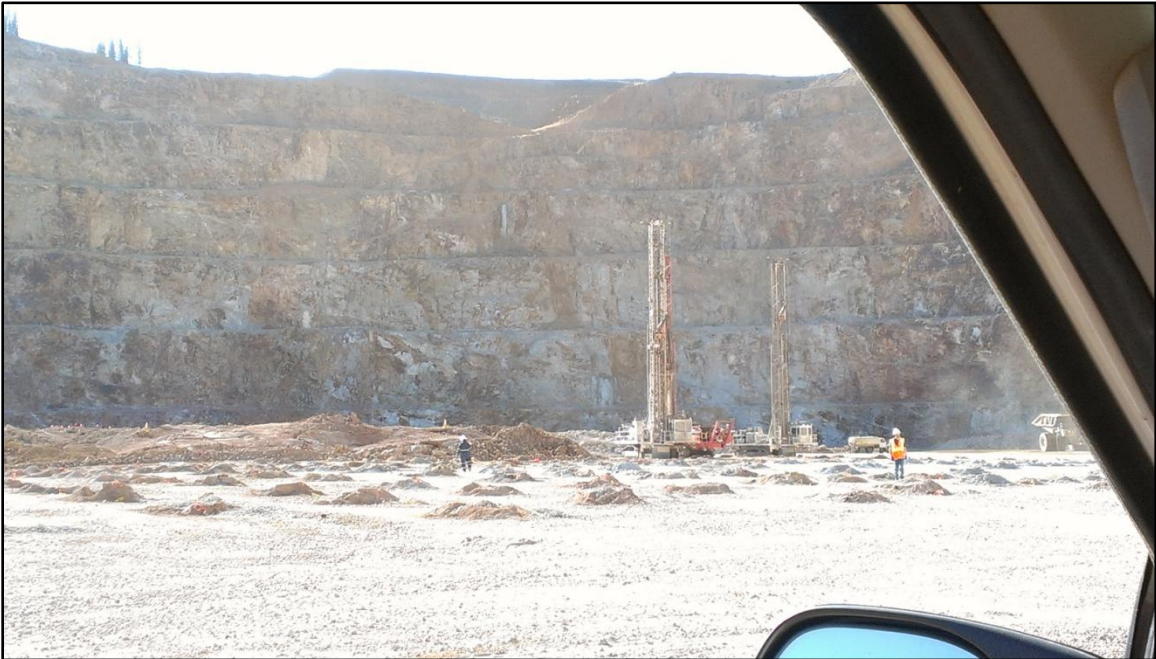
Photo 4. View looking west, showing production drilling in WHEX pit.

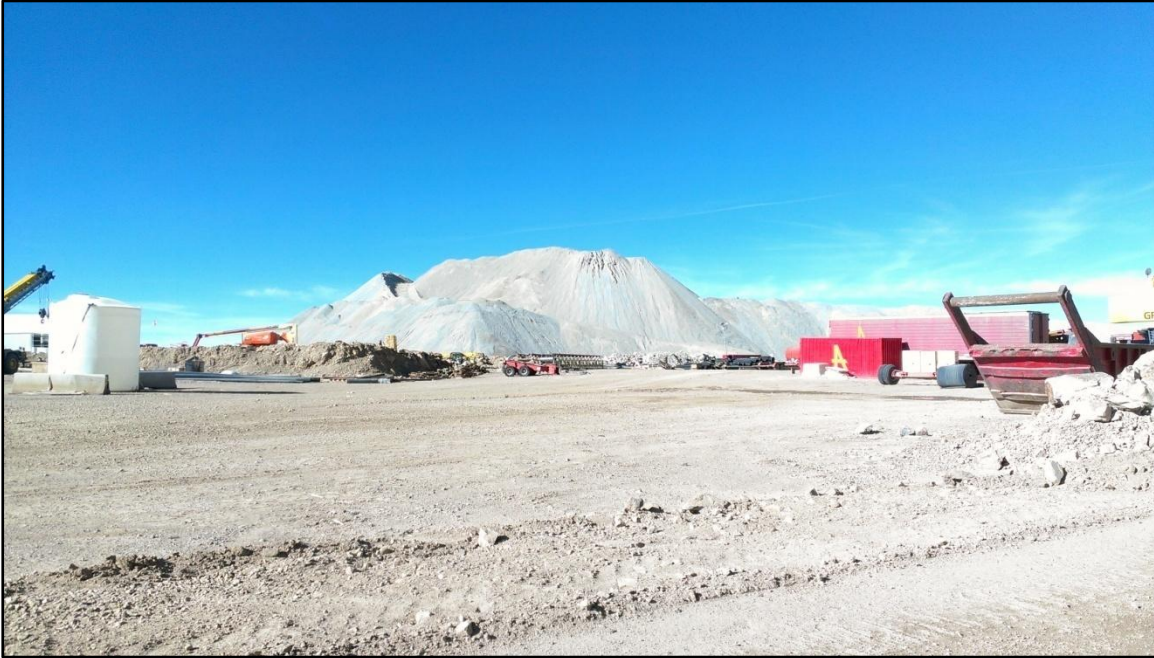
Photo 5. View looking west, showing AMES crusher operations where DCF is stockpiled.

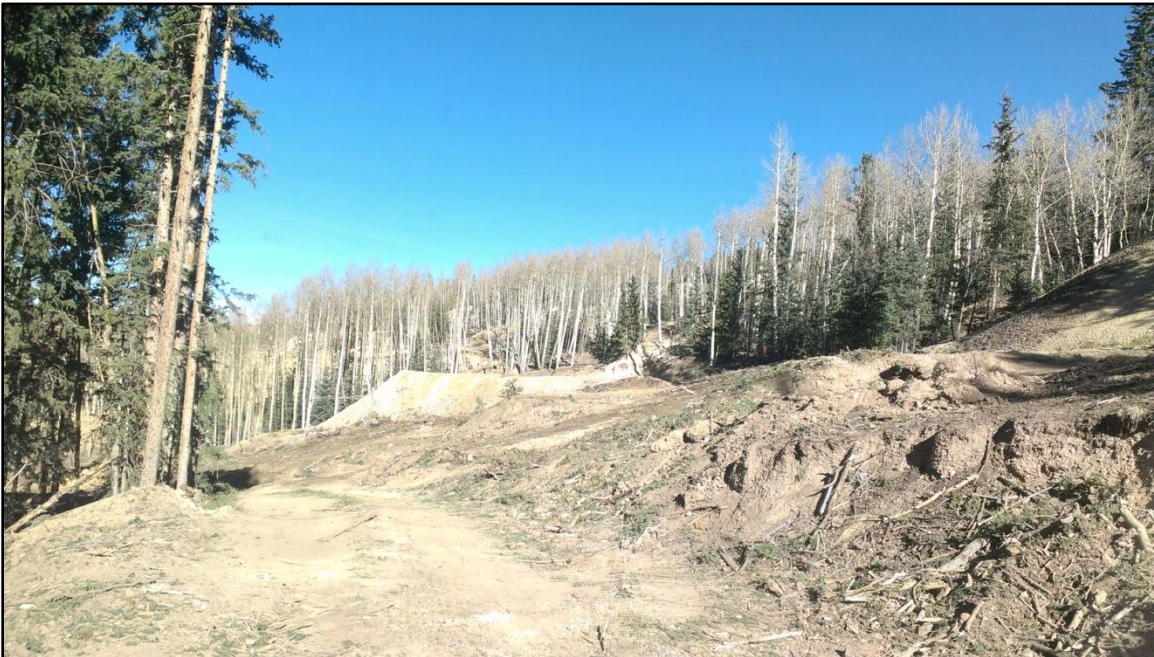
The Poverty Gulch area located at the northwestern edge of the permit area was also visited during the inspection. The Division observed the future location of a series of sediment control ponds (A-D, from lower elevation to higher elevation) which will be constructed in this area. The Division also observed the future site of sediment pond EMP #21, located near the northwestern permit boundary (Photo 6). This area had been cleared but construction of the pond had not yet begun.

Photo 6. View looking north, showing future location of pond EMP #21 located in far northwestern portion of permit area.

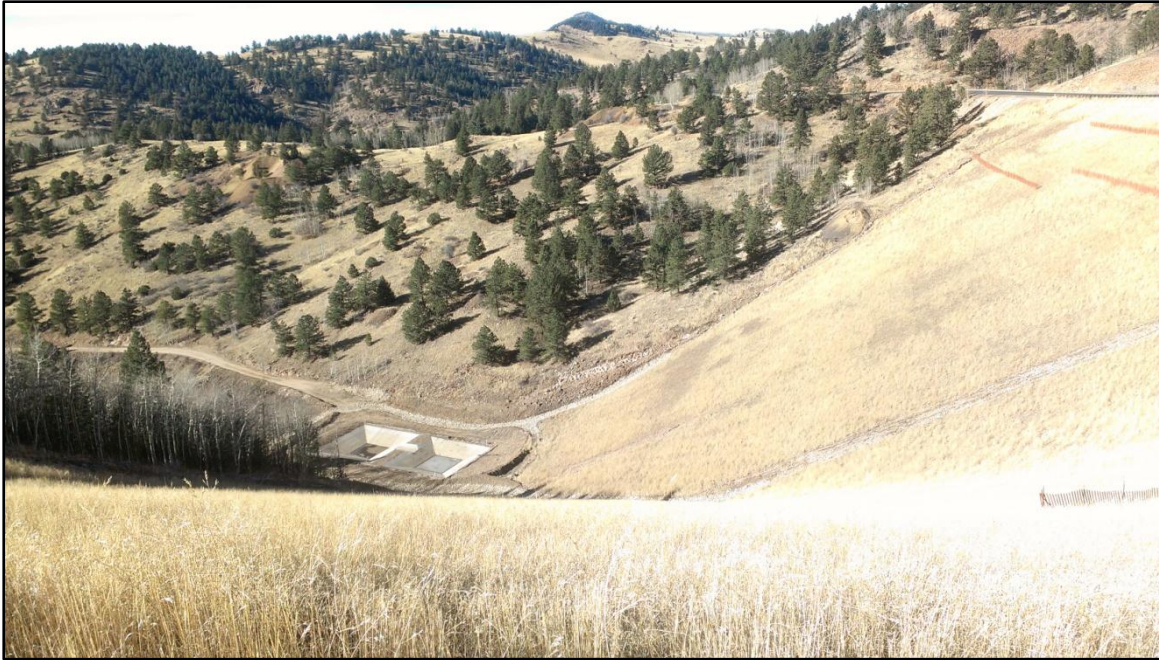
Photo 7. View looking northwest from Hwy 67 (at the top of the embankment), showing underdrain ponds located below in Squaw Gulch Valley on southwestern side of the embankment.

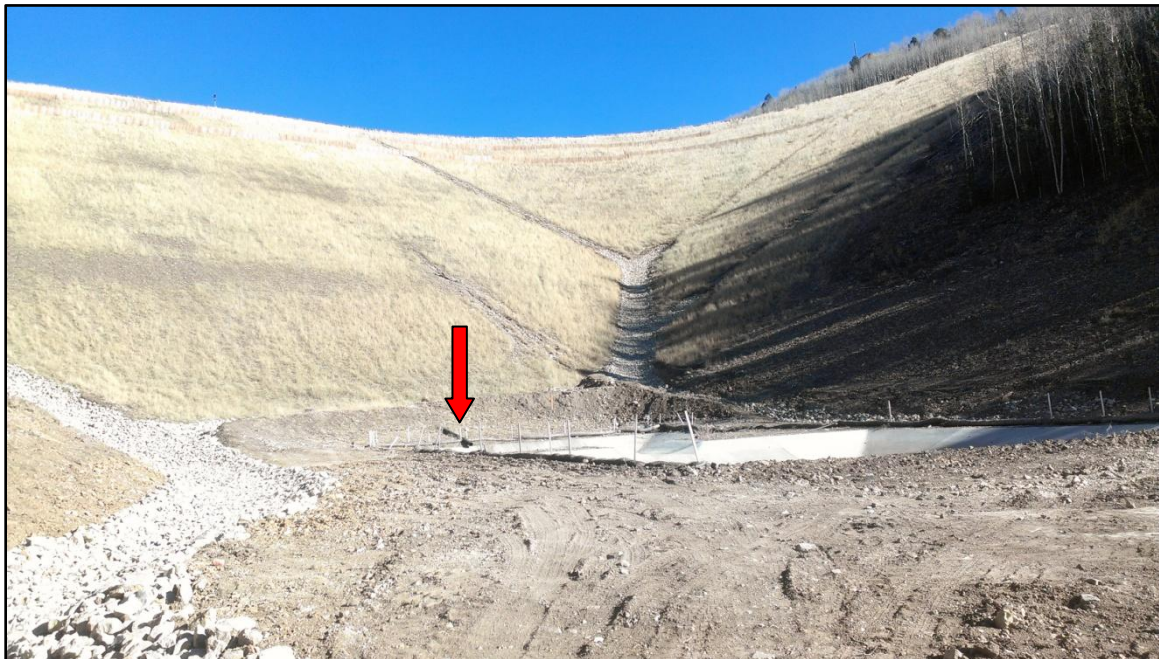
Photo 8. View looking east at southwest side of SGVLF toe berm, showing concrete-lined underdrain ponds. Primary underdrain pipe (indicated) exits toe berm toward ponds. Note channels along toe berm have been lined with riprap.

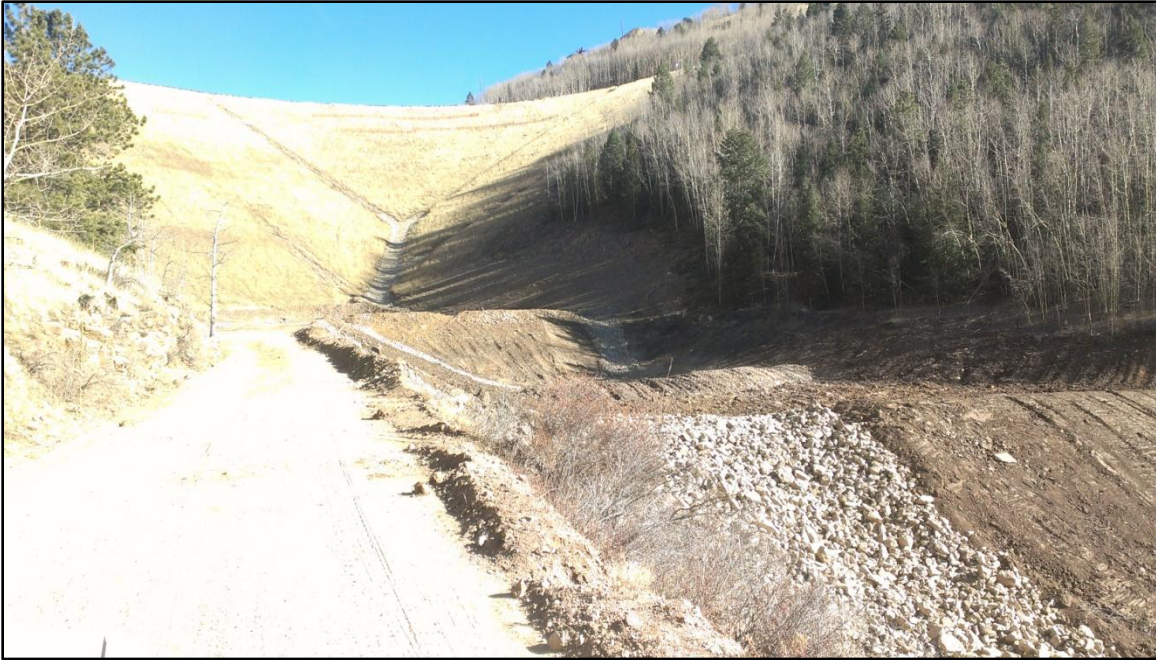
Photo 9. View looking east toward southwestern side of SGVLF embankment, showing stormwater pond constructed downgradient from underdrain ponds. Note riprap-lined diversion ditches.

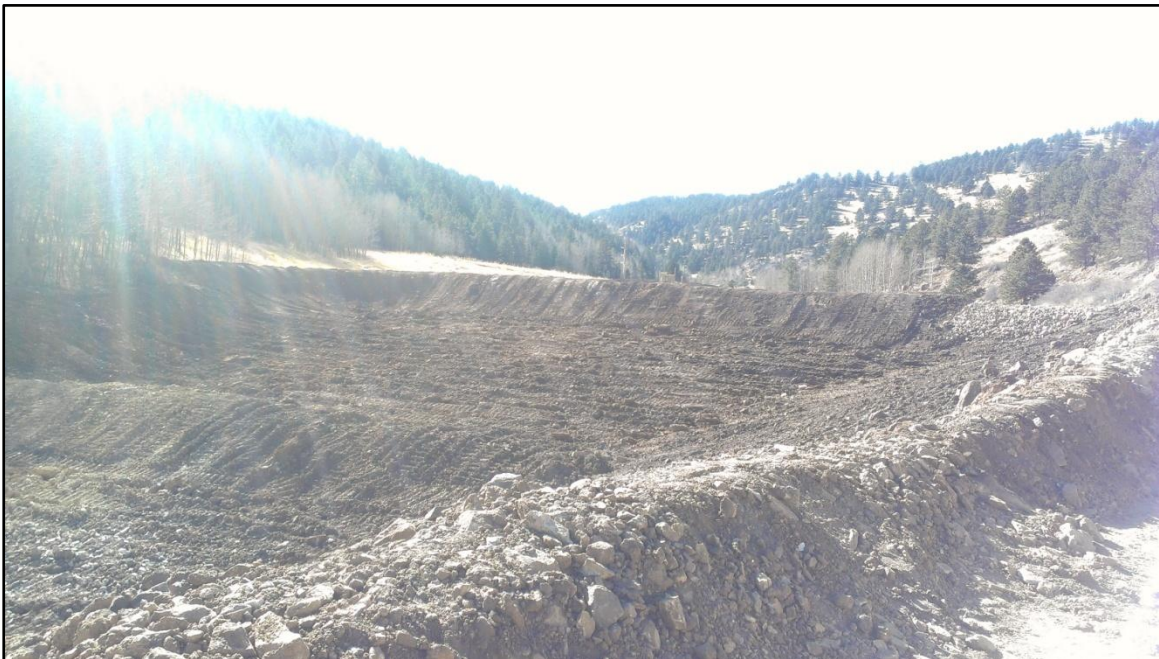
Photo 10. View looking southwest, showing southern portion of stormwater pond constructed downgradient from underdrain ponds.

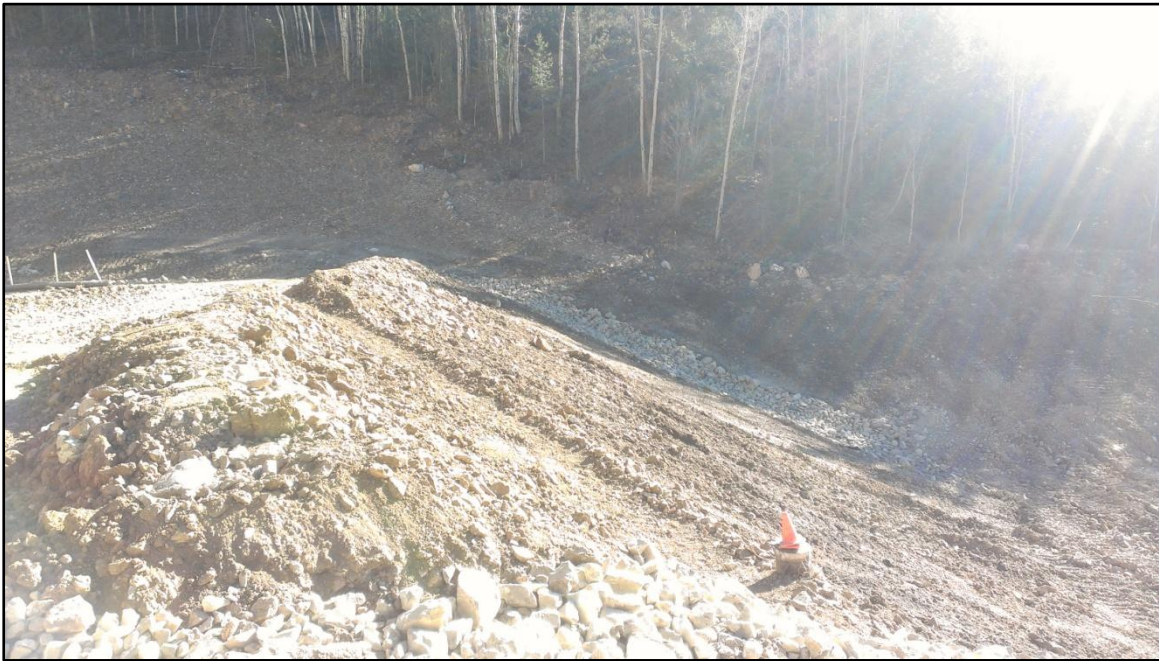
Photo 11. View looking southeast, showing northern bank of stormwater pond constructed just southwest of underdrain ponds.

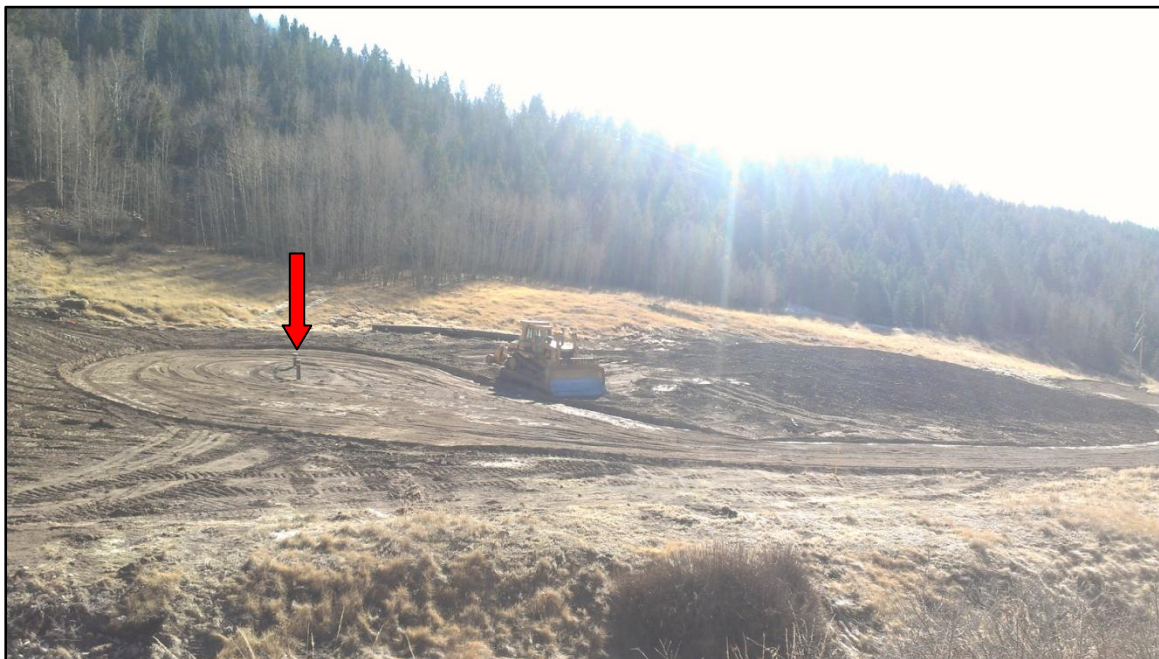
runoff from the toe berm into the stormwater pond. The Division observed two groundwater-monitoring wells located just downgradient from the stormwater pond which appeared to have been recently installed (Photo 12). The specific purpose of these wells was unclear at the time of the inspection. All disturbances observed within this valley are well within the Mine Life Extension 2 Permit Boundary approved in Amendment No. 10 (AM-10) on September 12, 2012.

Photo 12. View looking southeast, showing earthwork in progress downgradient from stormwater pond. Location of two groundwater monitoring wells is indicated.

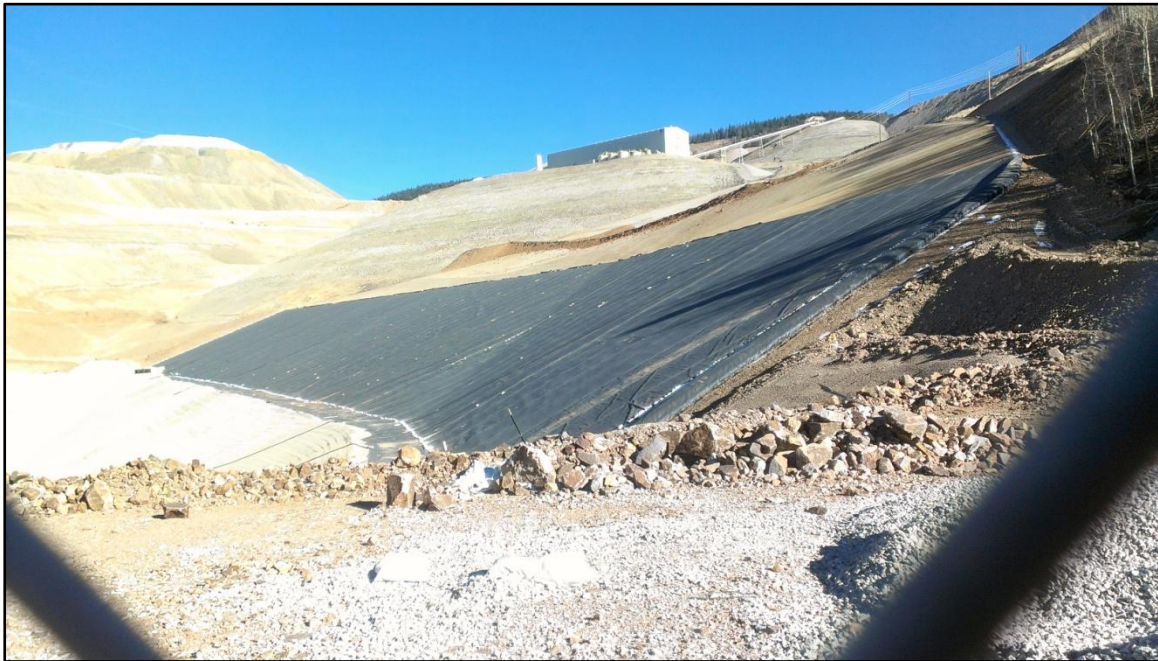
Photo 13. View looking east from SGVLF embankment, showing Phase I 80-mil DSMS LLDPE geomembrane liner installed on upper southeast portion of SGVLF, not covered by DCF. Note new high-grade mill facility located above.

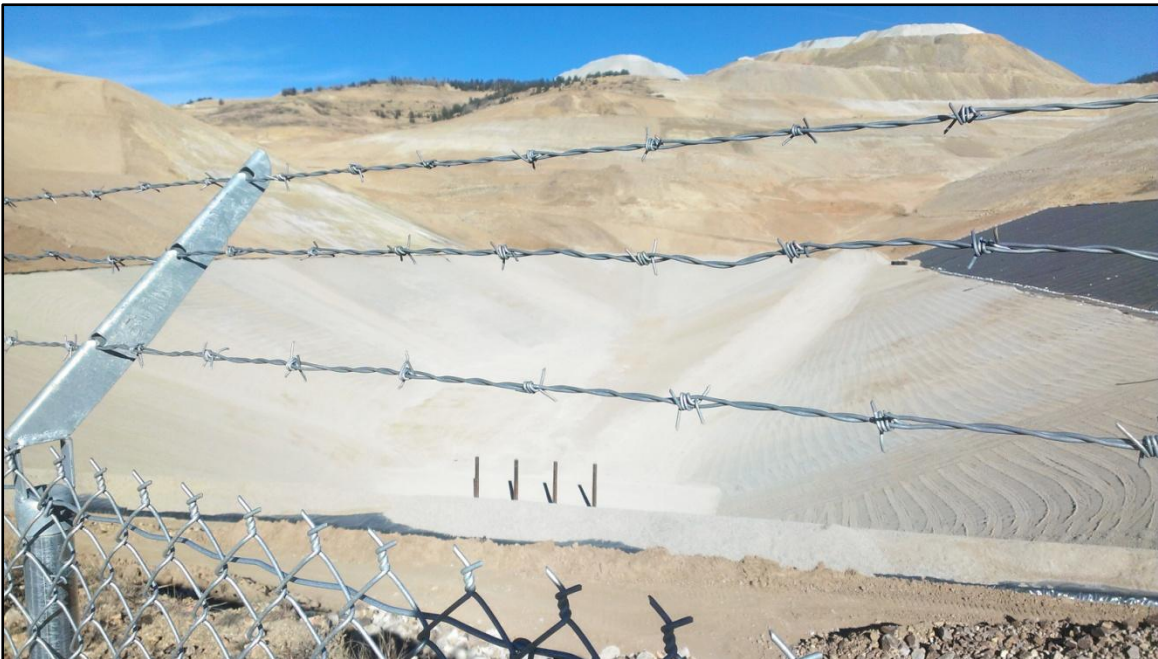
Photo 14. View looking northeast from SGVLF embankment, showing DCF covering accepted Phase I 80-mil DSMS LLDPE geomembrane liner in SGVLF. Note four LVSC riser pipes sticking up from southwestern end of the PSSA.
