COLORADO DIVISION OF RECLAMATION, MINING AND SAFETY
MINERALS PROGRAM INSPECTION REPORT
PHONE: (303) 866-3567

MINE NAME: Salt Canyon Project	MINE/PROSPECTING ID#: M-1997-064	MINERAL: Anhydrite, gypsum	COUNTY: Fremont
INSPECTION TYPE: Monitoring	INSPECTOR(S): Timothy A. Cazier	INSP. DATE: March 11, 2014	INSP. TIME: 12:00
OPERATOR: GCC Rio Grande, Inc.	OPERATOR REPRESENTATIVE: Damian Flores, Scott Peterson	TYPE OF OPERATION: 112c - Construction Regular Operation	
REASON FOR INSPECTION: Normal I&E Program	BOND CALCULATION TYPE: Partial Bond	BOND AMOUNT: \$69,832.00	
DATE OF COMPLAINT: NA	POST INSP. CONTACTS: Colo. Land Board	JOINT INSP. AGENCY: Colo. Land Board	
WEATHER: Cloudy	INSPECTOR'S SIGNATURE:

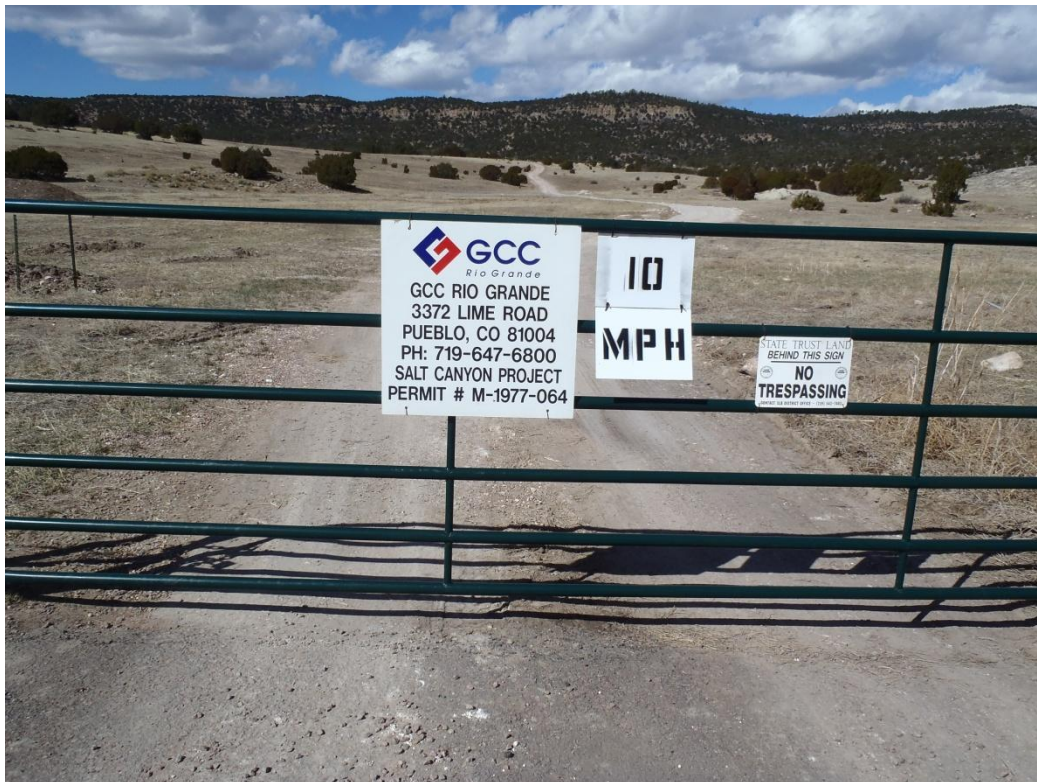
A permit sign was displayed at the site entrance (see **Photo 1**). The permit boundary appeared to be fenced along the entire perimeter (see **Photo 2**). Equipment observed on site included a grizzly screen (see **Photo 3**) in the pit and a loader. The Operator representatives explained the material is screened on site and crushed at GCC's Pueblo Plant. They further explained that overburden on site is shallow and is being stockpiled for use as vegetative media for reclamation.

Photo 1. Permit identification sign.

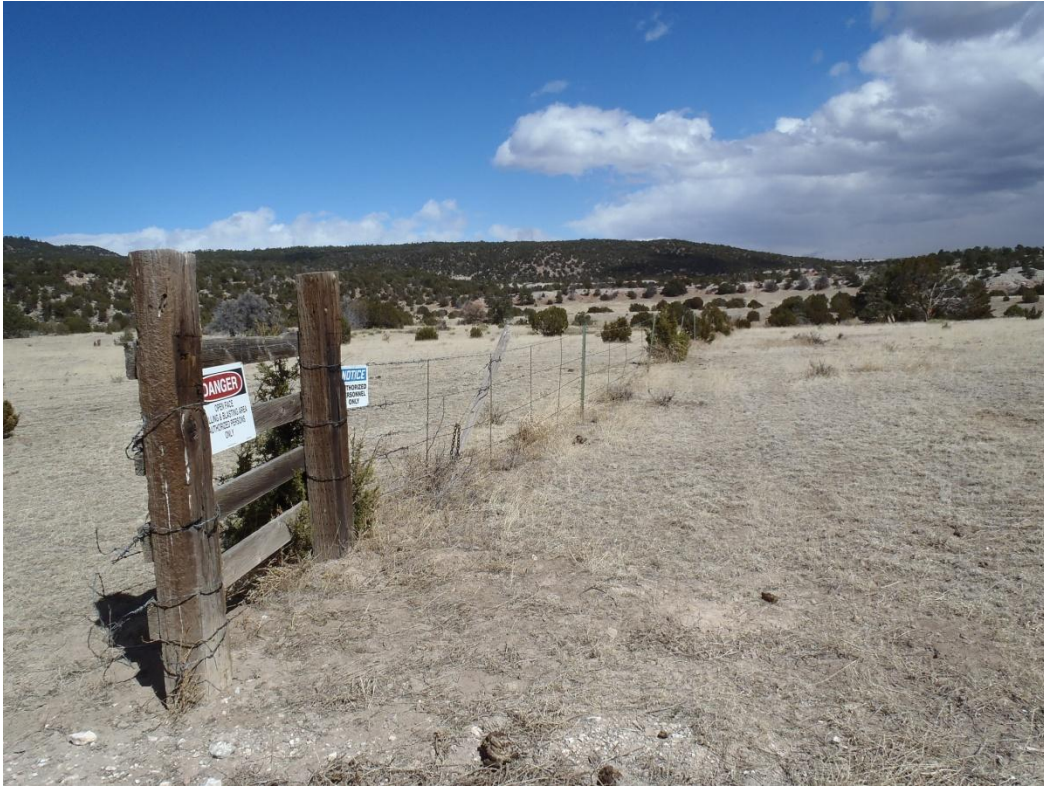
Photo 2. Typical permit boundary fence (looking NNW).

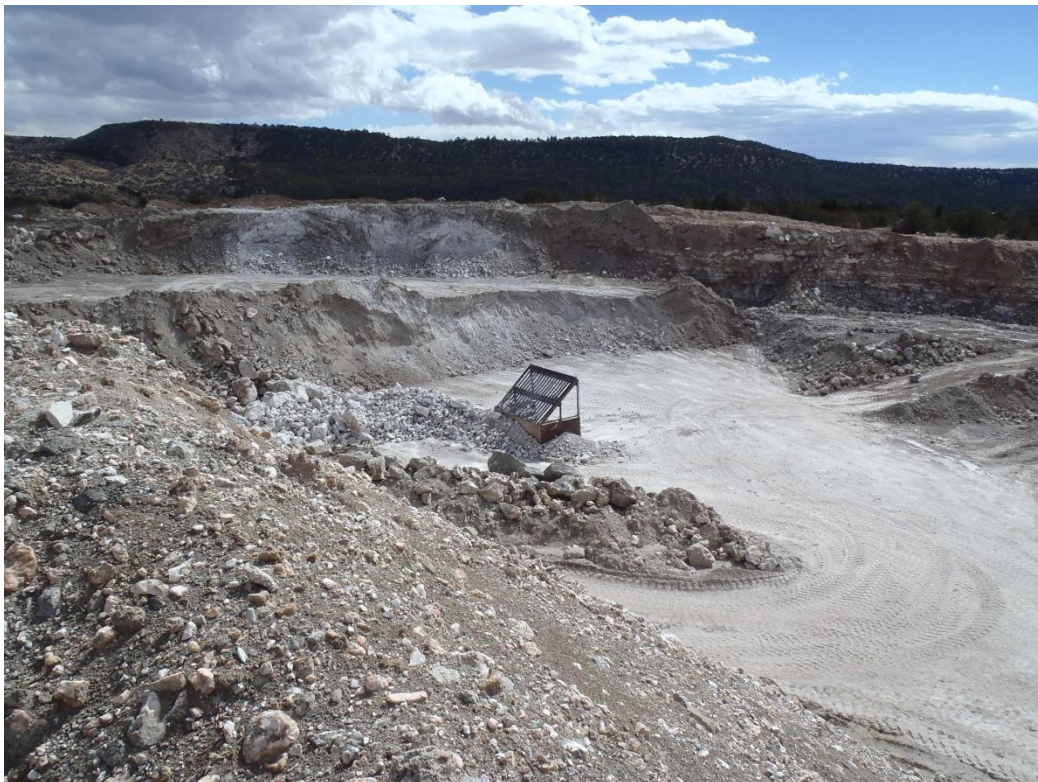
Photo 3. Grizzly screen and east highwall (looking SE).

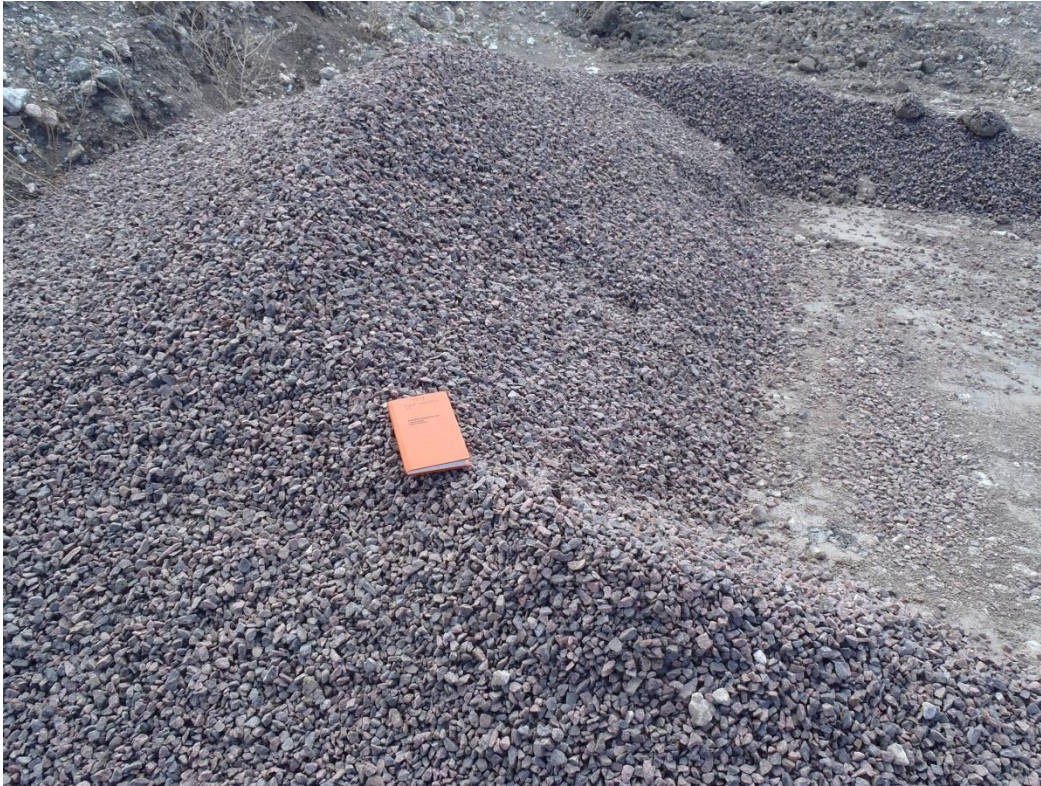
The Operator representatives explained that blast hole drilling is done by GCC, but the blasting operations are contracted out to Buckley. A small stockpile of stemming material was observed (see **Photo 4**).

Photo 4. Blasting stem material stockpile.
