COLORADO DIVISION OF RECLAMATION, MINING AND SAFETY
MINERALS PROGRAM INSPECTION REPORT
PHONE: (303) 866-3567

MINE NAME: Cañon Dolomite Quarry	MINE/PROSPECTING ID#: M-1977-376	MINERAL: Dolomite	COUNTY: Fremont
INSPECTION TYPE: Monitoring	INSPECTOR(S): Timothy A. Cazier	INSP. DATE: March 11, 2014	INSP. TIME: 09:30
OPERATOR: Continental Materials Corporation	OPERATOR REPRESENTATIVES: Andre Laroche, Gary Tuttle, Daniel Tezak	TYPE OF OPERATION: 112c - Construction Regular Operation

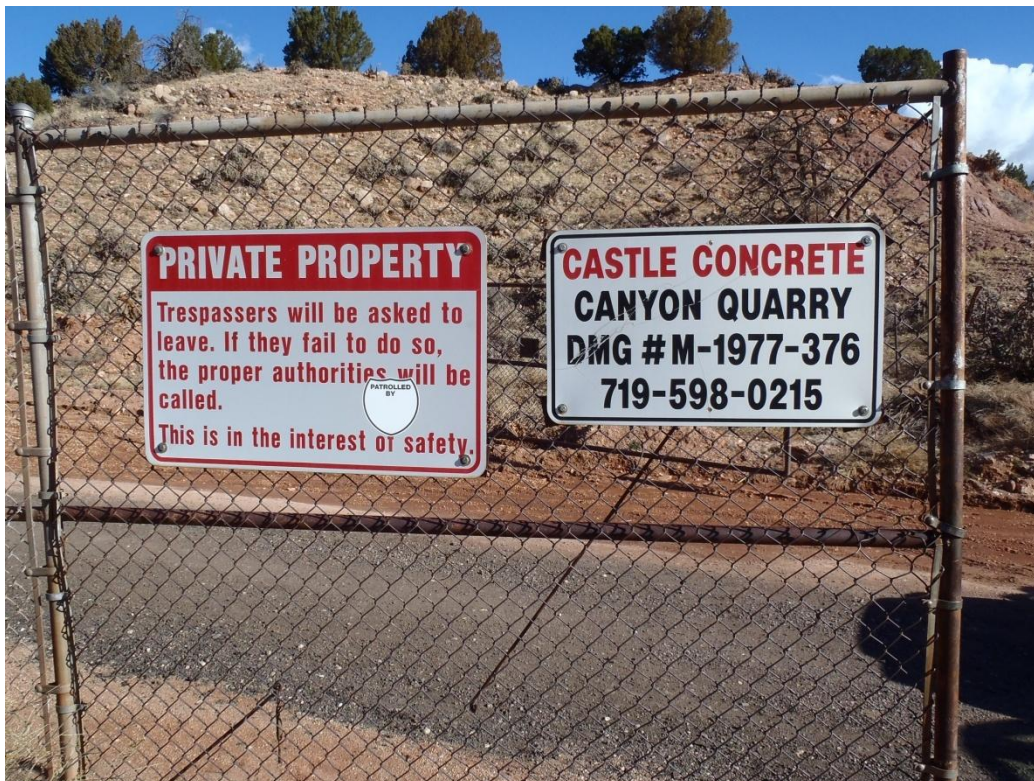
PROBLEM/POSSIBLE VIOLATION: Problem: The Permit was transferred from Castle Concrete Company to Continental Materials Corporation in 2003. The Permit Sign still lists Castle Concrete as the Operator.

A permit sign was displayed at the site entrance (see **Photo 1**). However, the sign list the previous Operator, Castle Concrete instead of Continental Materials. **The wrong name is cited as a problem on page 1 of this report.** The permit boundary appeared to be marked with PVC poles (see **Photo 2**). However, the permit boundary is considerably larger than the planned affected area, so not all the markers were visible from the pit area.

Photo 1. Permit identification sign (Note: previous Operator name).

CORRECTIVE ACTIONS: Correct the Operator name to Continental Materials Corporation on the Permit Sign and submit photographic documentation demonstrating the correction by the Due Date.

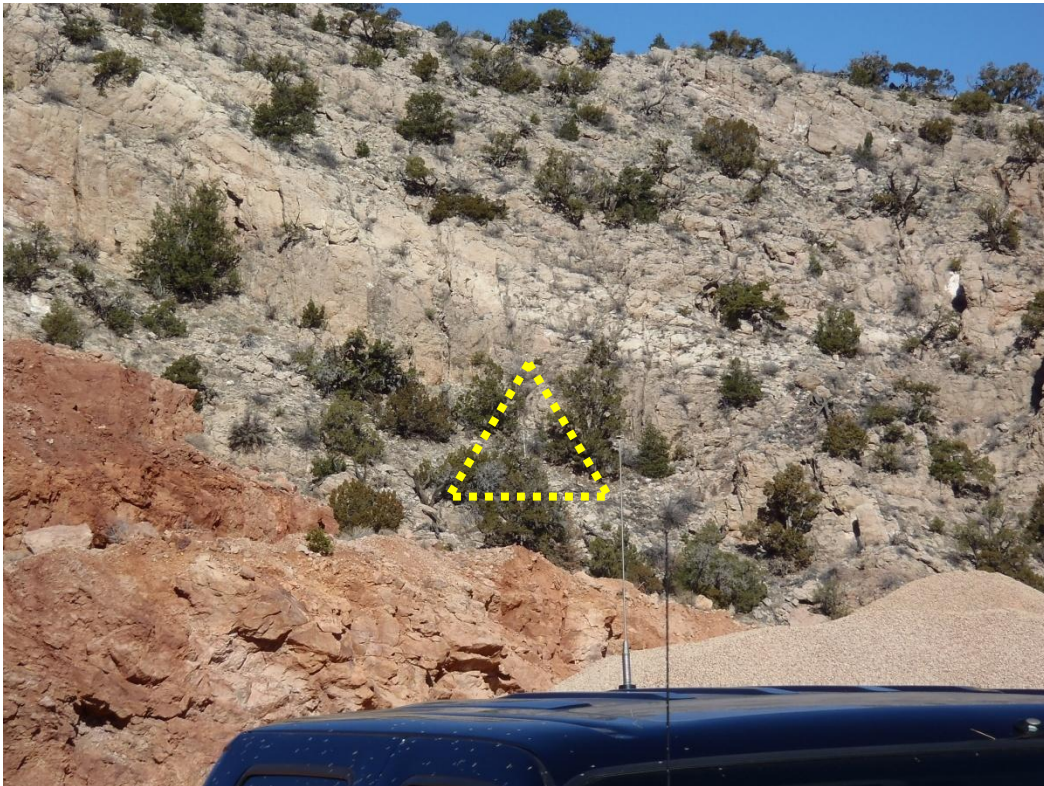
Photo 2. Typical permit boundary marker (looking north).

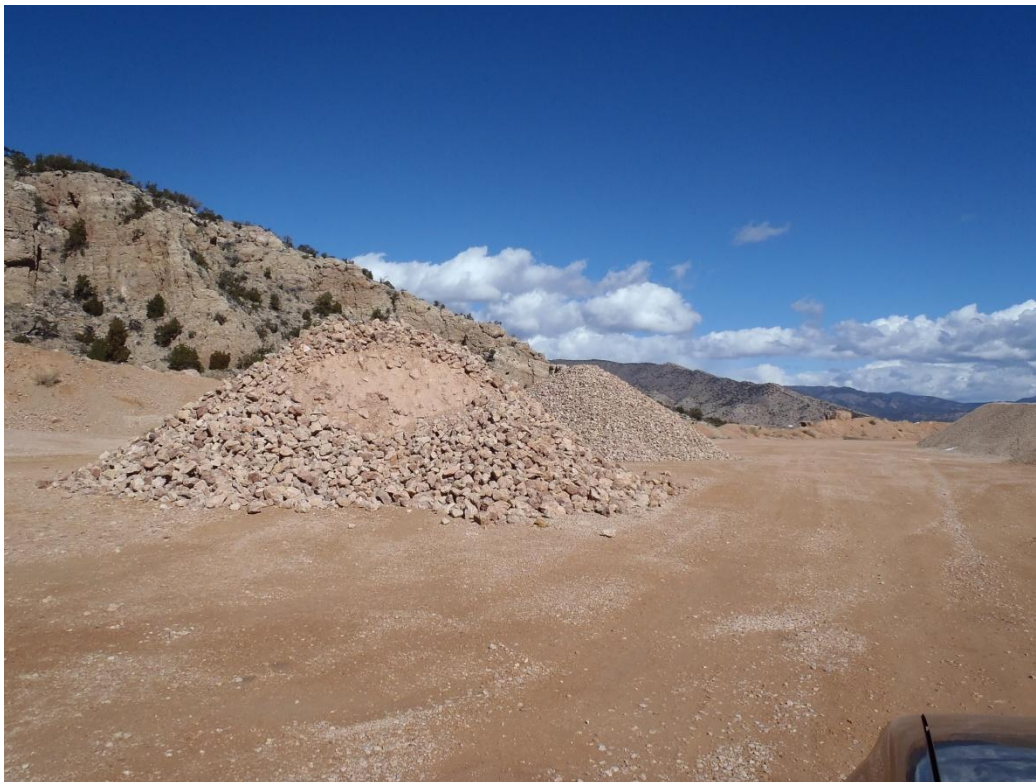
Photo 3. Stockpiles of varying size of crushed material (looking north).

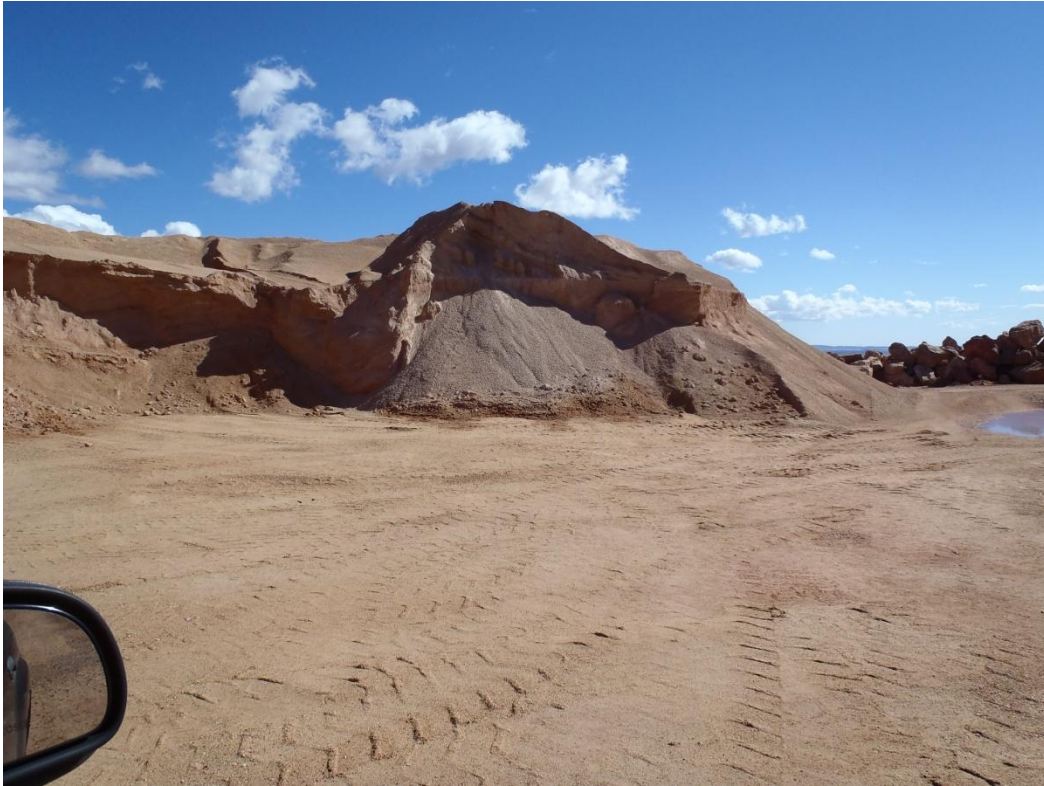
- i) Removing fines disposed in Echo Canyon when the pit floor was level with the canyon floor, or
 - ii) Stabilize the area with vegetation.
 - b) Fines status: It does not appear that any fines disposal has occurred in the Fines Disposal Area No. 1 for quite some time. Fines currently appear to be stockpiled on the pit floor. **The current approach to managing fines needs to be clarified.**

Photo 4. Large stockpile of crusher fines (looking NE).

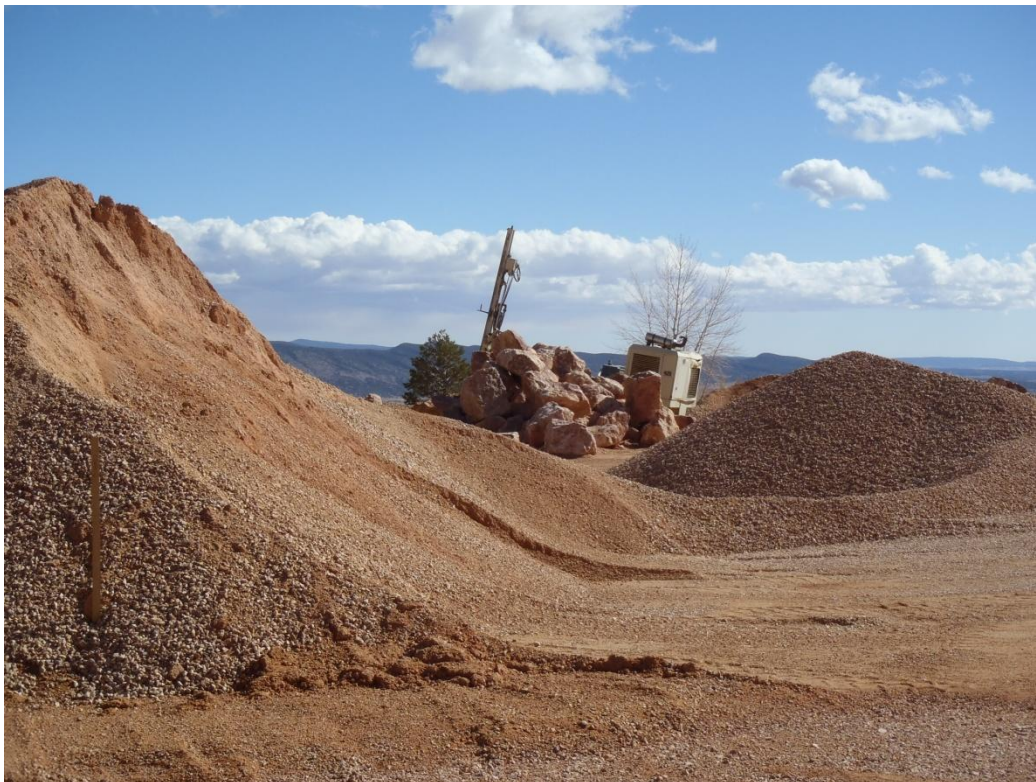
Photo 5. Parked drill rig (looking east).

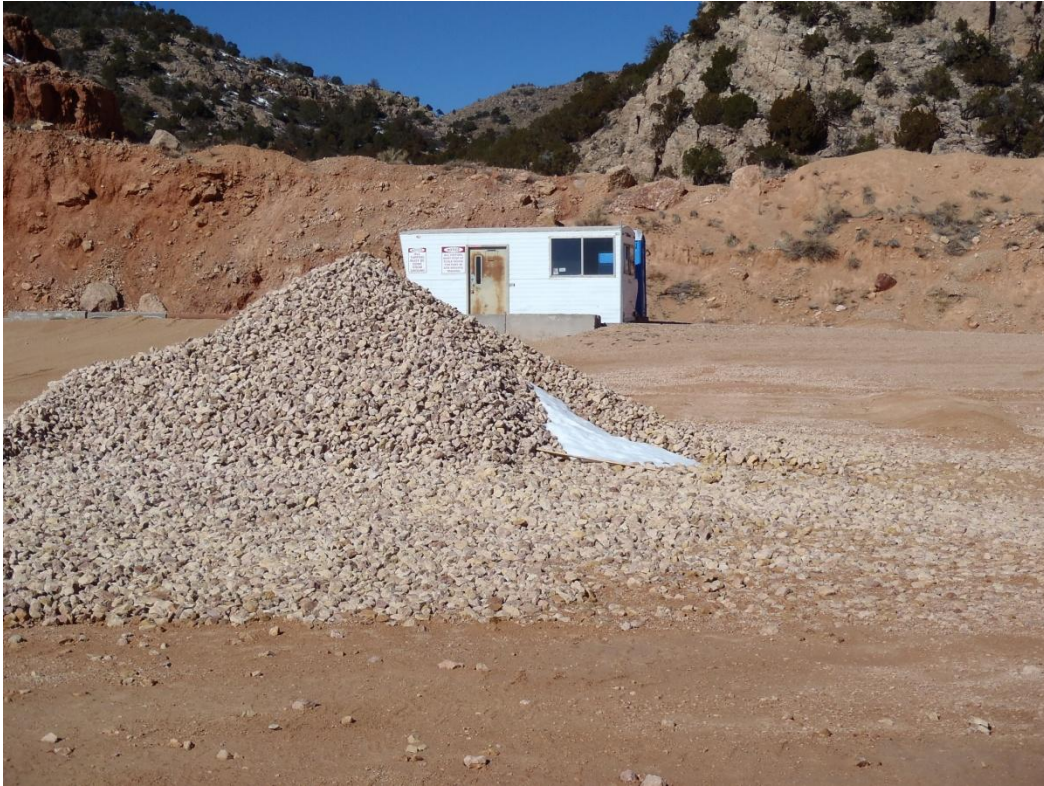
Photo 6. Scale house and truck scale (looking west).

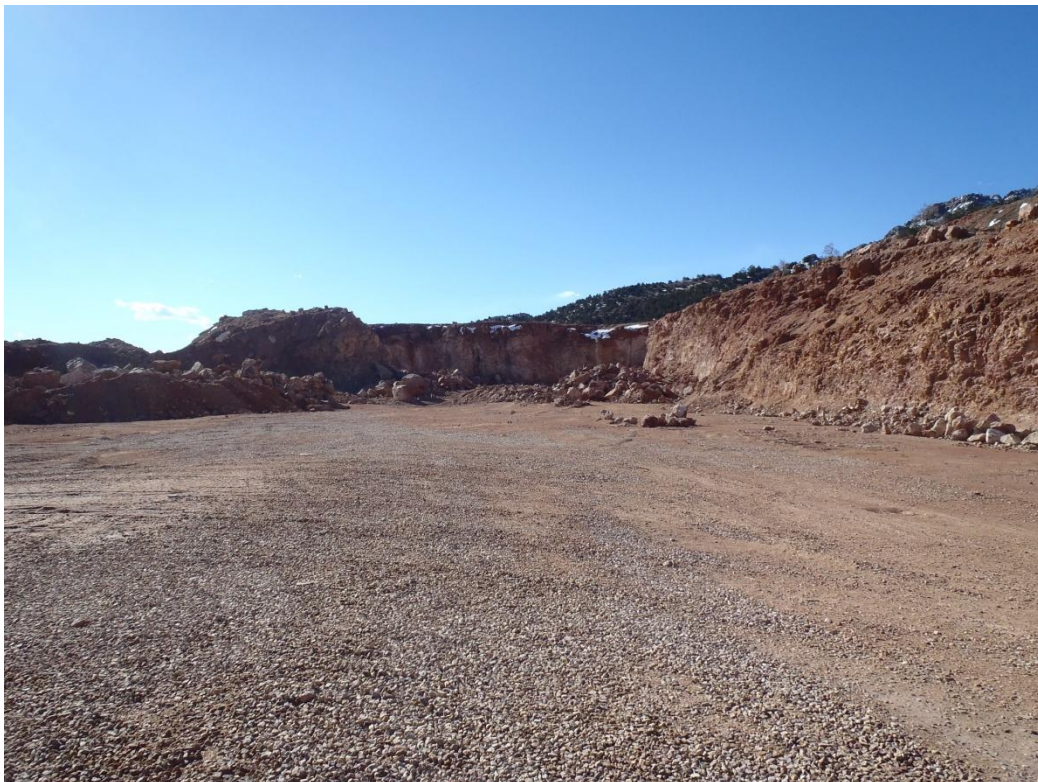
Photo 7. South highwall (looking south).

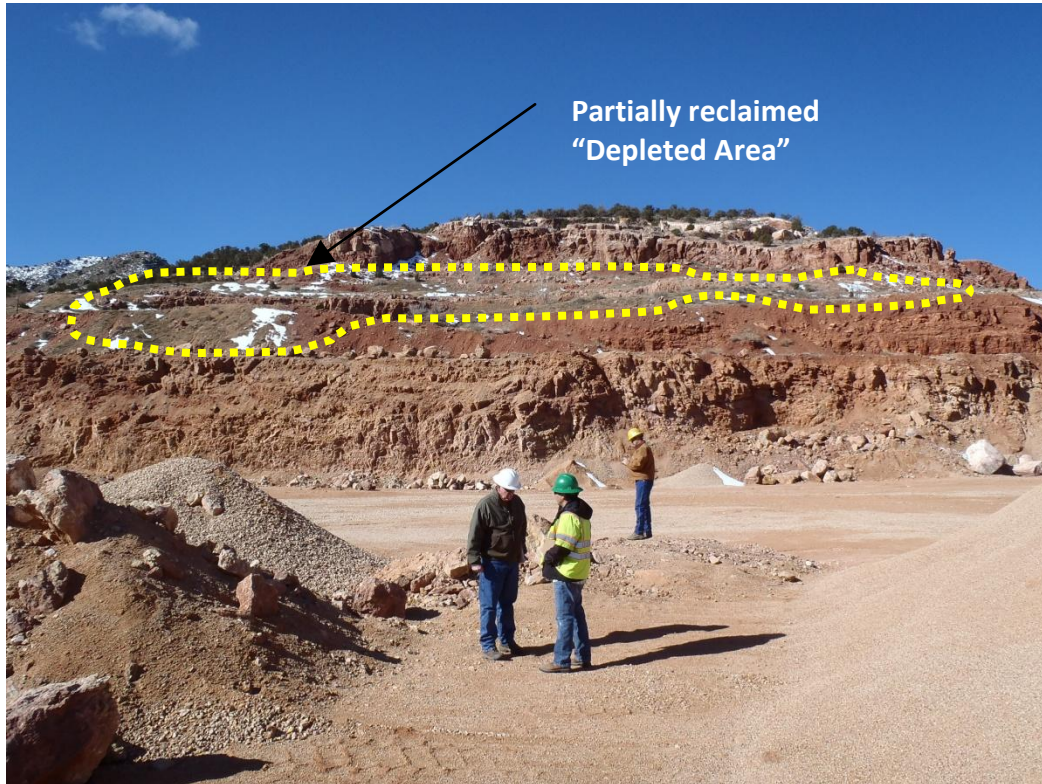
- 3) **Reclamation Plan status** (reference enclosed AM-01 Map):
- a) "Depleted Area(s)": **the required TR shall address the status of the "Depleted Area" reclamation.** The original application indicated the depleted area would be graded to slopes no steeper than 2H:1V and revegetated.

Photo 8. West highwall and partially reclaimed "depleted area" (looking west).

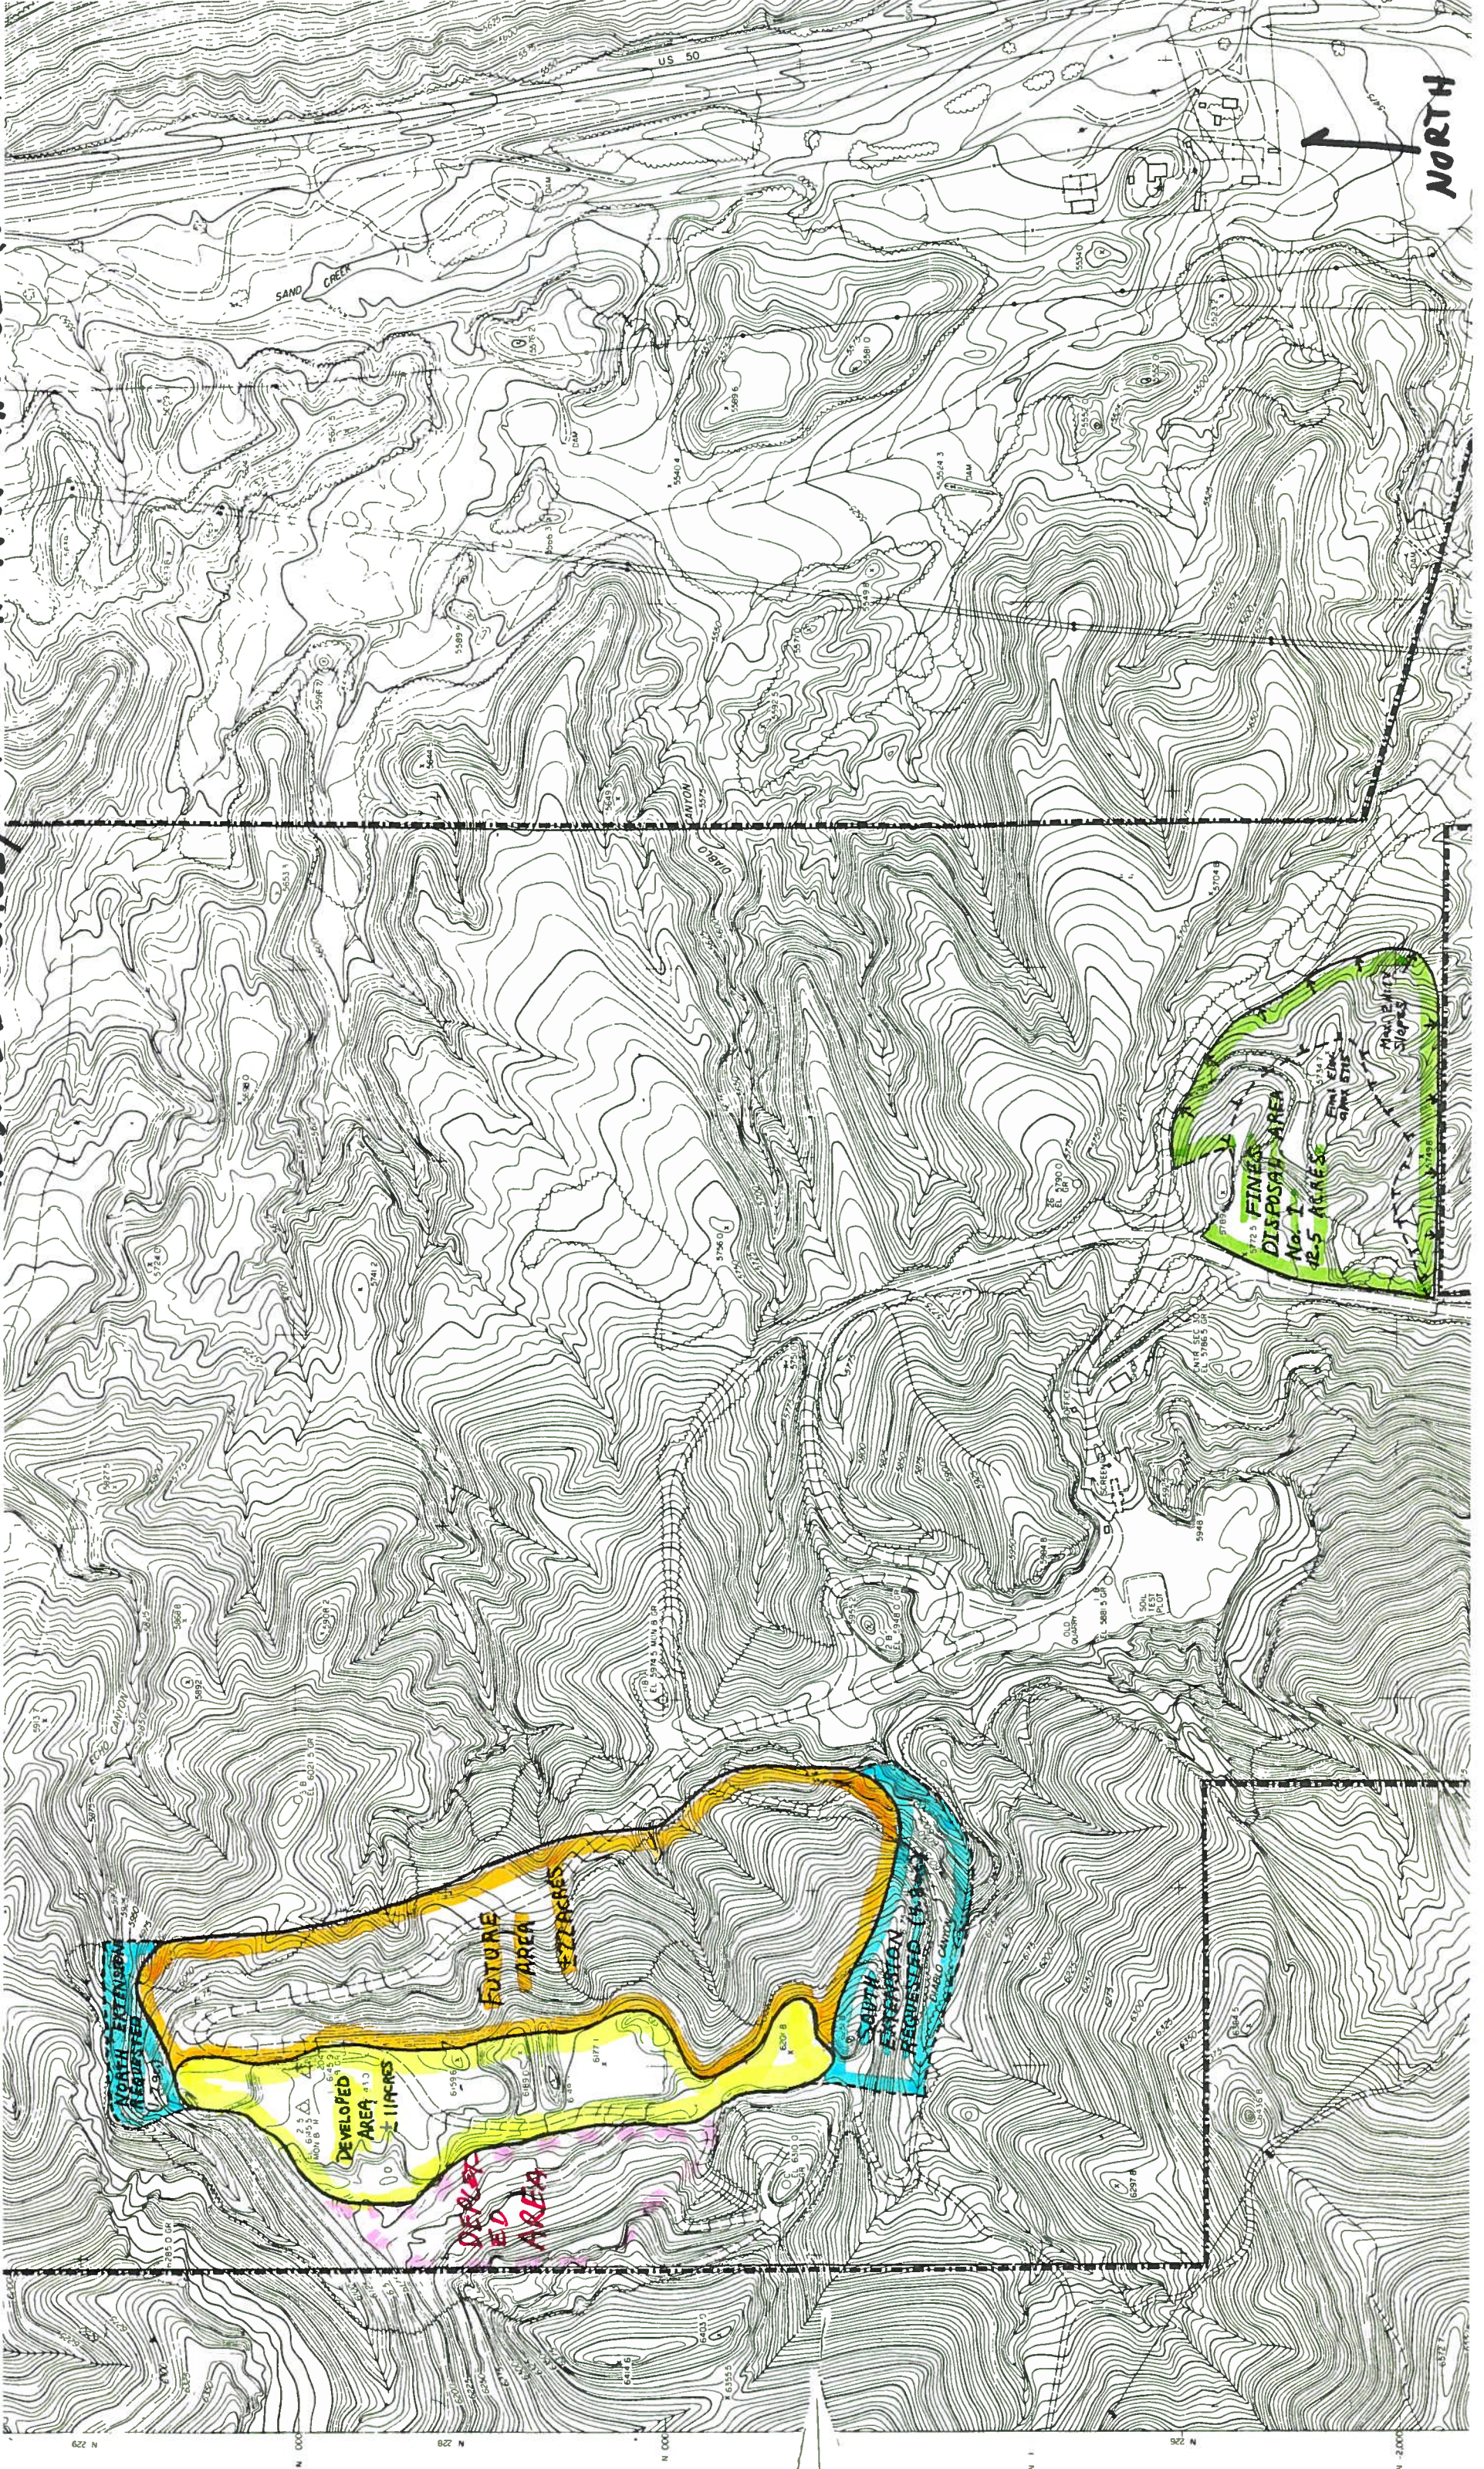
REDUCED SCALE / PARTIAL MAP FROM AM-01 (6-14-82)

- a) **AM-01 proposed two options for which the Division has not received any documentation since the 1982 approval for dealing with fines disposed in Echo Canyon.** The two options were:

- c) "22-Acre Future Area": The AM-01 map suggests the area east of the current pit might be mined in the future. There is no text in AM-01 specifically addressing the Future Area. **The "Future Area" inclusion in the mining plan needs to be clarified.**

- d) "North and South Extensions": The AM-01 map suggests the areas north and south of the current pit might be mined in the future. There is no text in AM-01 specifically addressing the "Requested" North and South Extensions. **The "North and South Extensions" inclusion in the mining plan need to be clarified.**
