# COLORADO DIVISION OF RECLAMATION, MINING AND SAFETY MINERALS PROGRAM INSPECTION REPORT

MINE NAME:	MINE/PROSPECTING ID#:	MINERAL:	COUNTY:
Nolte Pit #1	M-2012-016	Borrow material for	Garfield
INSPECTION TYPE:	INSPECTOR(S):	INSP. DATE:	INSP. TIME:
Monitoring	Stephanie J. Mitchell	January 27, 2015	10:00
OPERATOR:	OPERATOR REPRESENTATIVE:	TYPE OF OPERATION:	
Puckett Land Company	Chuck Whiteman	111 - Construction by Goverment Agency

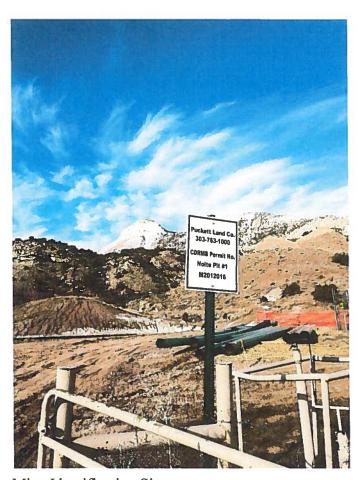
Mine Identification Sign

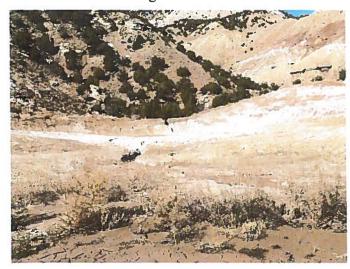
**PROBLEM/POSSIBLE VIOLATION:** Problem: Erosion gullies and ruts were observed on-site. This is a problem at this time for failure to protect the affected land from erosion pursuant to C.R.S. 34-32.5-116 (4) (j).

Follow-up inspection topics included vegetation establishment and weed control, erosion control measures and final grading. The rills and gullies observed in December 2012 are still evident. It does not appear that the Operator has conducted any maintenance on the site since it was last inspected by the Division. Weeds are still on site, but in less quantity than noted in December 2012. On the north side of the permit area, there are two rip rapped drainage channels that need maintenance. They both are not conveying water and sediment as engineered. There are rills and gullies forming on the outsides of the channels. This is noted as a problem at the beginning of the inspection report. The two ponds that retain water for over 72 hours are required to have a permit through the Colorado Division of Water Resources. The Division's records show that we do not have a copy of the permit or the Stormwater Management Plan. This is noted as a problem at the beginning of the inspection report and will need to be submitted by April 1, 2015. Final grading has not been conducted and has been noted as a problem as well at the beginning of the inspection report. More grading is necessary to complete the final grade of 3:1 slopes as submitted in the reclamation plan.

Rilling within the permit boundary- North area of permit boundary

**CORRECTIVE ACTIONS:** The operator shall provide photo documentation to the Division verifying erosion gullies and ruts have been repaired, and that the site has have been reconstructed and stabilized to prevent erosion damage by the corrective action date.

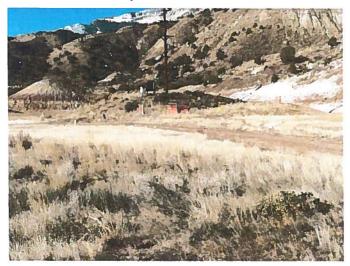
There is a lot of oil and gas activity on the site, including a gas line that is currently being installed through the permit area. The Operator mentioned that they may want to change the post mining land use to commercial land use. According to RULE 1.10.2, no amendments are allowed by State Statute. An Operator may only make changes defined under Rule 1.1(49). The result is that the Operator must submit a new permit as a 112(c) application. The fee associated with the new permit application is \$2,696.00. Much of the permit application exhibits can be used from the original 111 permit application, but re-submitted in the new application package. The Division would like to see a 112c Permit Application submitted by Puckett Land Company when all future land use is finalized with the entities involved. The present post mining land use submitted in the original 111 application is Rangeland. With all of the current oil and gas activity and the proposed use of a commercial site, the post mining land use shall be changed to Industrial/Commercial (IC) in the 112 c permit application.

Oil and Gas Activity

Looking Northwest

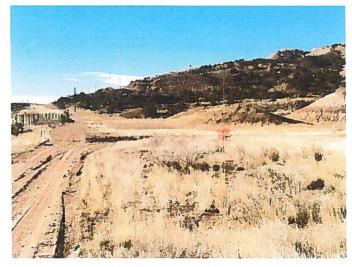
Looking West- Gas Line will be installed under road

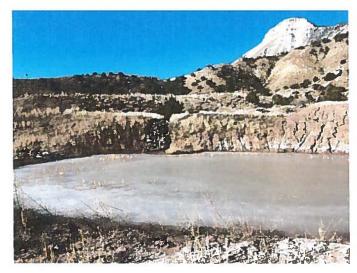
**PROBLEM/POSSIBLE VIOLATION:** Problem: The Division has no evidence that the operator has a valid well permit, substitute water supply plan, or approved water augmentation plan for the exposed groundwater at the site. This is a problem related to 34-32.5-116(4)(h) of the Colorado Revised Statutes and 3.1.6(1)(a) of the Construction Materials Rules and Regulations governing injury to existing water rights.

Pond in western part of permit area

**CORRECTIVE ACTIONS:** The operator shall demonstrate that the operation is in compliance with the Office of the State Engineer, show evidence that the operator is taking measures to bring the site into compliance with the SEO, or backfill the pits to at least two feet above the groundwater surface by the corrective action date specified.

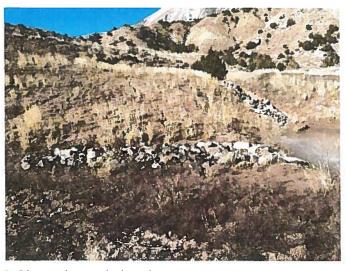
2 Channels needed maintenance

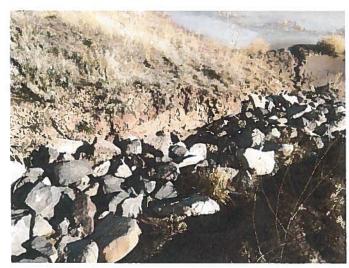
Rip Rapped Channels that need maintenance
