OLORADO DIVISION OF RECLAMATION, MINING AND SAFETY
MINERALS PROGRAM INSPECTION REPORT
PHONE: (303) 866-3567

MINE NAME: West Fork Pit	MINE/PROSPECTING ID#: M-2005-069	MINERAL: Gravel	COUNTY: Garfield
INSPECTION TYPE: Monitoring	INSPECTOR(S): Stephanie J. Mitchell	INSP. DATE: January 27, 2015	INSP. TIME: 13:00
OPERATOR: EnCana Oil & Gas (USA), Inc.	OPERATOR REPRESENTATIVE: Jason Eckman and Rod Cogburn	TYPE OF OPERATION: 112c - Construction Regular Operation

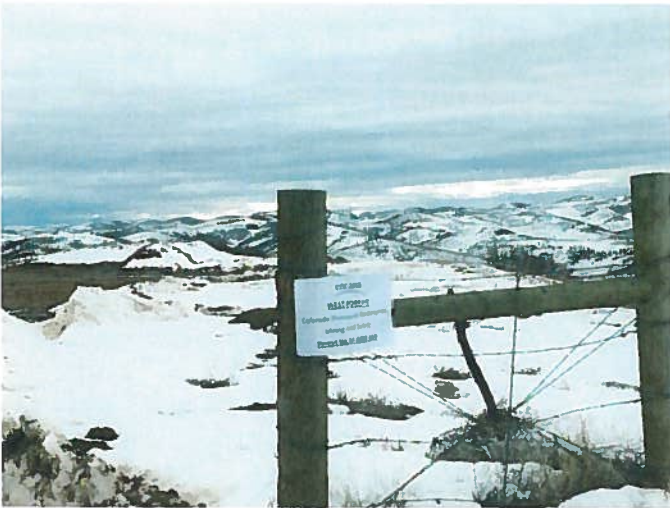
This is an 18.4 acre 112c mining operation for sand and gravel. A mine identification sign was in place at the entrance to the mine site. There were no permit boundary markers present and has been noted as a problem at the beginning of this inspection report.

Mine Identification Sign

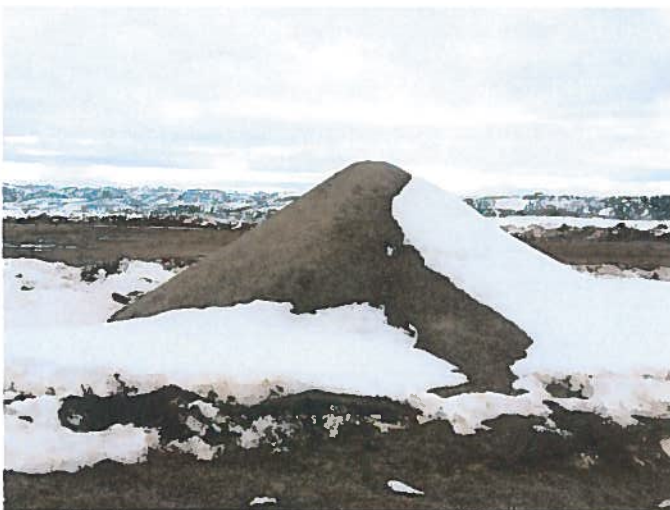
Topsoil and material stockpiles appear to be stable.

Material Stockpile

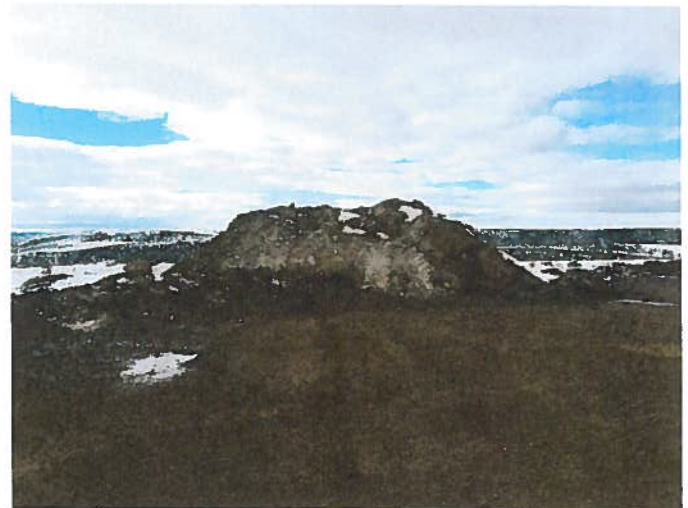
Material Stockpile
