COLORADO DIVISION OF RECLAMATION, MINING AND SAFETY
MINERALS PROGRAM INSPECTION REPORT
PHONE: (303) 866-3567

MINE NAME: Table Mountain Quarry	MINE/PROSPECTING ID#: M-1999-004	MINERAL: Silica (quartz, quartz)	COUNTY: Fremont
INSPECTION TYPE: Monitoring	INSPECTOR(S): Timothy A. Cazier	INSP. DATE: March 11, 2014	INSP. TIME: 12:50
OPERATOR: Tezak Heavy Equipment Co. Inc.	OPERATOR REPRESENTATIVE: Daniel Tezak	TYPE OF OPERATION: 112c - Construction Regular Operation

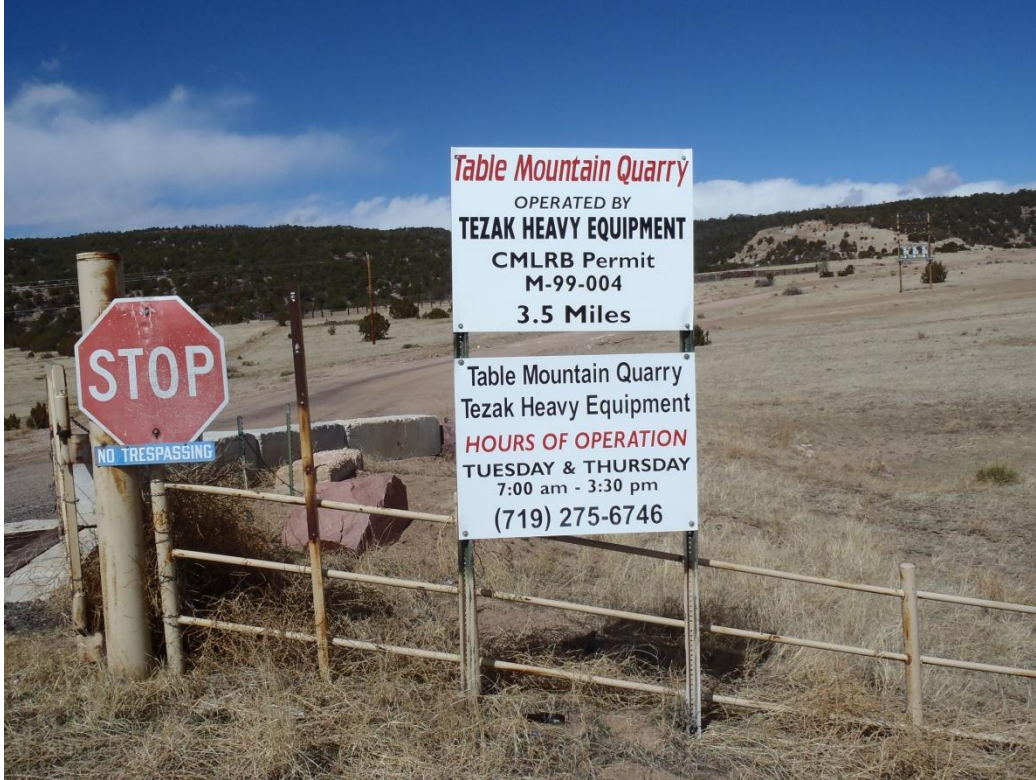
Markers & Boundary – A permit sign was displayed at the site entrance (see **Photo 1**). Mr. Tezak explained that the County Permit has restrictions to limit visual impact, such that mining activity is restricted by topography and the permit boundaries are not marked.

Photo 1. Permit identification sign.

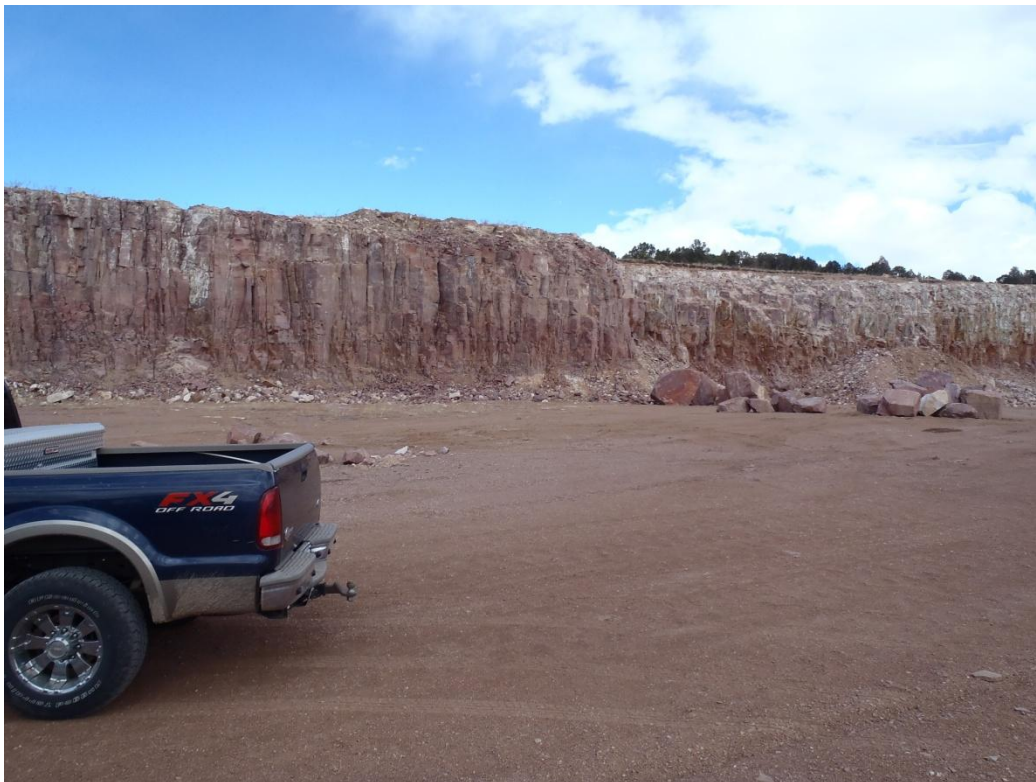
Mining Plan – The Area A highwall was estimated to be approximately 500 feet long (see **Photos 2 and 3**). The maximum height was approximately 30 feet and appeared relatively stable, with the exception of some minor rockfall. Several stockpiles of material were observed in the Area A pit (see **Photos 4 and 5**). Equipment observed on site included a screen, conveyor and loader (see **Photo 6**). Mr. Tezak indicated the Area B pit (see **Photos 7 and 8**) had not been active for quite some time.

Photo 2. Area A highwall (looking north).

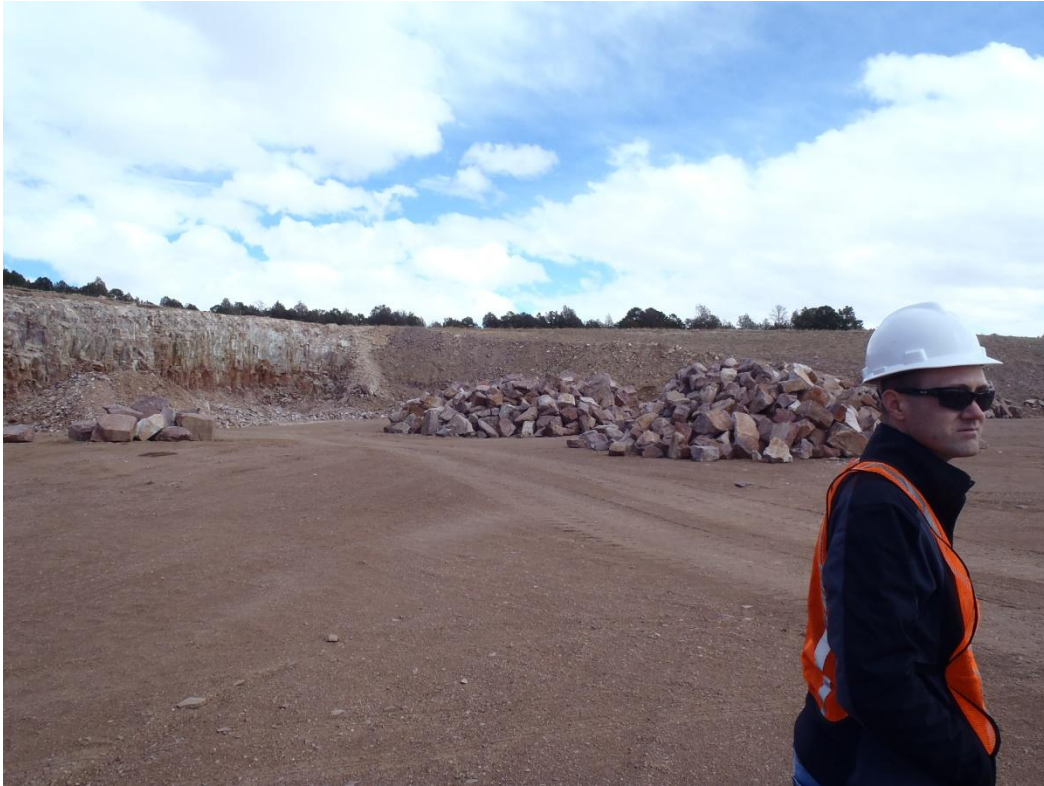
Photo 3. Area A highwall (looking NE).

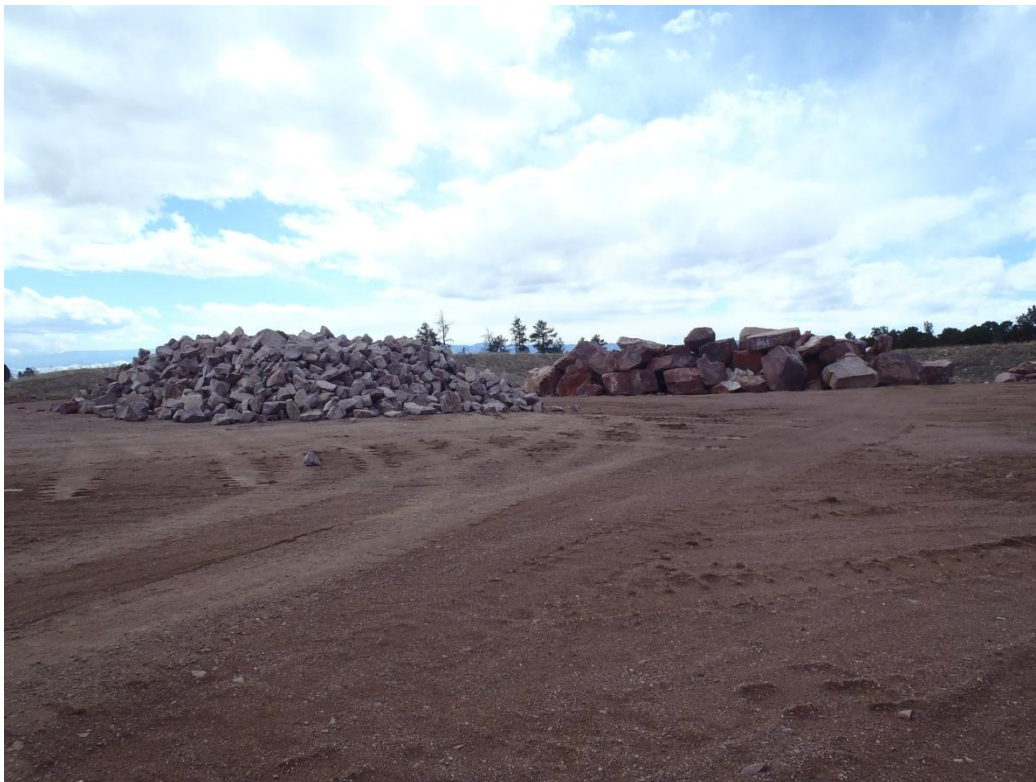
Photo 4. Area A pit material stockpiles (1 of 2).

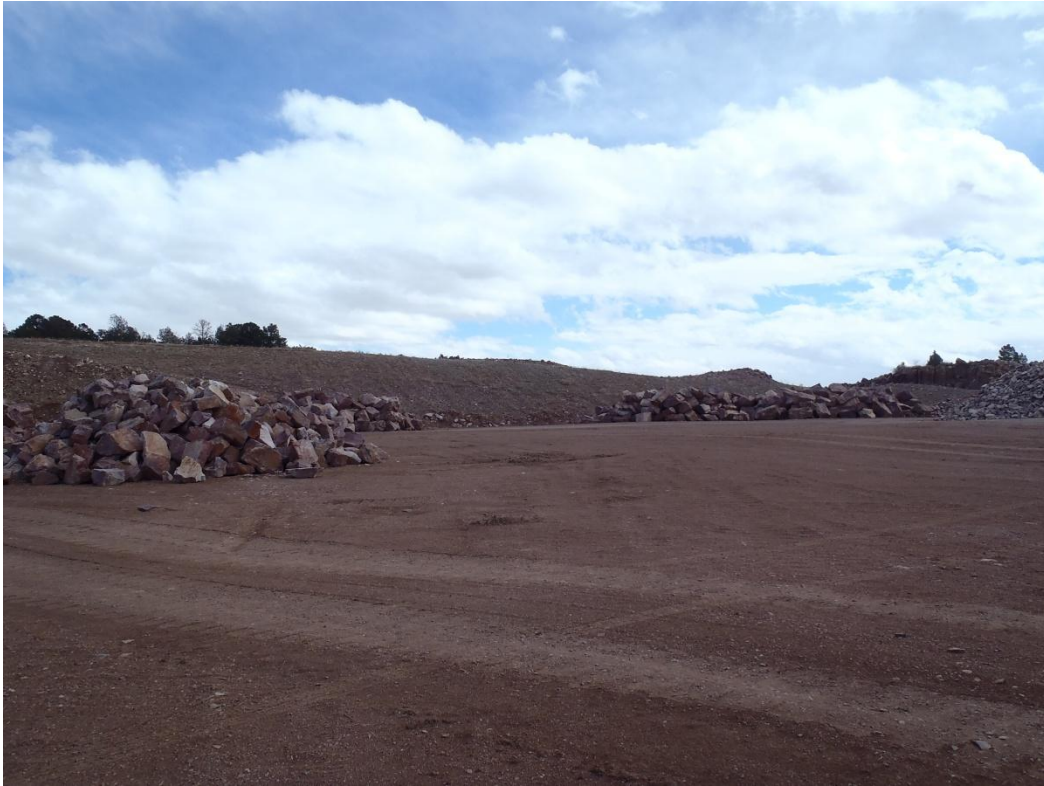
Photo 5. Area A pit material stockpiles (2 of 2).

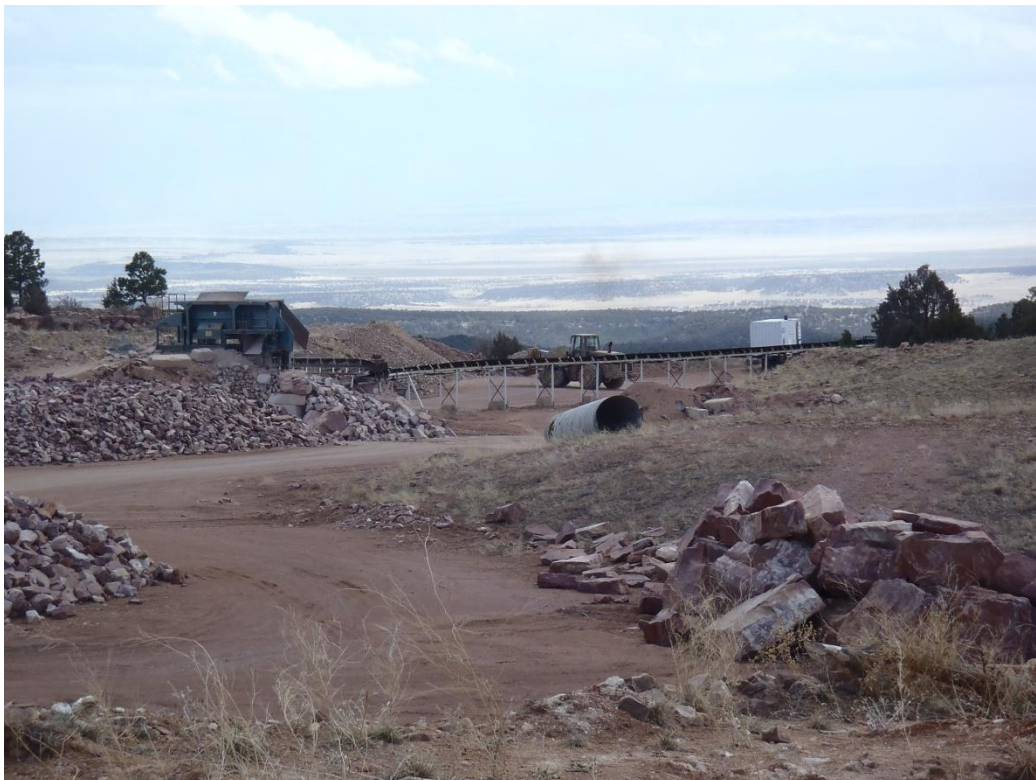
Photo 6. Grizzly screen, conveyor & loader (south of Area A pit).

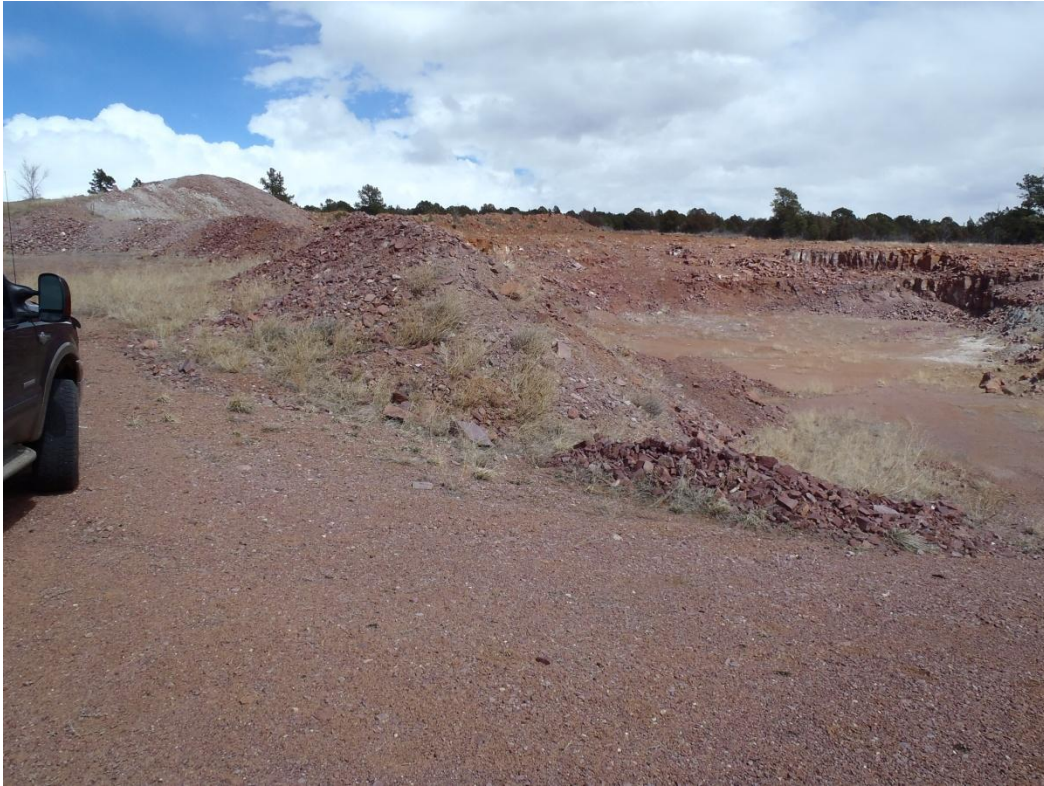
Photo 7. Area B pit (1 of 2) (looking NNE).

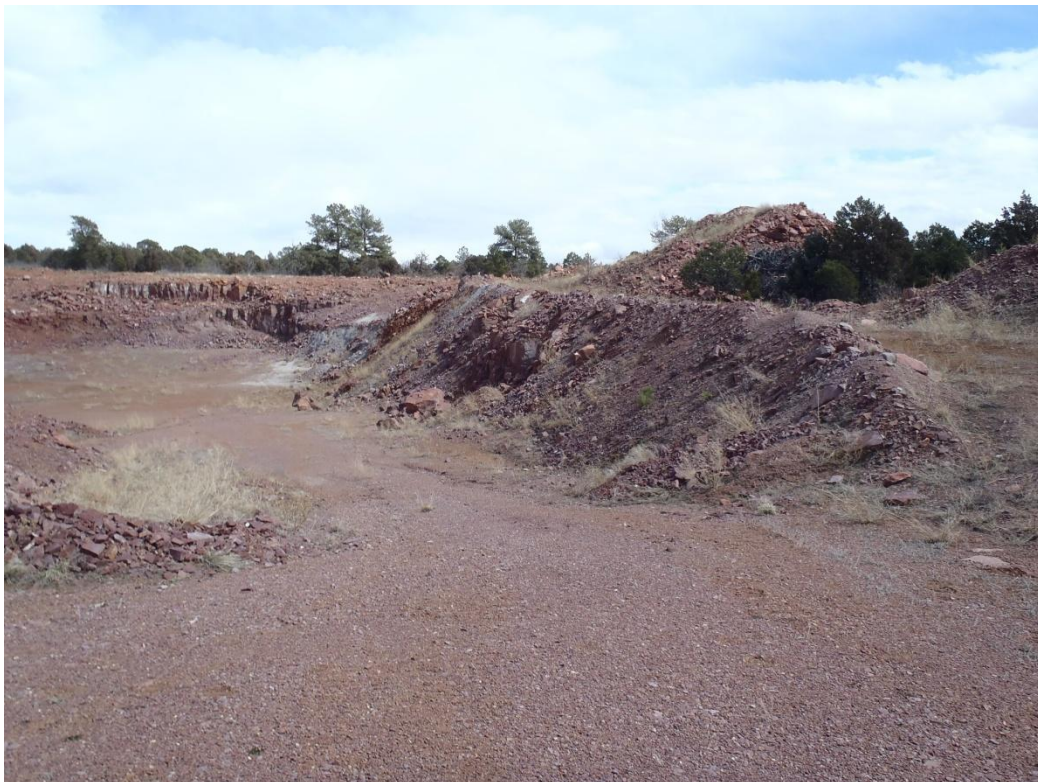
Photo 8. Area B pit (2 of 2) (looking east).

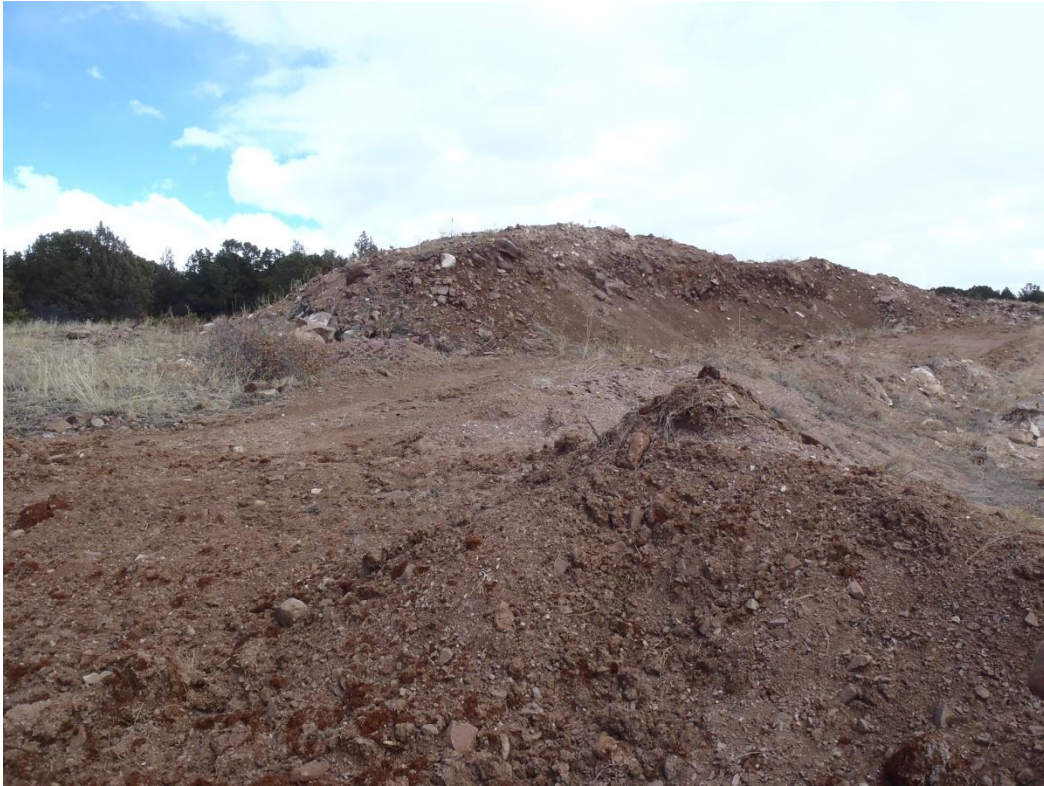
Reclamation – A topsoil stockpile was observed at the upgradient west side of the Area A pit (see **Photo 9**). An area west of Area A has been reclaimed, possibly to releasable standards (see **Photo 10**). The Division observed a quonset hut type structure (see **Photo 11**) near the south end of Area A, near the truck scale.

Photo 9. Topsoil stockpile observed at upgradient west side of Area A pit.

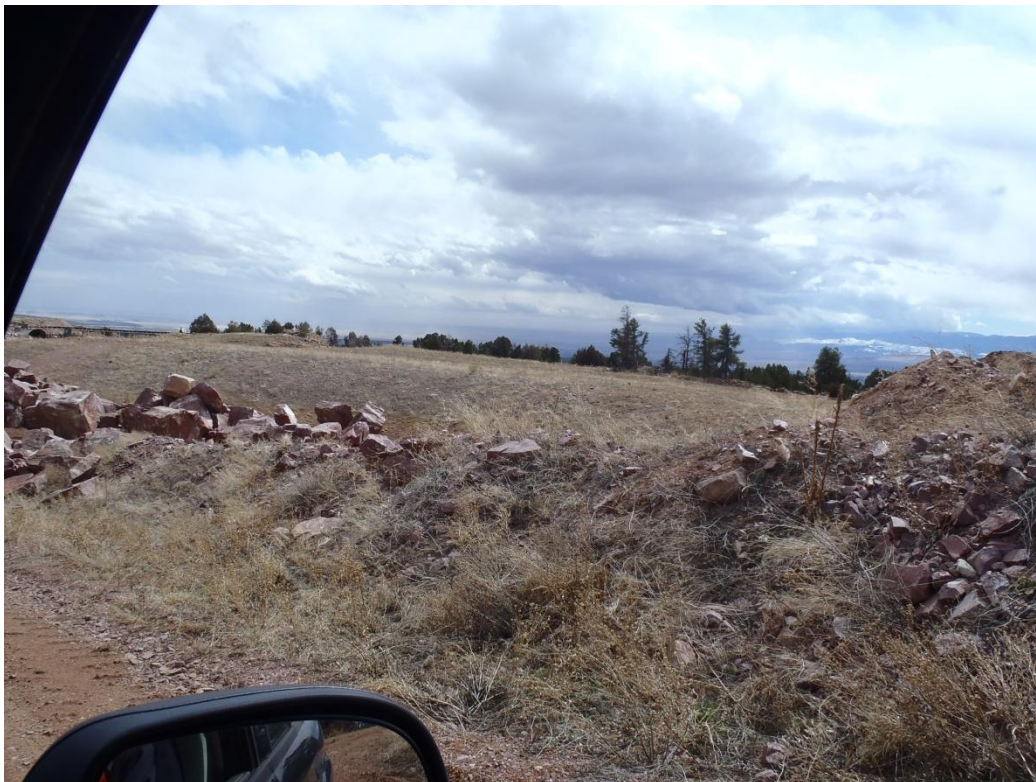
Photo 10. Area west of Area A – possibly reclaimed to releasable standards (looking south).

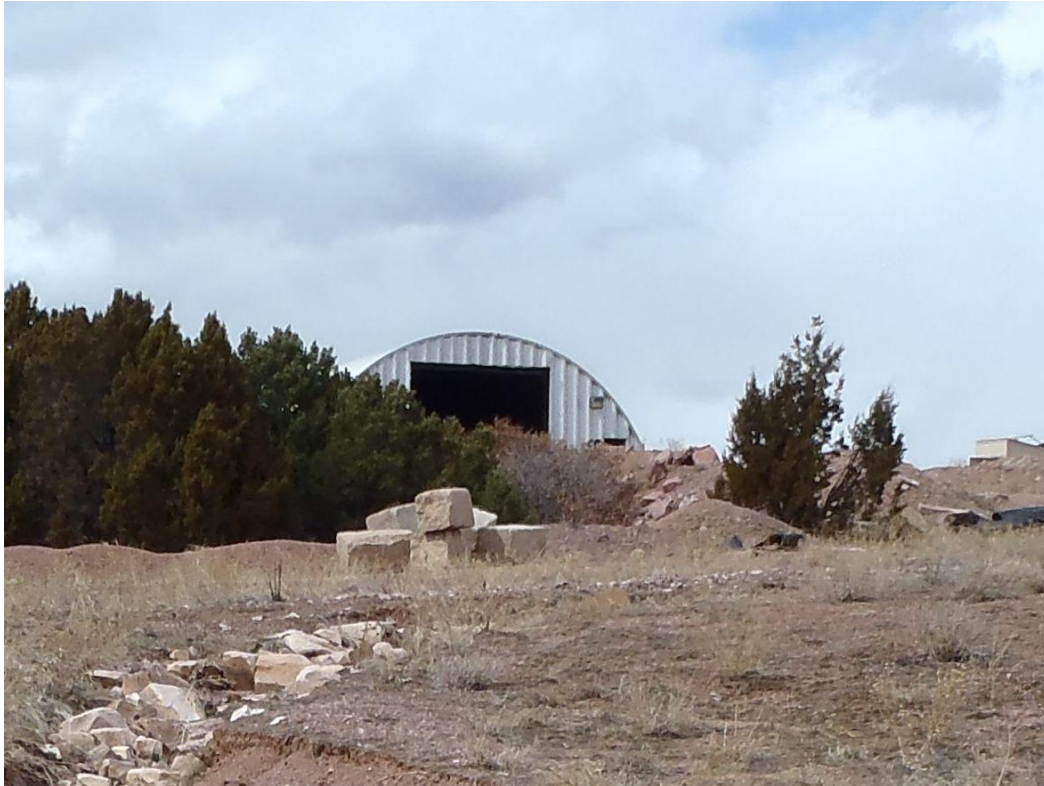
PROBLEM/POSSIBLE VIOLATION: Problem: The current approved reclamation plan does not address the existing quonset hut shop. The reclamation plan needs to be updated and clarified pursuant to C.R.S. 34-32.5-116 (1). The operator must describe or identify how the operator intends to conduct reclamation with respect to this structure.

- d) The Division cannot find any records for the quonset hut, nor reclamation plans and/or demolition costs for the structure. **The absence of a reclamation plan for this structure is cited as a problem on page 1 of this report.** A rough estimate for demolition of the structure indicates the existing bond is adequate for demolition.

Photo 11. Quonset hut shop (looking NW).

CORRECTIVE ACTIONS: The operator shall submit a Technical Revision, with the required \$216 revision fee, to update and clarify the current approved reclamation plan to reflect the existing structure by the corrective action date.

1. No problems or concerns were observed during the inspection.
2. A records review found no reclamation plans for the existing quonset hut shop. The Division requires a technical revision to document the reclamation plan for the quonset hut structure. The TR should include the structure's dimensions (including area and height) and thickness of concrete floors and/or foundations.
3. The bond appears adequate for the current disturbance. However, prior to any disturbance in Area C, the Operator shall submit a Technical Revision to update the reclamation plan and Exhibit L, reclamation cost estimate.

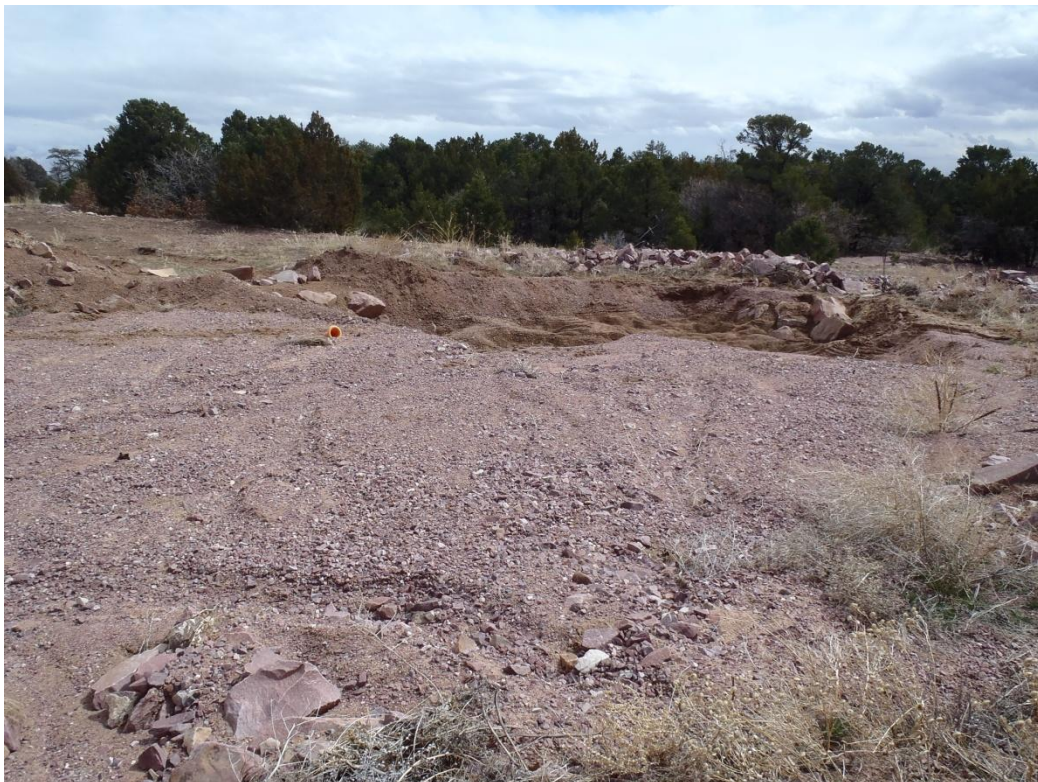
Environmental – The Division observed the sediment pond on the south end of the permit area (see **Photo 12**). The Division recommended to Mr. Tezak that the pond be cleaned out. The Division subsequently received photographic documentation of the repairs to the sediment ponds completed in March of 2014. The outfall channel from the pond (see **Photo 13**) is lined with riprap and appears to be adequately controlling erosion. The Division observed a stockpile of milled asphalt (also **Photo 13**) north of the sediment pond. Mr. Tezak indicated the milled asphalt would be used on the 3.5-mile haul road. No problems with erosion/sedimentation or noxious weeds were observed.

Photo 12. Sediment pond on the south end of the permit area (looking SE).

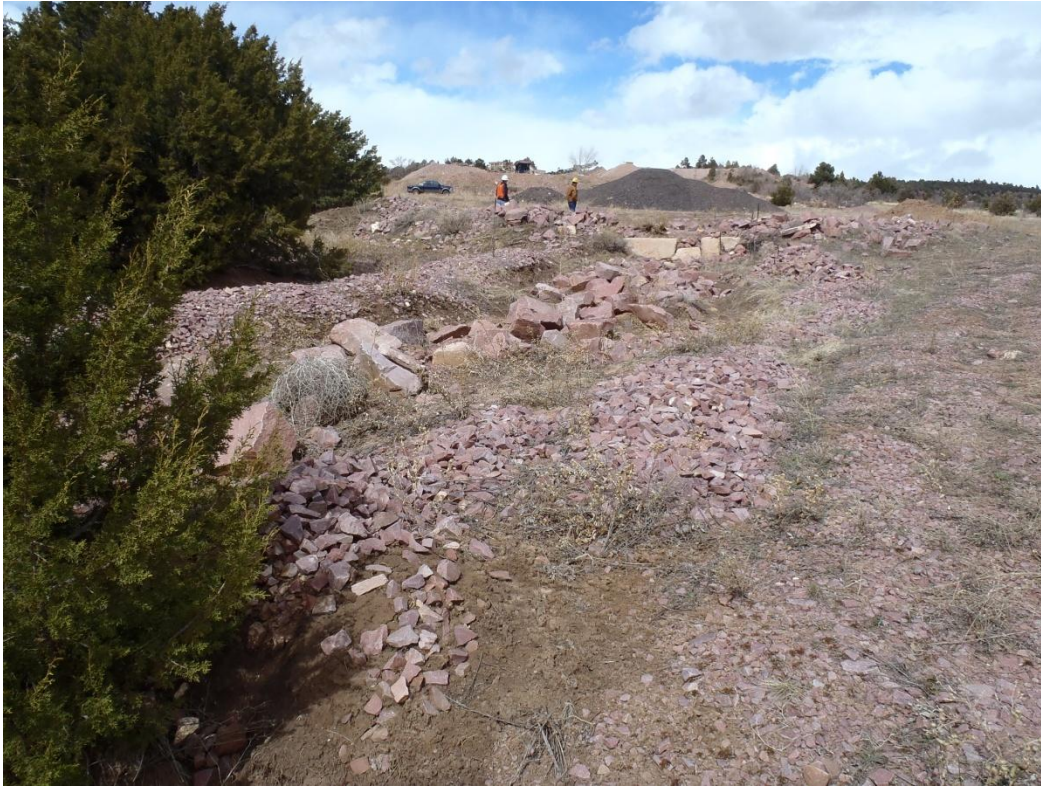
Photo 13. Riprap-lined outfall channel from sediment pond (looking north).
