COLORADO DIVISION OF RECLAMATION, MINING AND SAFETY
MINERALS PROGRAM INSPECTION REPORT
PHONE: (303) 866-3567

MINE NAME: Cresson Project	MINE/PROSPECTING ID#: M-1980-244	MINERAL: Gold	COUNTY: Teller
INSPECTION TYPE: Monitoring	INSPECTOR(S): Elliott R. Russell	INSP. DATE: February 24, 2015	INSP. TIME: 10:00
OPERATOR: Cripple Creek & Victor Gold Mining Company	OPERATOR REPRESENTATIVE: Chris Hanks	TYPE OF OPERATION: 112d-3 - Designated Mining Operation

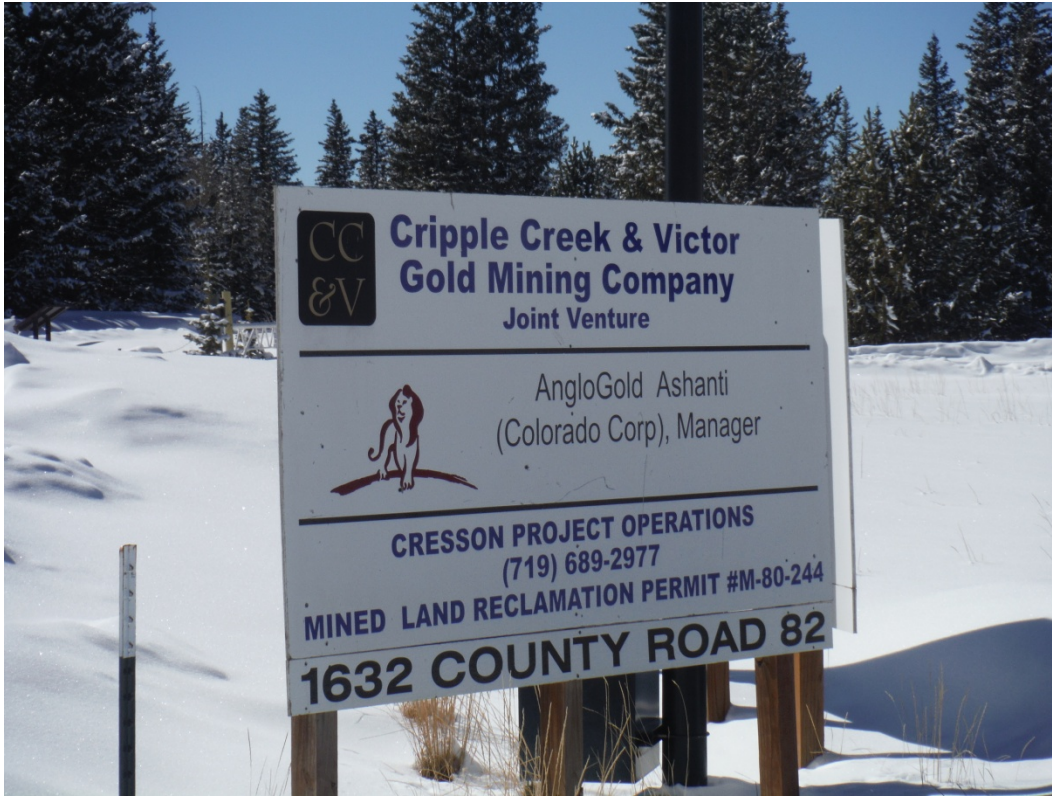
- A mine site identification sign (see **Photo 1**) was observed at the entrance to the Ironclad Facilities and was in compliance with Rule 3.1.12(1).
- The Phase V pad area of the Arequa Gulch Valley Leach Facility (AGVLF) was actively being loaded with ore and solution feeder lines were being laid down on various portions of the leaching pad (see **Photo 2**).

Photo 1. Site identification sign at the entrance of the Ironclad Facilities (south of County Road 82); looking southwest.

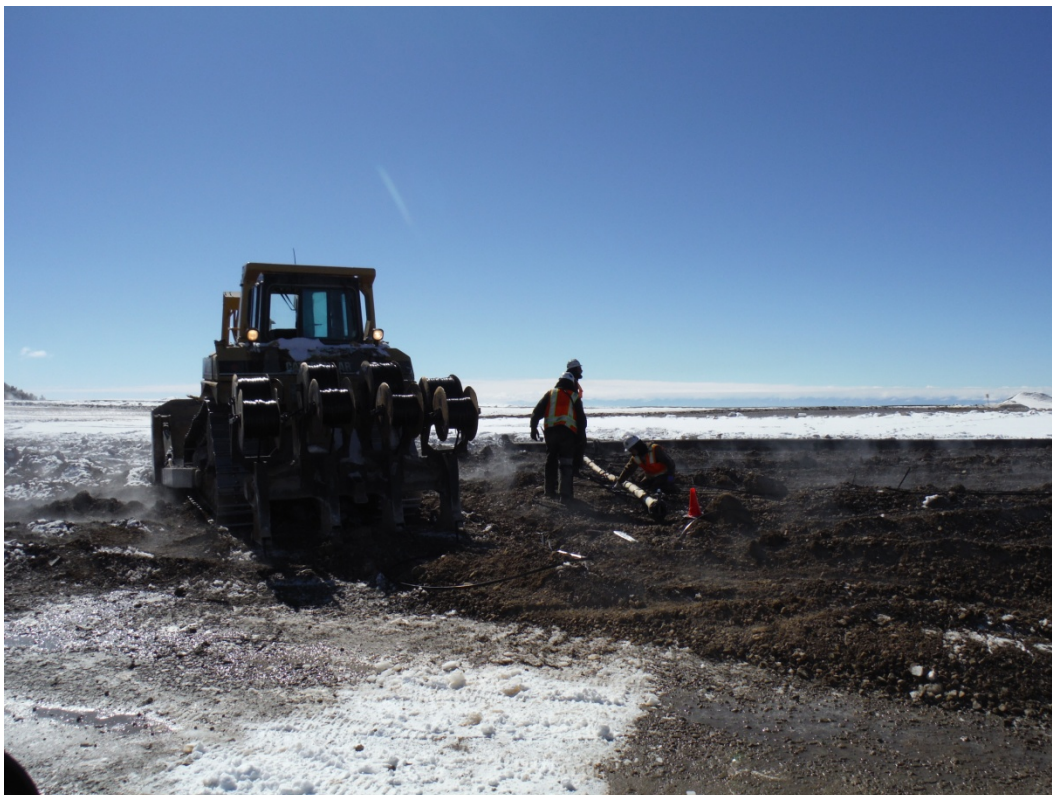
Photo 2. Placement of solution feeder lines at the 10,300' level of the leach pad, surface ripped to allow better infiltration of solution; looking south.

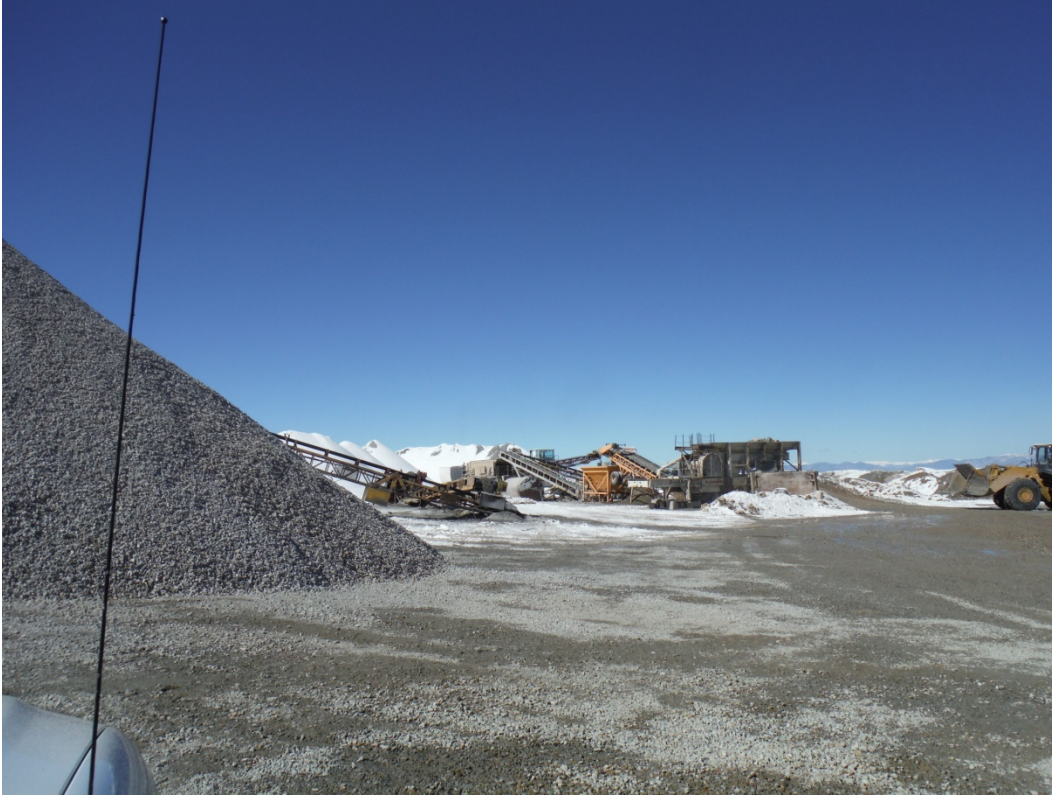
- The alternate location for crushing stemming material, used for packing blast holes, was inspected (see **Photo 3**). Mr. Hanks anticipated that the contractor would be finished crushing the material shortly because the volume for one year's use had nearly been crushed and stockpiled.

Photo 3. Crushed blasting material used for stemming; looking northwest.

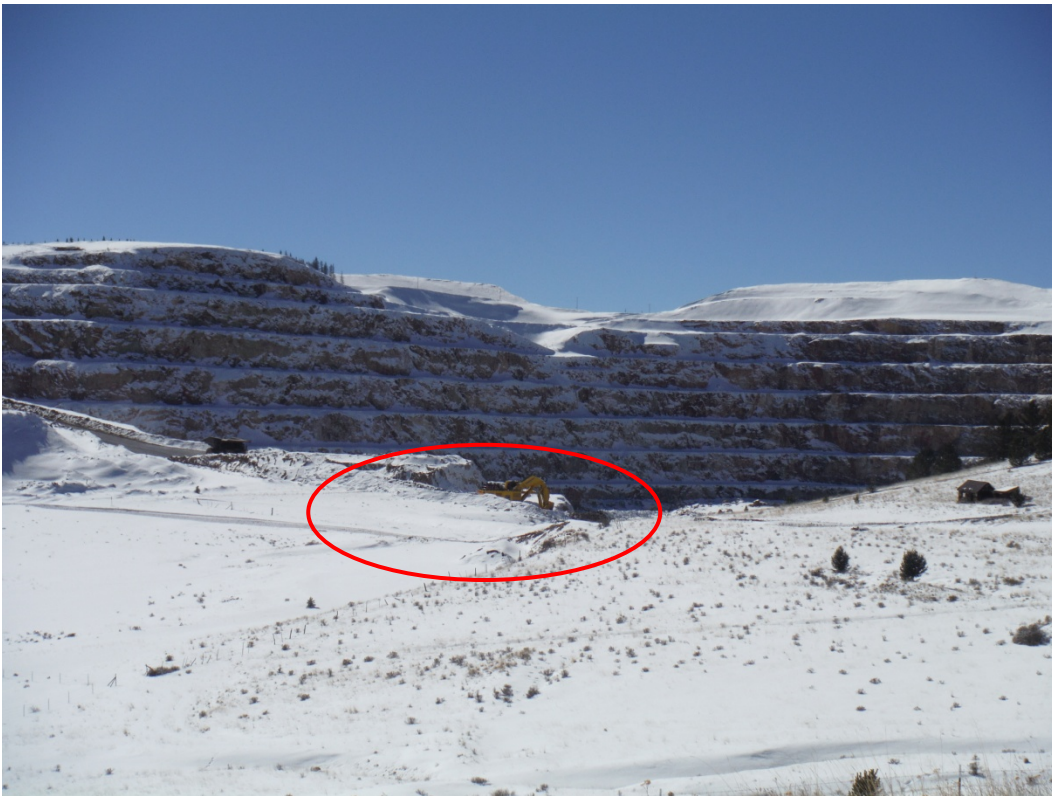
- The Division observed the general area in which the Grassy Valley 01 (GV-01) monitoring flume is located (see **Photo 4**). Pond 19, which is just upstream from the flume, has been disturbed from the Wildhorse Extension (WHEX) mining operation. Mr. Hanks stated that any water that would typically report to this pond now flows into the WHEX area leaving the flume dry. He discussed the possibility of submitting a letter requesting the removal of the flume and the sampling requirement of GV-01.

Photo 4. Area of Pond 19 and GV-01 circled in red (west of WHEX); looking east

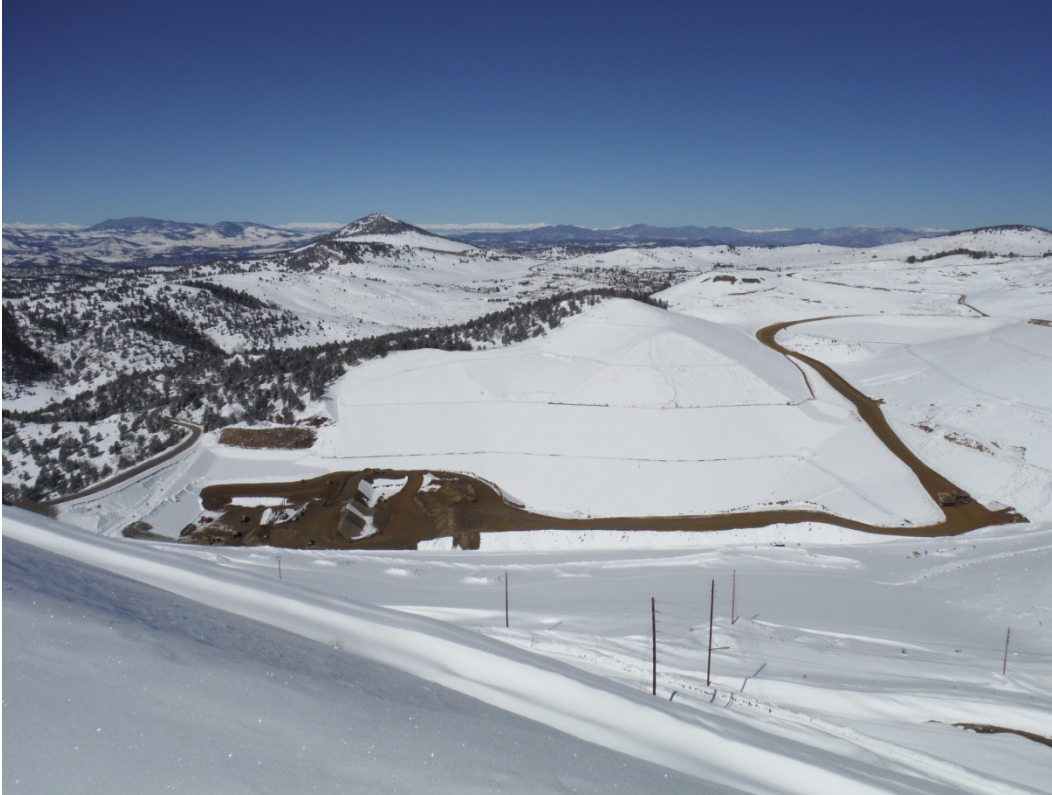
The Division and Mr. Hanks were accompanied by Ron DiDonato into the Squaw Gulch Valley Leach Facility (SGVLF) (see **Photo 5**). The Division observed:

Photo 5. Overview of the SGVLF; looking northwest.

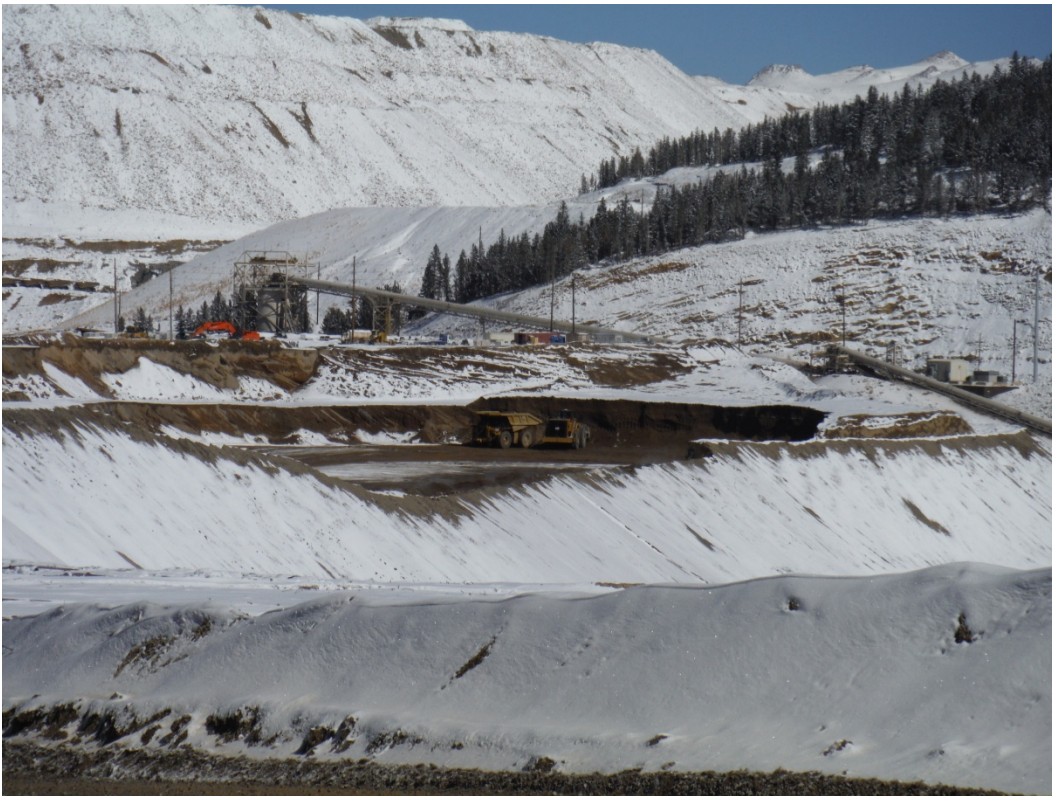
- The delivery and placement operations of spent ore into the southwest portion of the SGVLF Pregnant Solution Storage Area (PSSA). Spent ore is being removed from AGVLF Phase IV pad area, near the main crusher's truck loadout (see **Photo 6**);

Photo 6. Area in AGVLF Phase IV where spent ore is being extracted for the SGVLF, the main crusher's truck loadout in the background; looking northeast.

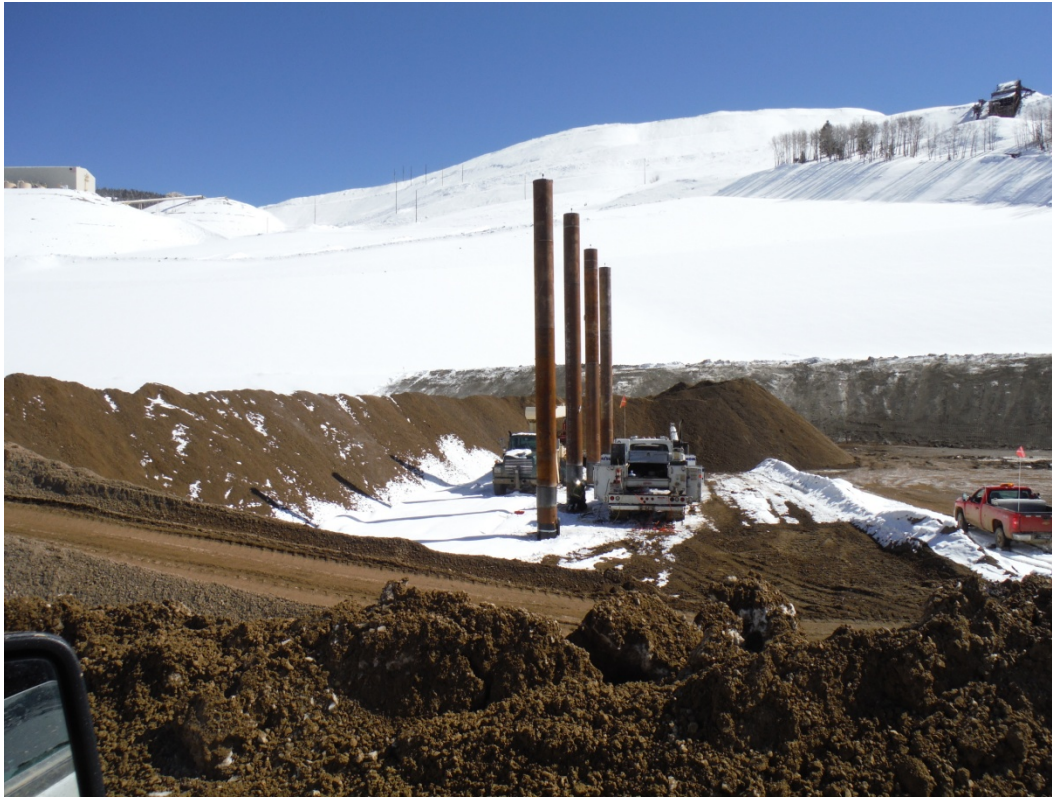
- The final segment (31' high) of the PSSA risers had been welded and the top elevation of the risers is now at 9,455' (see **Photo 7**);
- A GPS bulldozer removing snow on the slopes of the PSSA to ensure a clean, snow-free contact between the Drain Cover Fill (DCF) and the spent ore (see **Photo 8**). The operator was using the surveyed data file to accurately remove snow without removing the DCF;

Photo 7. Final segment of the SGVLF PSSA risers with 15' uncontrolled lifts of spent ore behind, snow cleared from the DCF in the background; looking southeast.

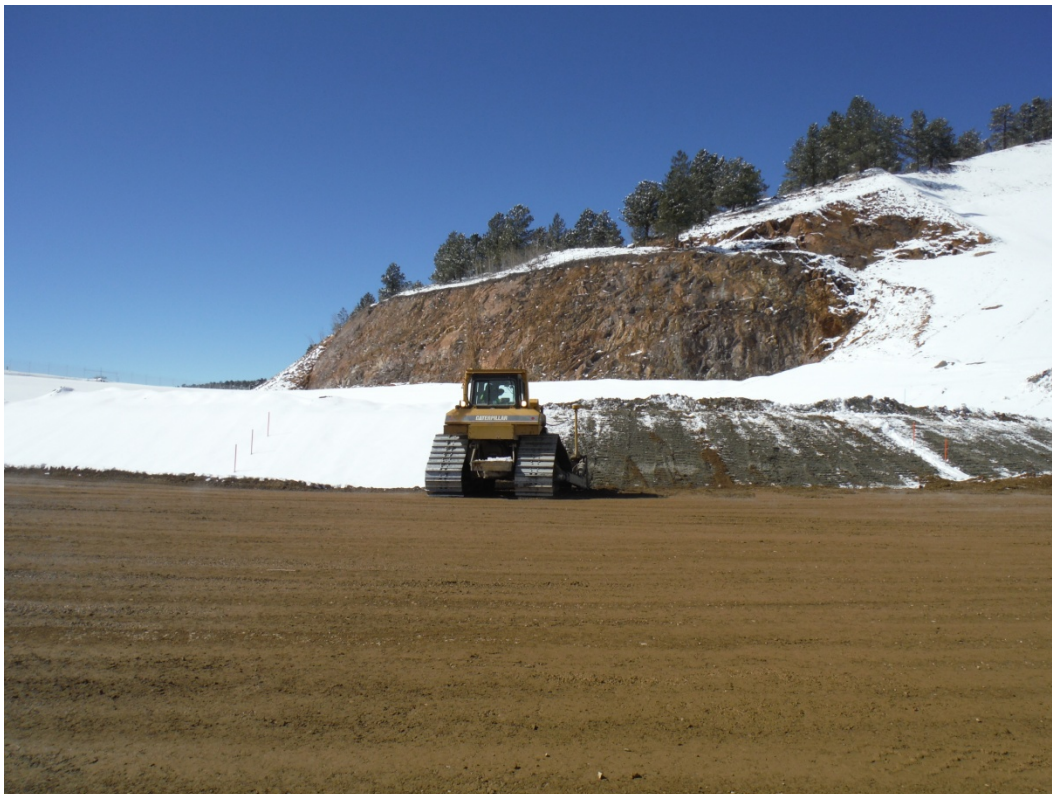
Photo 8. Bulldozer using GPS to remove snow from the DCF, currently standing on the compacted footprint of the new ADR; looking northwest.

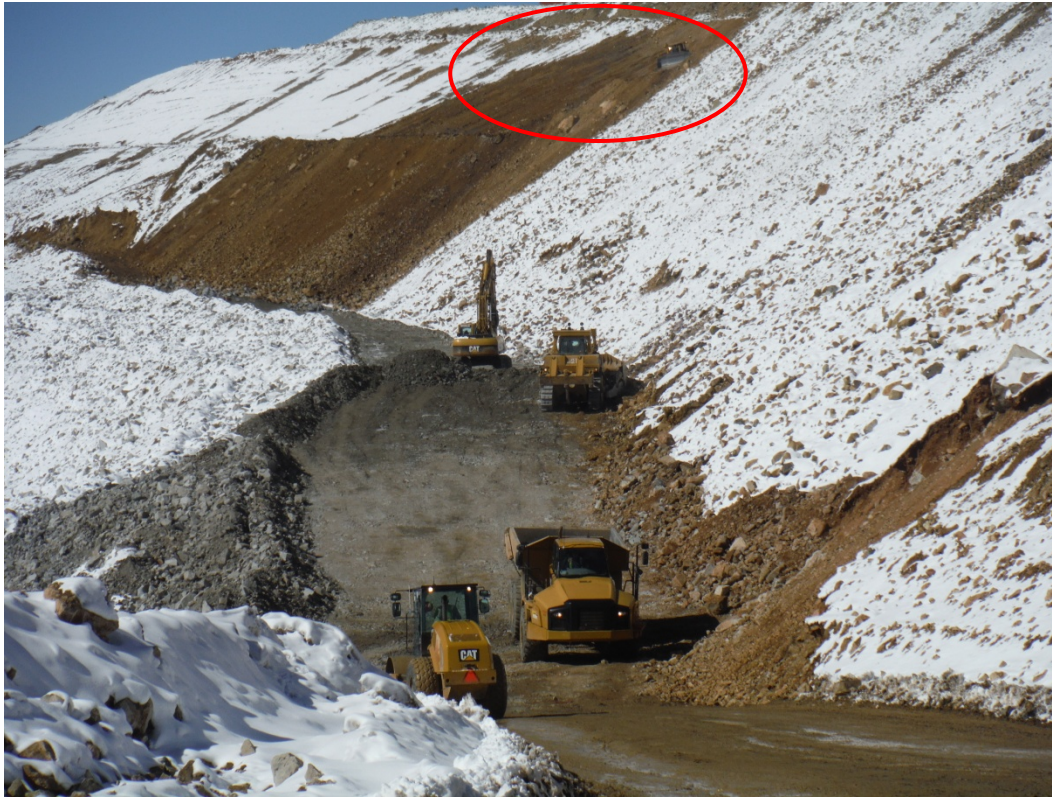
- Quality control and assurance personnel testing the compaction of the spent ore in the location footprint of the new ADR; and
- Final slope grading and the placement of Structural Fill (SF) on the upper reaches of the eastern half of the SGVLF Phase II (see **Photo 9**).

Photo 9. SF placement for Phase II of the SGVLF project, bulldozer working on the final grade circled in red; northwest.

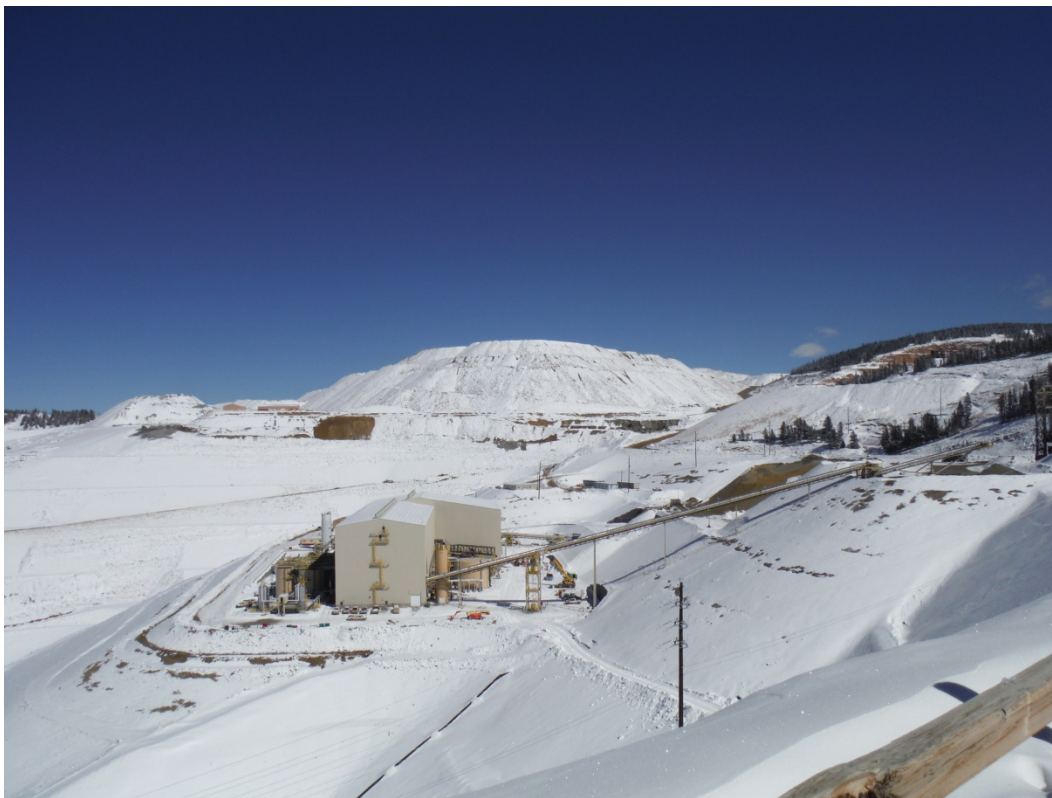
Mr. Hanks informed the Division that the new high-grade mill (see **Photo 10**) was currently being tested at 75% capacity for periods of 24 hours. The Division observed a small stockpile of processed ore (see **Photo 11**) had been conveyed from the mill; this stockpile is located approximately 300 feet west of the main crusher's truck loadout. The process ore, which has been agglomerated with cement, is planned to be loaded onto the AGVLF, or SGVLF upon its completion, for further gold recovery.

Photo 10. Overview of the new high-grade mill facility; looking north.

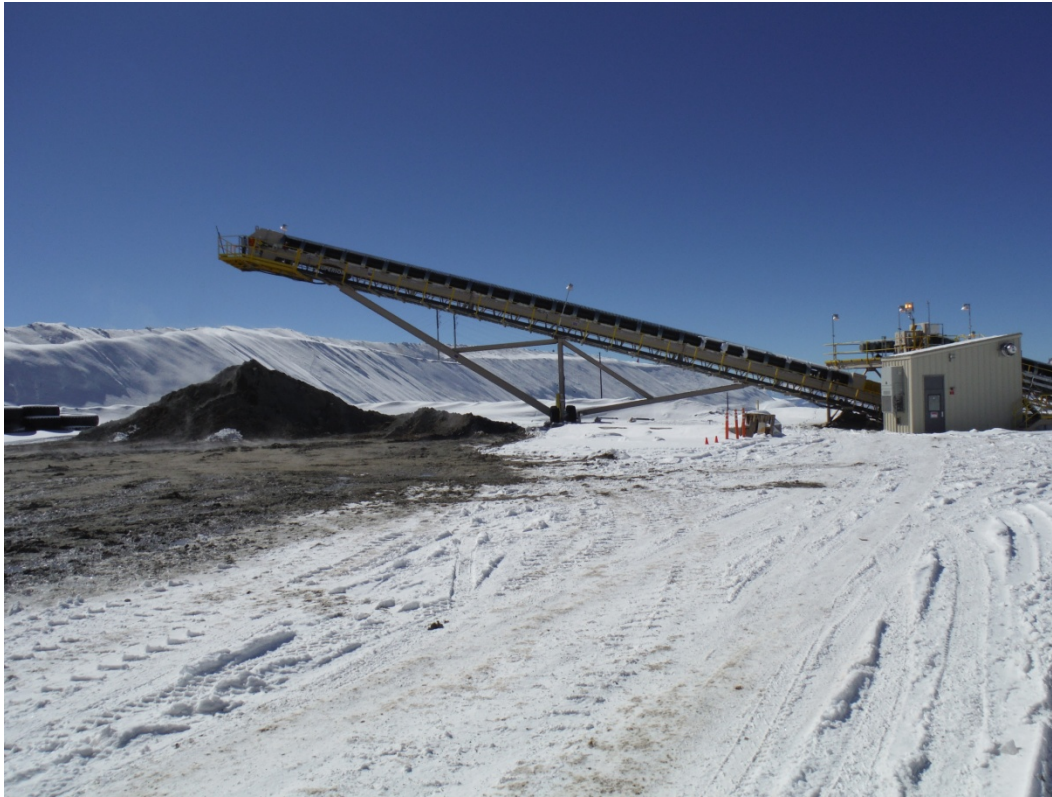
Photo 11. Agglomerated processed ore from the high-grade mill; looking south.
