COLORADO DIVISION OF RECLAMATION, MINING AND SAFETY
MINERALS PROGRAM INSPECTION REPORT
PHONE: (303) 866-3567

MINE NAME: County Line Pit	MINE/PROSPECTING ID#: M-1987-016	MINERAL: Sand and gravel	COUNTY: Lincoln
INSPECTION TYPE: Monitoring	INSPECTOR(S): Amy Eschberger	INSP. DATE: February 5, 2015	INSP. TIME: 09:00
OPERATOR: Lincoln County	OPERATOR REPRESENTATIVE: John DeWitt and Mark McHone	TYPE OF OPERATION: 110c - Construction Limited Impact

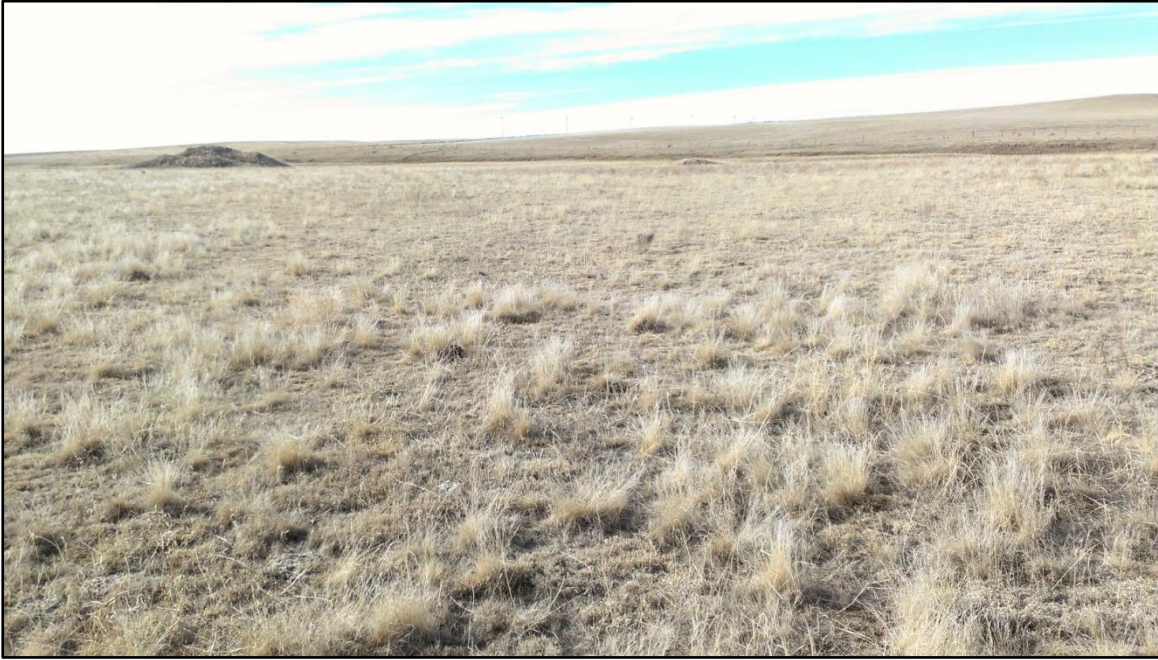
The Division inspected the land located north of the permit area that was released with the approval of AR-01. This area includes the two small stockpiles left for use by the landowner. This area is well-vegetated with native grasses and stable, and appears to have been undisturbed for a very long time (Photos 1-3). The Division also inspected the land located south of the permit area that was released with the approval of AR-01. This area is also well-vegetated with native grasses and stable (Photo 4). The creek banks upstream (northward) and downstream (southward) from the mined portion of the creek appear to be preserved and do not show any evidence of erosion at this time.

Photo 1. View looking southwest from access road, showing northern portion of original permit area that was released with AR-01.

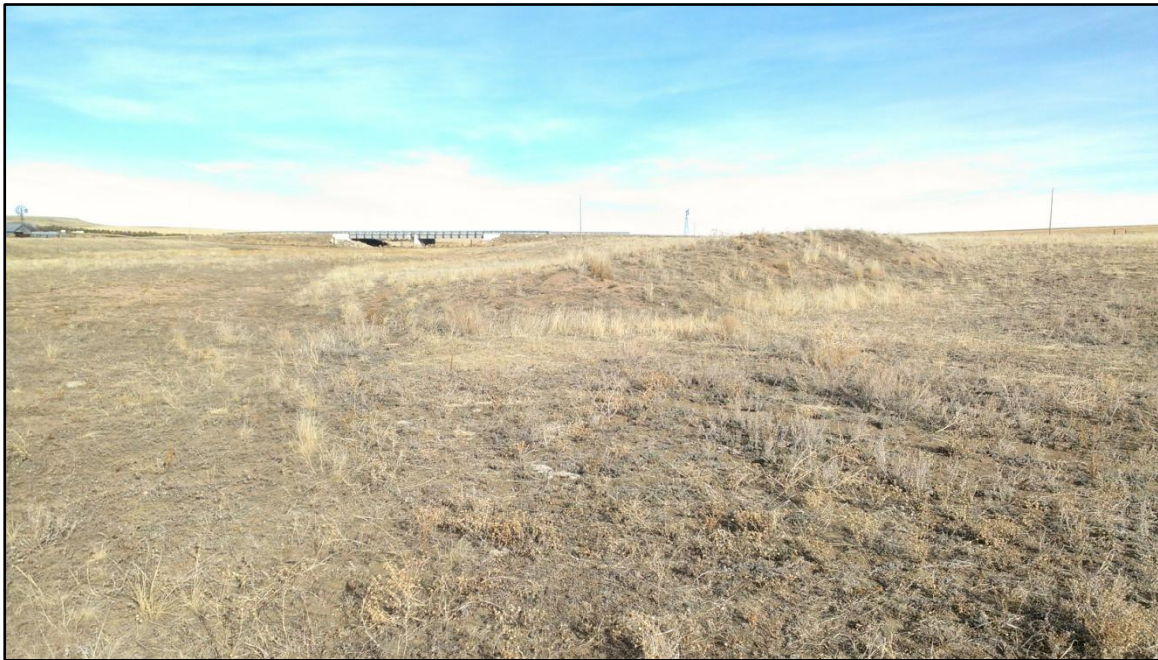
Photo 2. View looking north at small material stockpile left by previous CDOT operation that remains north of the current permit area. This portion of the original permit area was released with AR-01.

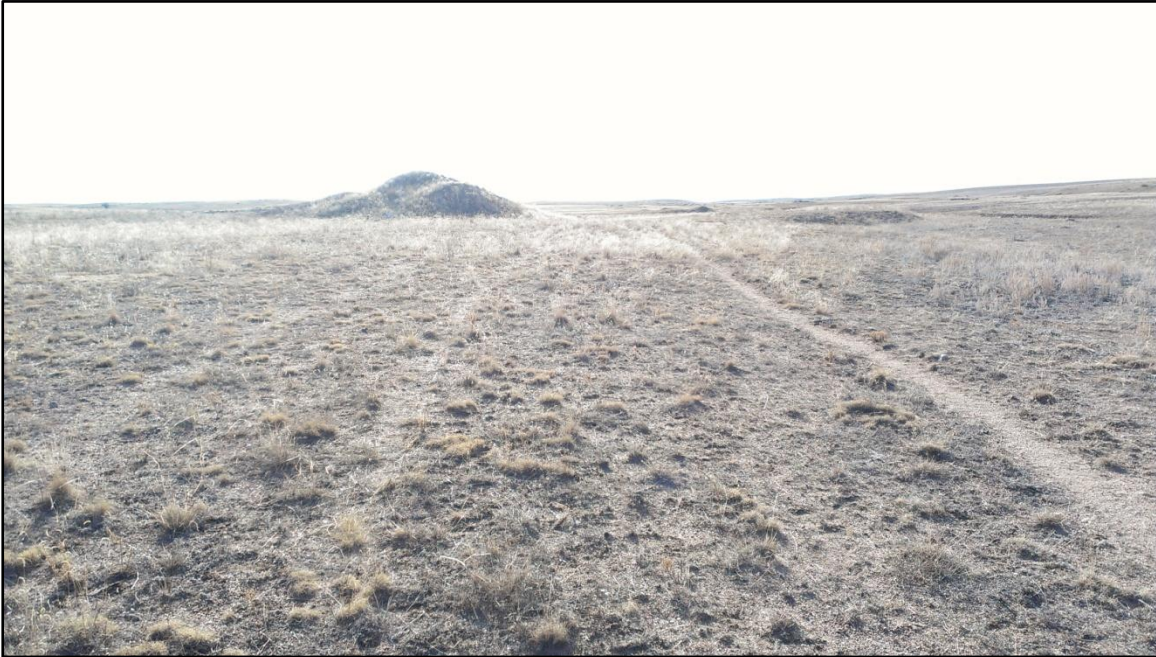
Photo 3. View looking south at other small material stockpile left by previous CDOT operation that remains north of the current permit area. This portion of the original permit area was released with AR-01.

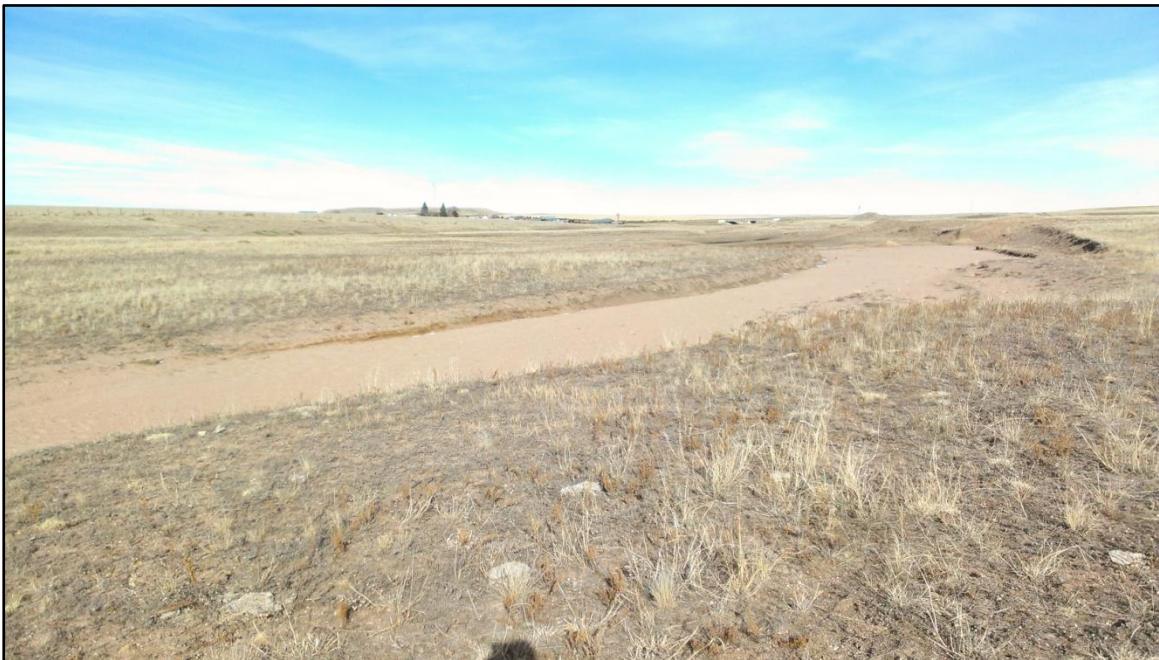
Photo 4. View looking northwest from south of permit area, showing portion of creek just downstream from the mining operation.

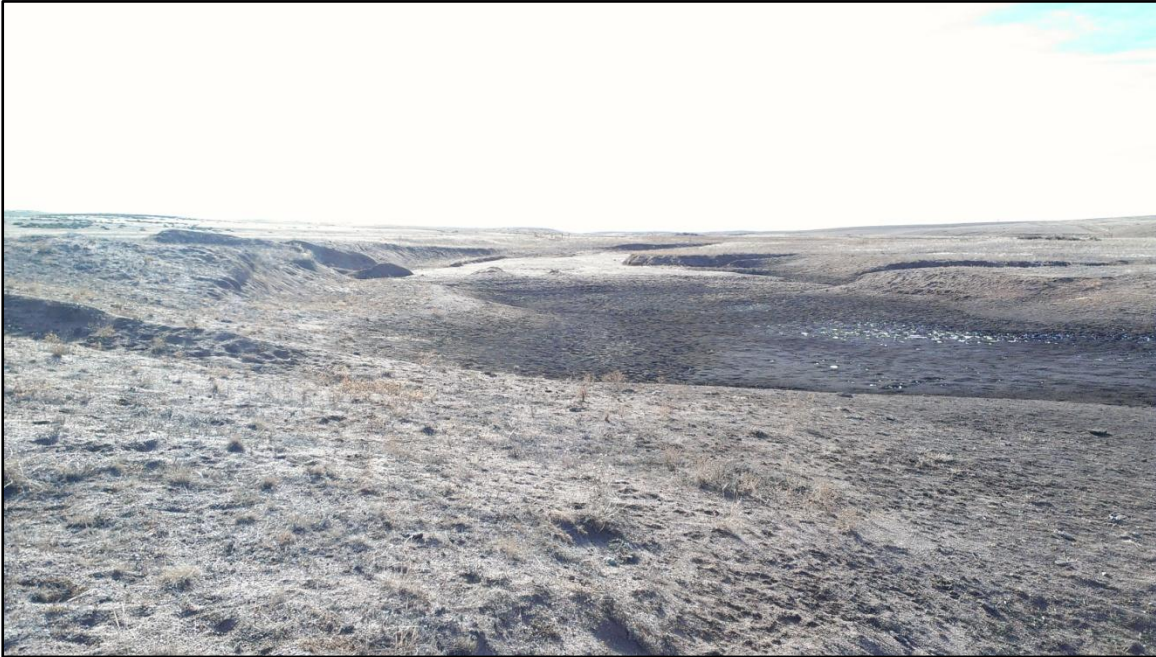
The Division also observed the disturbed portion of the creek where mining activities have occurred. There are a few shallow depressions along approximately 200 feet of the creek length where material was extracted, and two main trenches that appear to have been cut into the west bank at some time between 2006 and 2011, according to available historical aerial images of the site (Photos 5 and 6). Some native grasses and forbs have volunteered across the disturbed area. This portion of the creek appears to be stable at this time. However, as active mining resumes, the Operator should continue to maintain bank stability and keep from altering the natural alignment of the creek. The Operator originally held a Section 404 Permit from the Department of the Army (DA) for this site. However, according to a letter the Division received from the DA on 07/13/2001, this permit was revoked due to a Supreme Court ruling that eliminated their jurisdiction over this type of project.

Photo 5. View looking south from east creek bank, showing portion of the creek mined by this operation. Some water remains pooled up in the depression (at right) from recent storm.

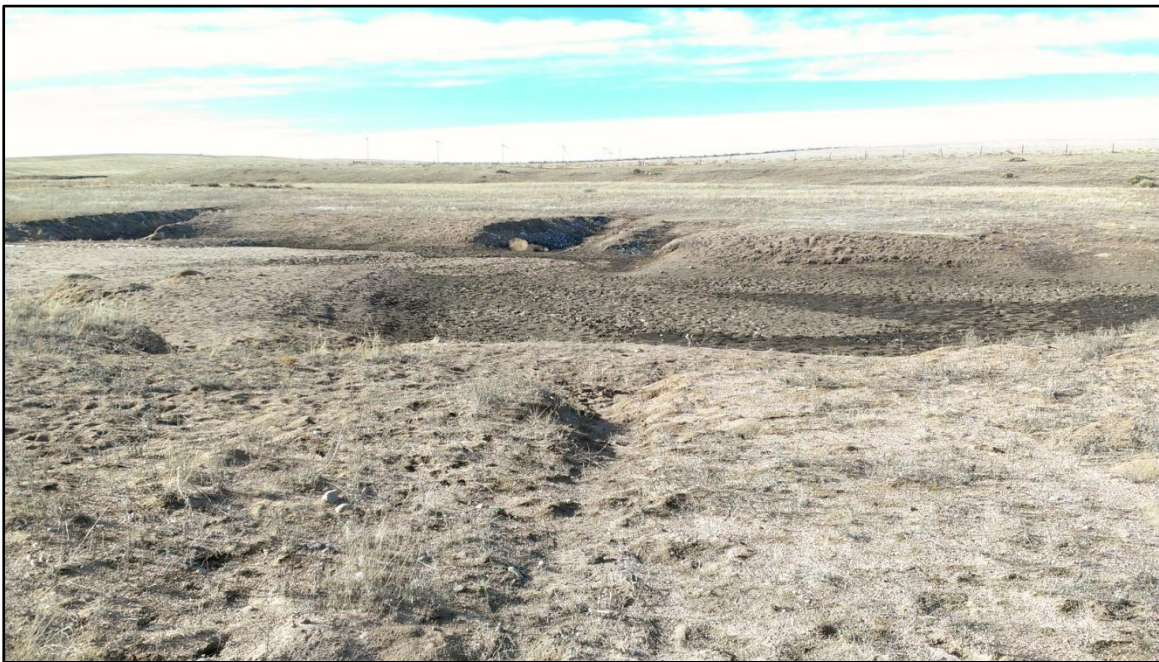
Photo 6. View looking southwest from east creek bank, showing mined portion of creek. Note trenches cut into west bank.
