COLORADO DIVISION OF RECLAMATION, MINING AND SAFETY
MINERALS PROGRAM INSPECTION REPORT
PHONE: (303) 866-3567

MINE NAME: Una Pit	MINE/PROSPECTING ID#: M-1980-080	MINERAL: Sand and gravel	COUNTY: Garfield
INSPECTION TYPE: Monitoring	INSPECTOR(S): Stephanie J. Mitchell	INSP. DATE: March 4, 2015	INSP. TIME: 09:30
OPERATOR: Grand Junction Concrete Pipe Co.	OPERATOR REPRESENTATIVE: Gayle Lyman and John Mueller	TYPE OF OPERATION: 112c - Construction Regular Operation

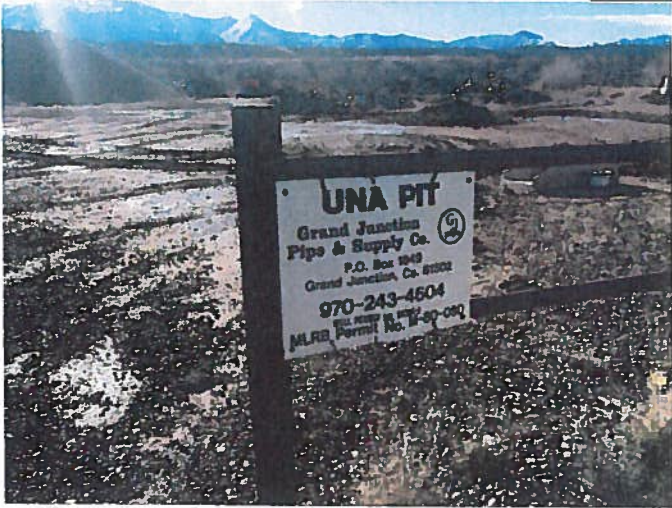
Adequate mine identification signage was noted at the entrance off of County Road 300 and is in accordance with Rule 3.1.12(1).

Mine Identification Sign

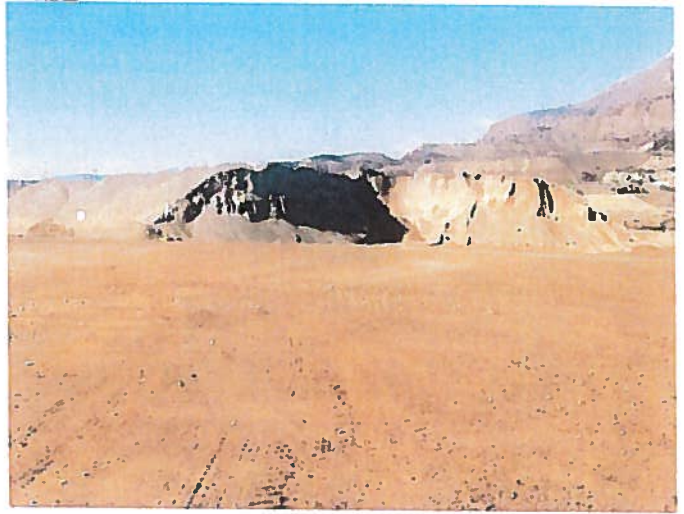
The permit area is delineated by fencing around the entire area. Material stockpiles and topsoil/overburden stockpiles appear to be stable. Mining is currently taking place in the Northeast corner of the permit area. Fuel Storage was contained in adequate mobile containers on flatbed trailers properly marked.

Material Stockpiles

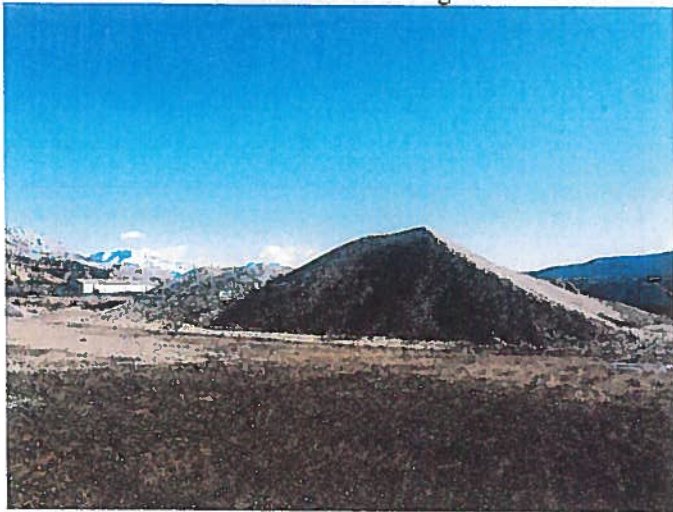
Material Stockpiles

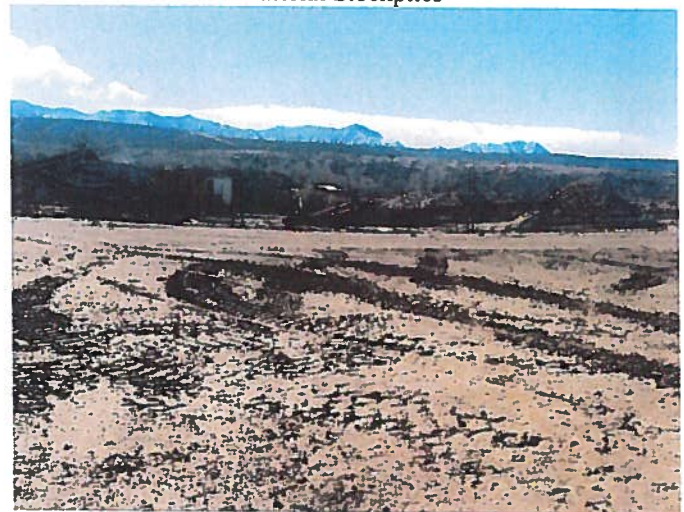
Crushing area

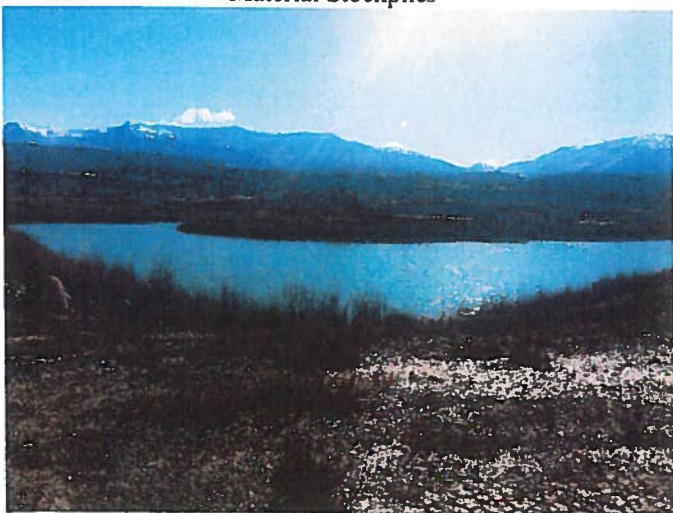
Pond in NW corner of permit area

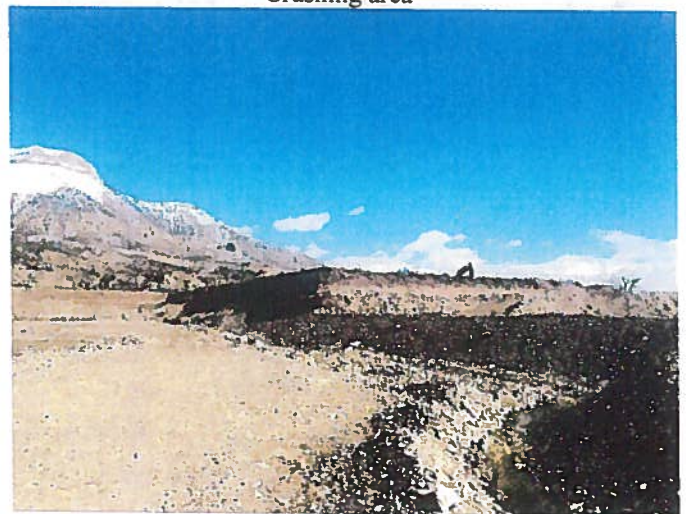
Highwall

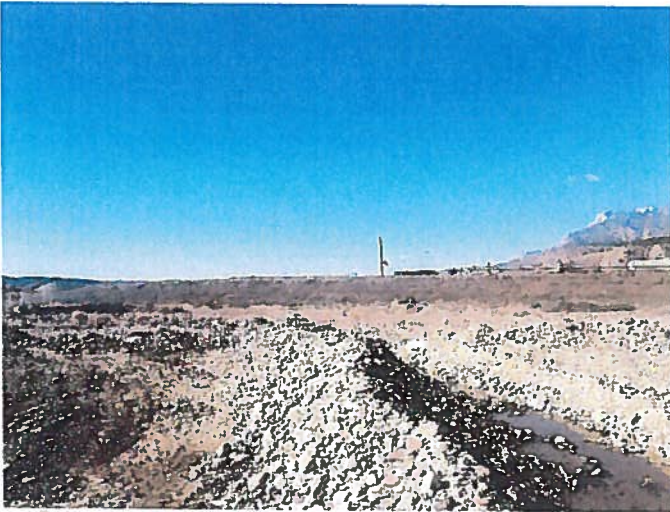
Area in the background that has been sloped/reclaimed SE corner of permit area

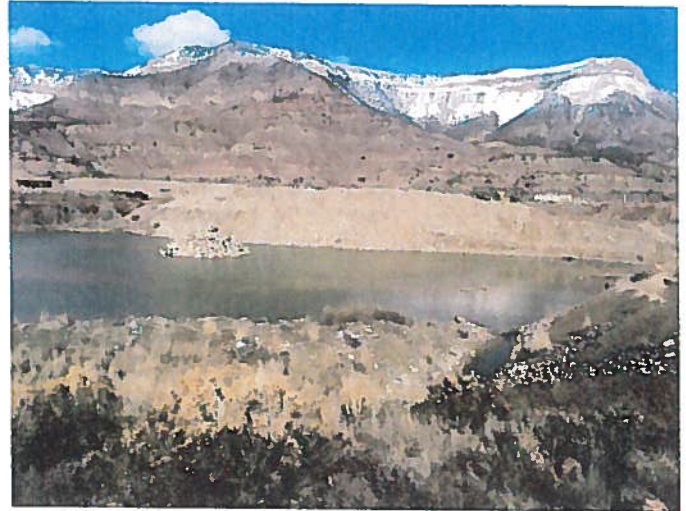
SW area Pond

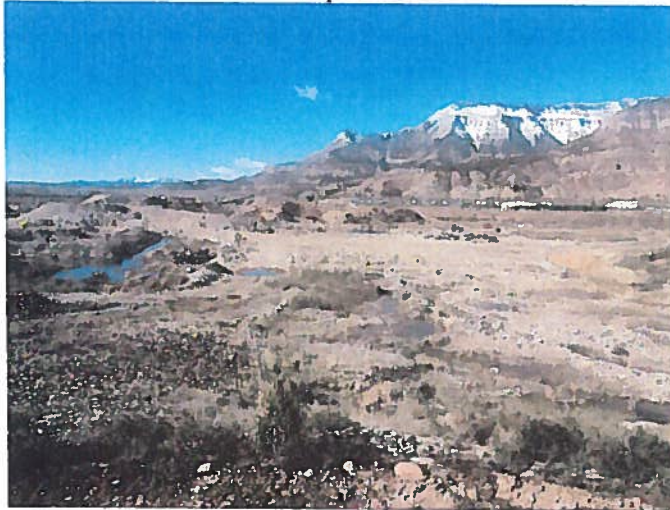
Overall Site Looking NW

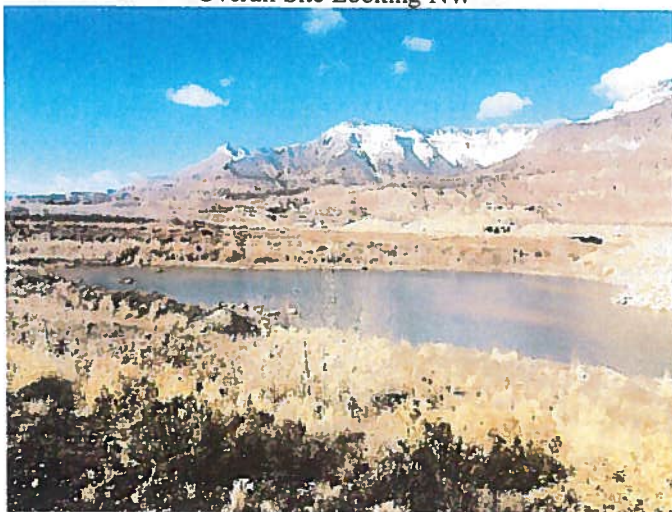
SW area pond
