COLORADO DIVISION OF RECLAMATION, MINING AND SAFETY
MINERALS PROGRAM INSPECTION REPORT
PHONE: (303) 866-3567

MINE NAME: Vulcan Exploration	MINE/PROSPECTING ID#: P-2014-010	MINERAL: Gold, silver	COUNTY: Gunnison
INSPECTION TYPE: Mineral Prospect Inspection	INSPECTOR(S): Bob Oswald	INSP. DATE: November 12, 2014	INSP. TIME: 15:30
OPERATOR: Vulcan Mammoth Chimney Mining Co.	OPERATOR REPRESENTATIVE: None	TYPE OF OPERATION: MP - Mineral Prospecting

REASON FOR INSPECTION: Surety Release Requested	BOND CALCULATION TYPE: None	BOND AMOUNT: \$2,000.00
DATE OF COMPLAINT: NA	POST INSP. CONTACTS: None	JOINT INSP. AGENCY: None
WEATHER: Cloudy	INSPECTOR'S SIGNATURE:

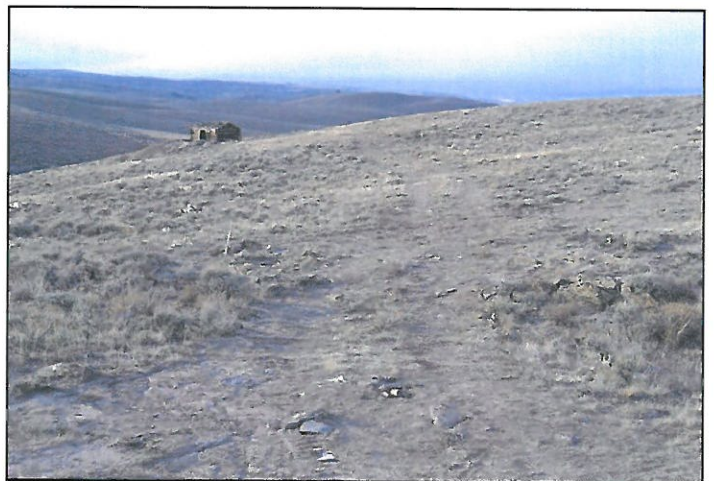
Above: Typical pre-existing two-track road
