**COLORADO DIVISION OF RECLAMATION, MINING AND SAFETY**  
**MINERALS PROGRAM INSPECTION REPORT**  
**PHONE: (303) 866-3567**

<b>MINE NAME:</b> Revenue Mine	<b>MINE/PROSPECTING ID#:</b> M-2012-032	<b>MINERAL:</b> Pb, Ag, Au	<b>COUNTY:</b> Ouray
<b>INSPECTION TYPE:</b> Monitoring	<b>INSPECTOR(S):</b> Wallace H. Erickson	<b>INSP. DATE:</b> March 27, 2015	<b>INSP. TIME:</b> 16:30
<b>OPERATOR:</b> Fortune Revenue Silver Mines, Inc	<b>OPERATOR REPRESENTATIVE:</b> Clint Fletcher, Dave Rigsby, Travis Fletcher, Jim Gubler	<b>TYPE OF OPERATION:</b> 112d-1 - Designated Mining Operation	
<b>REASON FOR INSPECTION:</b> High Priority Response to Complaint	<b>BOND CALCULATION TYPE:</b> Partial Bond	<b>BOND AMOUNT:</b> \$340,570.00	
<b>DATE OF COMPLAINT:</b> March 27, 2015	<b>POST INSP. CONTACTS:</b> MSHA, CDPHE	<b>JOINT INSP. AGENCY:</b> None	
<b>WEATHER:</b> Clear	<b>INSPECTOR'S SIGNATURE:</b>

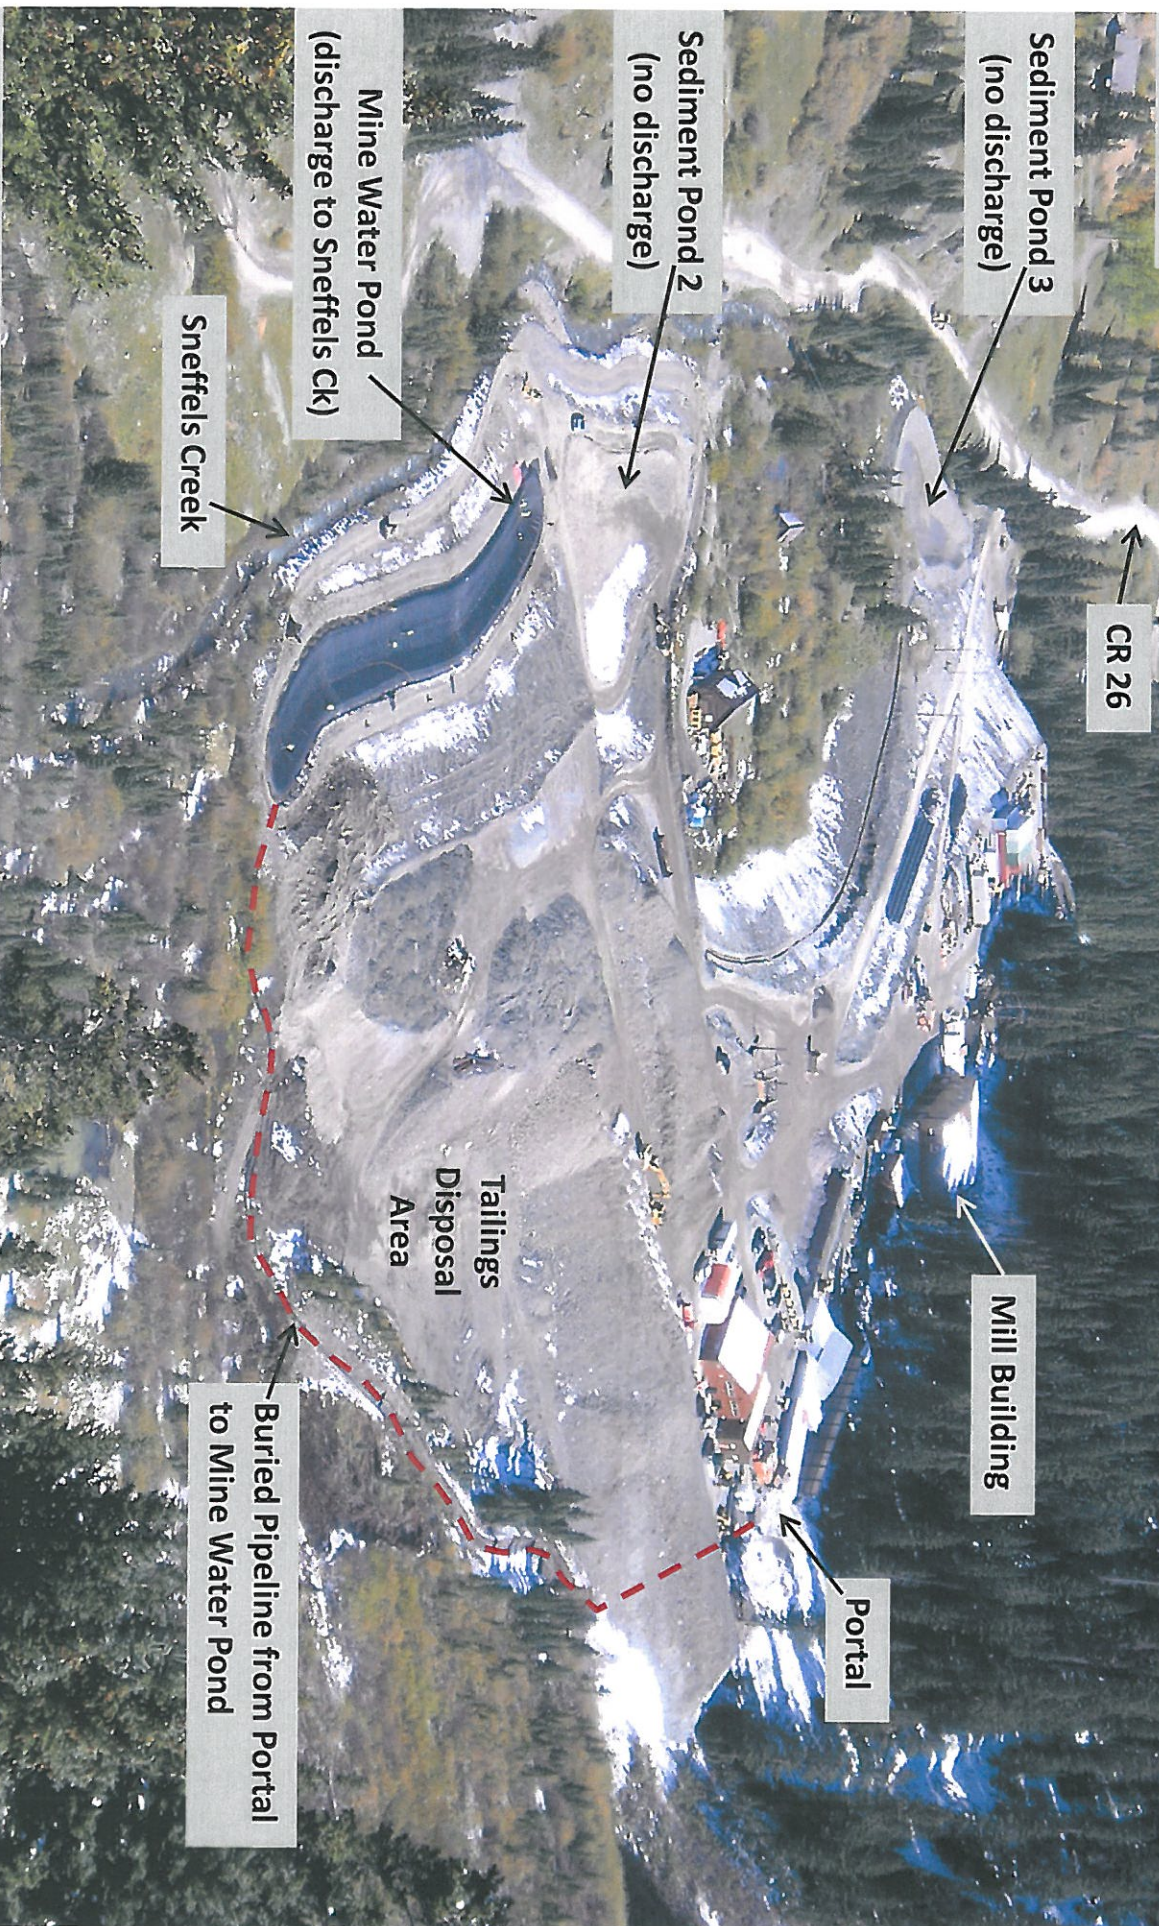
Revenue Mine  
M-2012-032  
October 3, 2014  
Photo 1

Photo 1 provides an overview of the operation and labels various features of the affected lands. As shown in Photos 1 through 4, mine drainage is treated for sediment at the Mine Water Pond prior to discharge to Sneffels Creek. Sneffels Creek is tributary to Canyon Creek. The confluence of Sneffels Creek and Canyon Creek is approximately 1.3 miles downstream of the permit area. The Division found no evidence of discharge from the mine site directly to Canyon Creek. Discharge from the Mine Water Pond to Sneffels Creek is regulated by permit number CO-0000003, issued and enforced by CDPHE. Storm water runoff from the site is regulated by permit number COR-04000, also issued and enforced by CDPHE.

View east, taken from a jeep trail nearby Governor Basin, showing the configuration of the Revenue Mine as of the date of the photograph, October 3, 2014.

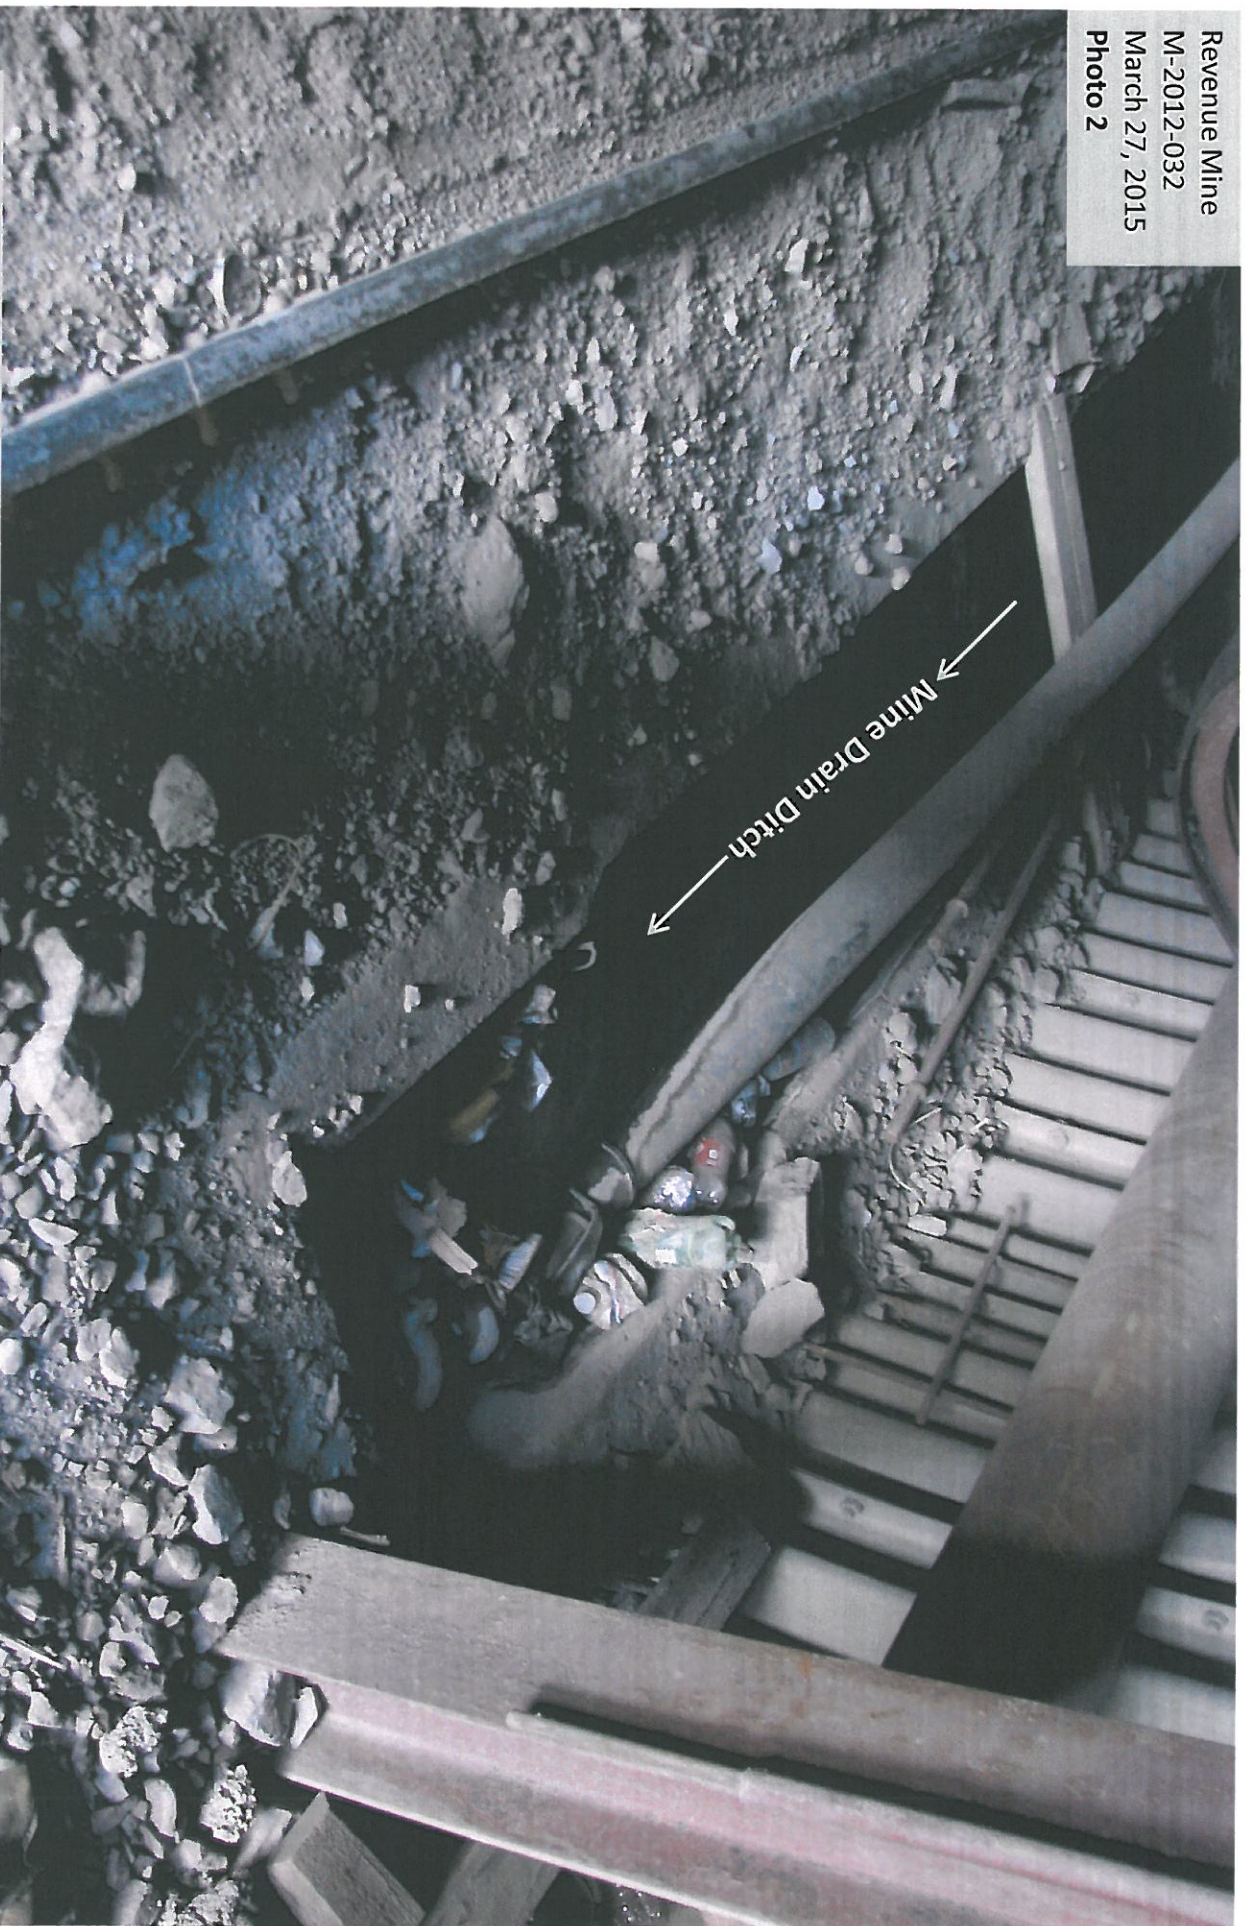
Revenue Mine  
M-2012-032  
March 27, 2015  
Photo 2

View inside the mine portal, showing termination of the mine drain ditch (piss ditch). At this point the ditch flow is routed into a pipeline which ultimately outlets to the mine water pond. As shown in this photo, trash is screened from the ditch flow prior to entering the pipeline. Mine drainage is treated for sediment at the mine water pond prior to discharge to Sneffels Creek, in accordance with the CDPHE discharge permit (CO-0000003).

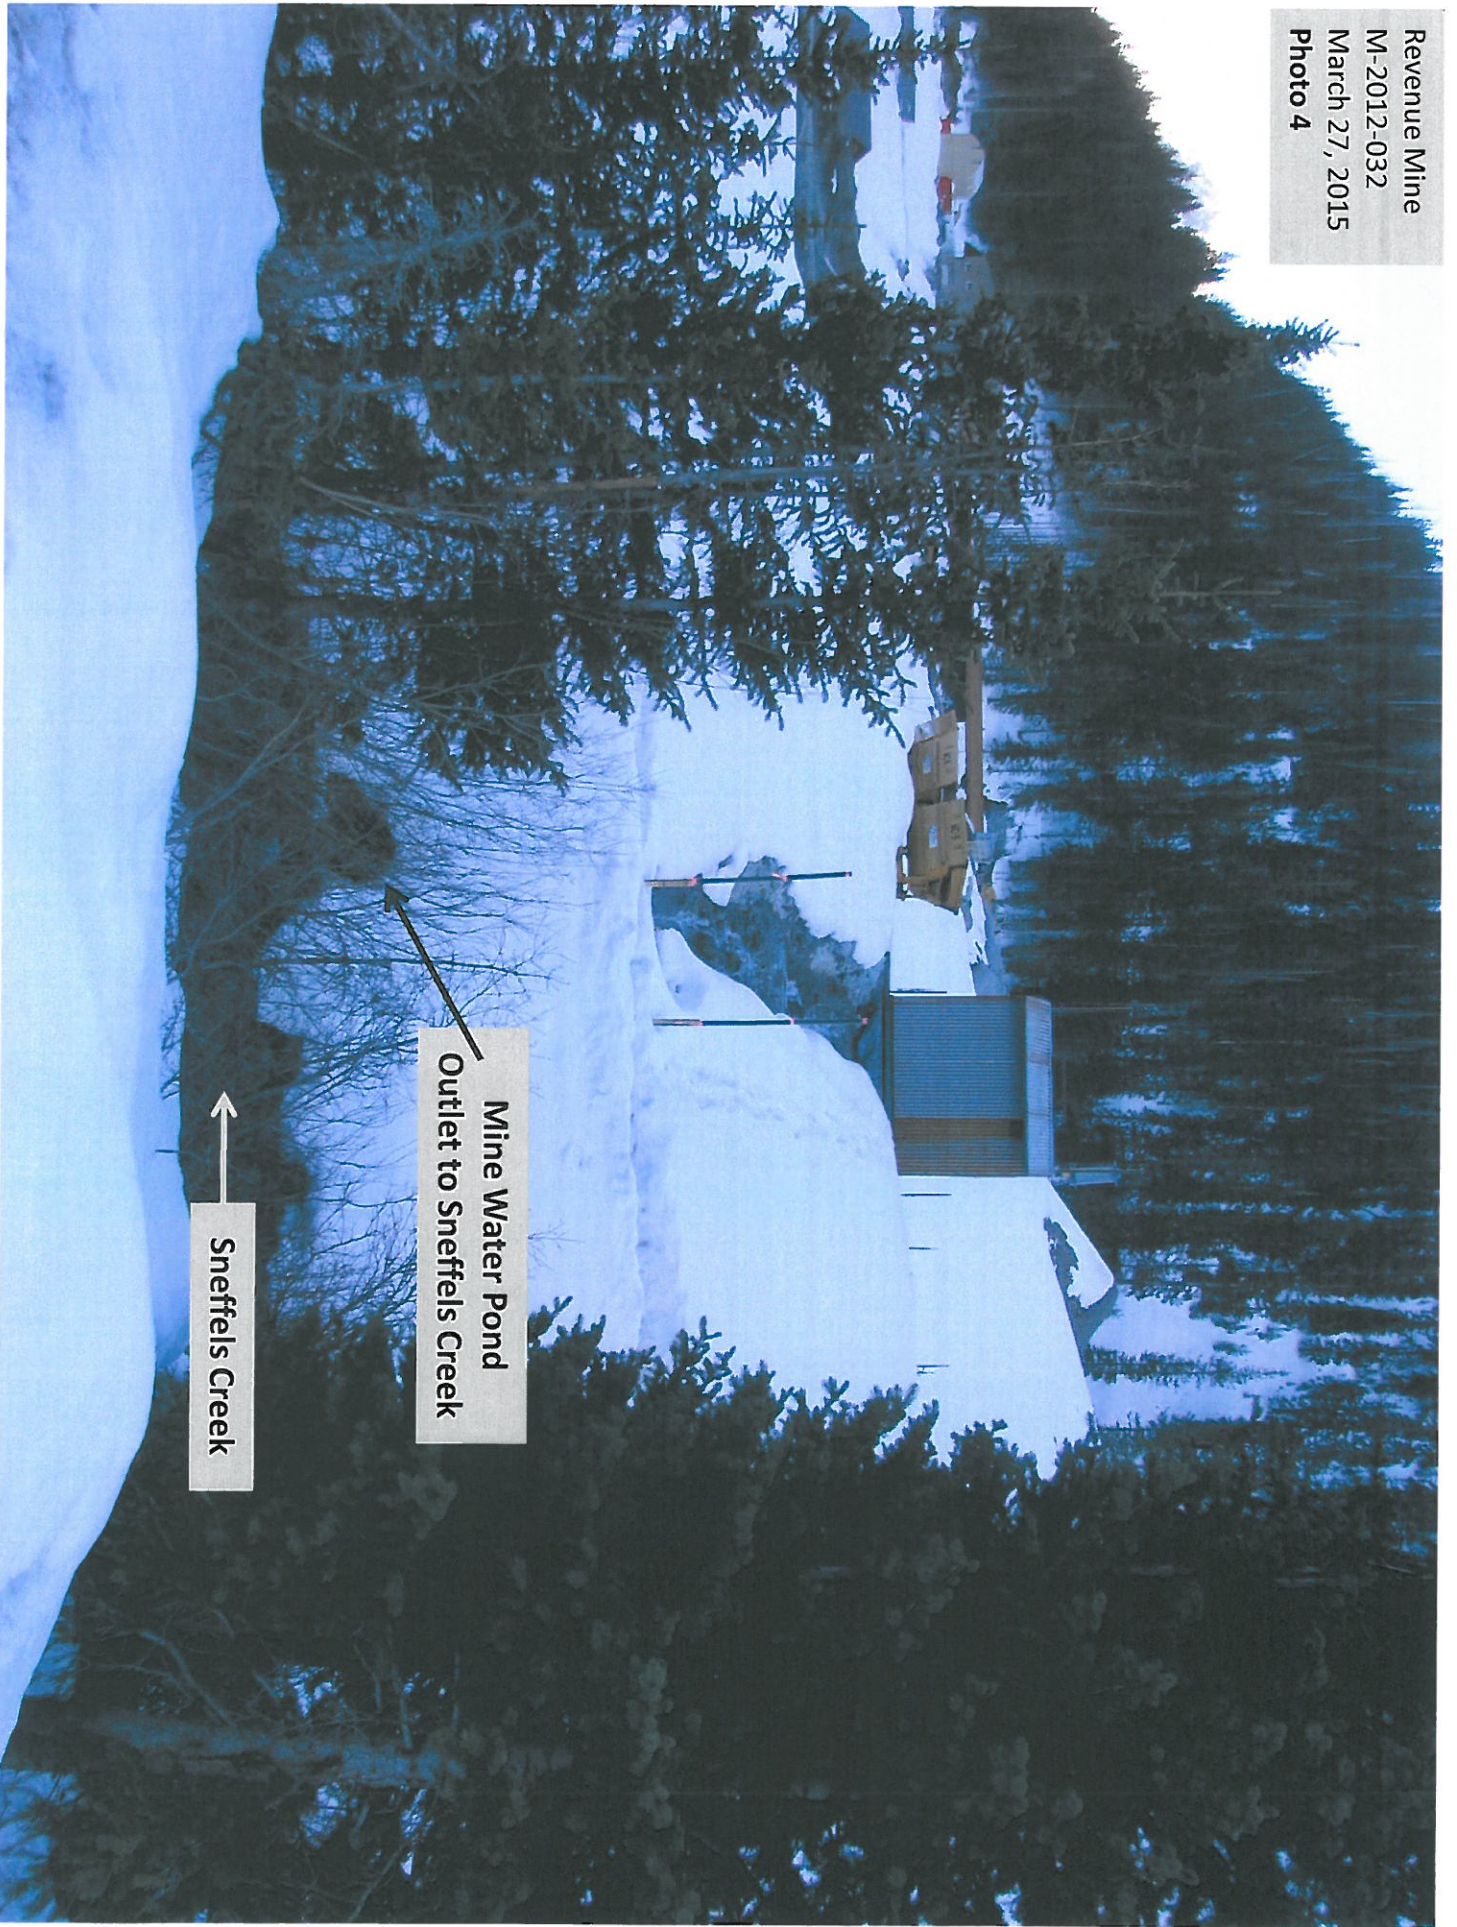
Mine Water Pond  
Outlet to Sneffels Creek

Sneffels Creek

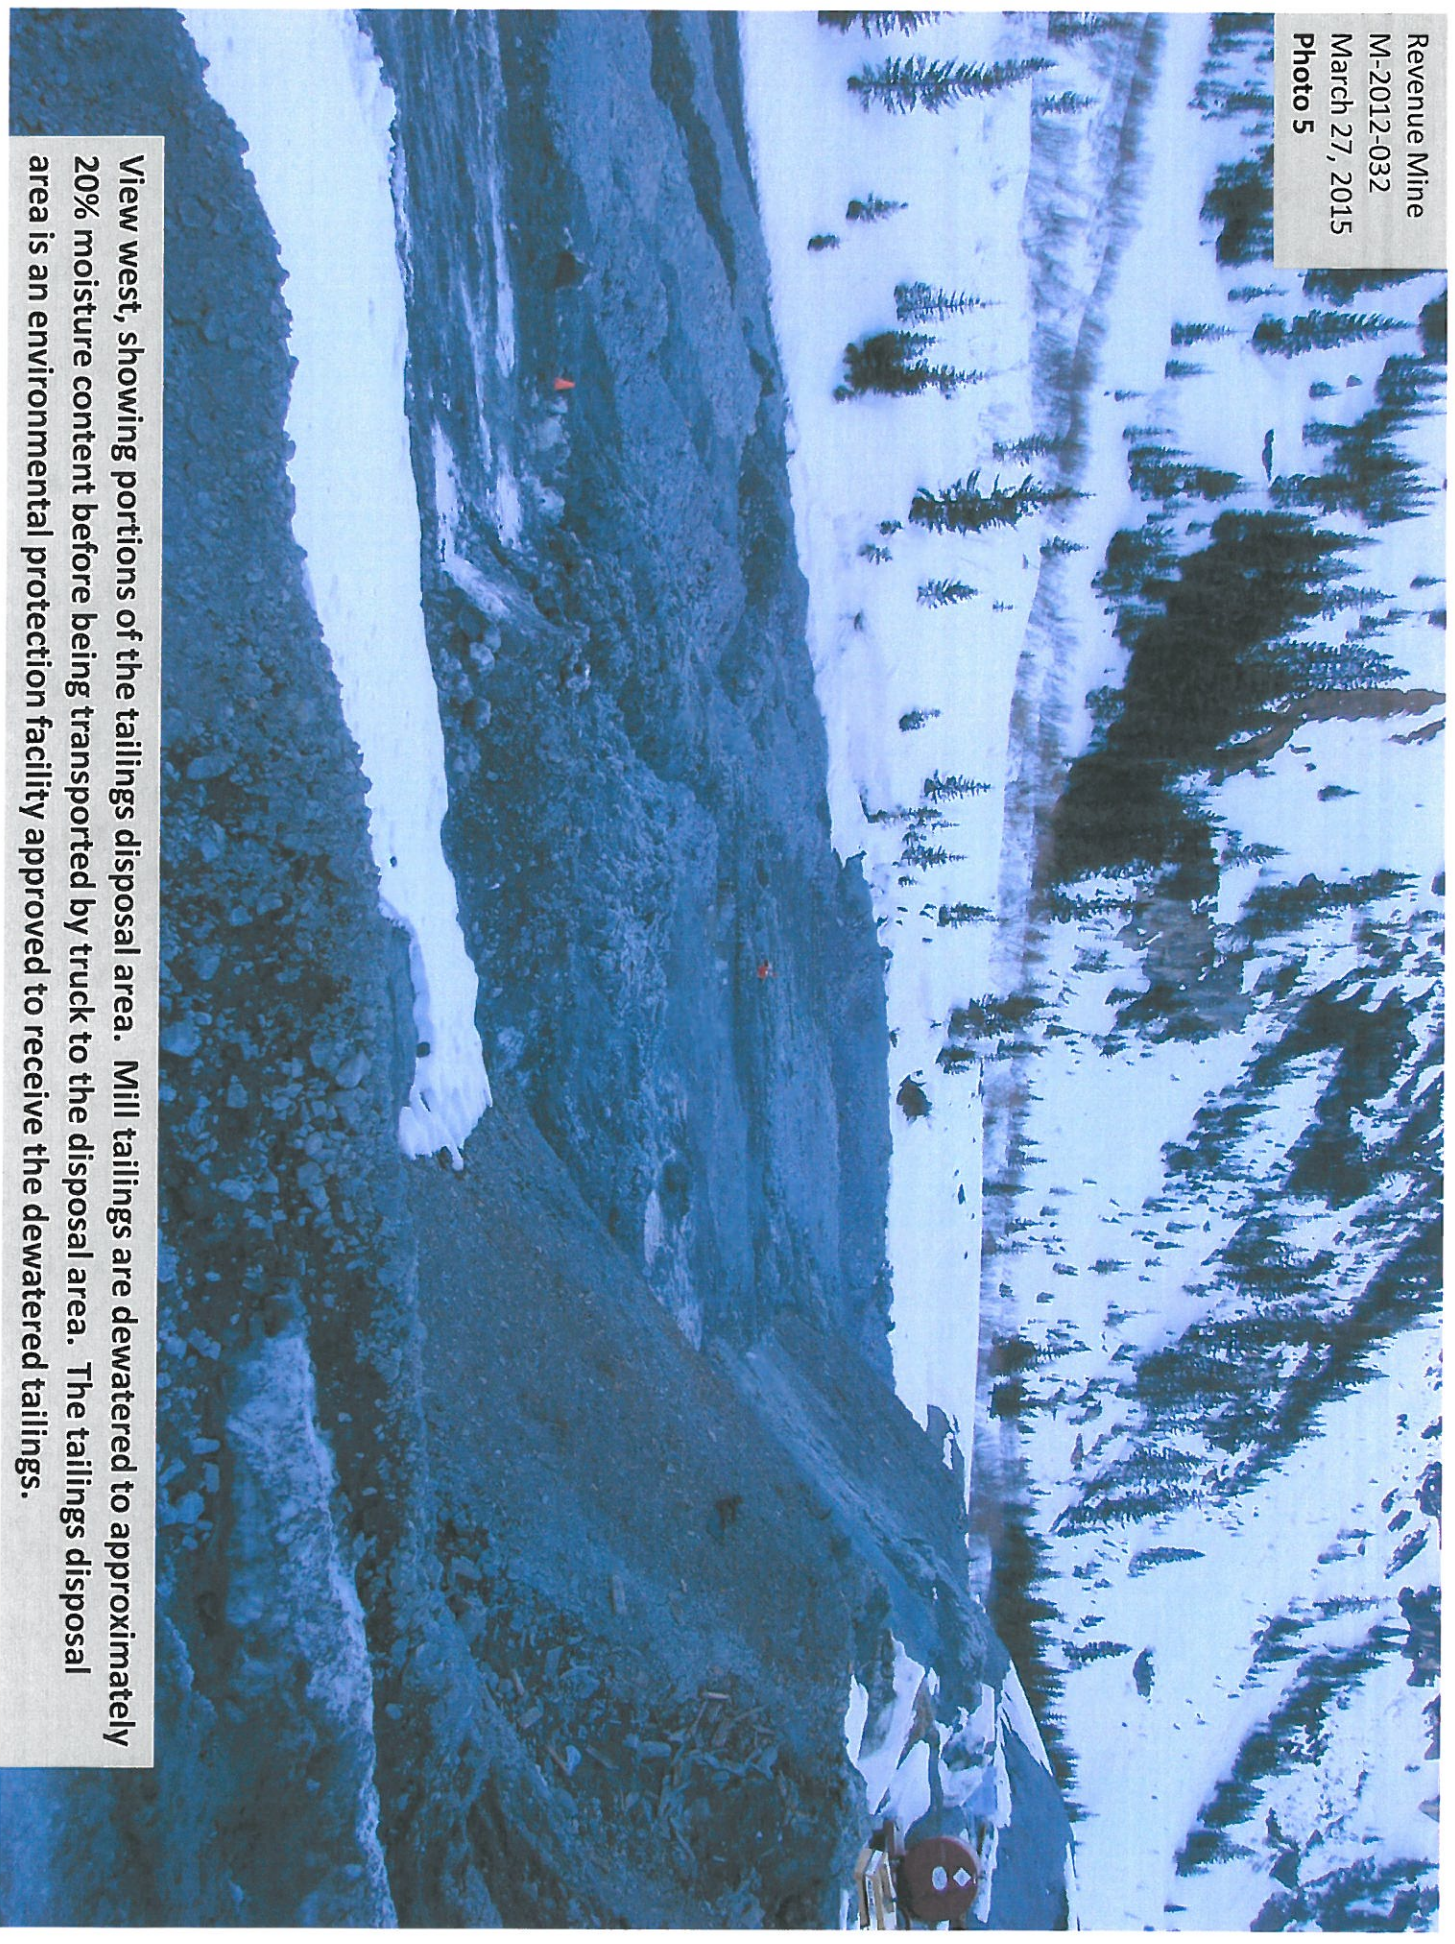
Revenue Mine  
M-2012-032  
March 27, 2015  
Photo 5

As shown in Photos 1 and 5, mill tailings were concentrated at the tailings disposal area. The operation is approved for temporary tailings storage at alternate areas during winter operations. All tailings are dewatered, by filter press, to approximately 20% moisture content within the mill facility prior to transport by truck to the disposal area. Fluids filtered from the tailings are recycled through the mill circuits with approximately 20% fresh water (mine drainage) added at the mill circuits. The majority of the mill facility is located underground. The concrete floors of the mill facility are graded to drain to various sumps located within the mill facility and thereby ensure containment and recycling of all metallurgical processing fluids. The milling operation is designed and approved as a non-discharging facility. Evidence of loss of containment of metallurgical processing fluids was not observed during the inspection.

View west, showing portions of the tailings disposal area. Mill tailings are dewatered to approximately 20% moisture content before being transported by truck to the disposal area. The tailings disposal area is an environmental protection facility approved to receive the dewatered tailings.

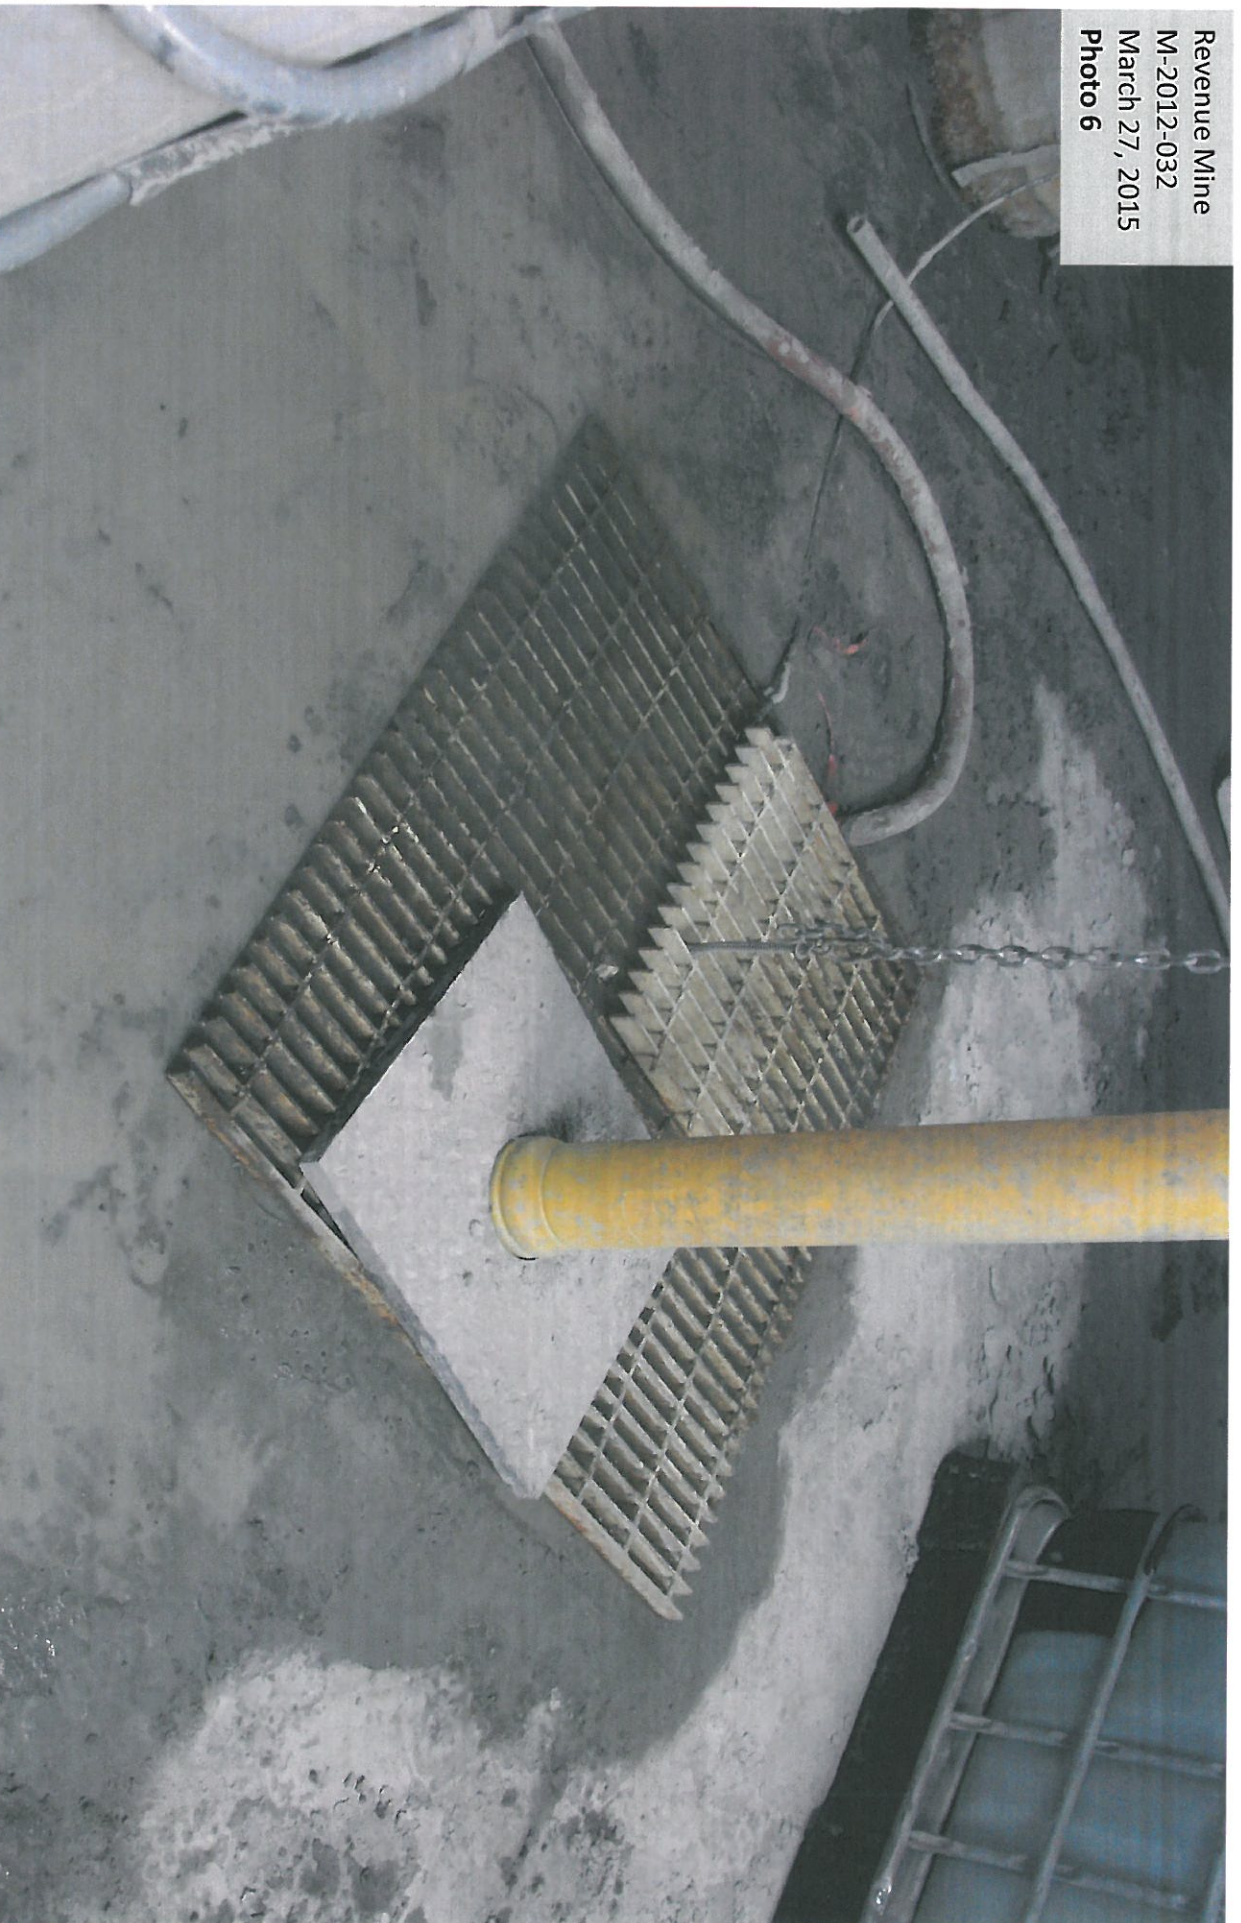
The concrete floor of the reagent bay drains to the sump, shown in this photo. A sump pump recycles fluids from the sump to the processing vessels. The mill facility and its associated reagent bay are non-discharging facilities with primary and secondary containment designed into the facility to ensure containment of all metallurgical processing fluids and/or designated chemicals. Evidence of loss of containment was not observed.

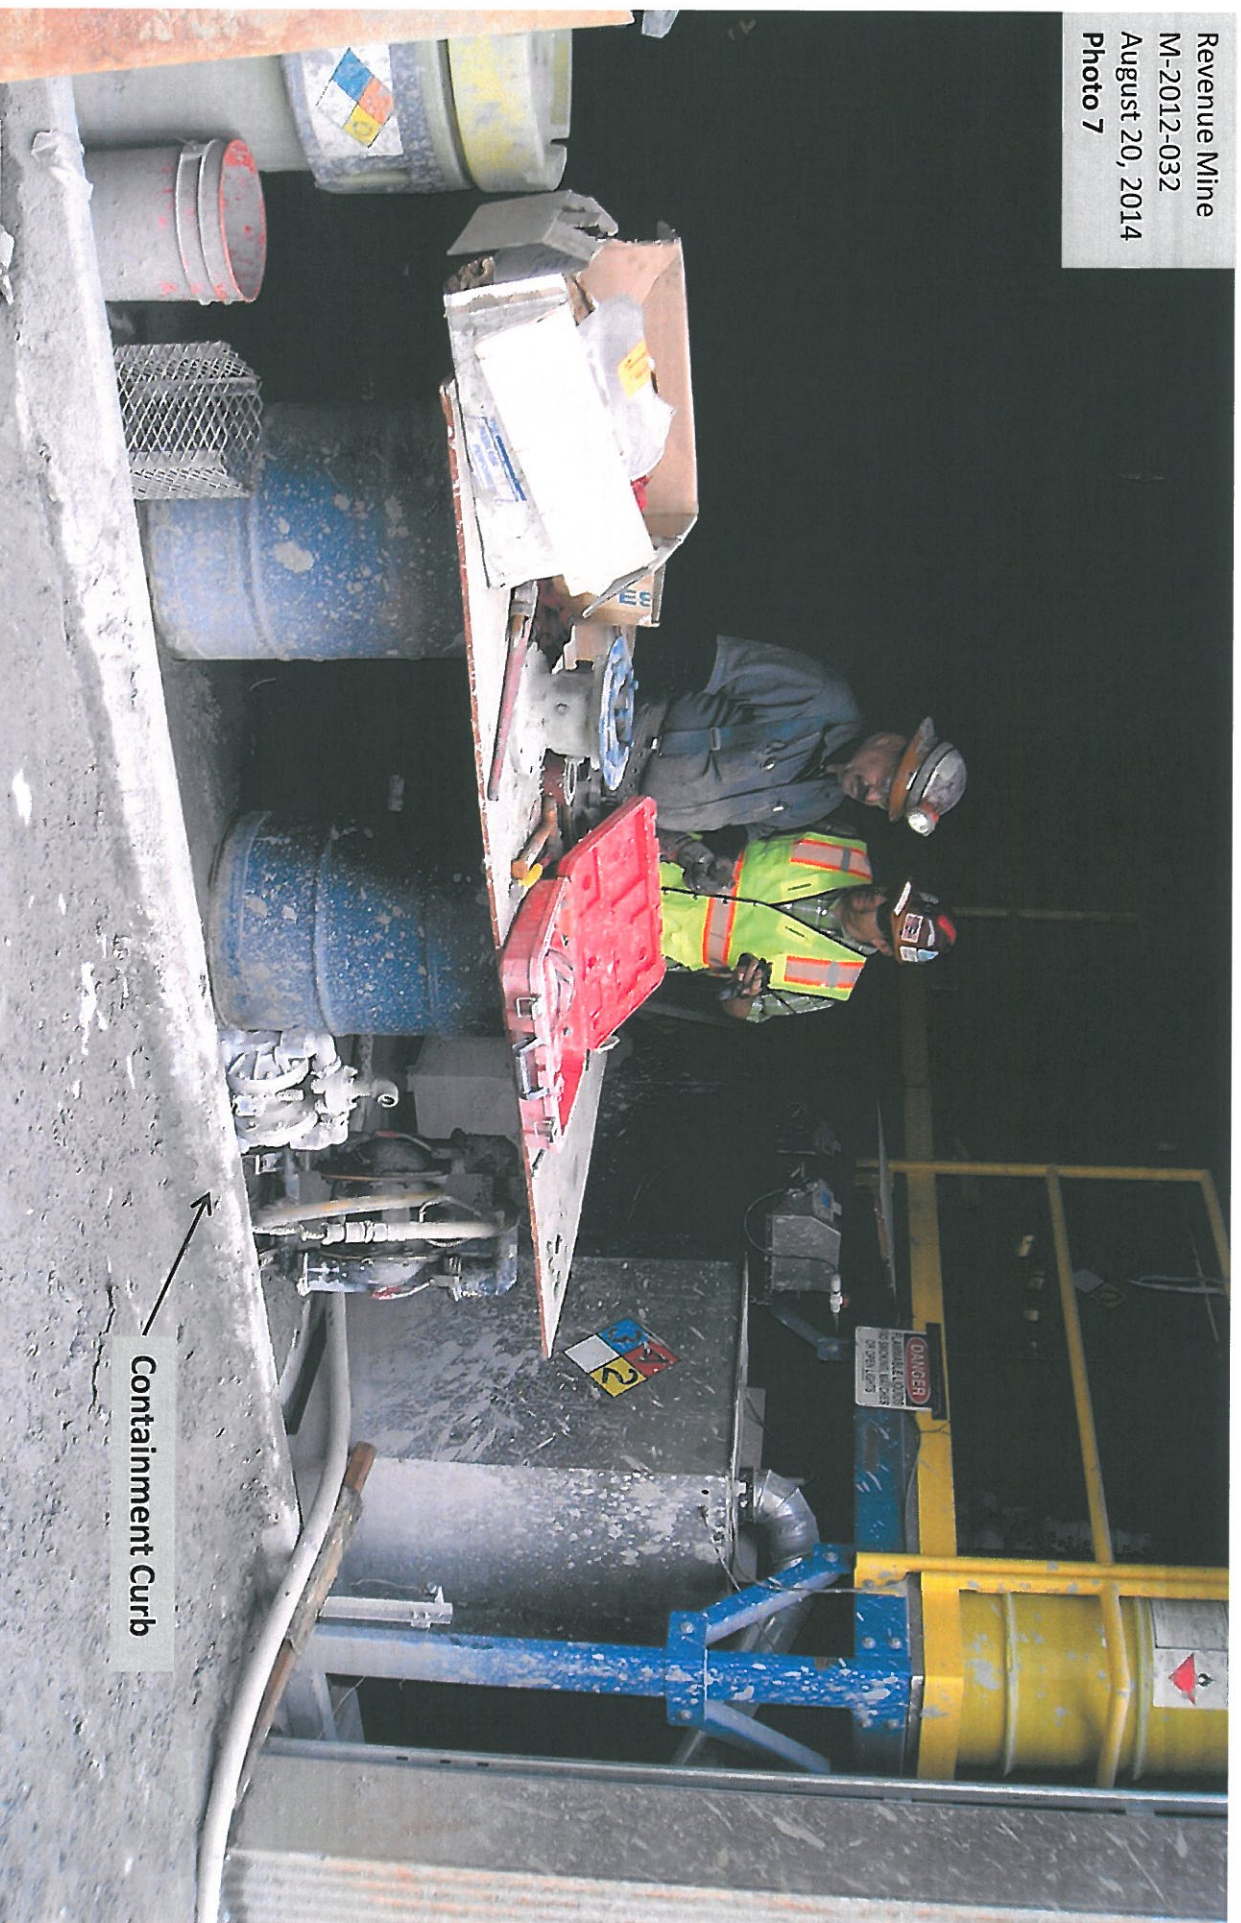
Containment Curb

Photo taken August 20, 2014, showing the entrance to the reagent bay of the mill building. As shown in this photo, the containment curb for the reagent bay was intact as of the date of this photo. The concrete curb ensures emergency containment for the reagent bay in the unlikely event all fluid vessels rupture simultaneously and temporarily overwhelm the sump and sump-pump system of the reagent bay.

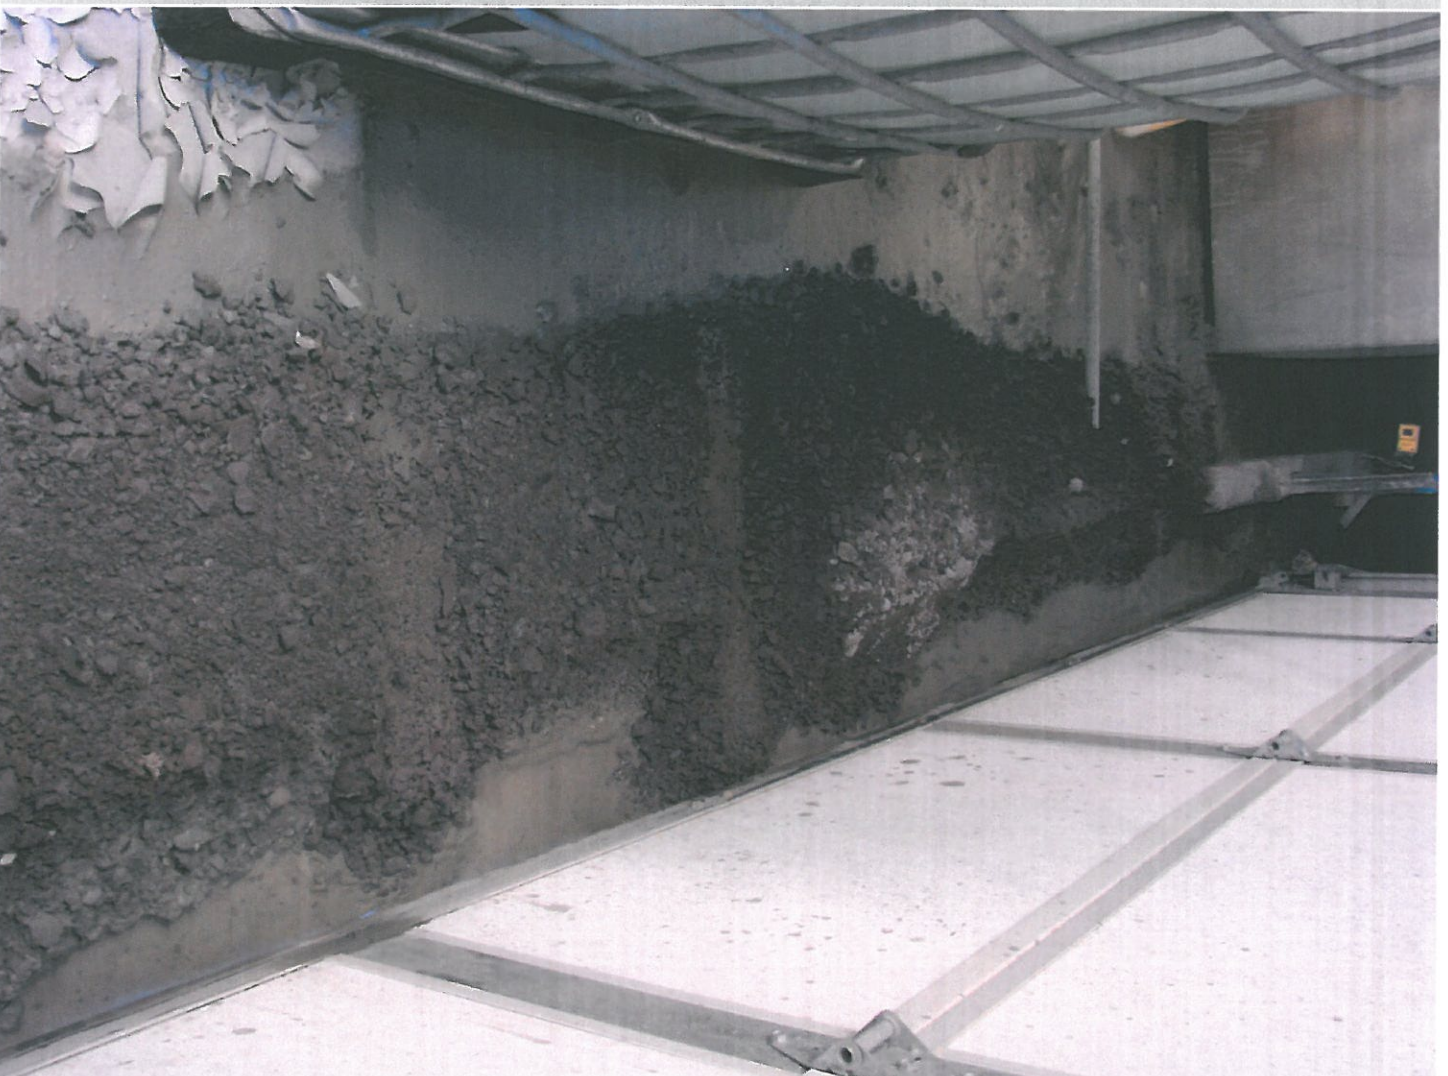
Revenue Mine  
M-2012-032  
March 27, 2015  
**Photo 8**

**PROBLEM:** Improper secondary and/or emergency containment of chemicals and/or processing fluids stored and utilized within the reagent bay.

Photo taken inside the reagent bay, showing a temporary earthen berm where the concrete curb was previously located (see Photo 7). According to the Operator, the curb was damaged February 2015, when struck by a fork lift. The concrete rubble was removed and replaced by a temporary earthen berm. Designs for an expanded containment system for the reagent bay is currently being reviewed by the Division through Technical Revision No. 5 (TR-05).

Evidence of loss of containment of metallurgical processing fluids and/or designated chemicals was not observed. However, the concrete curb was part of the redundant containment system for the reagent bay. The Division has noted a problem for the missing curb and has imposed a corrective action deadline whereby the issue must be resolved. Additional details of the corrective action and its associated deadline are provided in the text portion of this inspection report.

**CORRECTIVE ACTIONS:** Within 30 days of the signature date of this inspection report, due May 8, 2015, submit a written statement with photo documentation, prepared, signed and certified by a Colorado licensed professional engineer, demonstrating that the full containment capacity of the reagent bay has been restored in accordance with the designs previously approved by the Division.
