COLORADO DIVISION OF RECLAMATION, MINING AND SAFETY
MINERALS PROGRAM INSPECTION REPORT
PHONE: (303) 866-3567

MINE NAME: West Farm Pit	MINE/PROSPECTING ID#: M-2008-078	MINERAL: Gravel and sand	COUNTY: Prowers
INSPECTION TYPE: Surety-Related Inspection	INSPECTOR(S): Amy Eschberger	INSP. DATE: March 17, 2015	INSP. TIME: 15:20
OPERATOR: GP Aggregates, LLC	OPERATOR REPRESENTATIVE: Ron Peterson	TYPE OF OPERATION: 112c - Construction Regular Operation

REASON FOR INSPECTION: Surety Related	BOND CALCULATION TYPE: Complete Bond	BOND AMOUNT: \$678,977.00
DATE OF COMPLAINT: NA	POST INSP. CONTACTS: None	JOINT INSP. AGENCY: None
WEATHER: Clear	INSPECTOR'S SIGNATURE: <i>Amy Eschberger</i>	SIGNATURE DATE: April 8, 2015

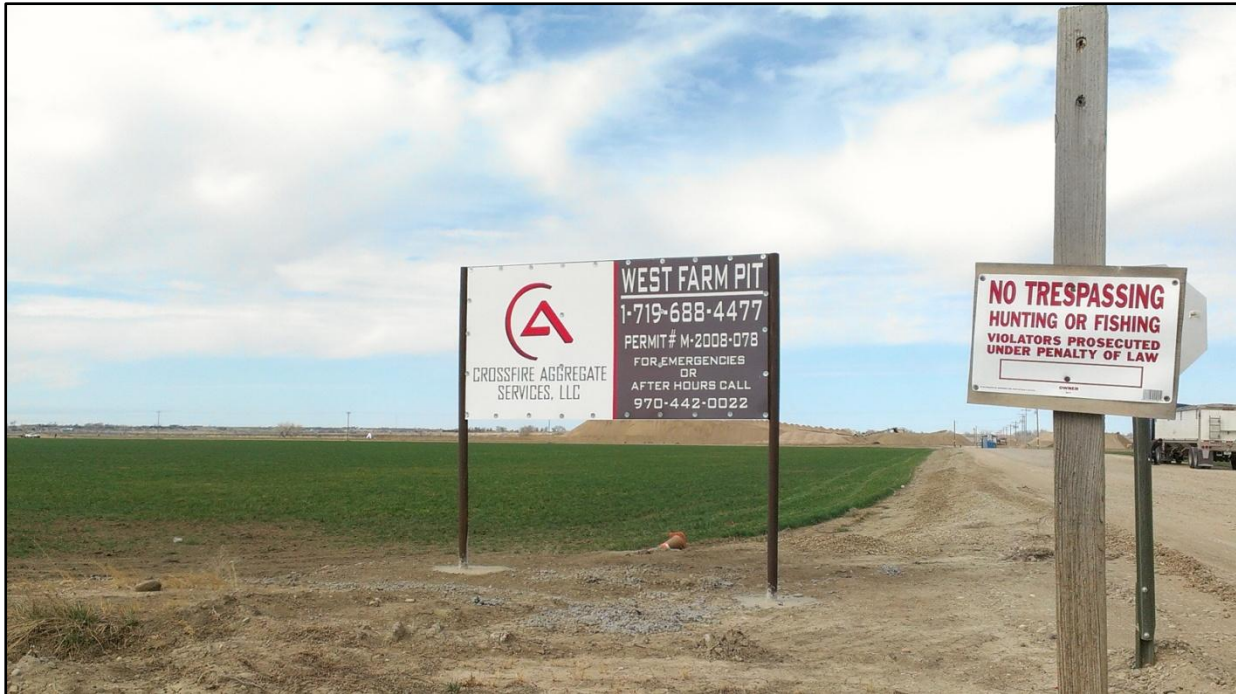
At the time of the inspection, the weather was cool and overcast, and the ground was dry. A permit sign was posted at the main entrance to the site off of County Rd HH.5 (Photo 1). The permit boundary was delineated with PVC pipes and metal stakes. The site was operational during the inspection, including mining and material processing in the Phase 1-4 area (Photos 2 and 3), material processing and stockpiling in the Phase 13 area (Photos 4 and 5), and hauling material off site from these areas. The Division estimates that the operation has currently disturbed approximately 75 acres. The operation is currently mining in Phases 1 and 3 within the slurry wall enclosed area. The mining walls are approximately 50-55 feet in height, and are being maintained at 3H:1V slopes (Photos 6 and 7) with mining activities kept a minimum of 25 feet from the inside edge of the slurry wall (as approved in TR-02). The mining walls appeared to be stable, showing no signs of major sloughing.

Photo 1. View of permit sign posted at main entrance to site off of Co Rd HH.5.

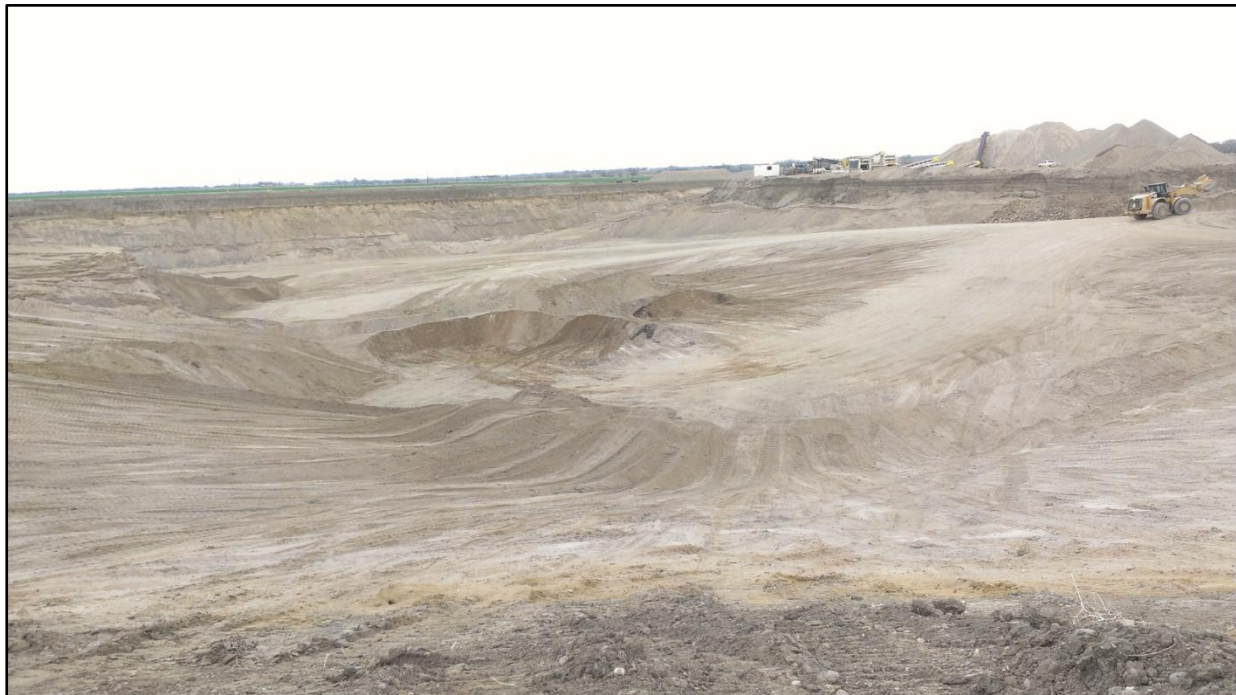
Photo 2. View looking southeast into active pit located in northwestern portion of permit area.

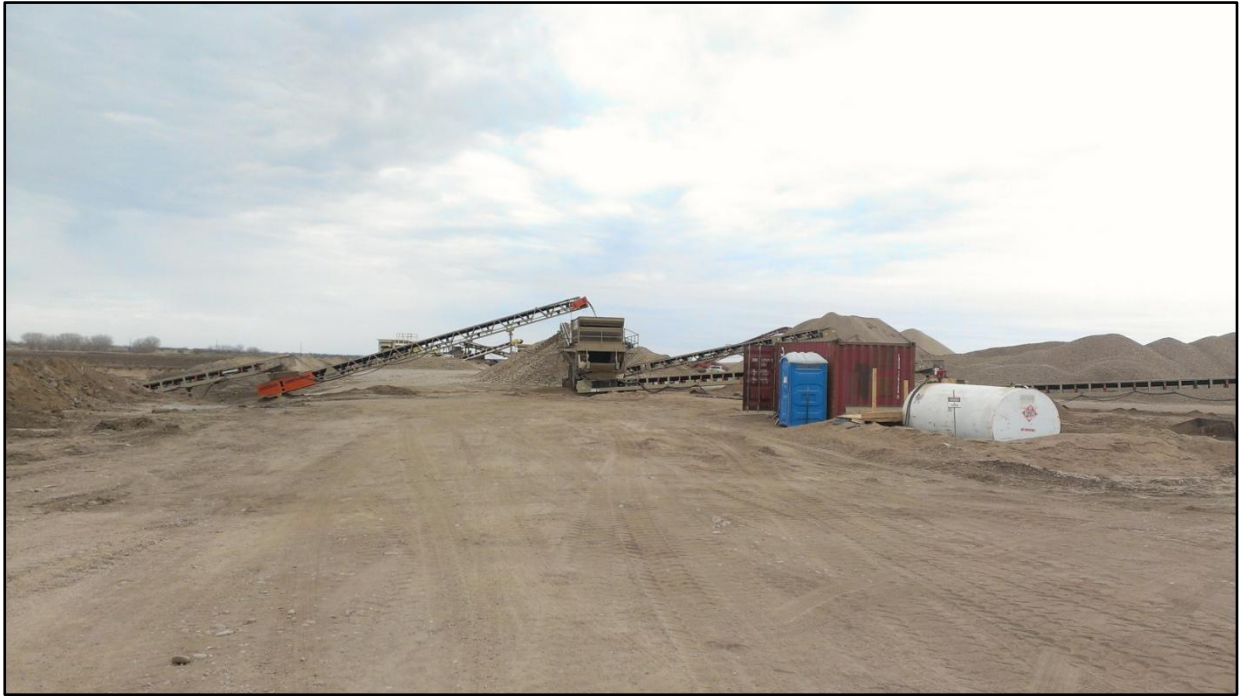
Photo 3. View looking east at material processing area located just south of active pit in northwestern portion of permit area.

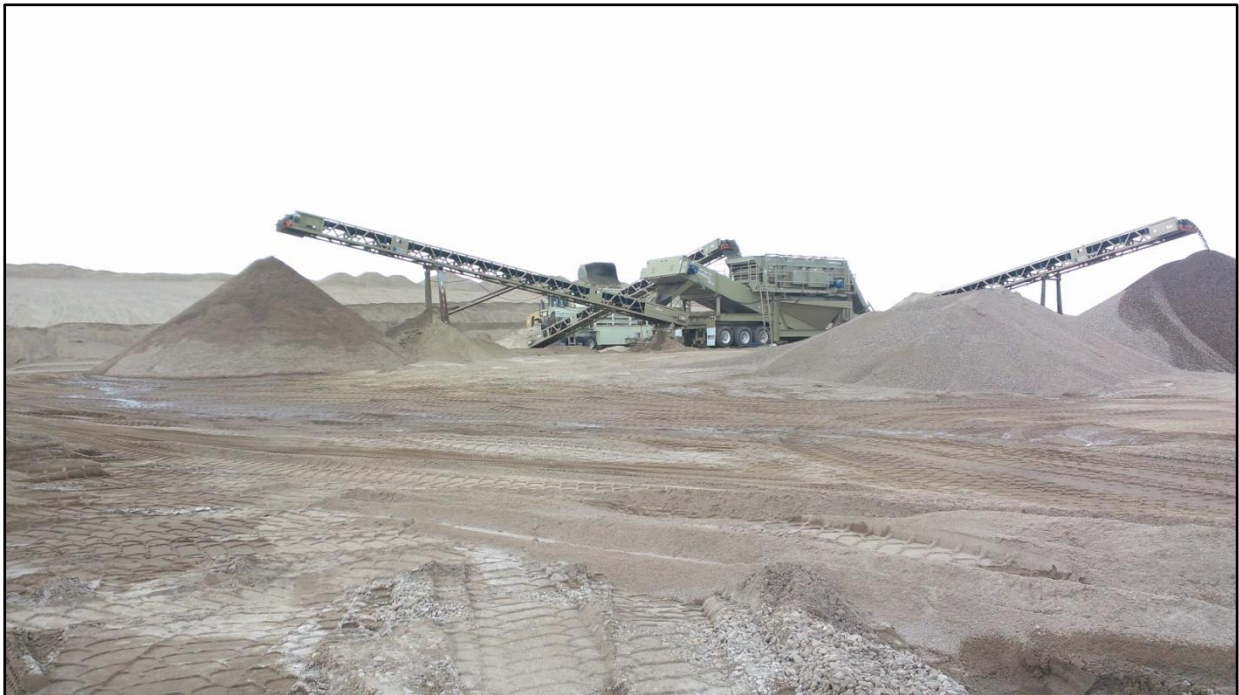
Photo 4. View looking west at material wash plant located in Phase 13 in western portion of permit area.

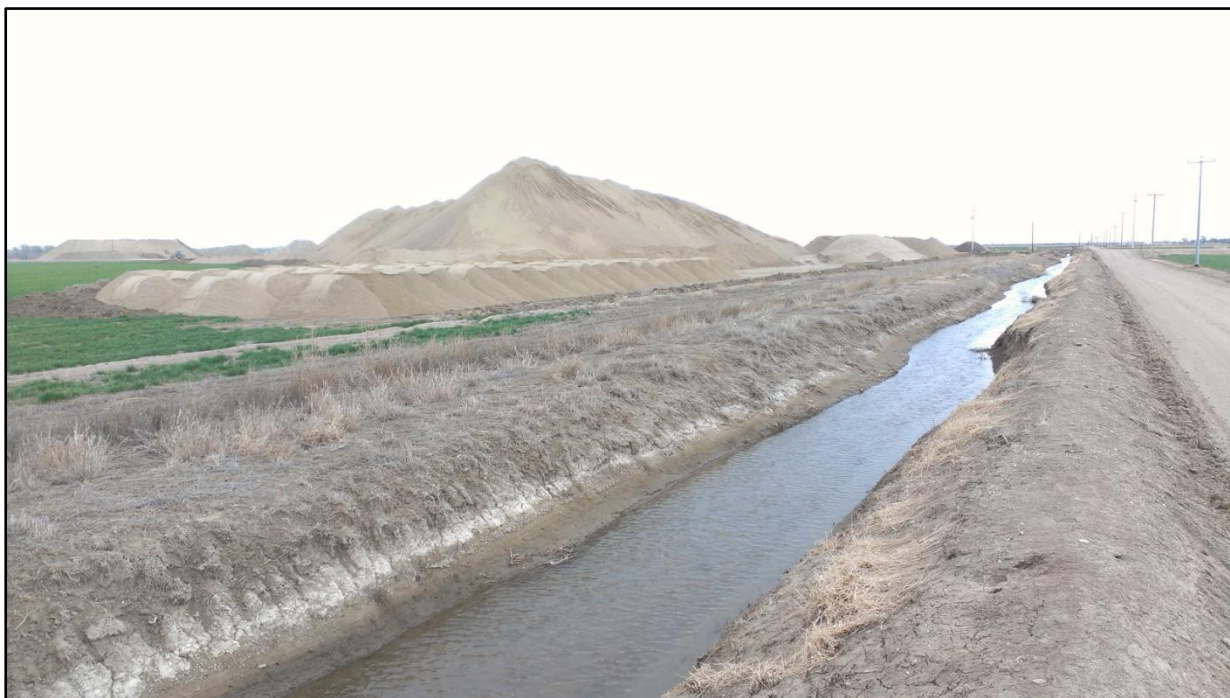
Photo 5. View looking east at Phase 13 located in western portion of permit area where material is washed and stockpiled. Note existing irrigation ditch and Co Rd HH 8/10 running E-W just south of Phase 13.

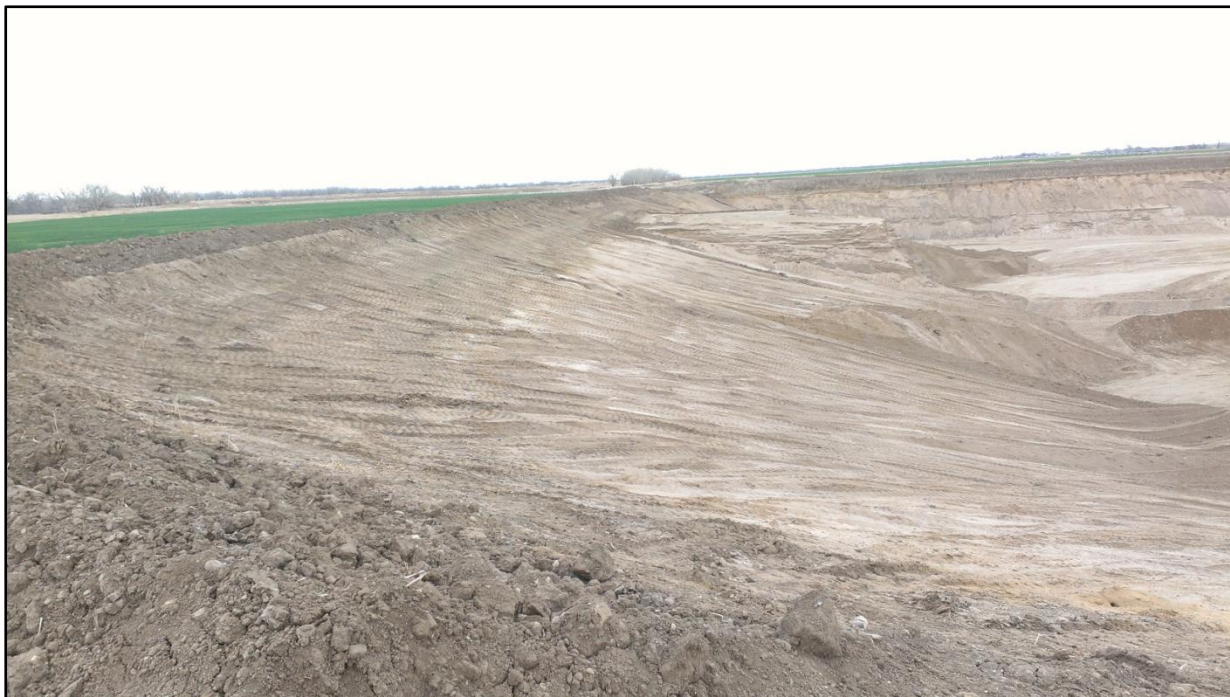
Photo 6. View looking east across northern mining wall, showing slopes maintained at 3H:1V, in accordance with approved Mining Plan.

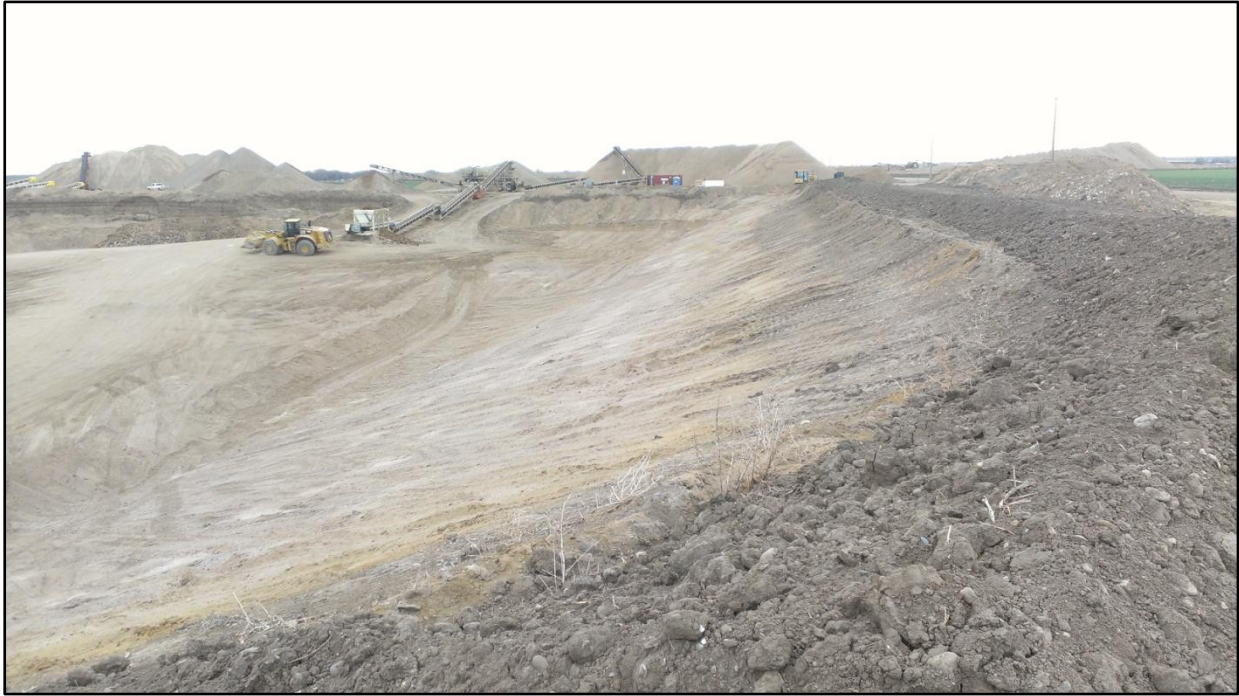
Photo 7. View looking south across western mining wall, showing slopes maintained at 3H:1V, in accordance with approved Mining Plan.

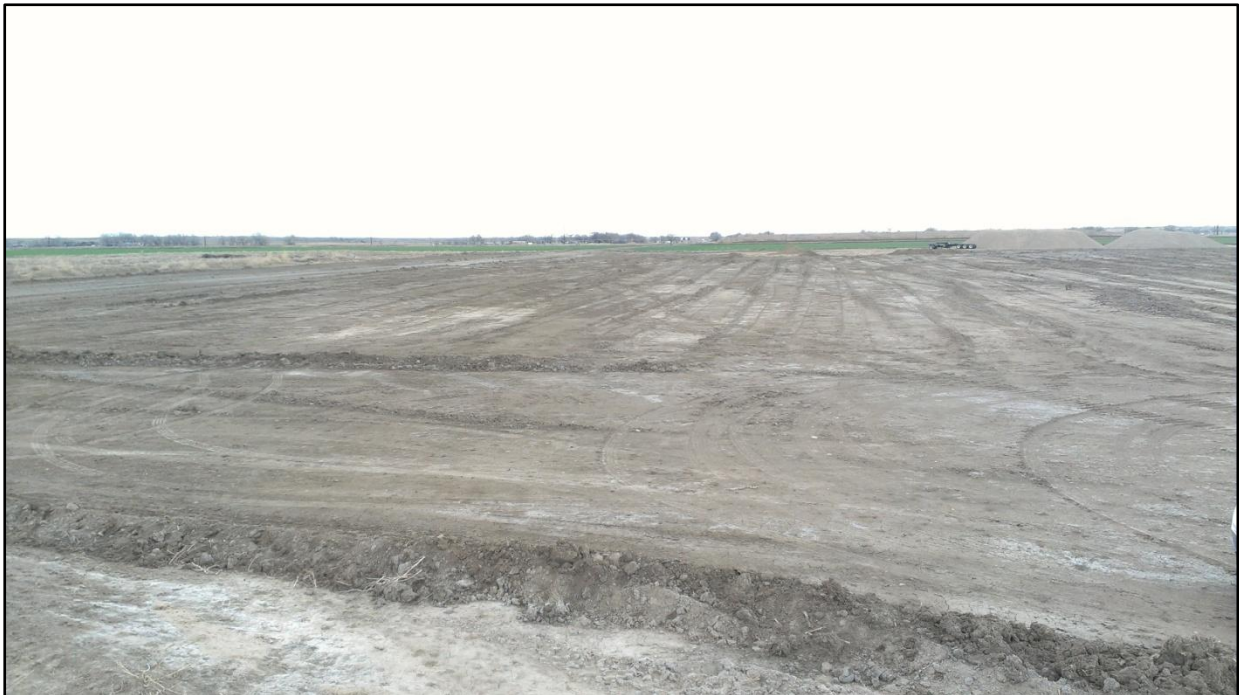
The Operator has stripped topsoil from approximately 11 acres just east of the current pit (within the slurry wall enclosure) in preparation for mining (Photo 8). A small settling pond is located in the northeastern corner of this area (Photo 9). The Operator appears to hold a current Substitute Water Supply Plan that accounts for evaporative losses from this pond. The far eastern portion of the slurry wall enclosed area (approximately 8.2 acres; Photo 10) had not yet been disturbed by the operation at the time of the inspection. The Phase 13 area located in the western portion of the permit area includes a material wash plant (see Photo 4), several large material stockpiles (see Photo 5), and two settling ponds (located just north of the wash plant; Photos 11 and 12). Water used to wash material is directed into the settling ponds, then pumped out and re-used in the process. It appears that evaporative losses from the two ponds are covered by the Substitute Water Supply Plan.

Photo 8. View of area just east of active pit (within slurry wall enclosure) where topsoil has been stripped in preparation for mining.

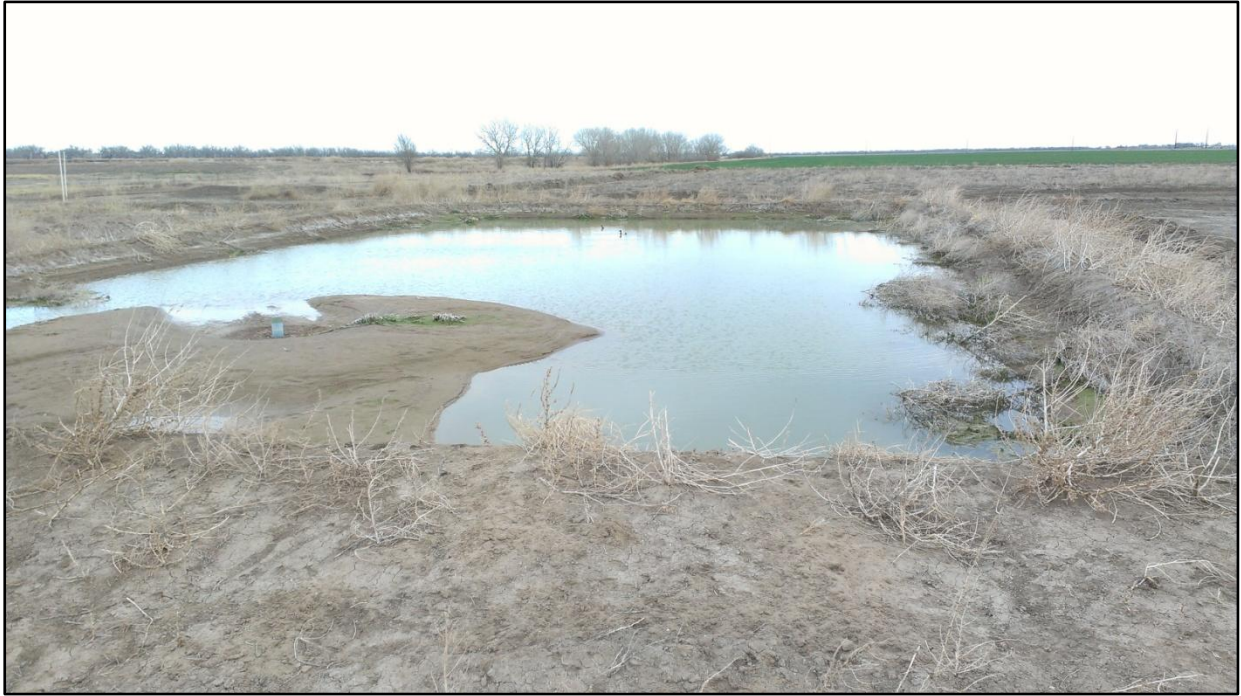
Photo 9. View of small settling pond located east of active pit, within slurry wall enclosed area.

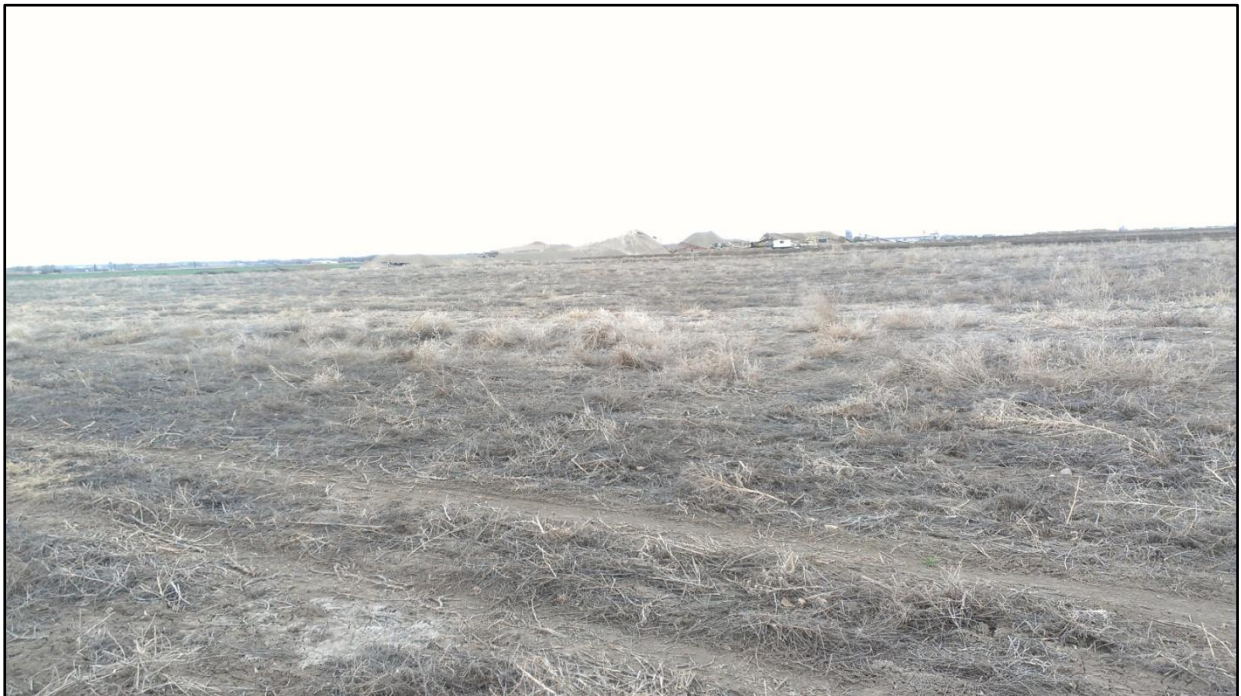
Photo 10. View of far eastern portion of slurry wall enclosed area that has not yet been stripped of topsoil.

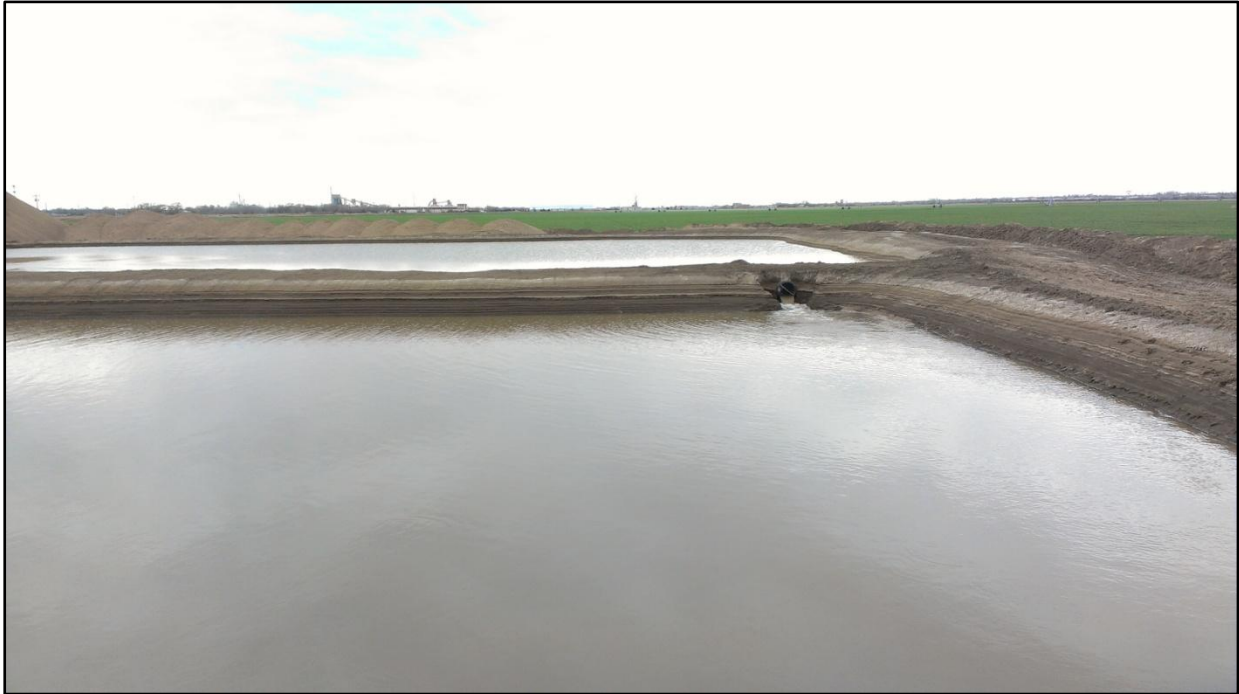
Photo 11. View looking west, showing northern portion of settling ponds used for recycling water from material wash plant (located in Phase 13).

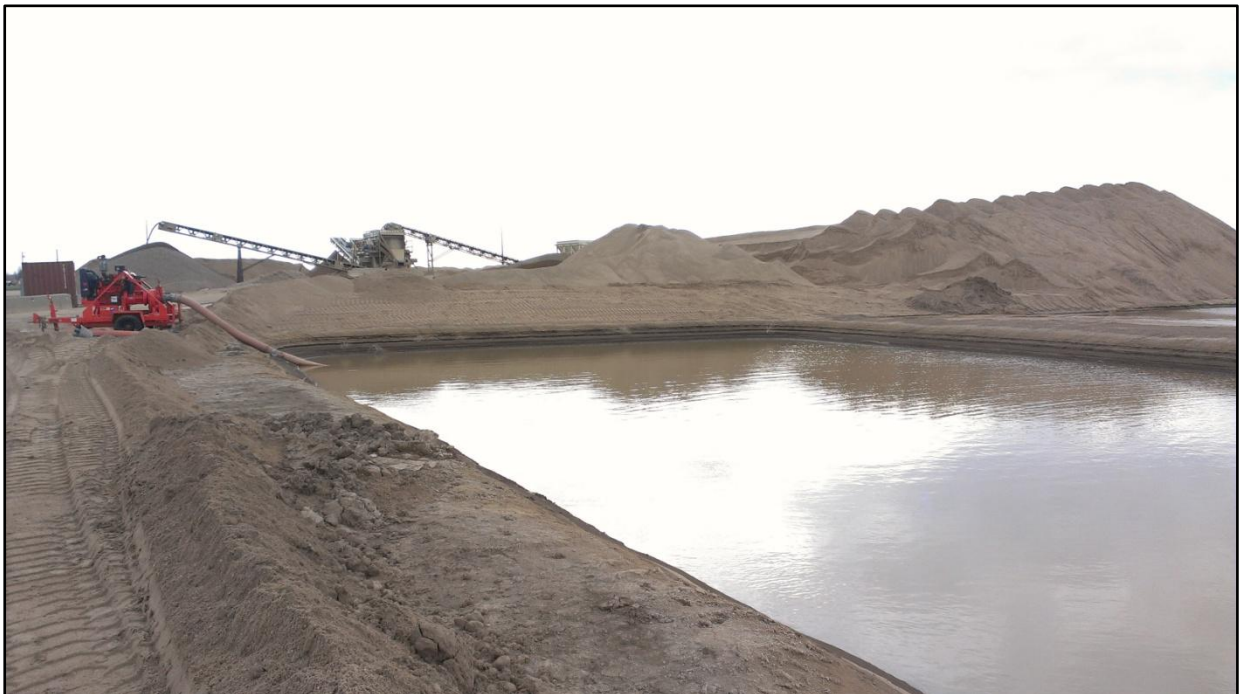
Photo 12. View looking south, showing southern portion of settling ponds used for recycling water from material wash plant (located in Phase 13).

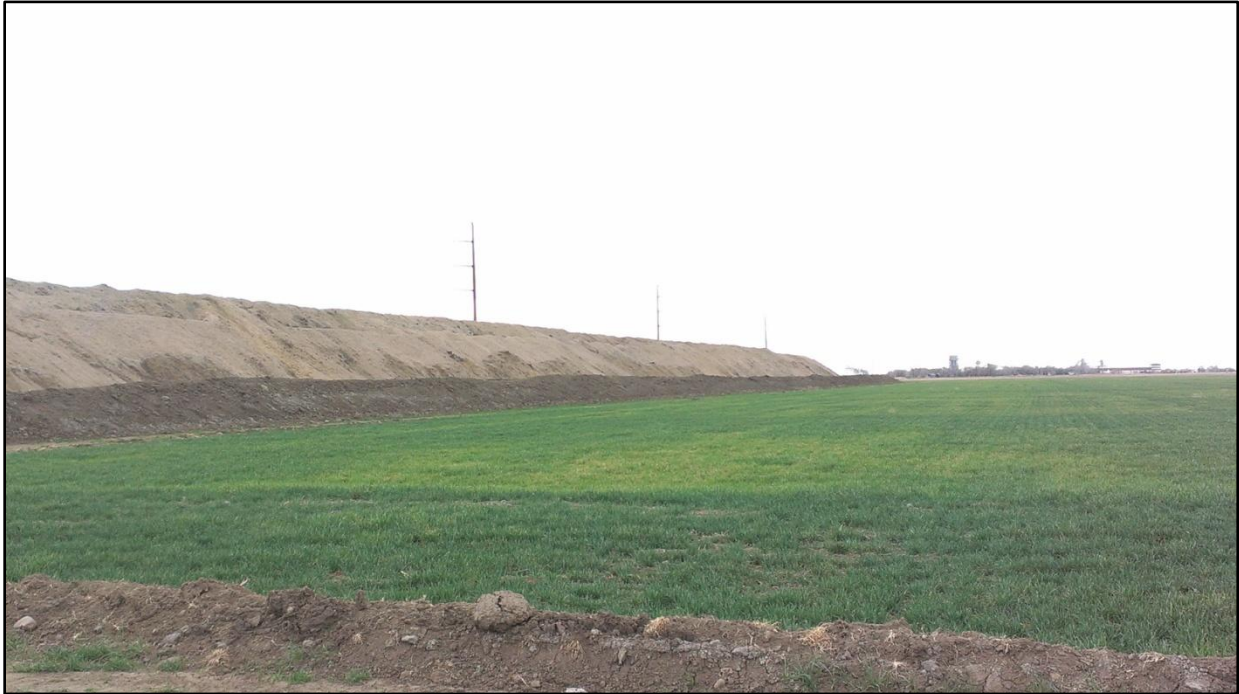
Topsoil and overburden are stored in the southwestern portion of the permit area, near Co Rd HH.5 (Photo 13). The Division estimates that the footprint of this stockpile currently covers approximately 9.0 acres. It appears that, initially, the overburden and topsoil were being stockpiled together. However, topsoil is now being properly separated and placed in its own stockpile just north of the current one. The Operator has hydro-mulched the western (Photo 14) and southern sides of the large overburden/topsoil stockpile that face the adjacent residences. This stockpile appears to be stable at this time.

Photo 13. View of large topsoil/overburden stockpile present along southwestern permit boundary. Topsoil is now being separated from overburden and placed just north of current stockpile (note darker material in front).

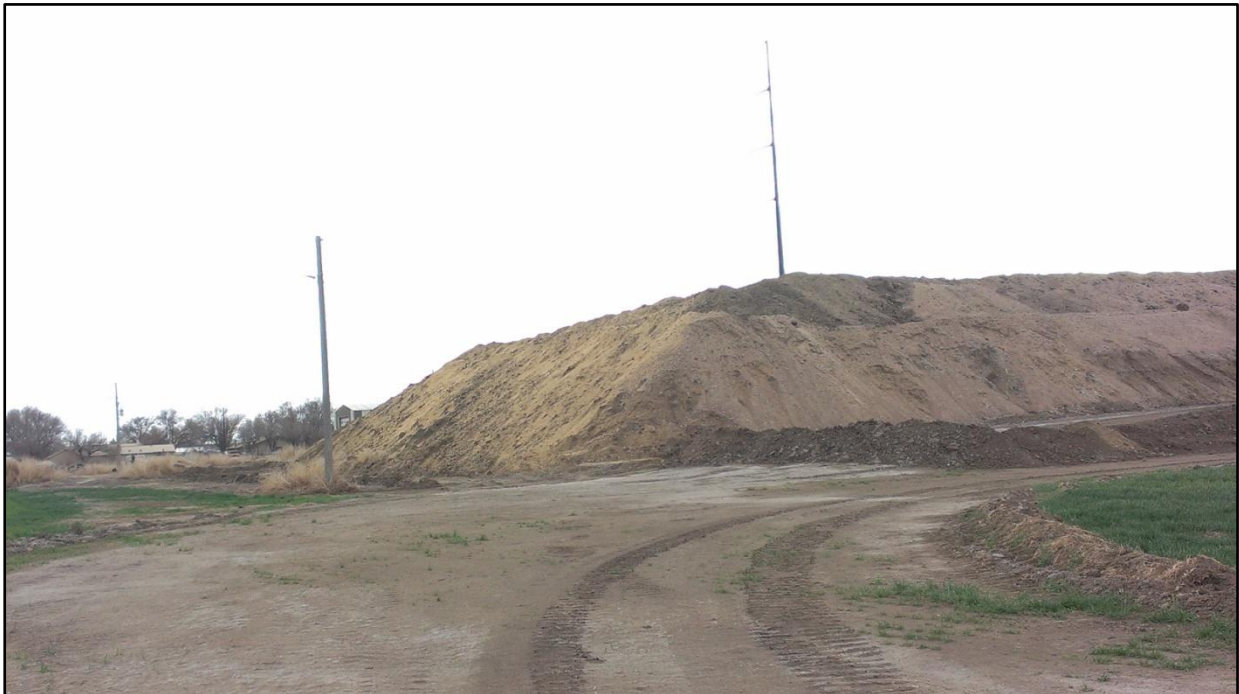
Photo 14. View of eastern side of large overburden/topsoil stockpile that was recently hydromulched (yellow in color).
