COLORADO DIVISION OF RECLAMATION, MINING AND SAFETY
MINERALS PROGRAM INSPECTION REPORT
PHONE: (303) 866-3567

MINE NAME: East Bradbury Pit	MINE/PROSPECTING ID#: M-2010-016	MINERAL: Sand and gravel	COUNTY: Mesa
INSPECTION TYPE: Monitoring	INSPECTOR(S): Travis H. Marshall	INSP. DATE: March 26, 2015	INSP. TIME: 10:45
OPERATOR: Grand Junction Pipe & Supply Co.	OPERATOR REPRESENTATIVE: Gayle Lyman	TYPE OF OPERATION: 112c - Construction Regular Operation

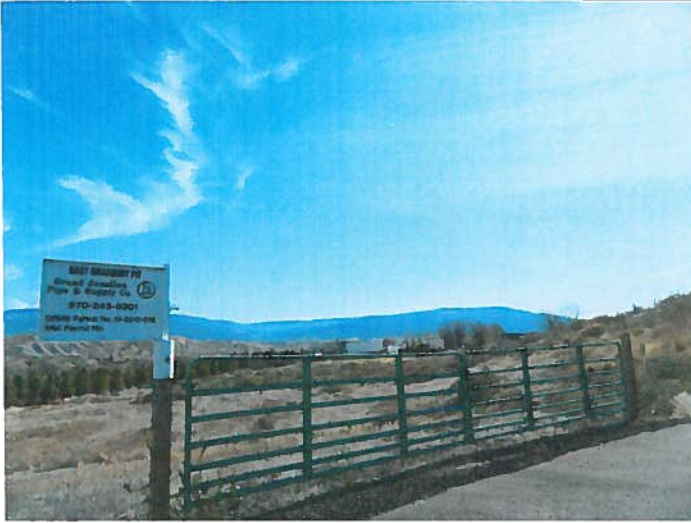
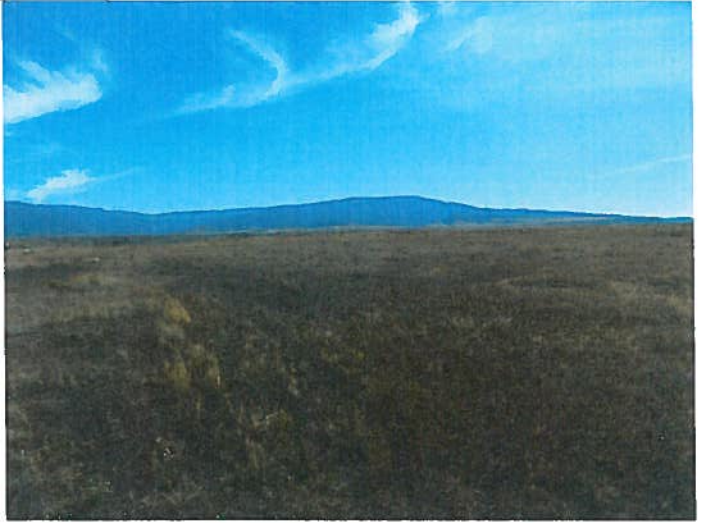
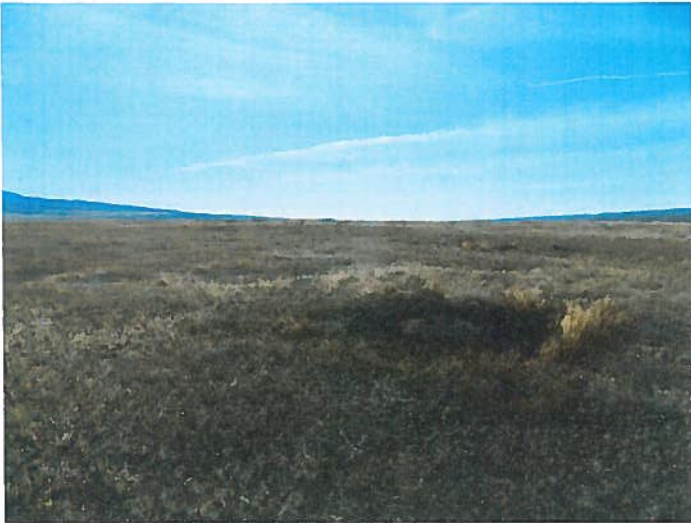
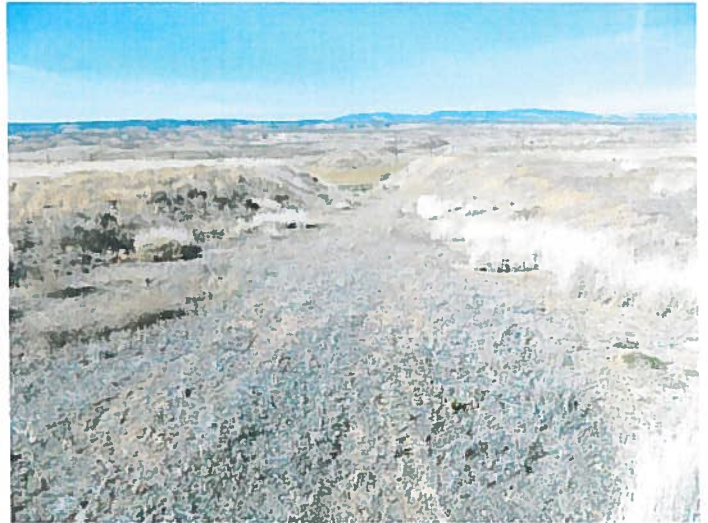
No mining related activity was observed at the site.

Photos that show the conditions observed during the inspection are included at the end of this report.
