COLORADO DIVISION OF RECLAMATION, MINING AND SAFETY
MINERALS PROGRAM INSPECTION REPORT
PHONE: (303) 866-3567

MINE NAME: Guenzi S & G Pit	MINE/PROSPECTING ID#: M-1987-159	MINERAL: Sand and gravel	COUNTY: Logan
INSPECTION TYPE: Monitoring	INSPECTOR(S): Elliott R. Russell	INSP. DATE: April 15, 2015	INSP. TIME: 09:45
OPERATOR: Logan County	OPERATOR REPRESENTATIVE: Rob Quint & Chad Wright	TYPE OF OPERATION: 112c - Construction Regular Operation

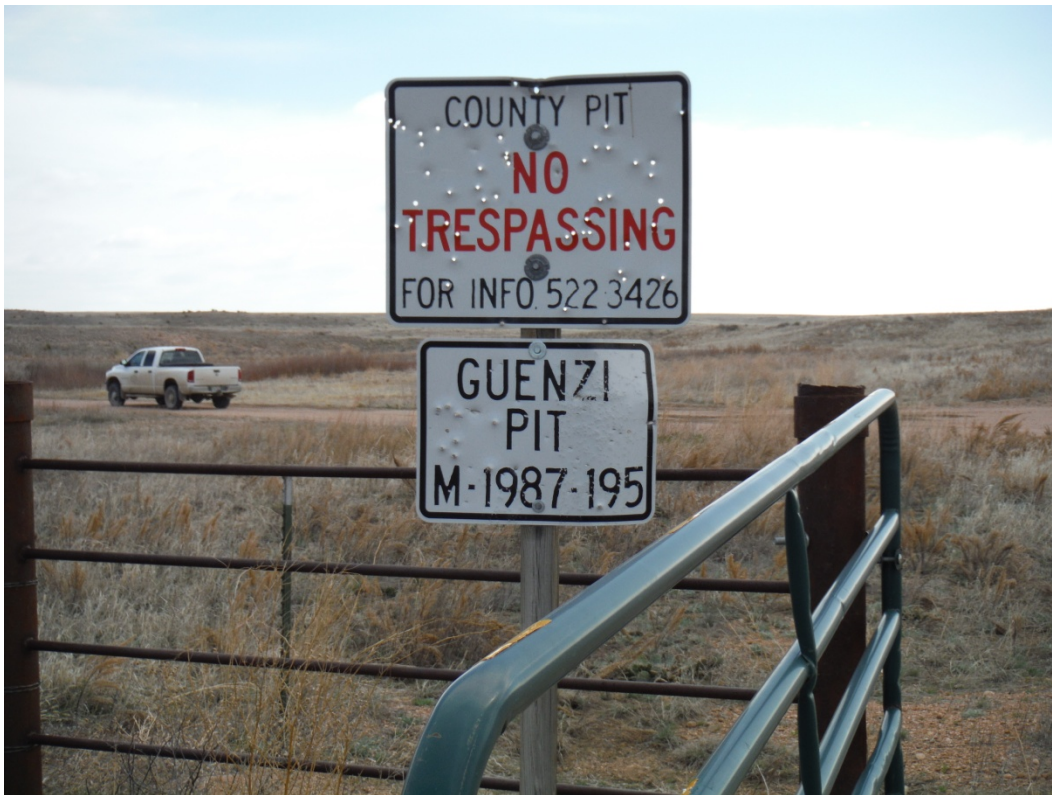
PROBLEM/POSSIBLE VIOLATION: Problem: The mine identification sign was not posted at the entrance of the mine site. This is a problem for failure to post a mine identification sign as required by Rule 3.1.12(1).

Permit identification sign at the site entrance, incorrect permit number; looking east.

CORRECTIVE ACTIONS: The operator shall, at the entrance of the mine site, post a sign which shall be clearly visible from the access road with the following: the name of the operator, a statement that a reclamation permit for the operation has been issued by the Colorado Mined Land Reclamation Board, and the permit number. The operator shall submit photo documentation that a proper sign has been posted by the corrective action date.

CORRECTIVE ACTION DUE DATE: 5/31/15

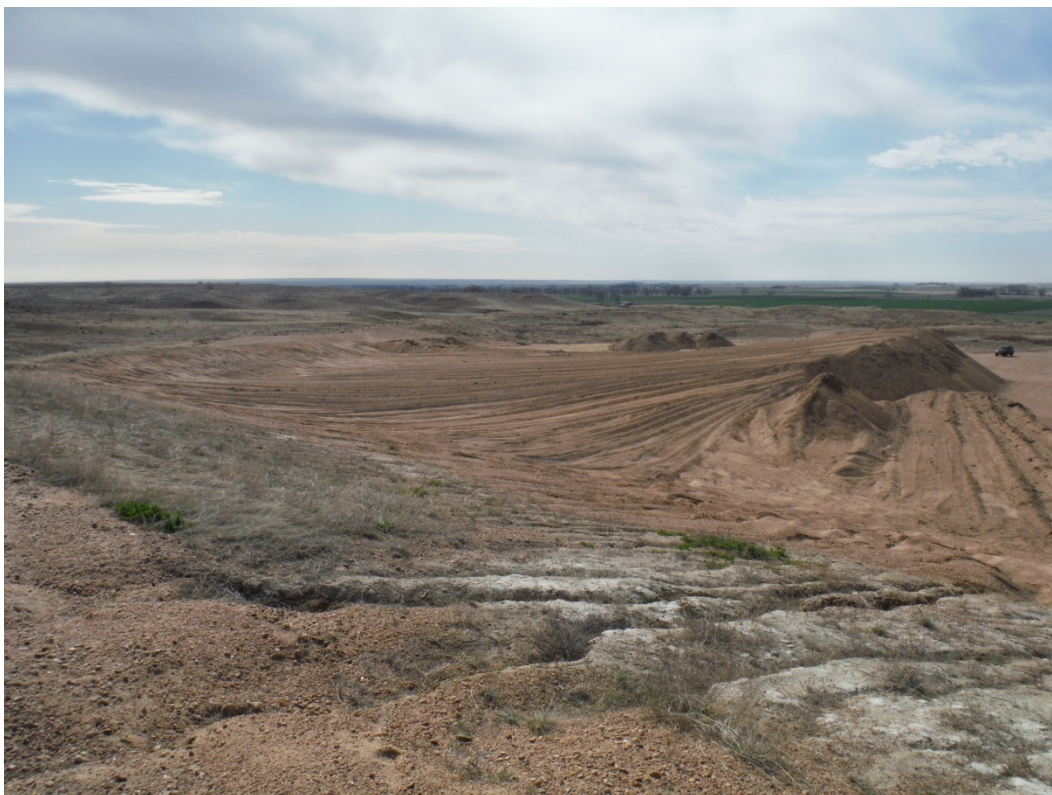
Site overview; looking southeast from the northern permit boundary.

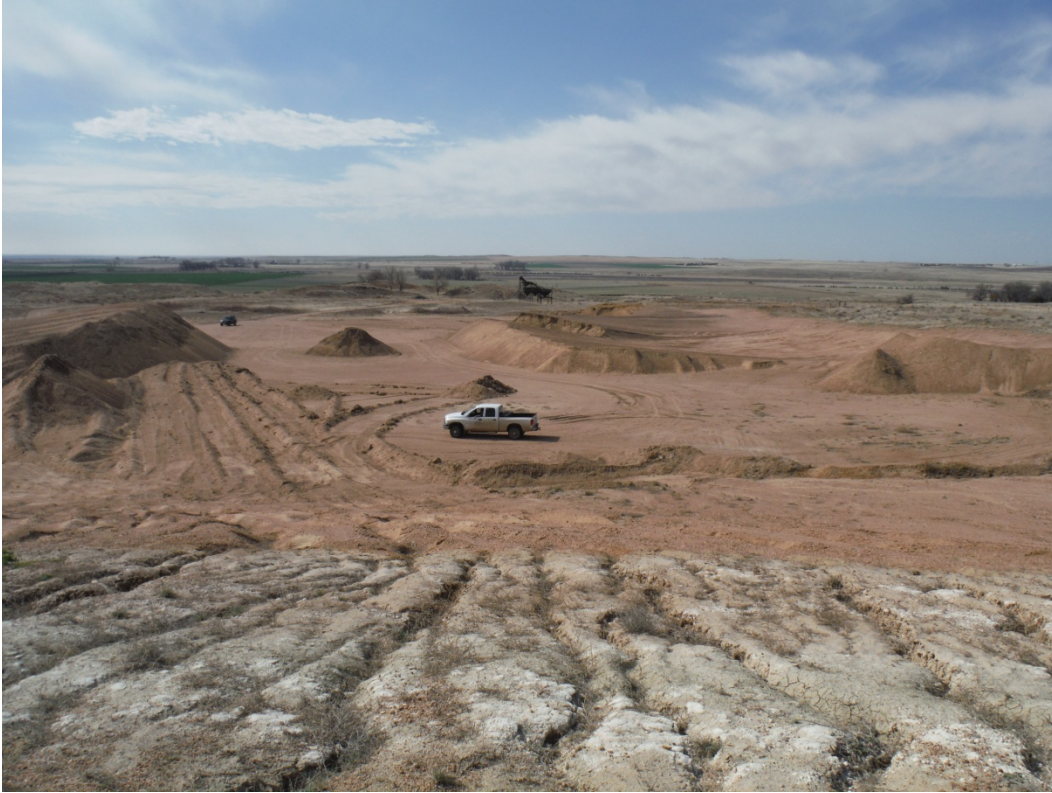
Site overview; looking south from the northern permit boundary.

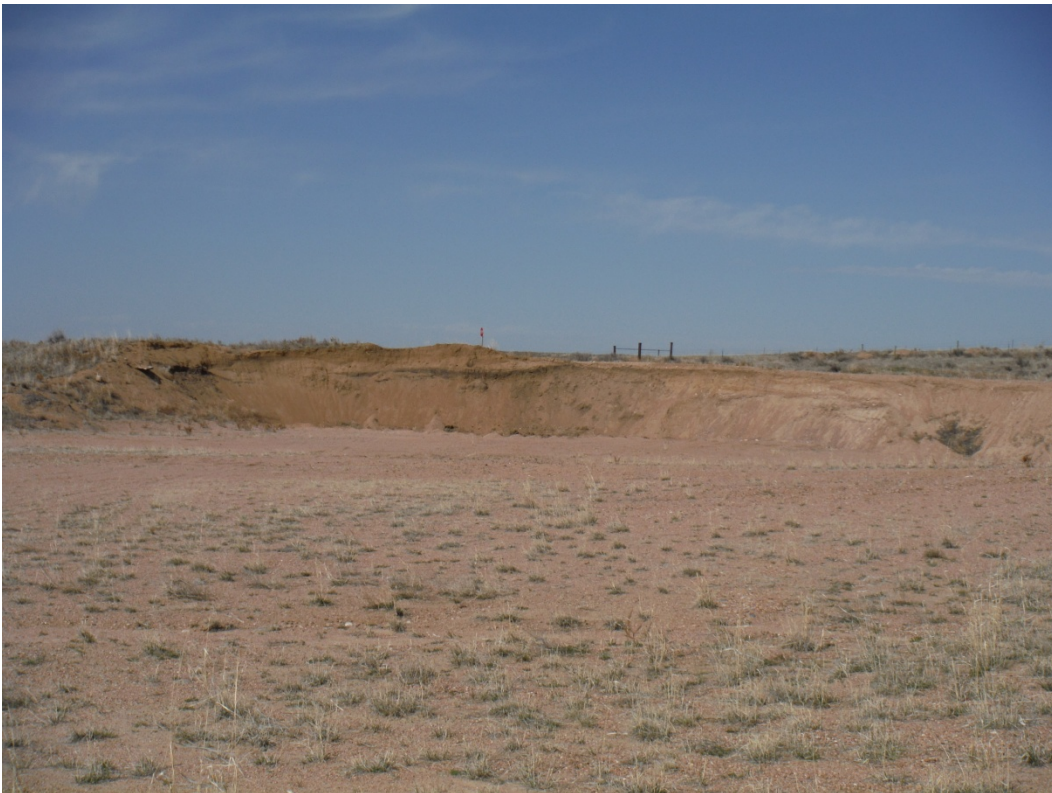
Southernmost (original 110c pit) mined area and inactive digging face; looking west.

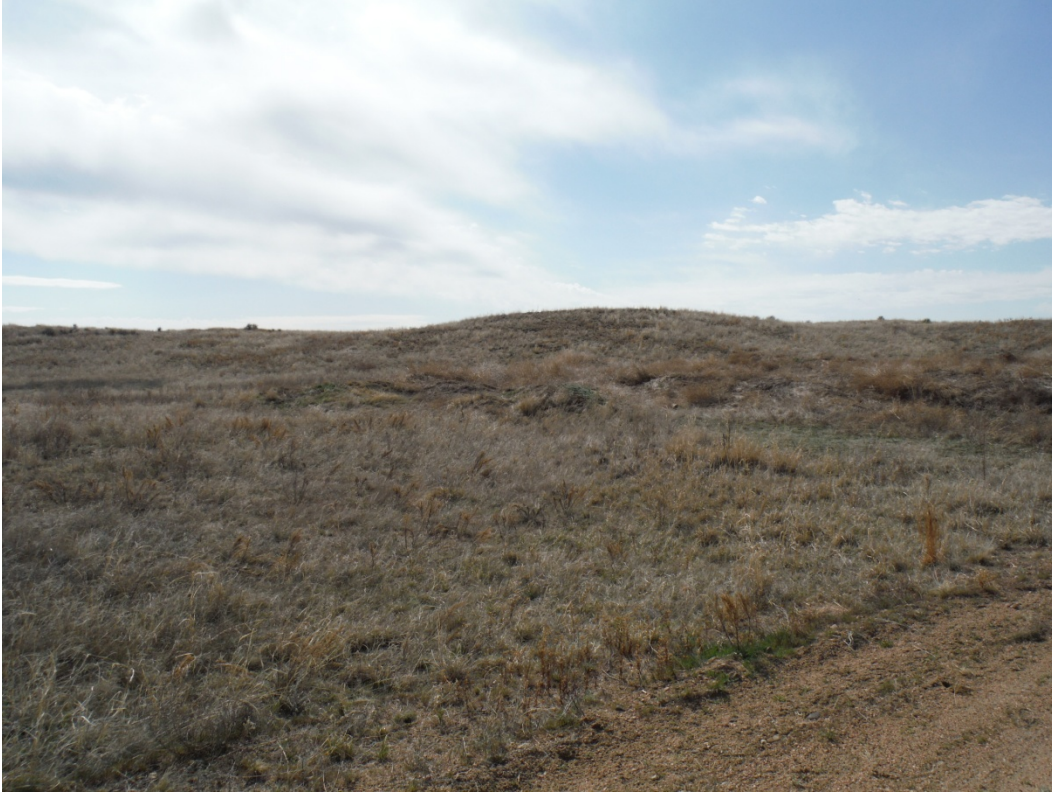
Vegetated topsoil piles in the southeast portion of the permit; looking southest.

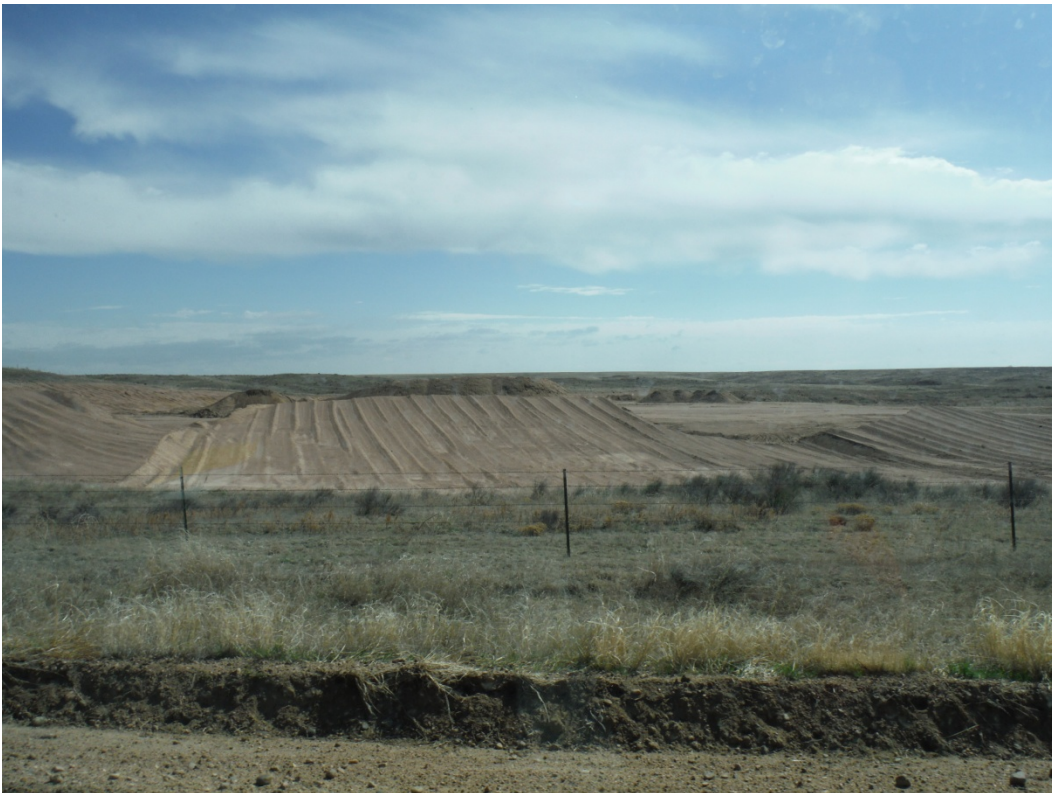
Northwestern mining area; looking east form CR 21.5.
