**COLORADO DIVISION OF RECLAMATION, MINING AND SAFETY**  
**MINERALS PROGRAM INSPECTION REPORT**  
**PHONE: (303) 866-3567**

<b>MINE NAME:</b> Bob Terrill Clay Pit	<b>MINE/PROSPECTING ID#:</b> M-1999-029	<b>MINERAL:</b> Clay (general)	<b>COUNTY:</b> Logan
<b>INSPECTION TYPE:</b> Monitoring	<b>INSPECTOR(S):</b> Elliott R. Russell	<b>INSP. DATE:</b> April 15, 2015	<b>INSP. TIME:</b> 11:15
<b>OPERATOR:</b> Logan County	<b>OPERATOR REPRESENTATIVE:</b> Rob Quint & Chad Wright	<b>TYPE OF OPERATION:</b> 110c - Construction Limited Impact

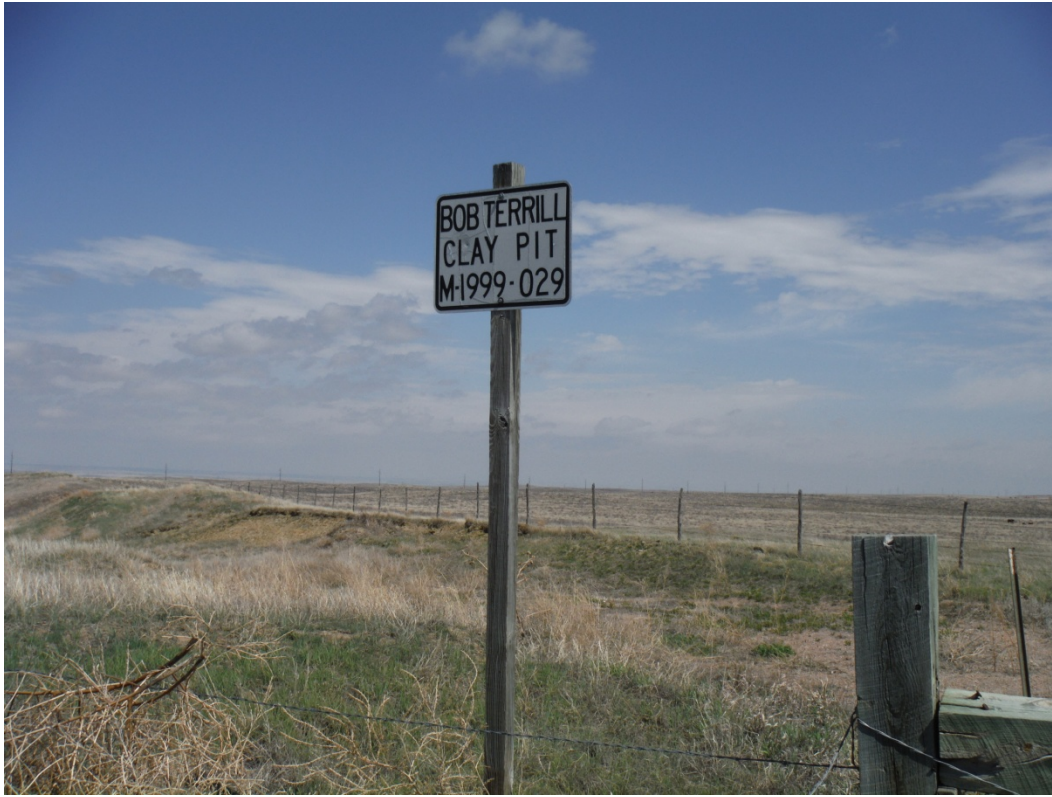
Permit identification sign at the site entrance; looking northeast.

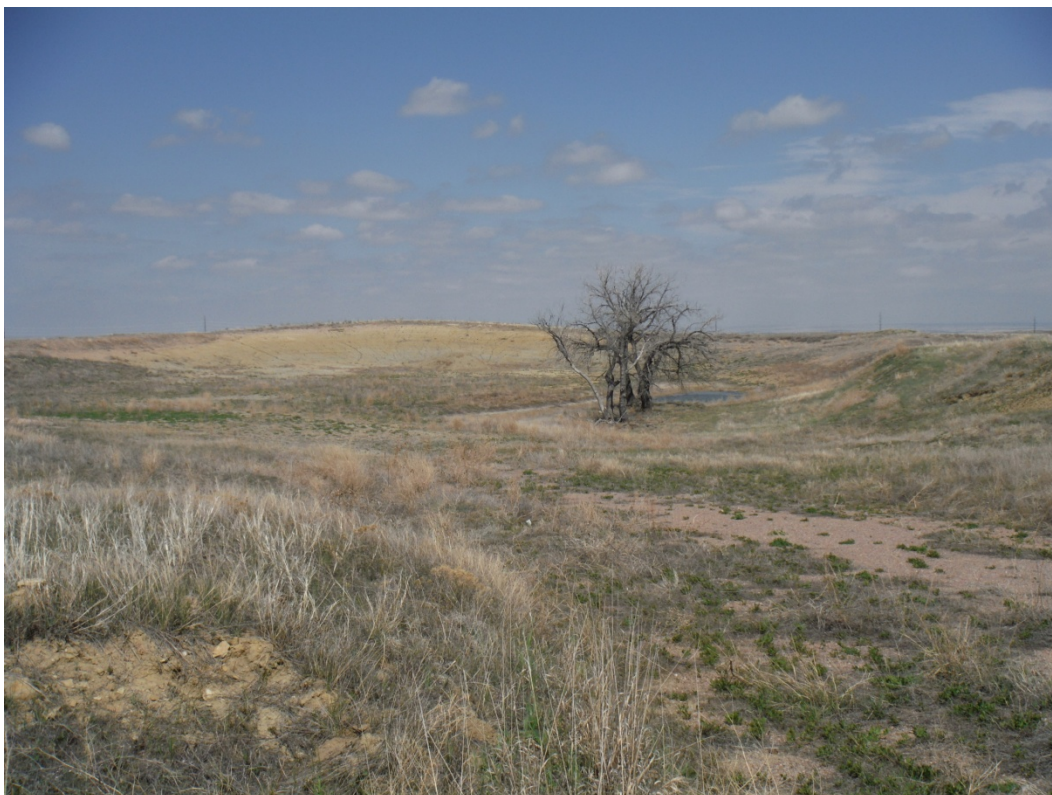
Site overview; looking northwest from the mine entrance.

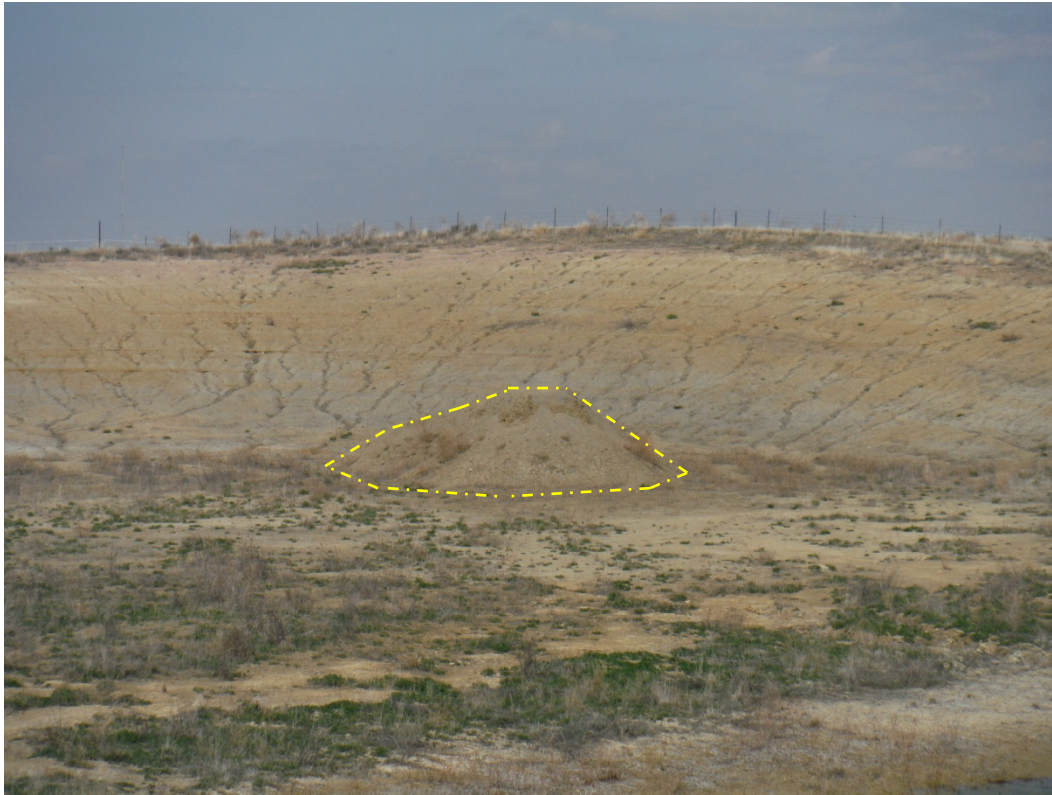
Product stockpile at toe of northwest slope; looking northwest.

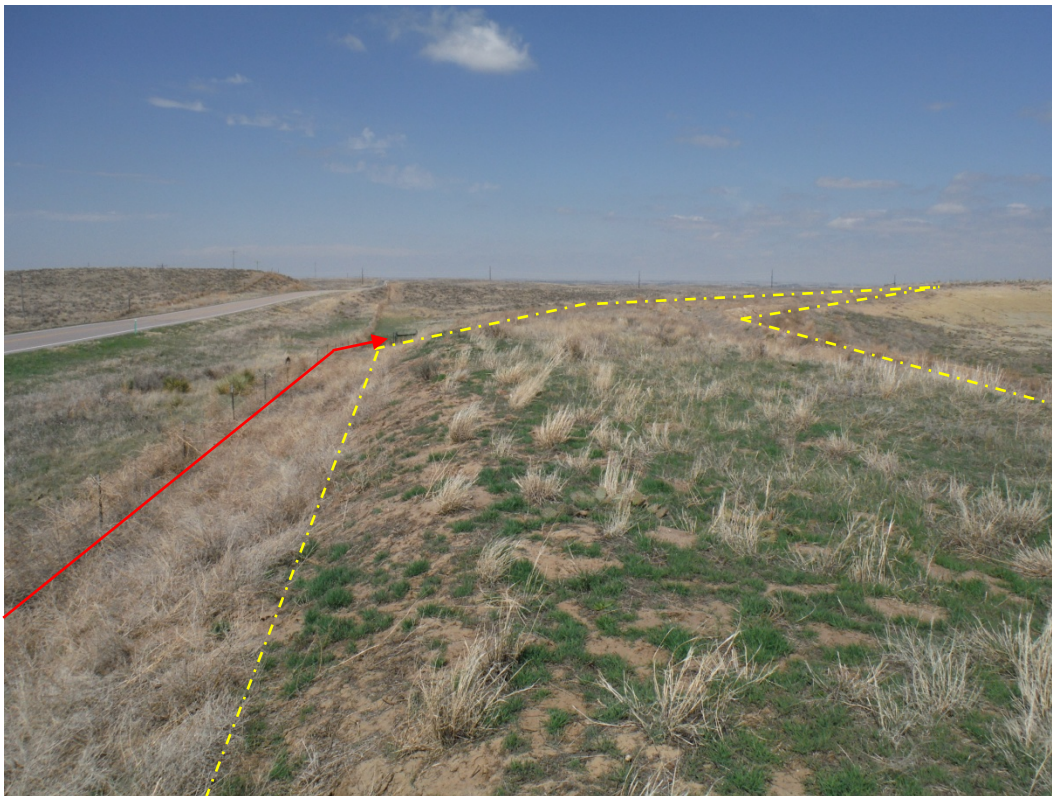
The Operator only mines clay from the site for uses at the County Landfill. The site consists of a single excavated area approximately 7 acres in size. Topsoil has been stripped from the entire site and piled along the southern and western boundaries. The pit area is at its maximum size for this permit; Mr. Wright stated that if the landfill requested more clay, they would extract material from the site by mining deeper due to the permit's size constraint. A small stockpile of material was observed at the toe of the northwestern slope. The Operator was reminded to keep the site active and in compliance by conducting mining activity (extracting, processing, stockpiling, hauling, etc.) at least once every year at the site.

Topsoil stockpile (yellow) along southern and western permit boundary (red); looking northwest.

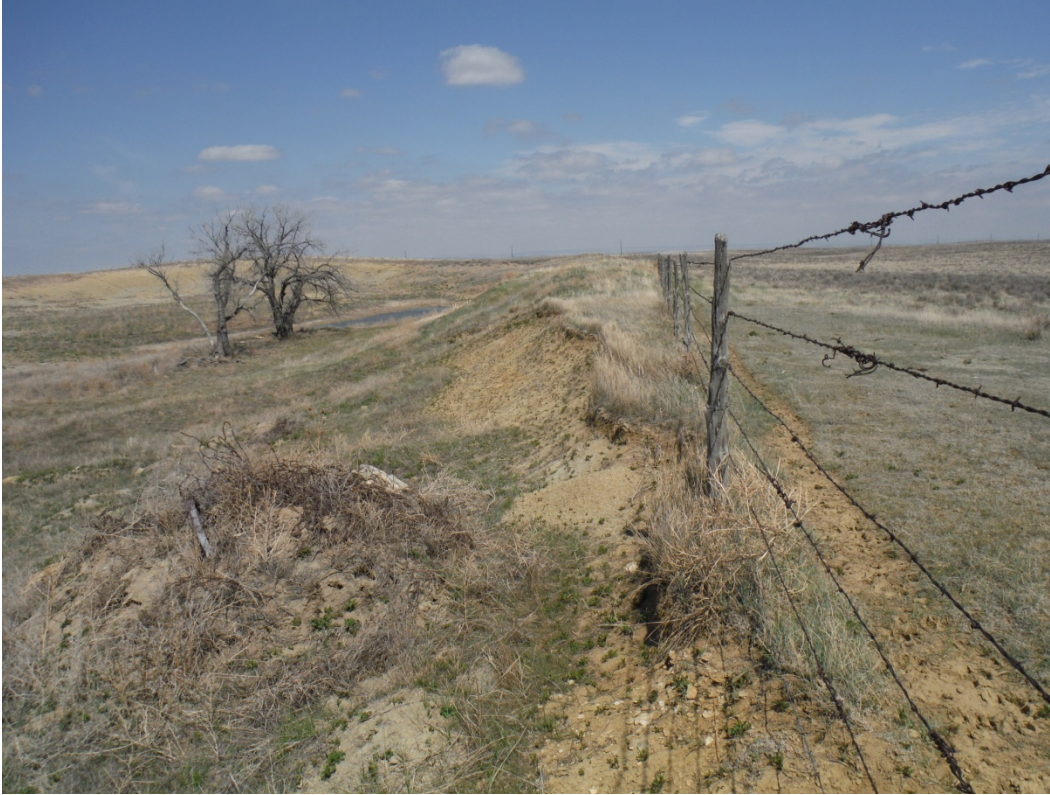
The Division observed some erosion in the southeast portion of the site. This erosion appears to be headcutting/migrating to the east and is very close to the eastern boundary line. At this time, this will not be cited as a problem because the feature is entirely within the permit and drains toward the pit area (remains on-site). The Division recommends monitoring this feature and possibly backfilling/grading this area appropriately to ensure this feature does not affect lands outside of the permit boundary.

Erosion near the eastern permit boundary; looking north.
