COLORADO DIVISION OF RECLAMATION, MINING AND SAFETY
MINERALS PROGRAM INSPECTION REPORT
PHONE: (303) 866-3567

MINE NAME: Lindstrom Gravel Pit	MINE/PROSPECTING ID#: M-1993-069	MINERAL: Sand and gravel	COUNTY: Logan
INSPECTION TYPE: Monitoring	INSPECTOR(S): Elliott R. Russell	INSP. DATE: April 15, 2015	INSP. TIME: 12:00
OPERATOR: Logan County	OPERATOR REPRESENTATIVE: Rob Quint & Chad Wright	TYPE OF OPERATION: 112c - Construction Regular Operation	
REASON FOR INSPECTION: Normal I&E Program	BOND CALCULATION TYPE: None	BOND AMOUNT: NA	
DATE OF COMPLAINT: NA	POST INSP. CONTACTS: None	JOINT INSP. AGENCY: None	
WEATHER: Clear	INSPECTOR'S SIGNATURE:

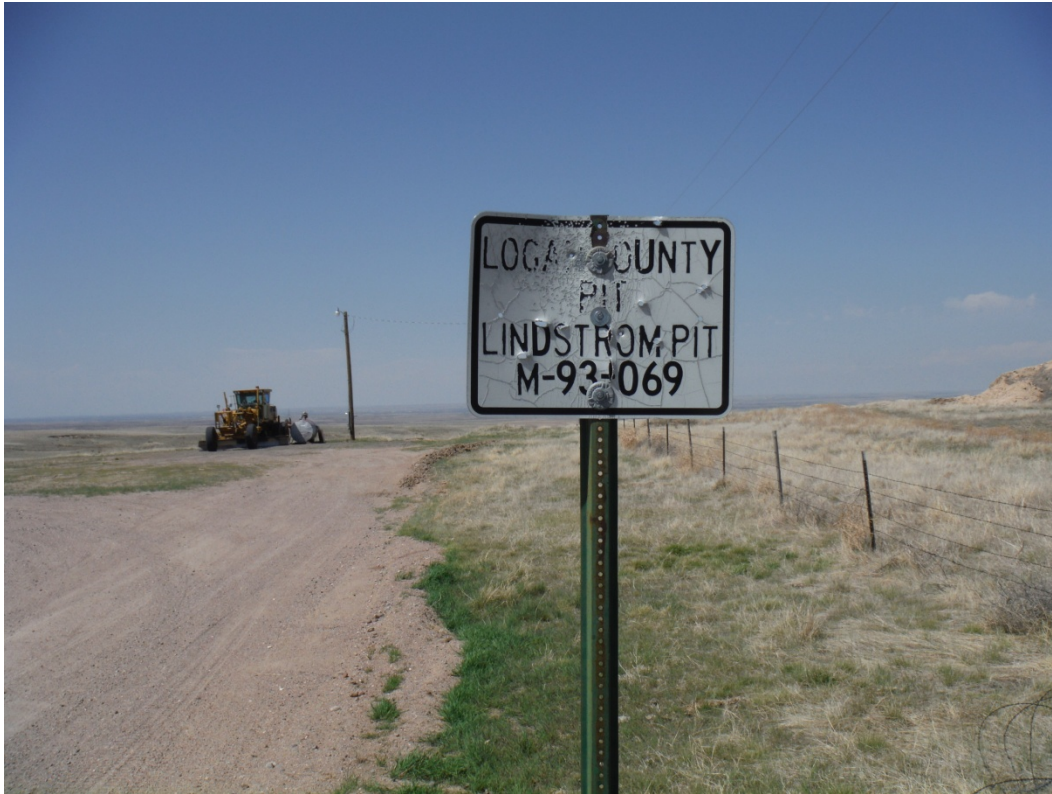
Permit identification sign at the site entrance; looking west.

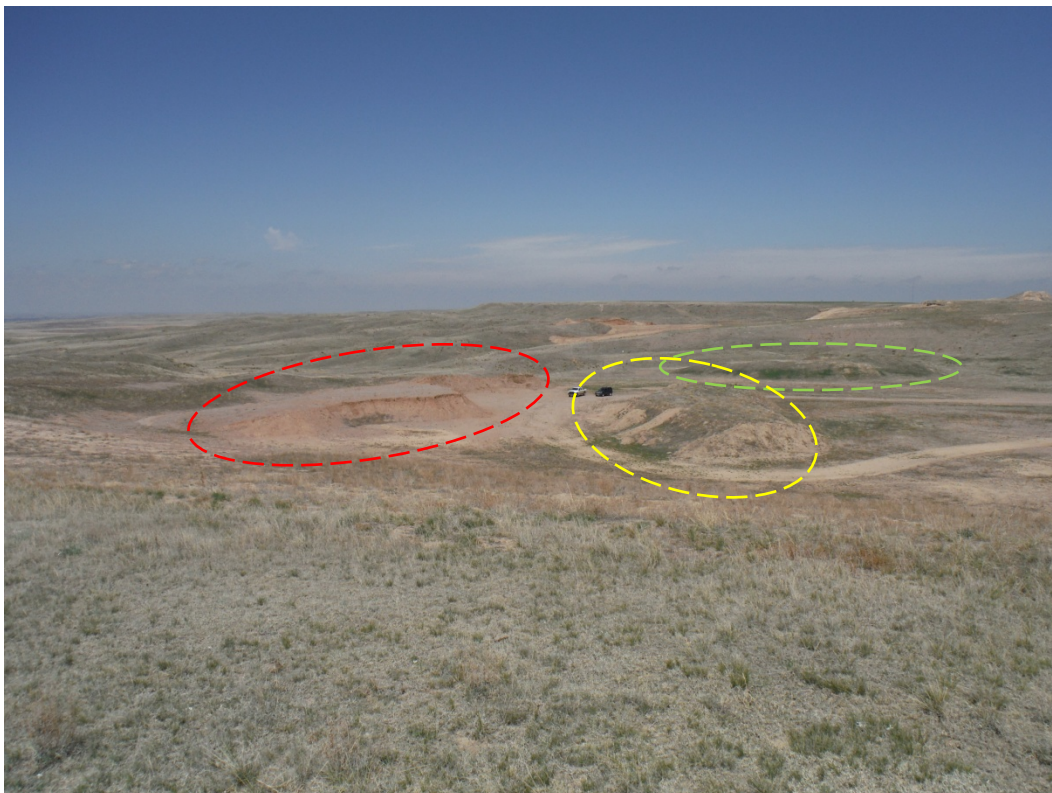
Site overview with M-2000-149 in the background, Stockpiles circled: product (red), overburden (yellow), topsoil (green); looking north from the southern permit boundary.

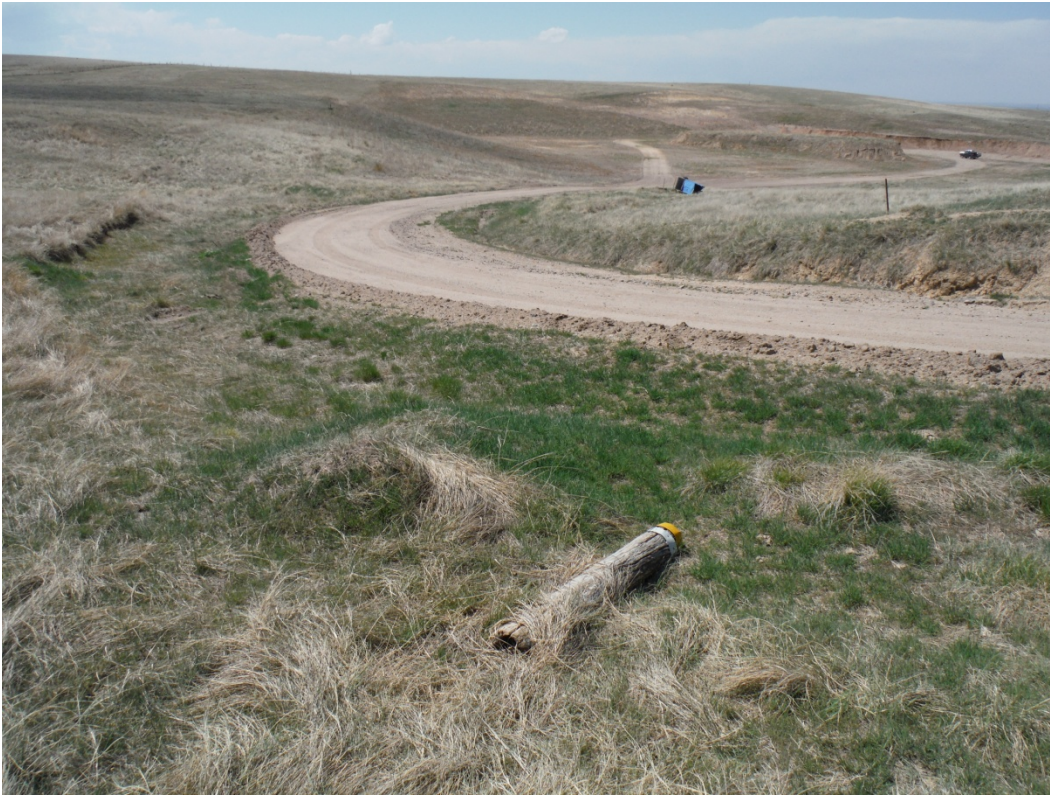
PROBLEM/POSSIBLE VIOLATION: Problem: The affected area boundary markers are missing or incorrectly placed. This is a problem for failure to maintain boundary markers around the affected area as required by Rule 3.1.12(2).

Northeast boundary marker with no locatable survey pin; looking southwest.

CORRECTIVE ACTIONS: The operator shall conduct a survey and replace the boundary markers in the correct location(s). The operator shall provide the boundary marker coordinates and photo documentation to the Division that this has been done by the corrective action date.

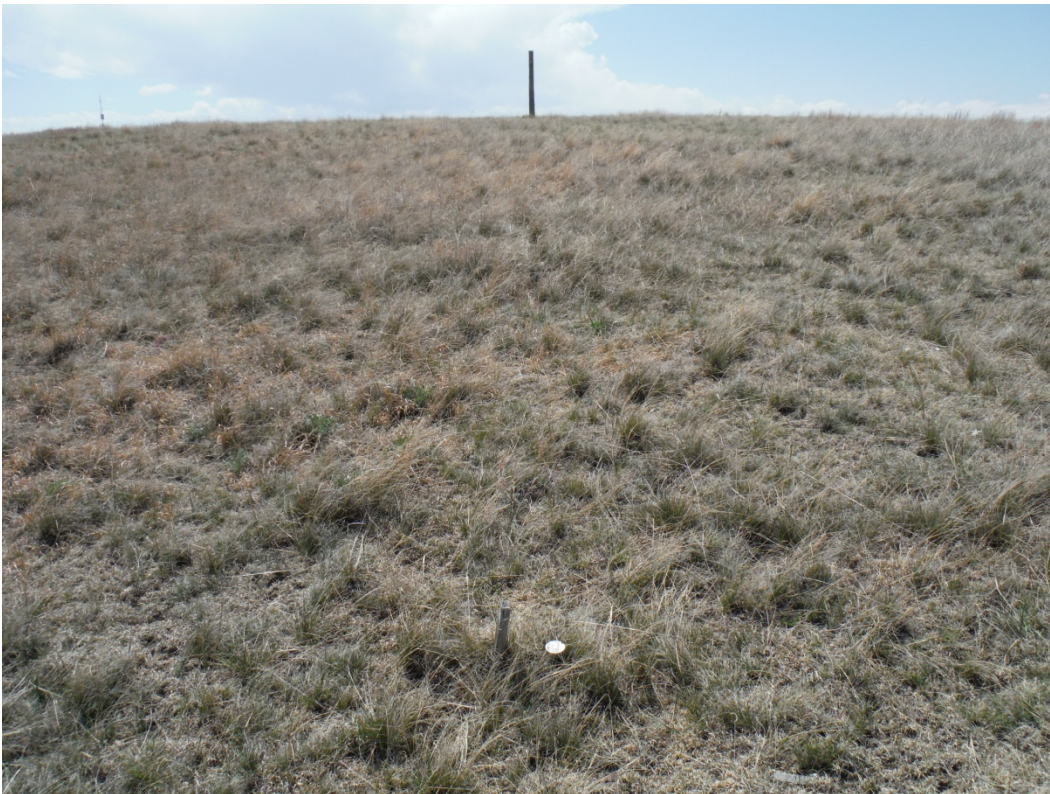
One of the contradicting boundary corners along the southern permit boundary, survey pin in foreground and wood post in background; looking south at the southwest boundary corner.

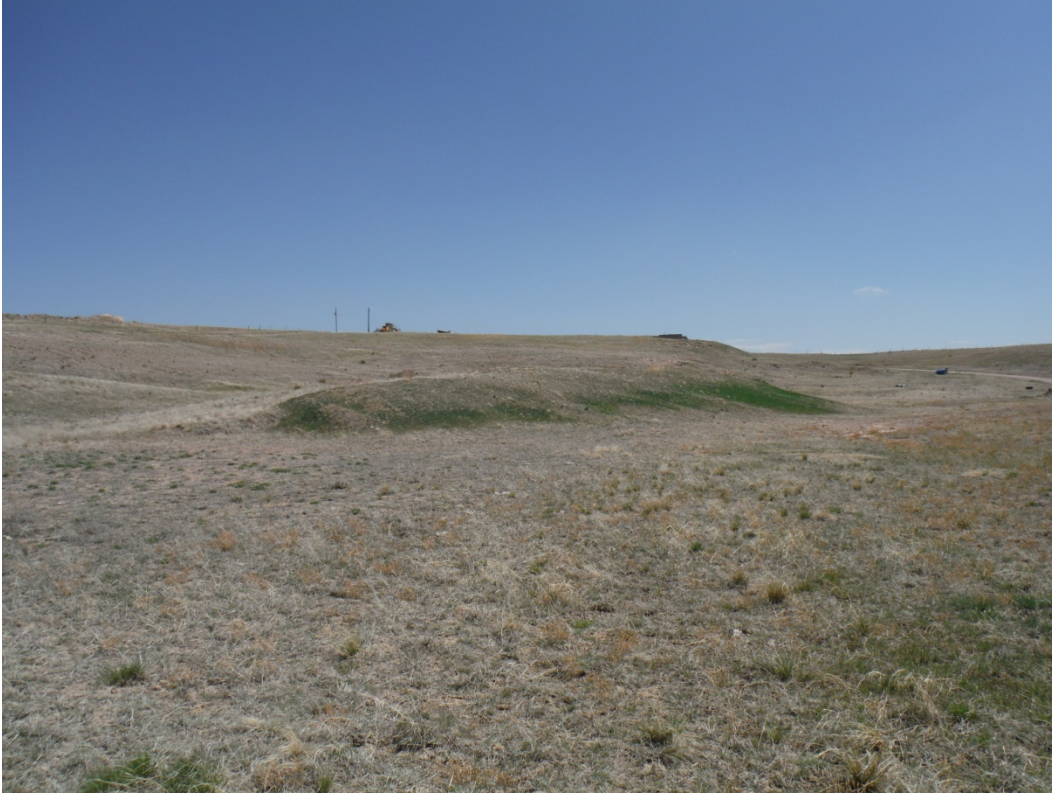
Vegetated topsoil pile in the northern portion of the permit; looking east.

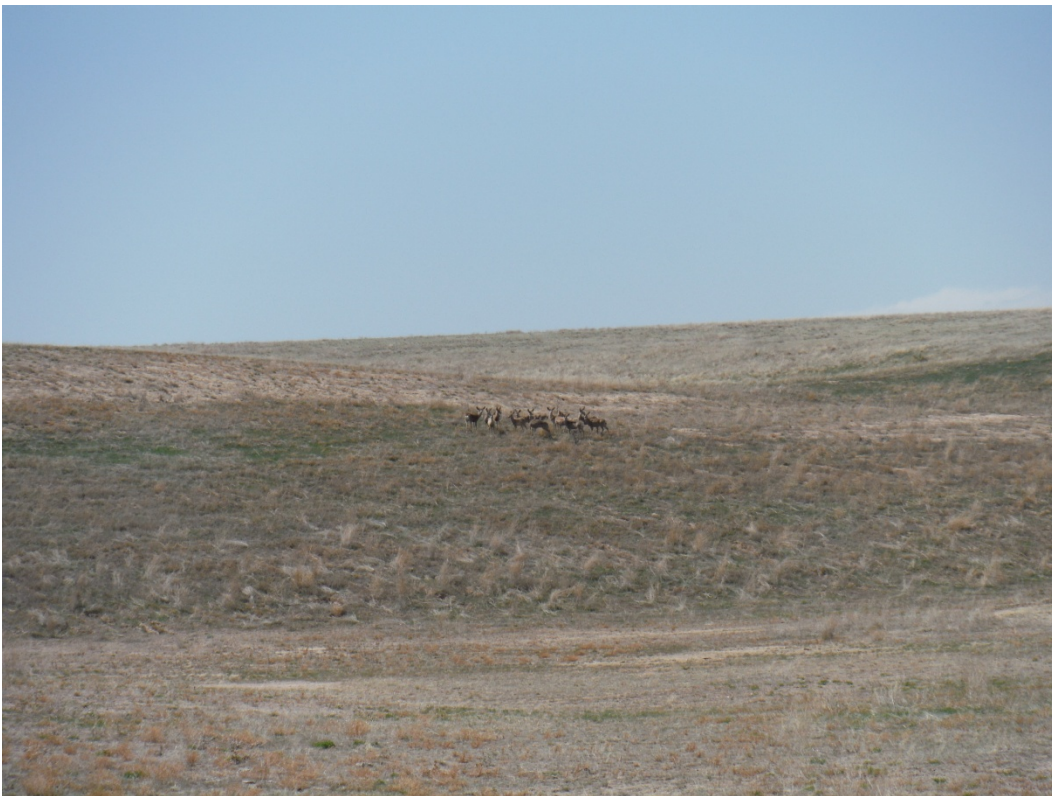
Deer herd within the permit boundary; looking south.

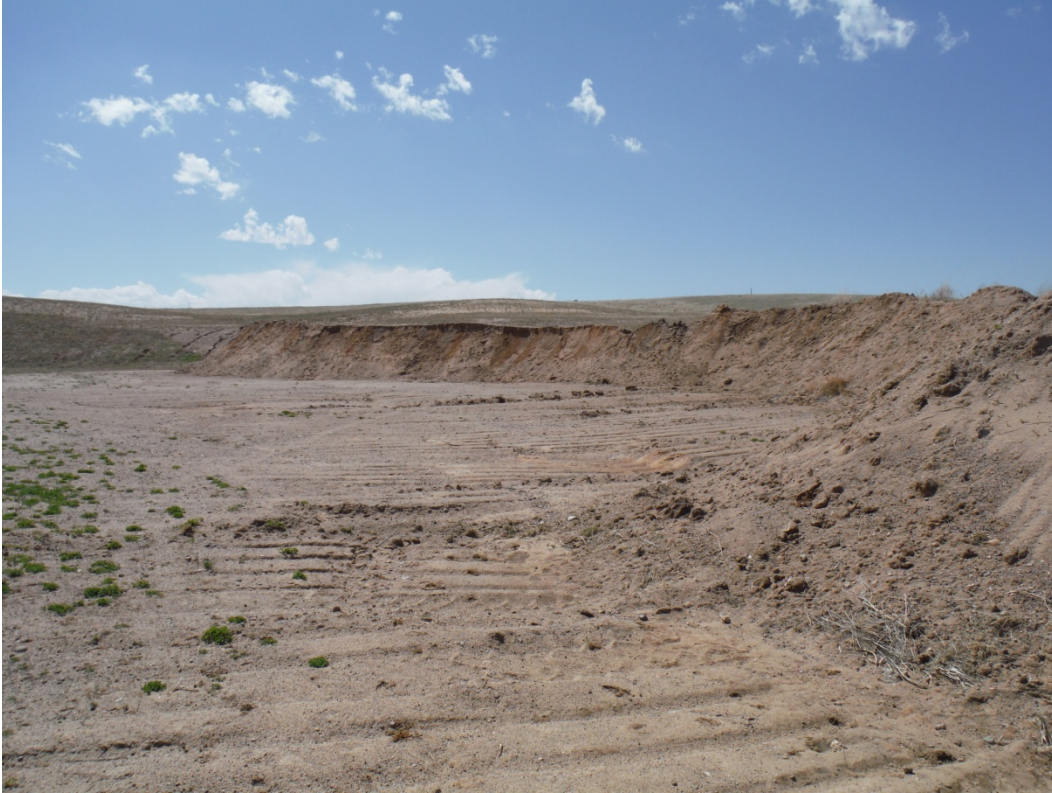
Product stockpile located on pit floor; looking south.

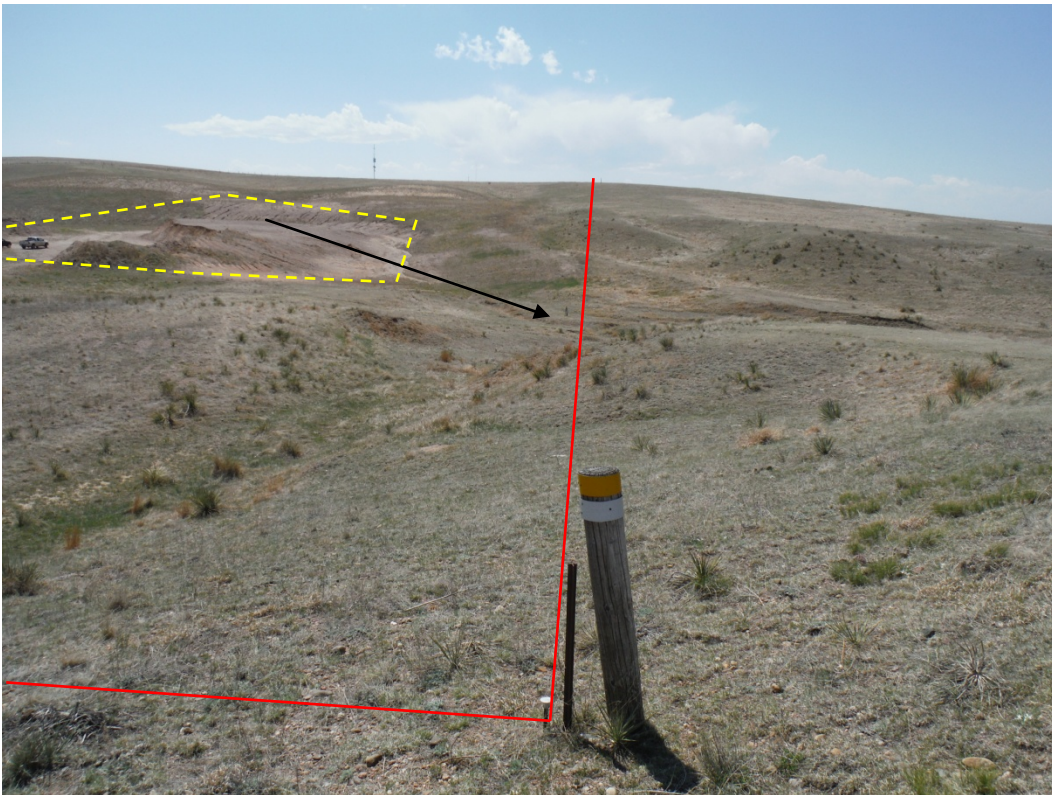
PROBLEM/POSSIBLE VIOLATION: Problem: Erosion gullies and ruts were observed on-site. This is a problem at this time for failure to protect the affected land from erosion pursuant to C.R.S. 34-32.5-116 (4) (j).

The Division and the Operator's representatives discussed that the site drains toward the northwest, which is also the direction of the overall drainage in the area. While walking the western permit boundary, the Division stated that there could be a possibility for an off-site impact if stormwater were allowed to flow (from the non-vegetated disturbed area) down the drainage. To reduce the chance for a possible future compliance/violation issue, the Division has cited this as a problem requiring corrective action; the Operator shall implement a Best Management Practice across the lowest area of disturbance near the western permit boundary. This approach should either allow stormwater to be contained on site or let the stormwater's energy to dissipate enough to let sediment settle out before leaving the site.

Northwest boundary marker, barren disturbed area (yellow), flow direction indicated by arrow, approximate permit boundary (red); looking south.

CORRECTIVE ACTIONS: The operator shall provide photo documentation to the Division verifying that the site has have been reconstructed and stabilized to prevent erosion damage by the corrective action date.
