COLORADO DIVISION OF RECLAMATION, MINING AND SAFETY
MINERALS PROGRAM INSPECTION REPORT
PHONE: (303) 866-3567

MINE NAME: Neal Pit	MINE/PROSPECTING ID#: M-1983-148	MINERAL: Sand and gravel	COUNTY: Montrose
INSPECTION TYPE: Preoperation Inspection	INSPECTOR(S): Wallace H. Erickson	INSP. DATE: April 15, 2015	INSP. TIME: 15:30
OPERATOR: Montrose County	OPERATOR REPRESENTATIVE: Norm David, Dean Cooper	TYPE OF OPERATION: 112c - Construction Regular Operation	
REASON FOR INSPECTION: Preoperation Inspection	BOND CALCULATION TYPE: None	BOND AMOUNT: \$0.00	
DATE OF COMPLAINT: NA	POST INSP. CONTACTS: None	JOINT INSP. AGENCY: None	
WEATHER: Cloudy	INSPECTOR'S SIGNATURE:

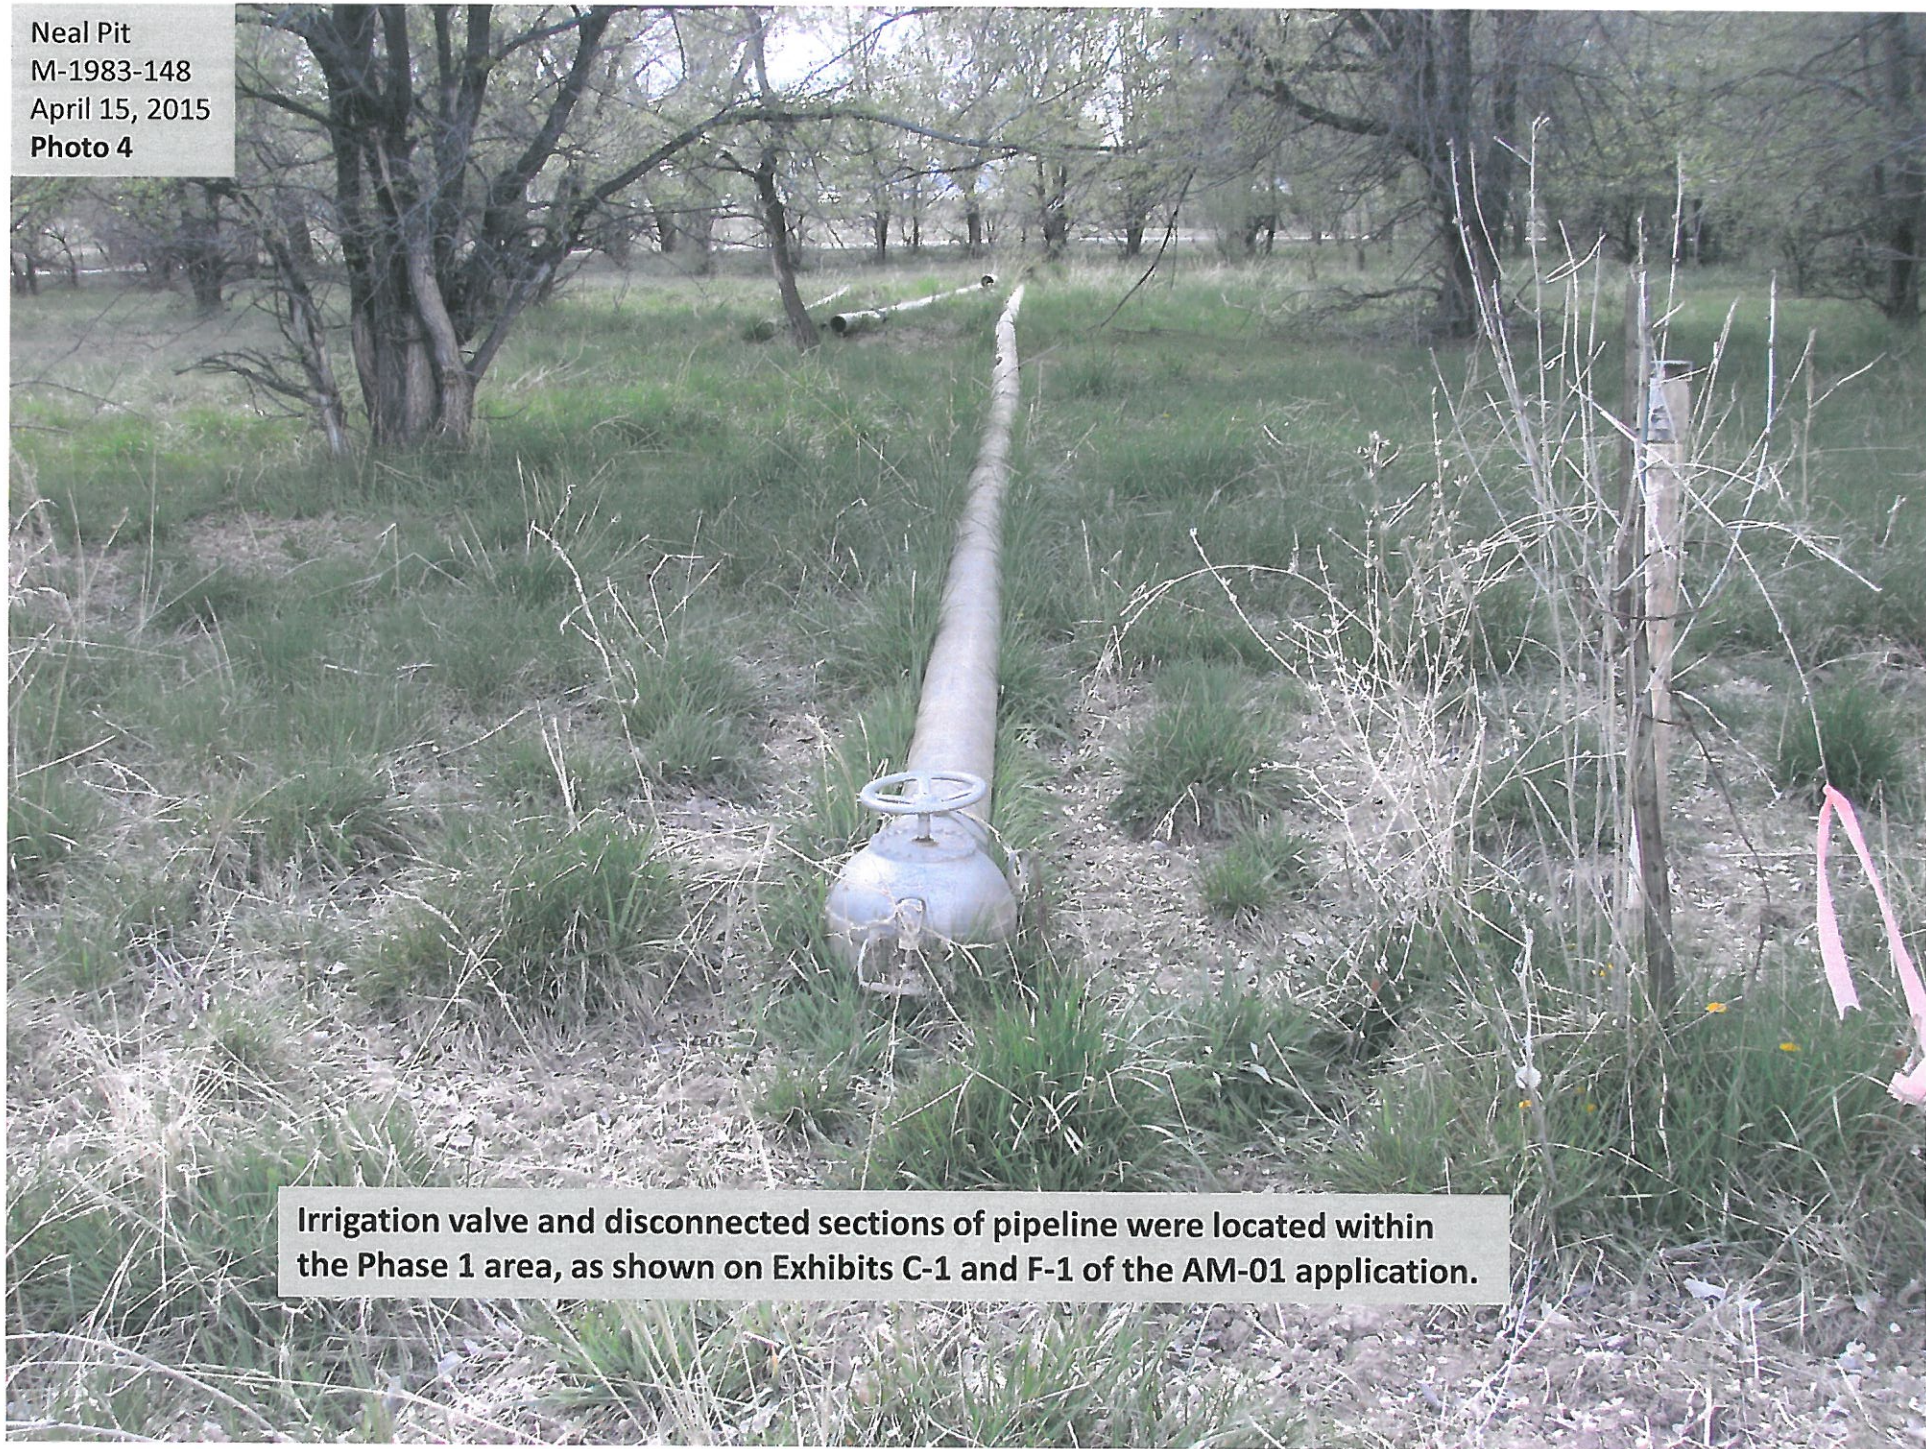
Neal Pit
M-1983-148
April 15, 2015
Photo 4

Irrigation valve and disconnected sections of pipeline were located within the Phase 1 area, as shown on Exhibits C-1 and F-1 of the AM-01 application.

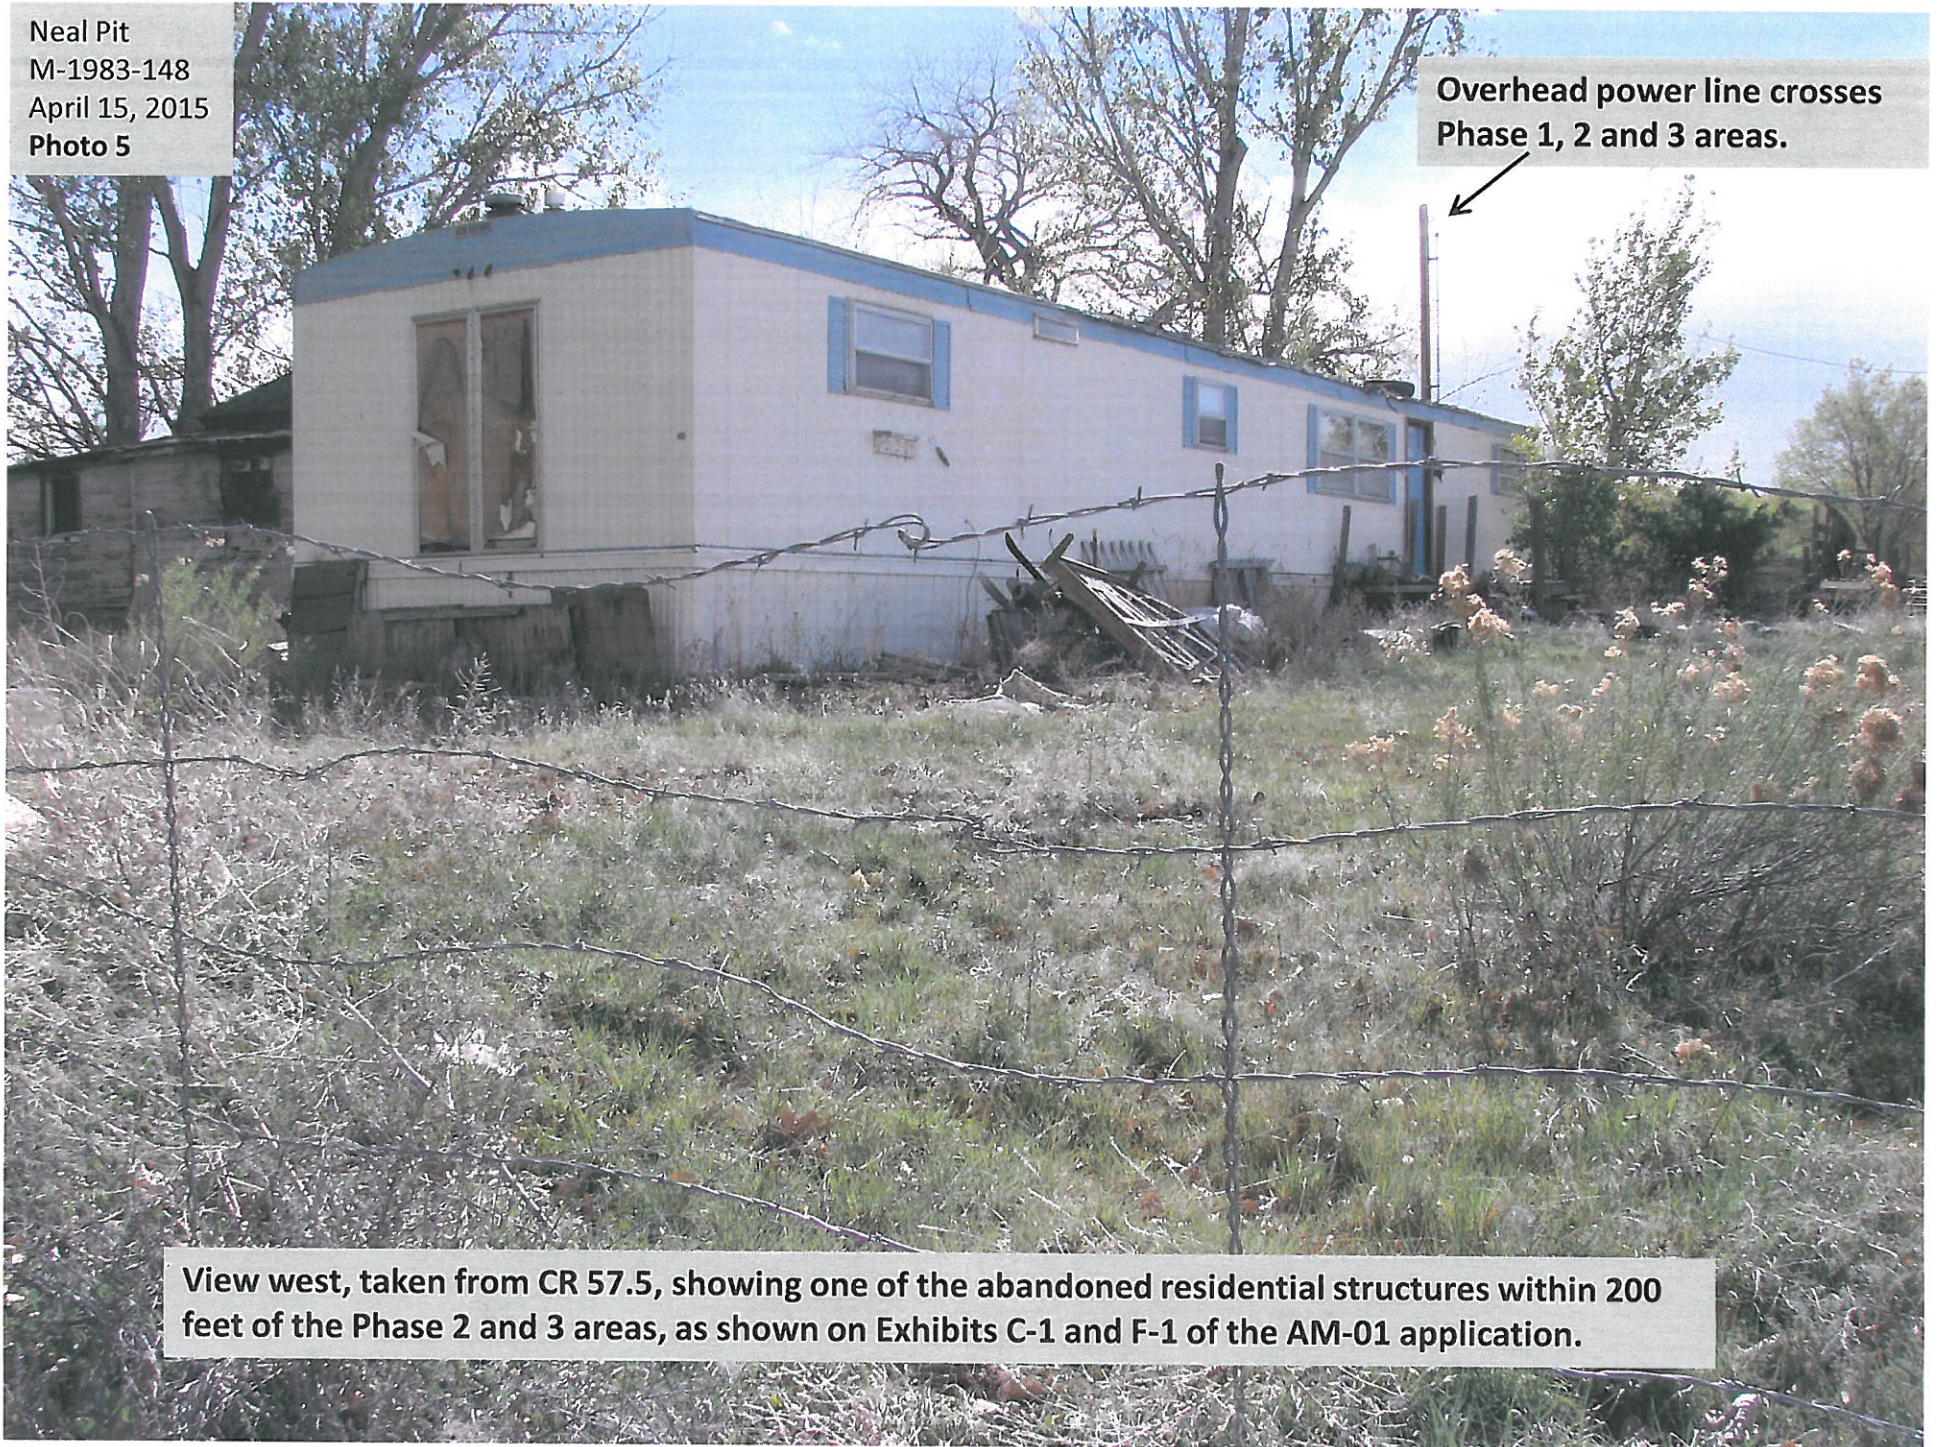
Neal Pit
M-1983-148
April 15, 2015
Photo 5

Overhead power line crosses
Phase 1, 2 and 3 areas.

View west, taken from CR 57.5, showing one of the abandoned residential structures within 200 feet of the Phase 2 and 3 areas, as shown on Exhibits C-1 and F-1 of the AM-01 application.

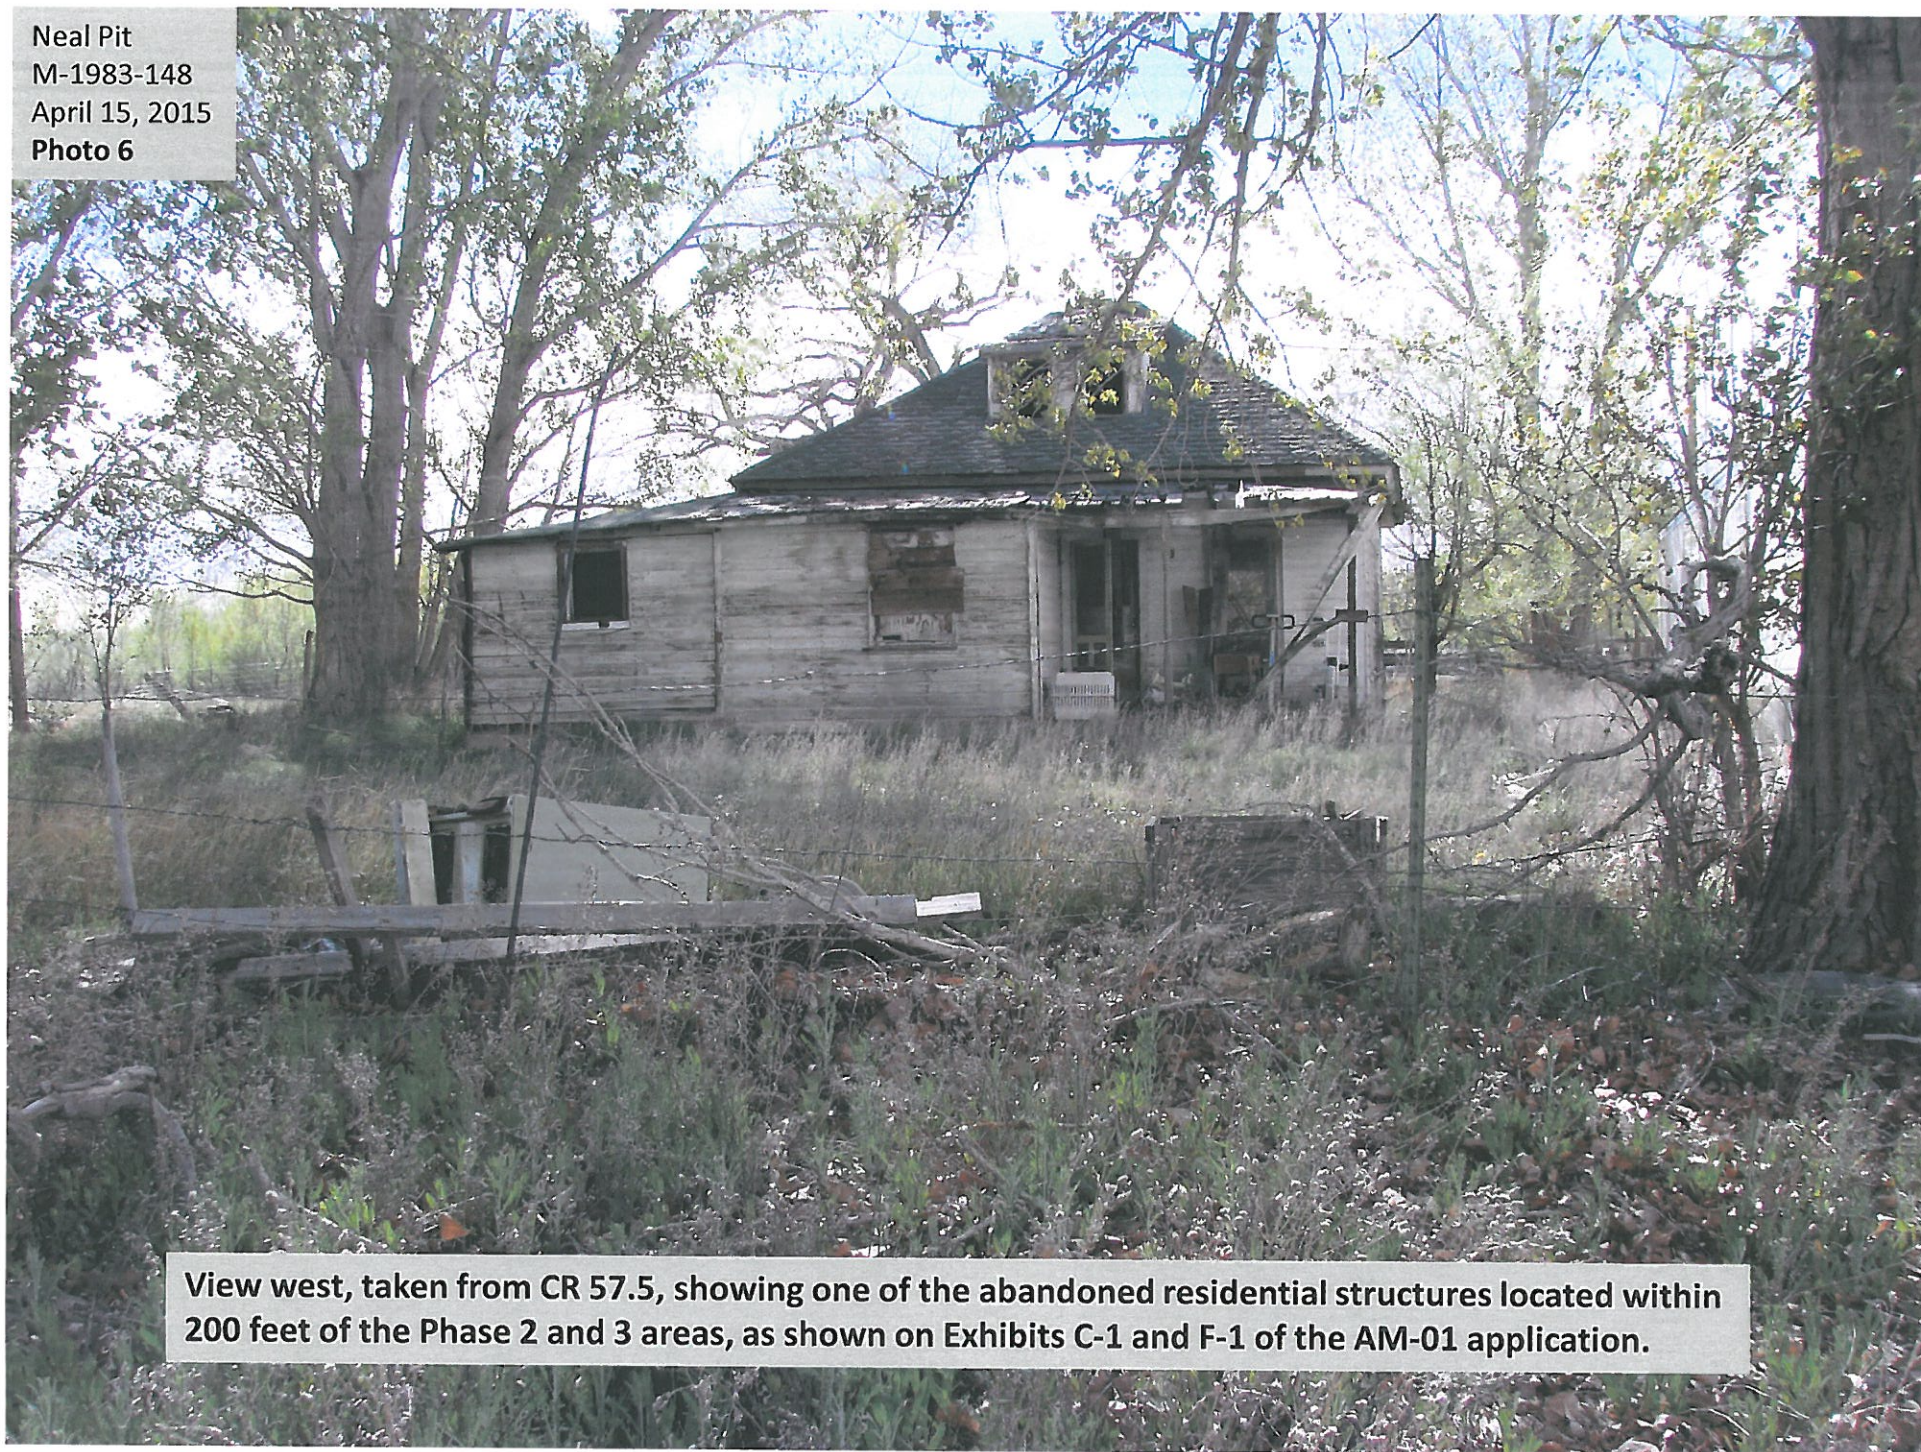
Neal Pit
M-1983-148
April 15, 2015
Photo 6

View west, taken from CR 57.5, showing one of the abandoned residential structures located within 200 feet of the Phase 2 and 3 areas, as shown on Exhibits C-1 and F-1 of the AM-01 application.

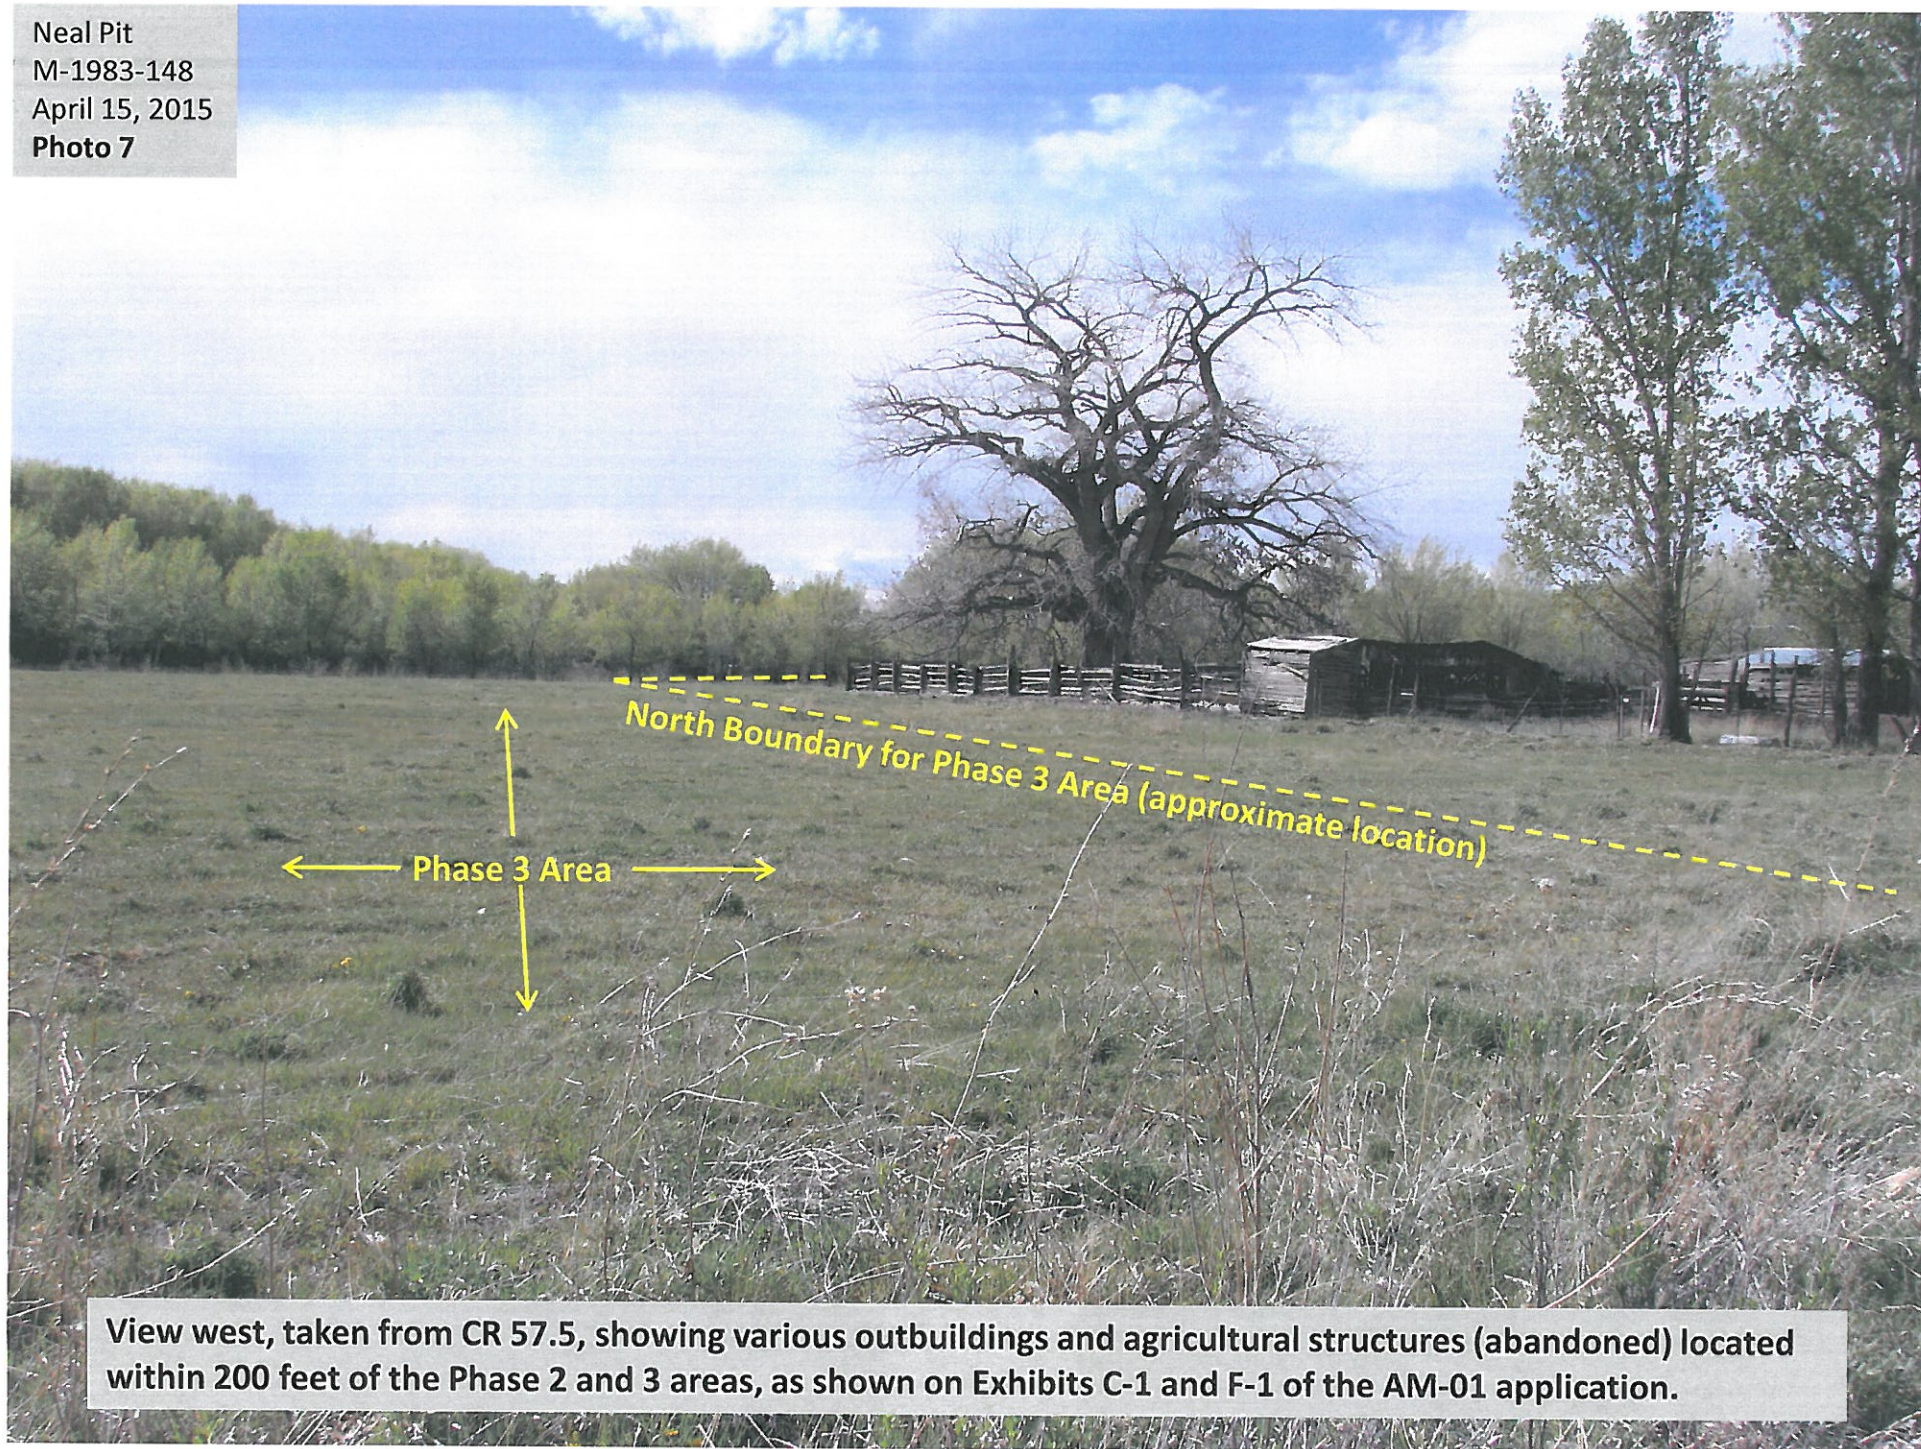
Neal Pit
M-1983-148
April 15, 2015
Photo 7

View west, taken from CR 57.5, showing various outbuildings and agricultural structures (abandoned) located within 200 feet of the Phase 2 and 3 areas, as shown on Exhibits C-1 and F-1 of the AM-01 application.

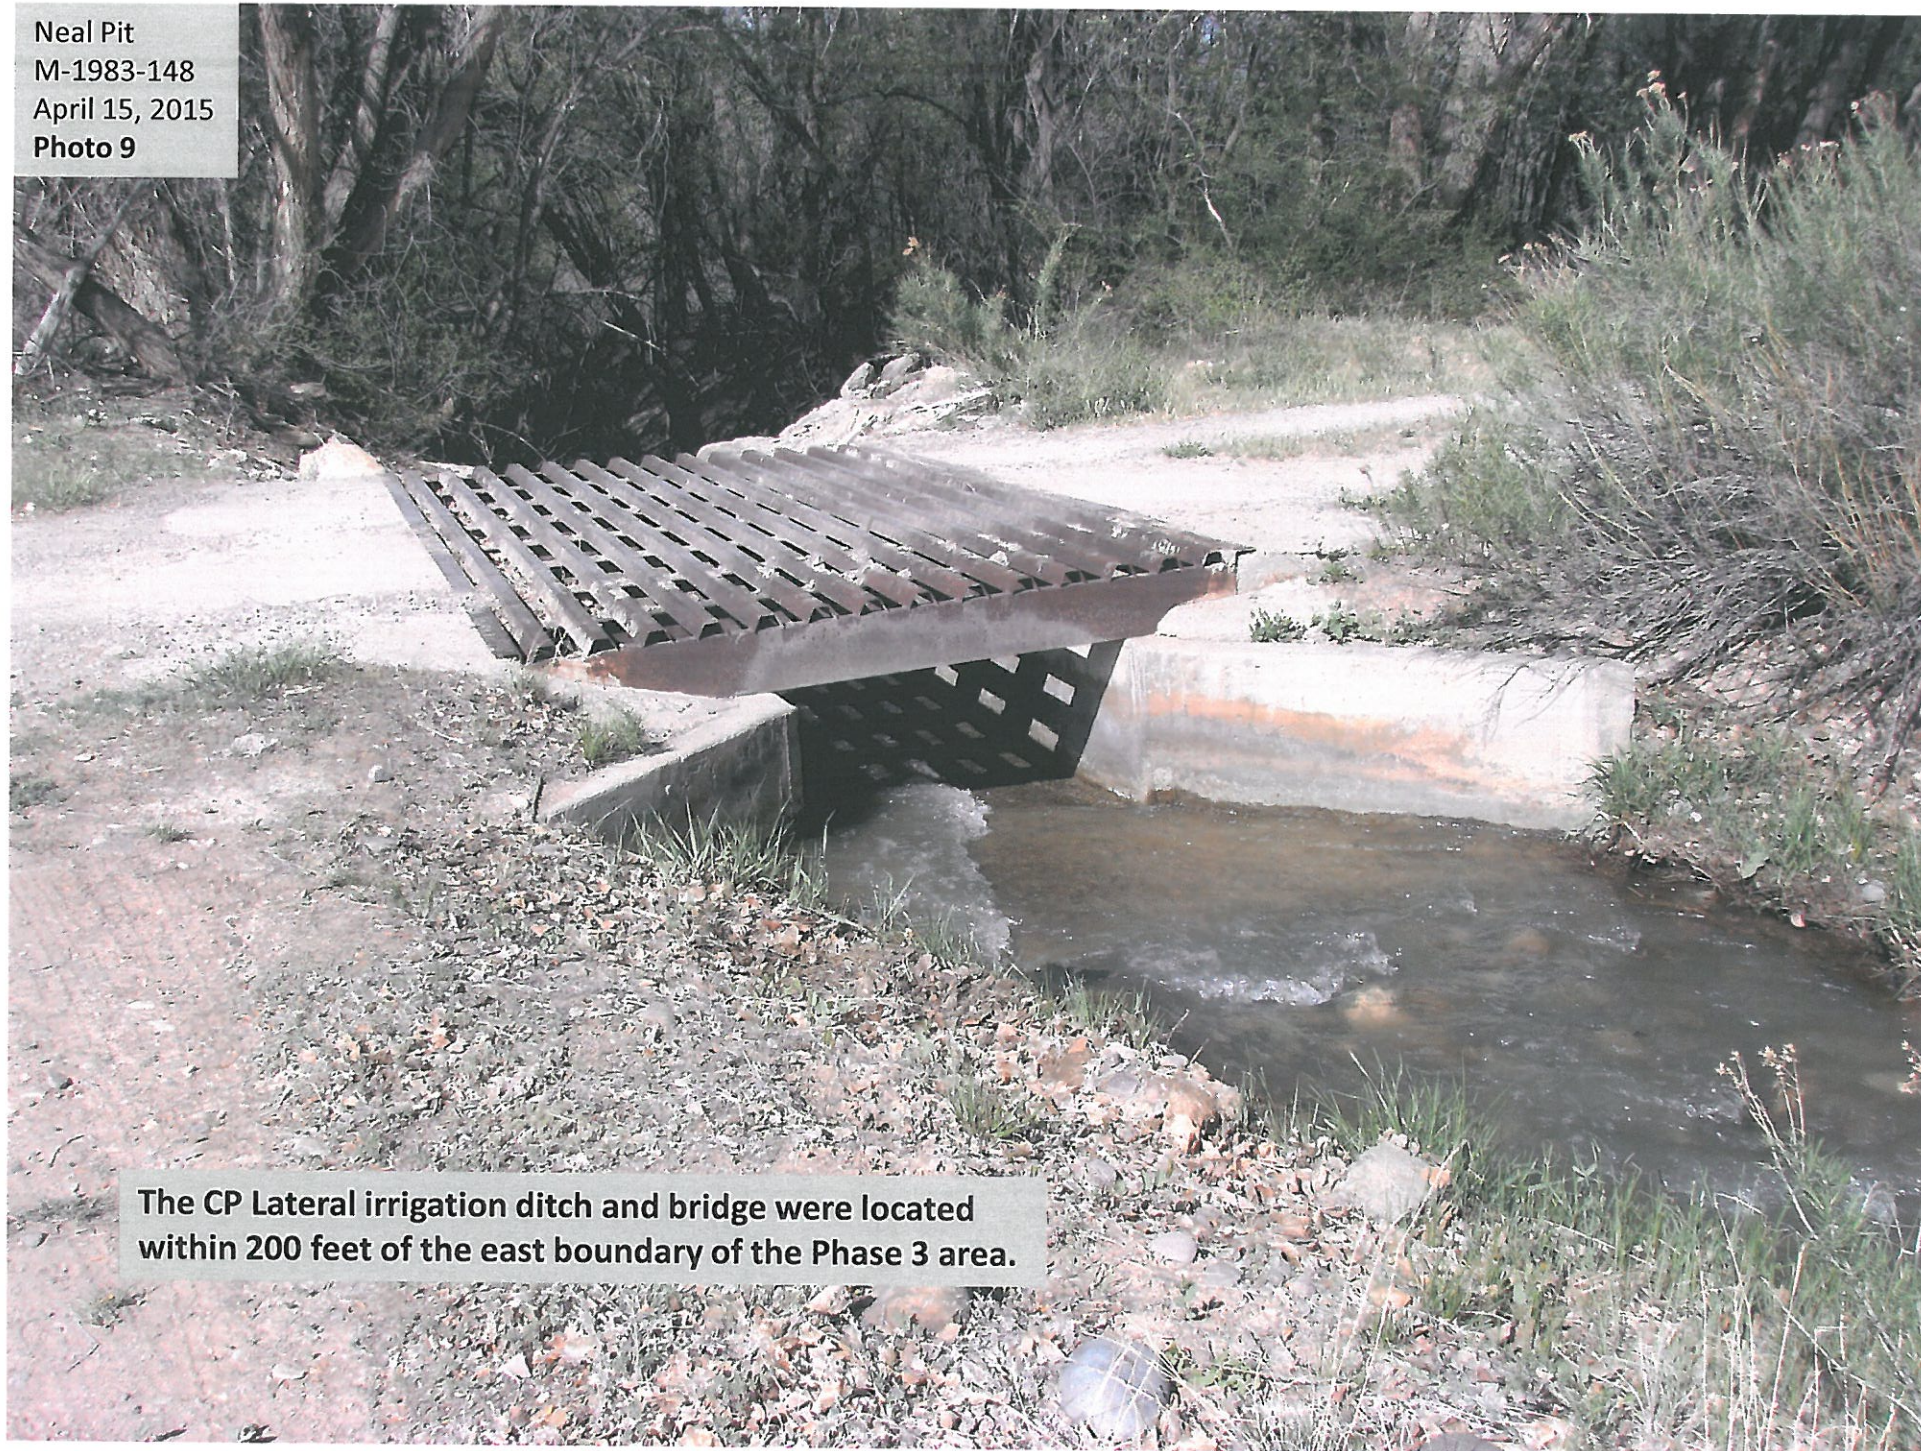
Neal Pit
M-1983-148
April 15, 2015
Photo 9

The CP Lateral irrigation ditch and bridge were located within 200 feet of the east boundary of the Phase 3 area.

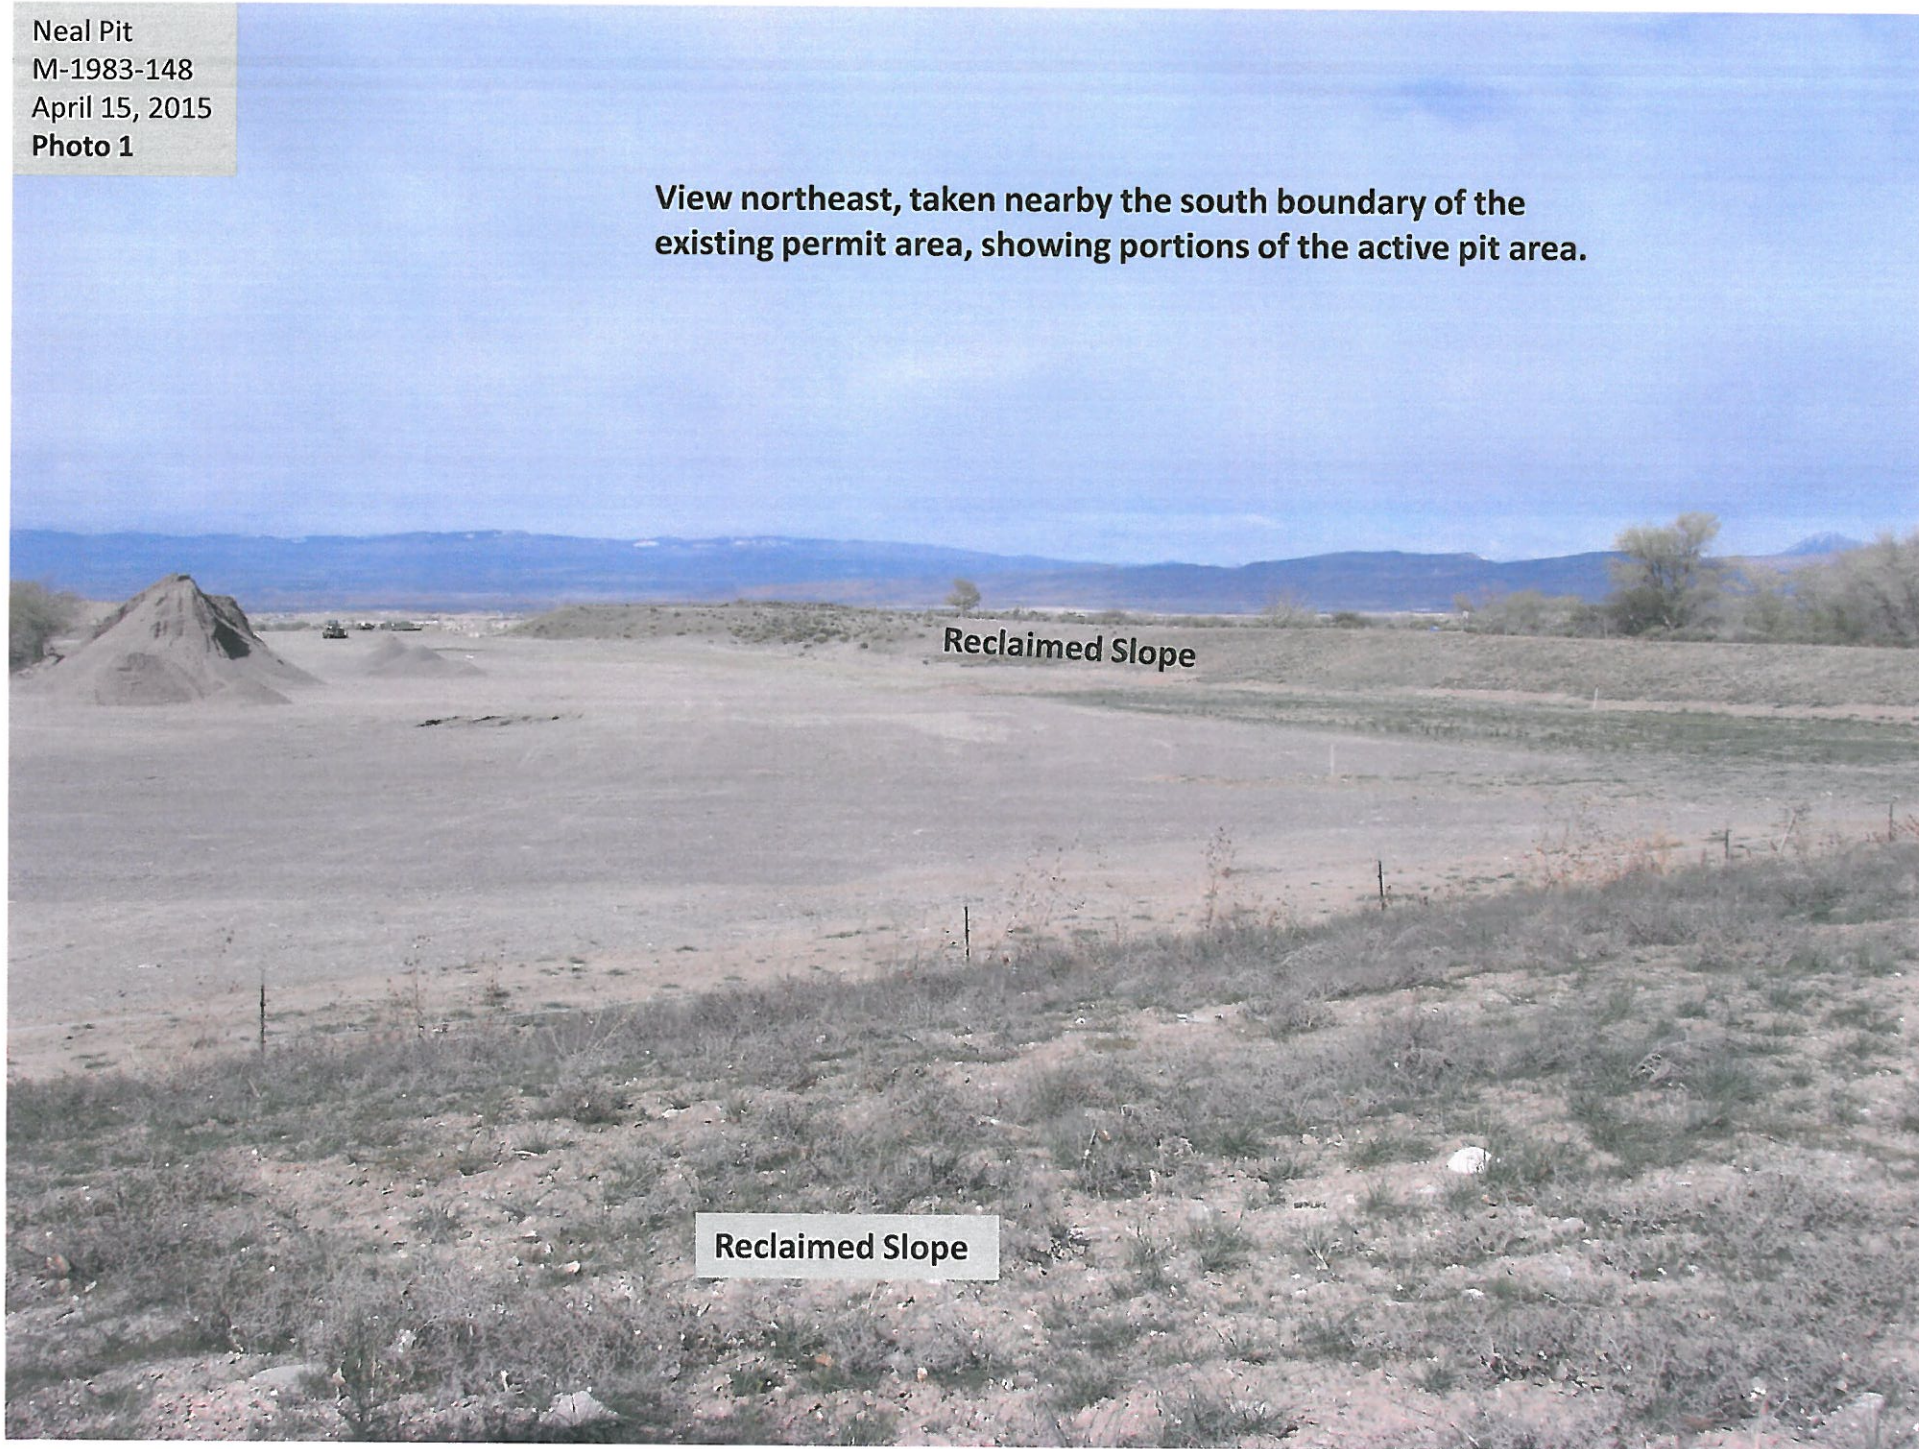
Neal Pit
M-1983-148
April 15, 2015
Photo 1

Mining activities were dormant during the time of the inspection. Various stockpiles of mined materials were located on the pit floor. Storm water containment berms appeared intact and well maintained for the active pit area. The active pit area appeared stable; evidence of slumping, excessive erosion or infestation by prohibited noxious weeds was not observed. The Operator is conducting reclamation contemporaneously as the mining advances, as evidenced by the reclaimed highwalls located along the east and south portions of the active pit area. (Photos 1, 2 and 3)

View northeast, taken nearby the south boundary of the existing permit area, showing portions of the active pit area.

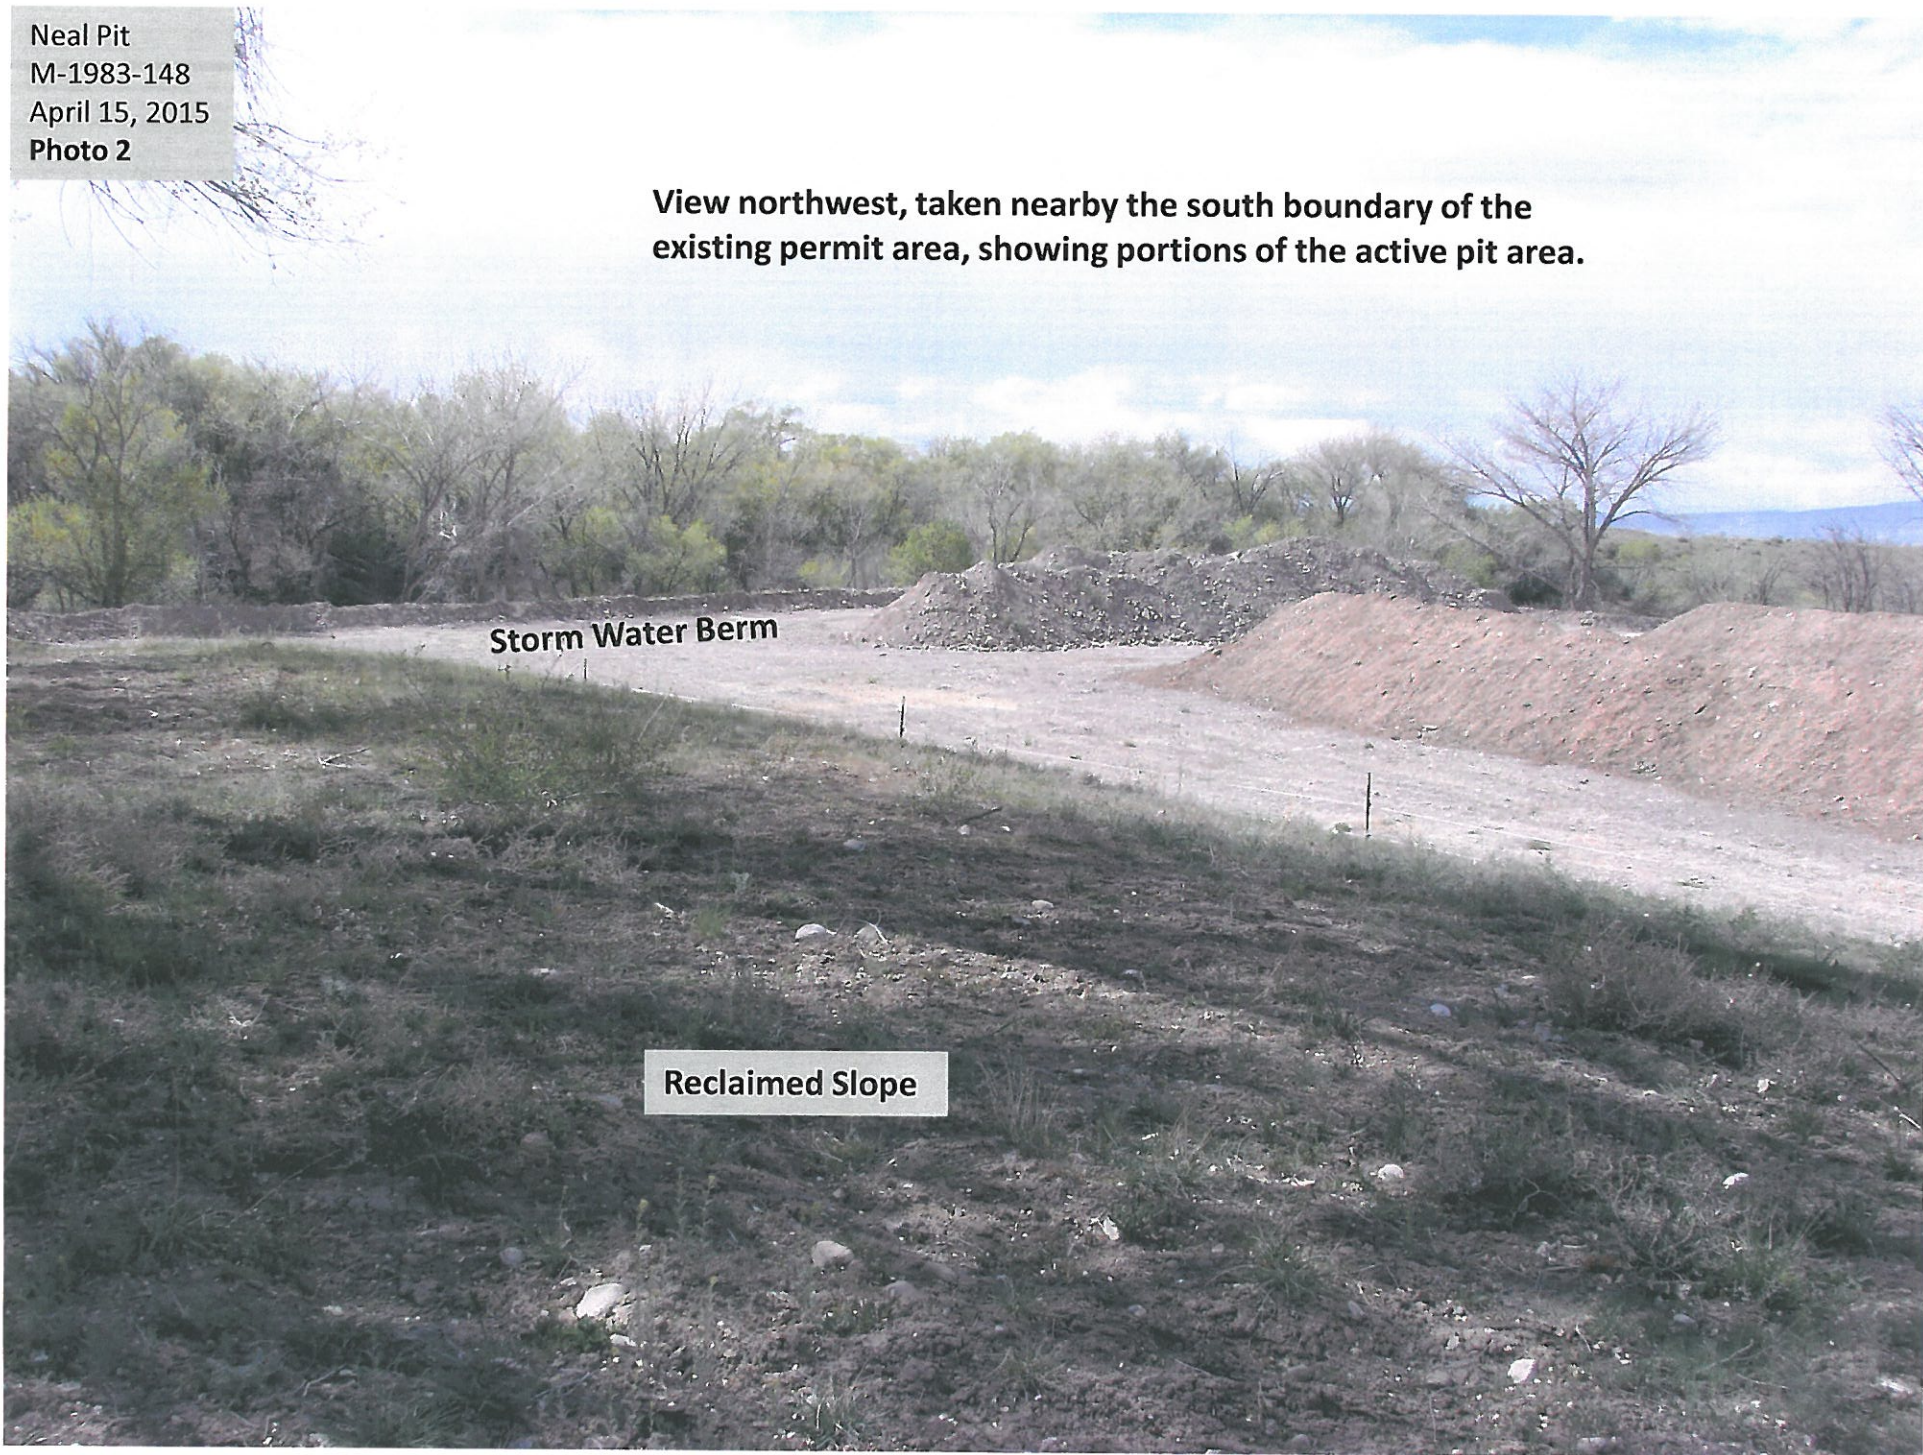
Neal Pit
M-1983-148
April 15, 2015
Photo 2

View northwest, taken nearby the south boundary of the existing permit area, showing portions of the active pit area.

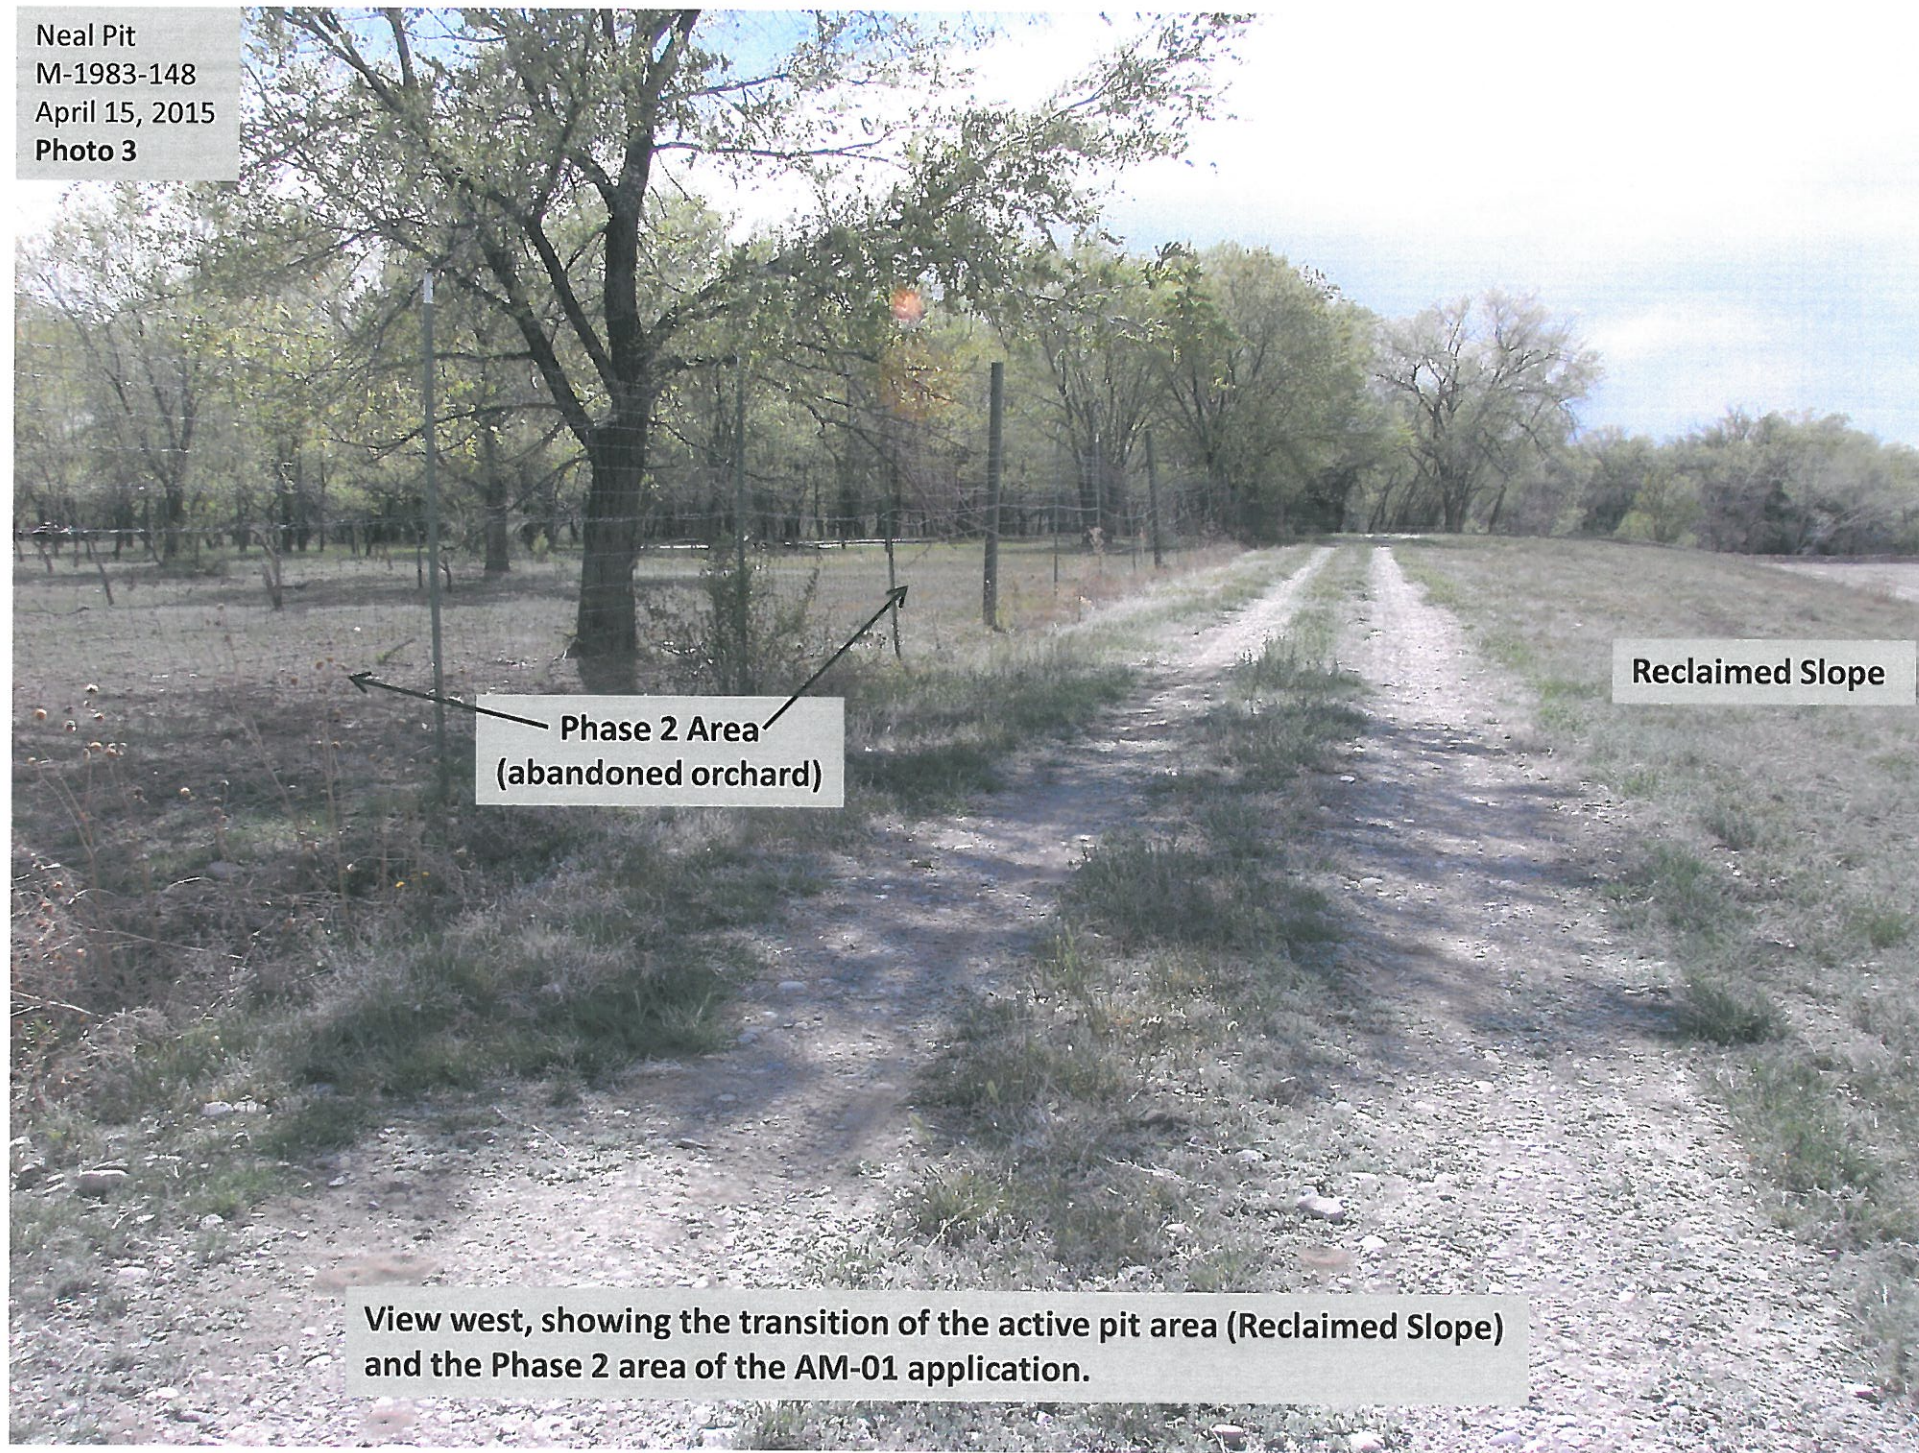
Neal Pit
M-1983-148
April 15, 2015
Photo 3

View west, showing the transition of the active pit area (Reclaimed Slope) and the Phase 2 area of the AM-01 application.
