**COLORADO DIVISION OF RECLAMATION, MINING AND SAFETY**  
**MINERALS PROGRAM INSPECTION REPORT**  
**PHONE: (303) 866-3567**

| <b>MINE NAME:</b><br>C-LP-21 Mine | <b>MINE/PROSPECTING ID#:</b><br>M-1977-305 | <b>MINERAL:</b><br>Uranium and Vanadium | <b>COUNTY:</b><br>Montrose |
| <b>INSPECTION TYPE:</b><br>Monitoring | <b>INSPECTOR(S):</b><br>Dustin Czapla | <b>INSP. DATE:</b><br>April 29, 2015 | <b>INSP. TIME:</b><br>14:00 |

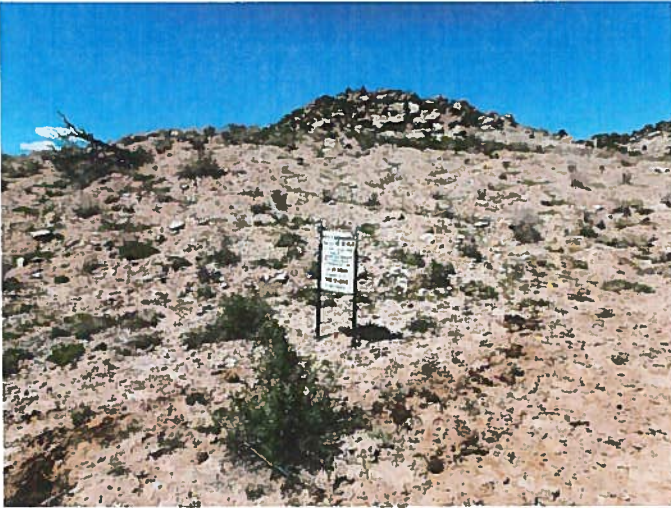
Figure 1: Reclaimed waste rock pile

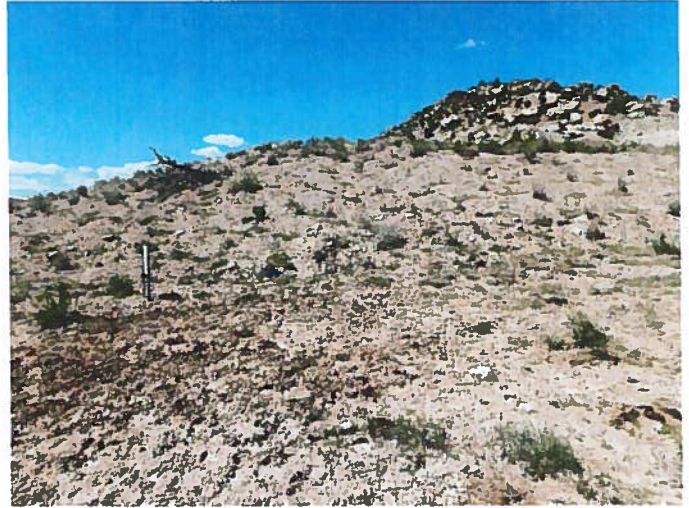
Figure 2: Reclaimed waste rock pile

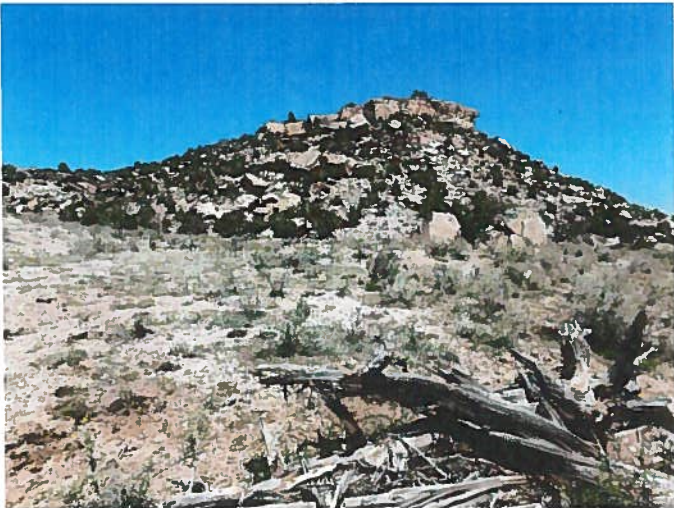
Figure 3: View toward the reclaimed portal
