COLORADO DIVISION OF RECLAMATION, MINING AND SAFETY
MINERALS PROGRAM INSPECTION REPORT
PHONE: (303) 866-3567

MINE NAME: JD-9 Mine	MINE/PROSPECTING ID#: M-1977-306	MINERAL: Uranium and vanadium	COUNTY: Montrose
INSPECTION TYPE: Monitoring	INSPECTOR(S): Dustin Czapla	INSP. DATE: April 29, 2015	INSP. TIME: 12:30
OPERATOR: Cotter Corporation	OPERATOR REPRESENTATIVE: Jim Sheridan	TYPE OF OPERATION: 112d-1 - Designated Mining Operation

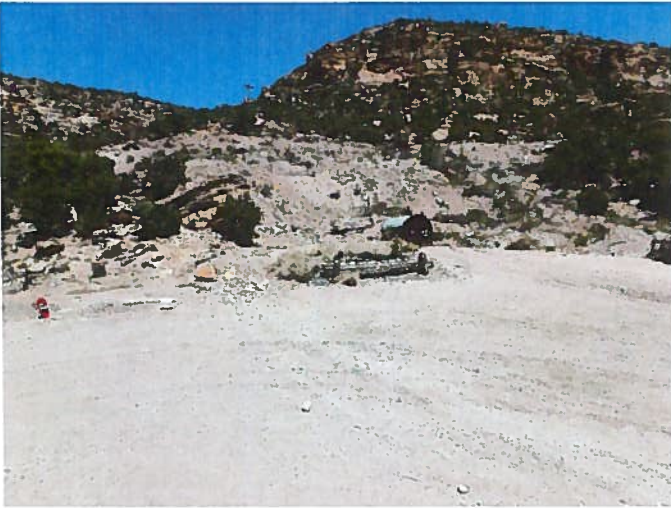
The Bull Canyon area conditions appeared unchanged from the Division's last inspection. There is a mine building located on the main mine bench area. Several pieces of dilapidated equipment and refuse were observed around the building. An empty fuel tank in a lined containment pit is located here. The portal in this area collapsed years ago and has not yet been reopened.

Figure 1: Collapsed portal

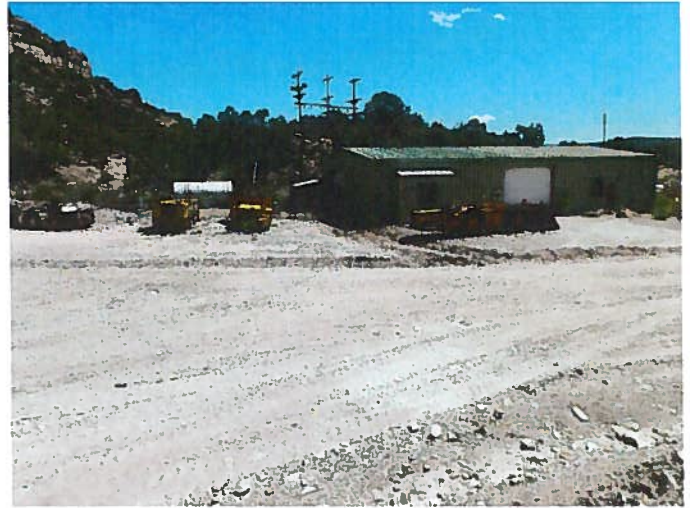
Figure 2: Shop area

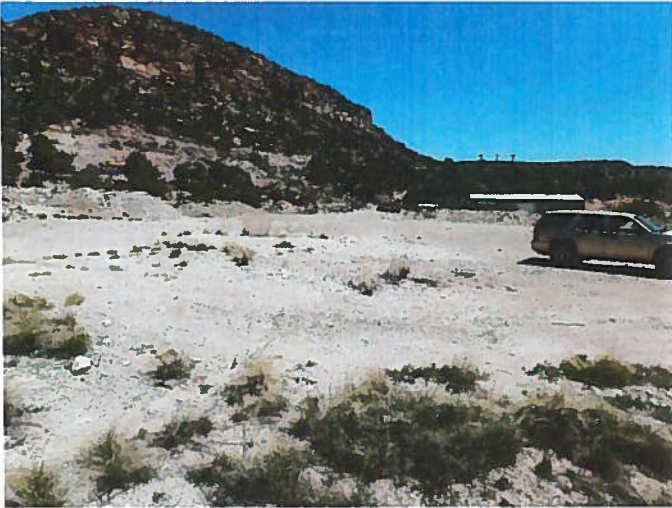
Figure 3: Mine bench

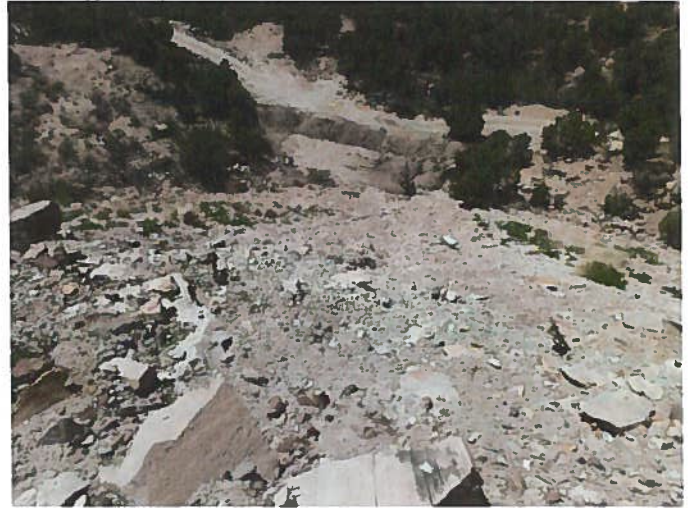
Figure 4: Retention pond

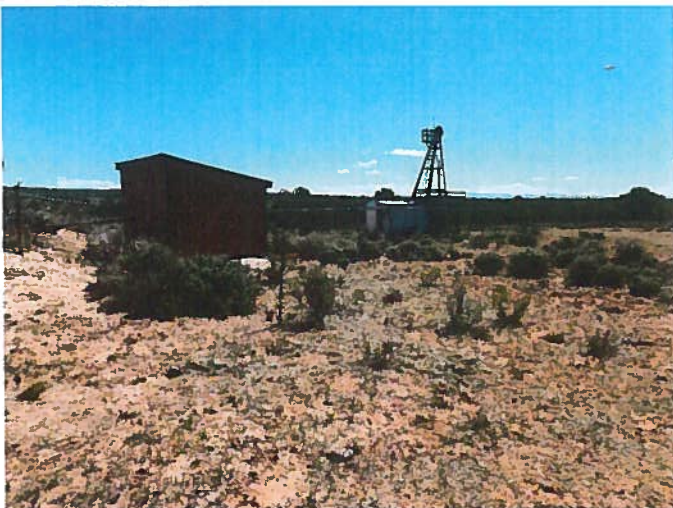
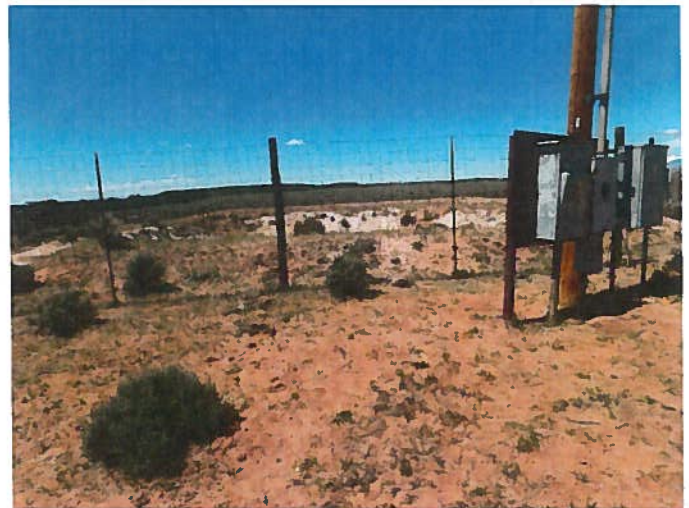
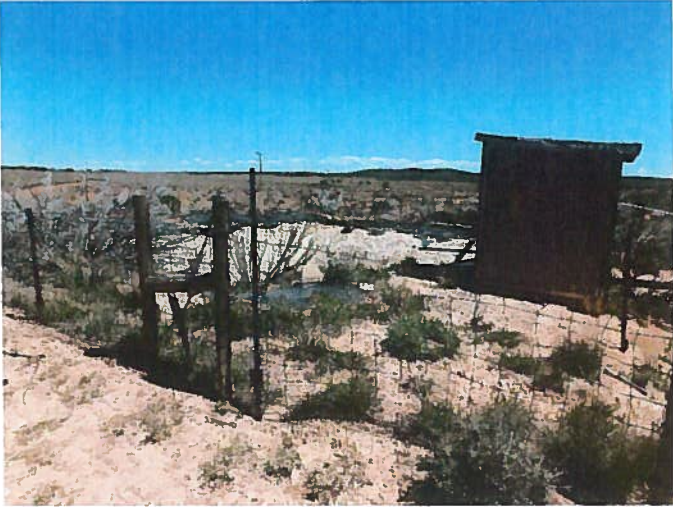
Vent fans and water treatment plant are located in this area. The water treatment plant is not currently in use. Treatment ponds were dry during the inspection. Facilities in this area appeared secure.

Figure 5: Water treatment area
