**COLORADO DIVISION OF RECLAMATION, MINING AND SAFETY**  
**MINERALS PROGRAM INSPECTION REPORT**  
**PHONE: (303) 866-3567**

<b>MINE NAME:</b> CM-25 Mine	<b>MINE/PROSPECTING ID#:</b> M-1977-307	<b>MINERAL:</b> Uranium and vanadium	<b>COUNTY:</b> Montrose
<b>INSPECTION TYPE:</b> Monitoring	<b>INSPECTOR(S):</b> Dustin Czapla	<b>INSP. DATE:</b> April 29, 2015	<b>INSP. TIME:</b> 15:00
<b>OPERATOR:</b> Cotter Corporation	<b>OPERATOR REPRESENTATIVE:</b> Jim Sheridan	<b>TYPE OF OPERATION:</b> 110d - Designated Limited Impact

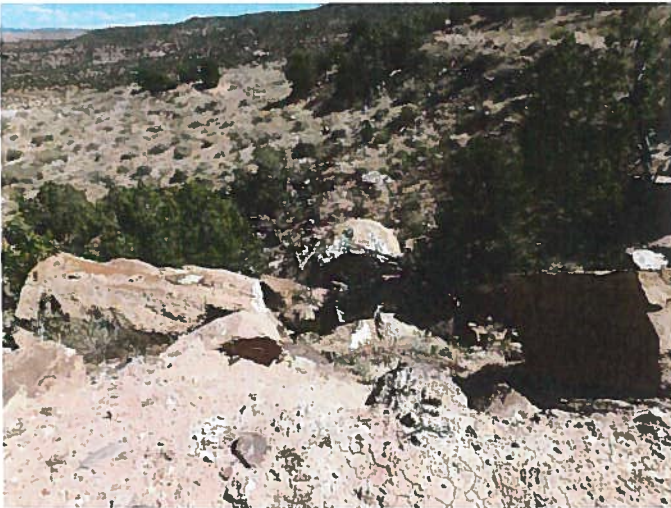
Figure 1: Looking east toward portal and waste dump.

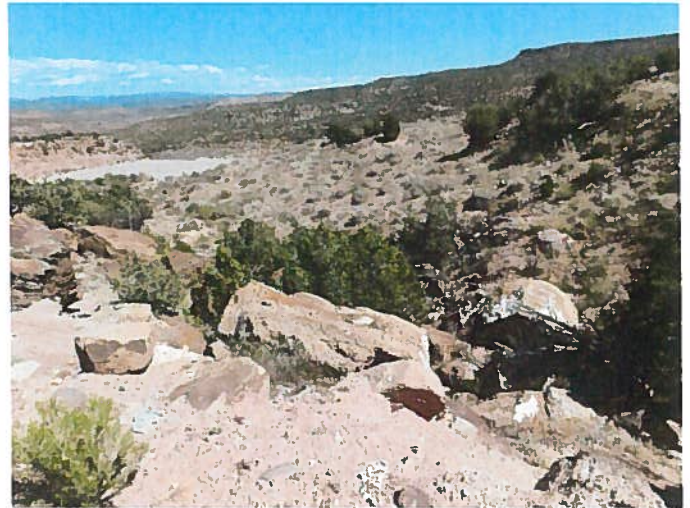
Figure 2: Looking east toward portal and waste dump.
