COLORADO DIVISION OF RECLAMATION, MINING AND SAFETY
MINERALS PROGRAM INSPECTION REPORT
PHONE: (303) 866-3567

| MINE NAME: SM-18 Mine | MINE/PROSPECTING ID#: M-1978-116 | MINERAL: Uranium and vanadium | COUNTY: Montrose |
| INSPECTION TYPE: Monitoring | INSPECTOR(S): Dustin Czapla | INSP. DATE: April 29, 2015 | INSP. TIME: 16:00 |

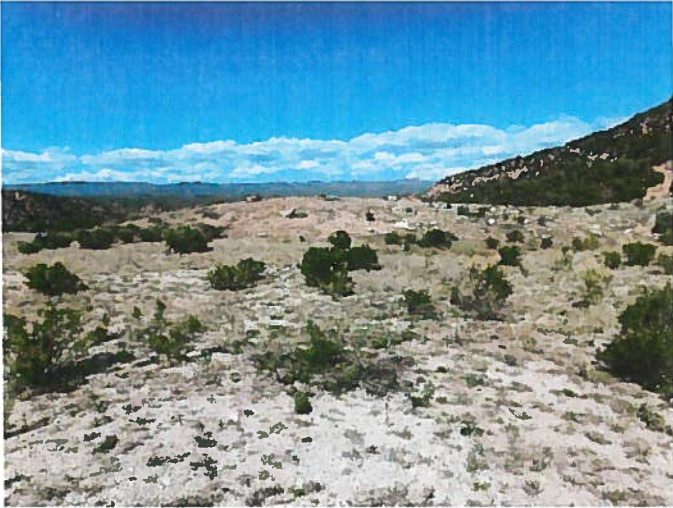
The north portion of the affected area, on the north side of Spring Creek Mesa, consists of the old reclaimed portal and mine area. A steel building is located in this area. Vegetation in this area is becoming well established.

Figure 1: Reclaimed waste rock pile on north side of Spring Creek Mesa

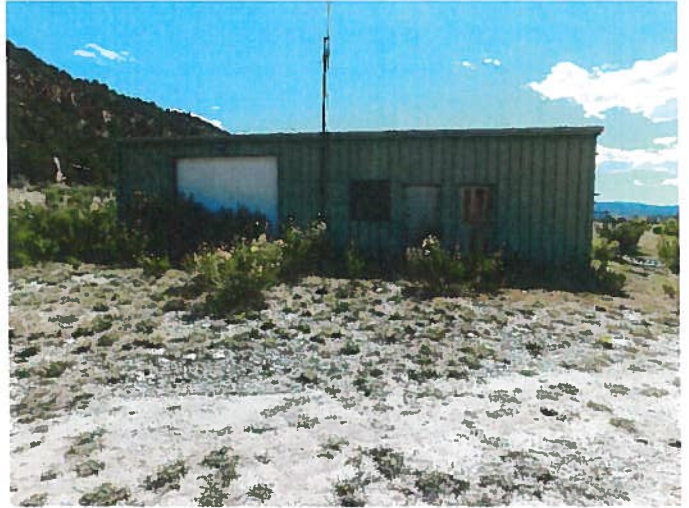
Figure 2: Mine building located on north side of Spring Creek Mesa

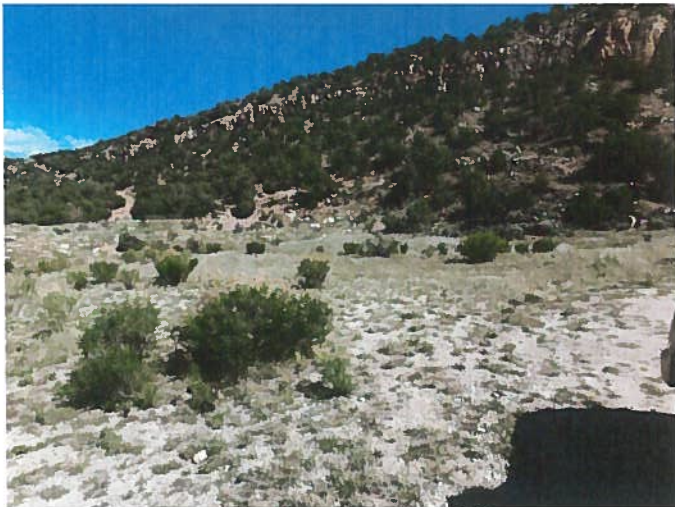
Figure 3: Reclaimed portal on north side of Spring Creek Mesa

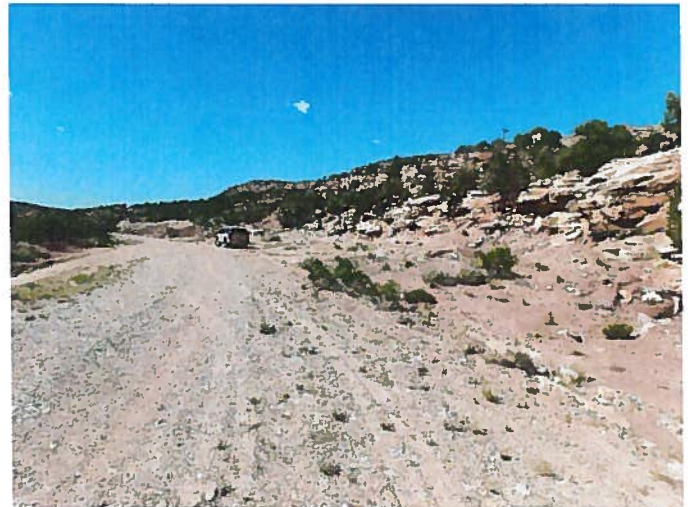
Figure 4: Stormwater retention area

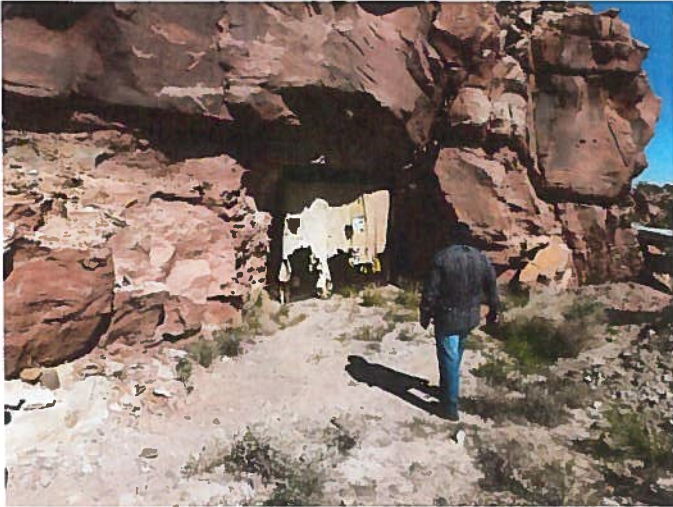
Figure 5: Wright portal

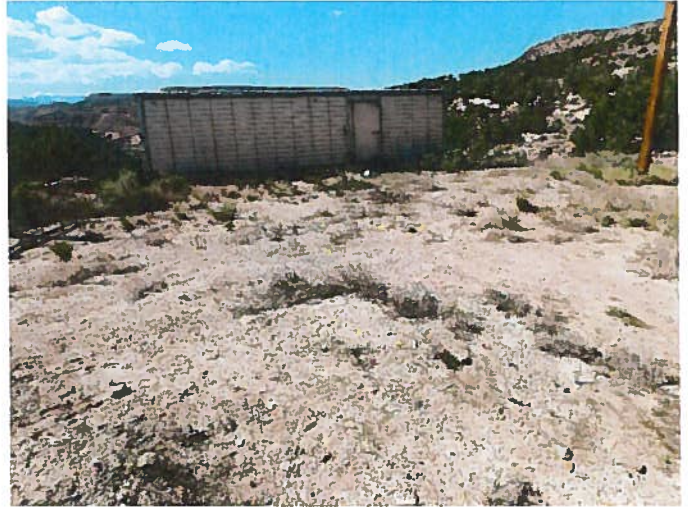
Figure 6: Operations area above Wright Portal

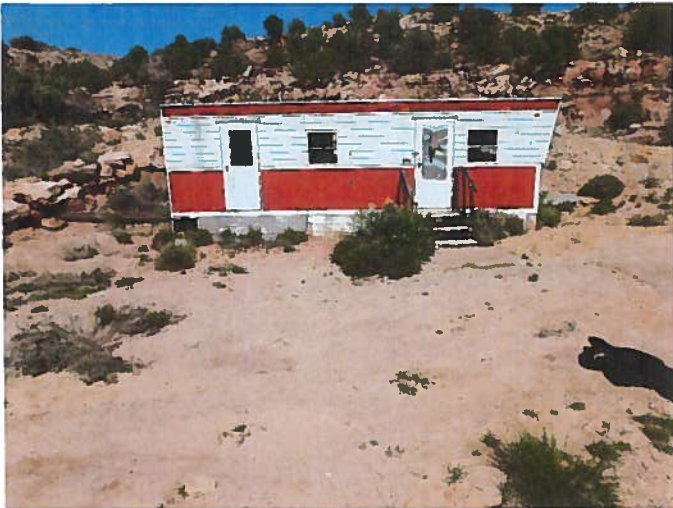
Figure 7: Operations area above Wright Portal

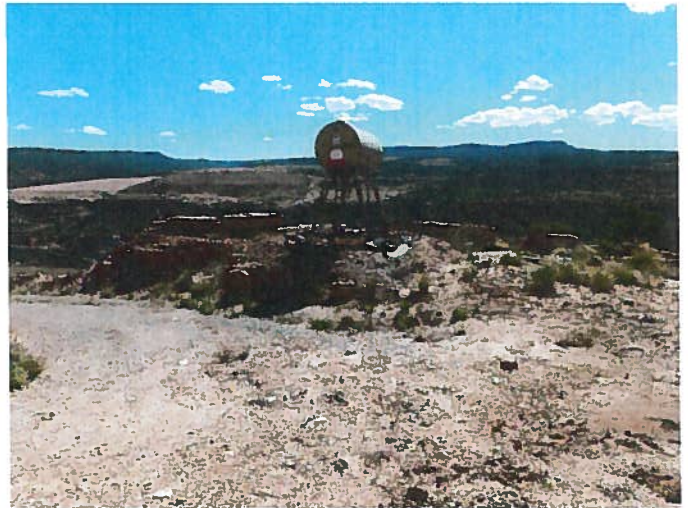
Figure 8: Operations area above Wright Portal
