COLORADO DIVISION OF RECLAMATION, MINING AND SAFETY
MINERALS PROGRAM INSPECTION REPORT
PHONE: (303) 866-3567

MINE NAME: C-JD-8	MINE/PROSPECTING ID#: M-1984-014	MINERAL: Uranium and vanadium	COUNTY: Montrose
INSPECTION TYPE: Monitoring	INSPECTOR(S): Dustin M. Czapla	INSP. DATE: April 29, 2015	INSP. TIME: 11:30
OPERATOR: Cotter Corporation	OPERATOR REPRESENTATIVE: Jim Sheridan	TYPE OF OPERATION: 112d-1 - Designated Mining Operation

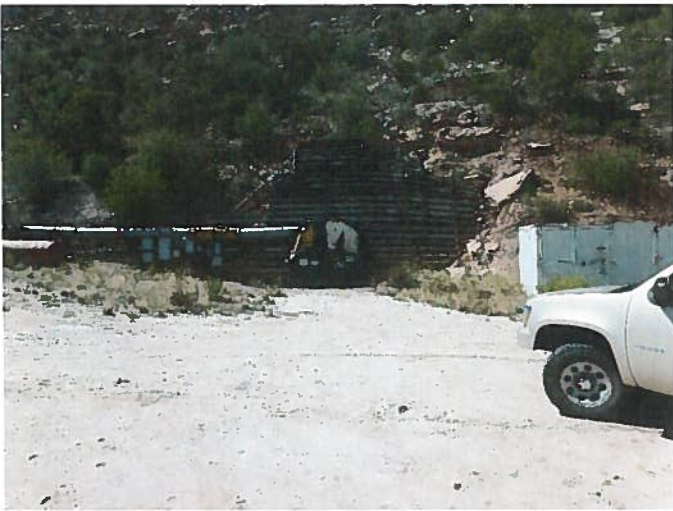
Figure 1: JD-8 portal

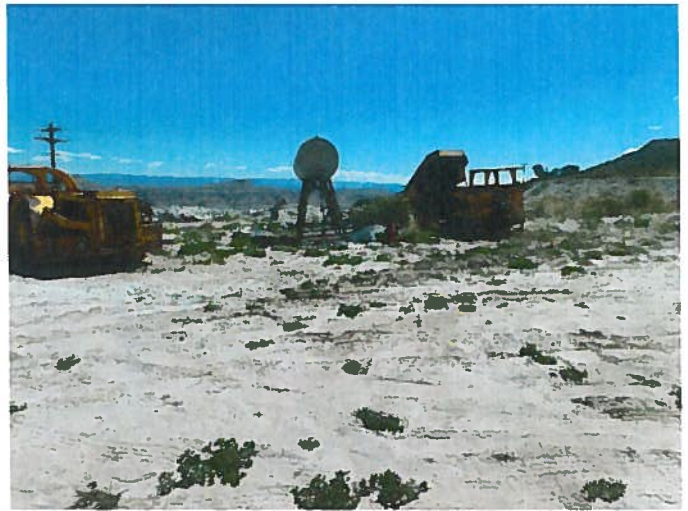
Figure 2: Operations area on mine bench

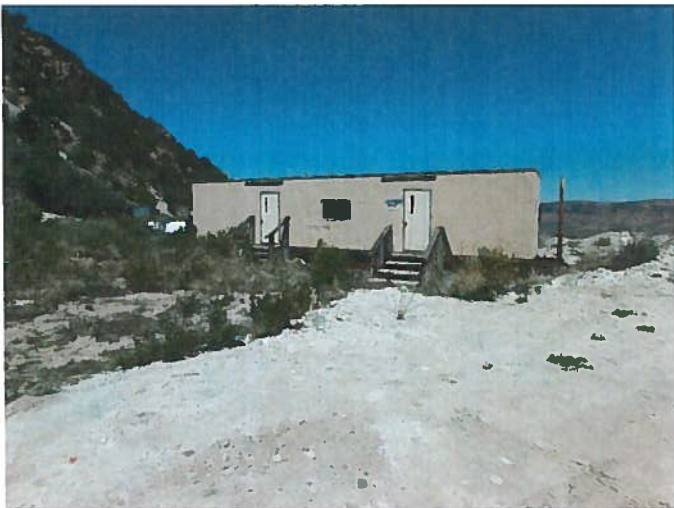
Figure 3: Operations area on mine bench

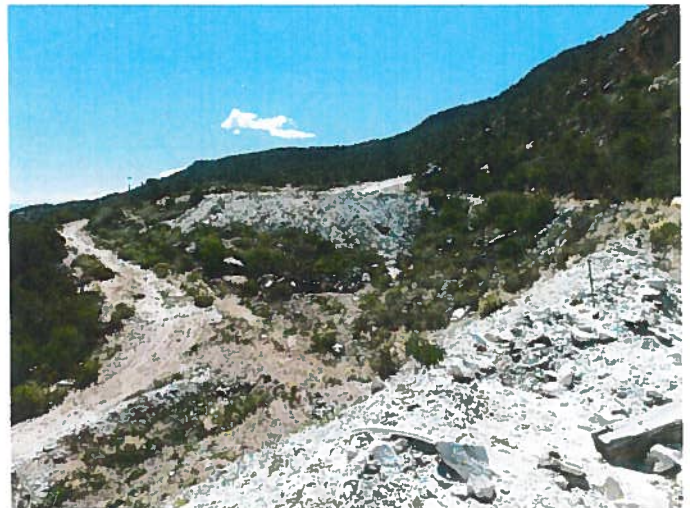
The sites storm water control features appeared to be functioning properly.

Figure 4: Sediment retention pond and waste rock dump on east side of mine bench
