COLORADO DIVISION OF RECLAMATION, MINING AND SAFETY
MINERALS PROGRAM INSPECTION REPORT
PHONE: (303) 866-3567

MINE NAME: JD-7 Pit	MINE/PROSPECTING ID#: M-1979-094-HR	MINERAL: Uranium and vanadium	COUNTY: Montrose
INSPECTION TYPE: Monitoring	INSPECTOR(S): Dustin Czapla	INSP. DATE: April 29, 2015	INSP. TIME: 10:00
OPERATOR: Cotter Corporation	OPERATOR REPRESENTATIVE: Jim Sheridan	TYPE OF OPERATION: 112d-3 - Designated Mining Operation

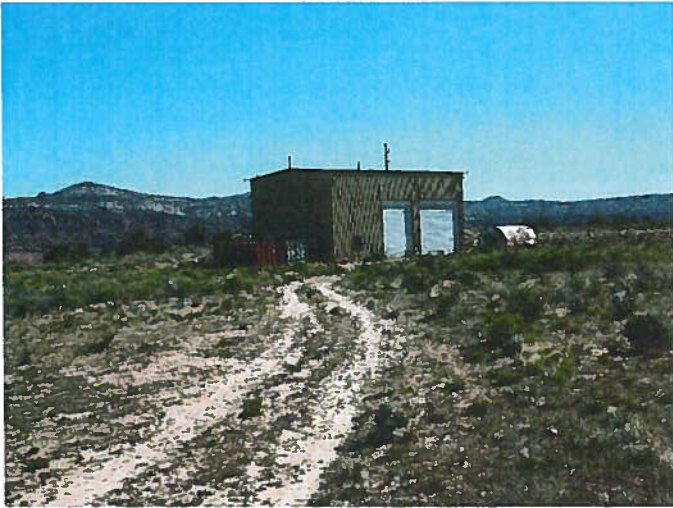
Figure 1: Shop area on northeast side of pit

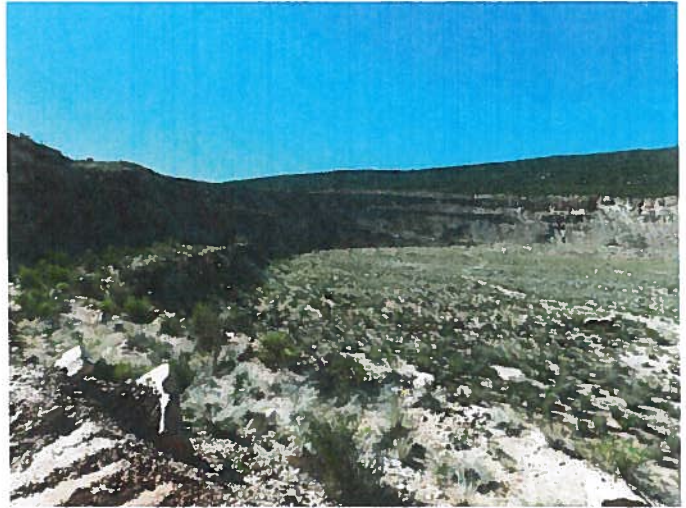
The pit floor and dump area to the west appeared to be well vegetated and stable. A benched highwall, with overall slopes approximately 1H:1V, is located on the east and south sides of the pit. No major stability issues were noted during this inspection.

Figure 2: East highwall

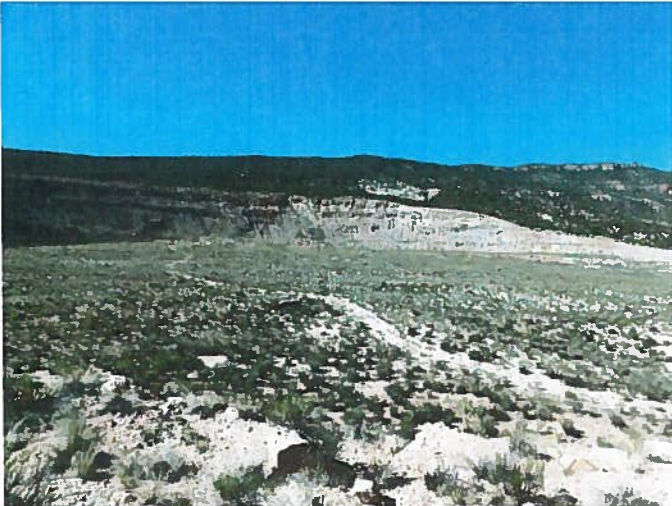
Figure 3: View toward south highwall

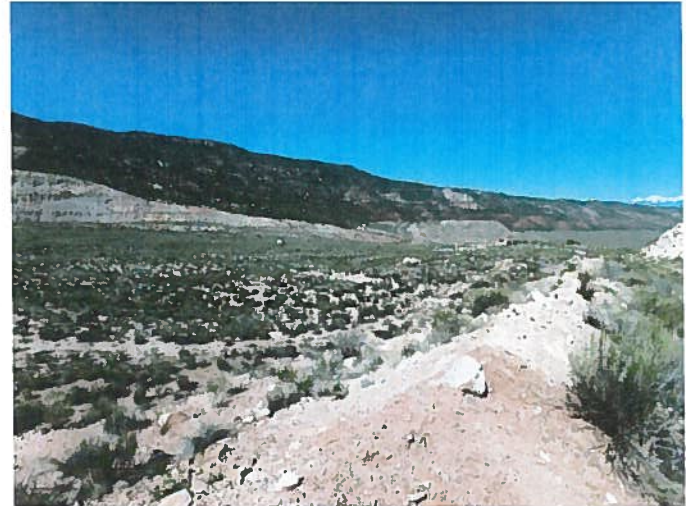
Figure 4: View toward south highwall

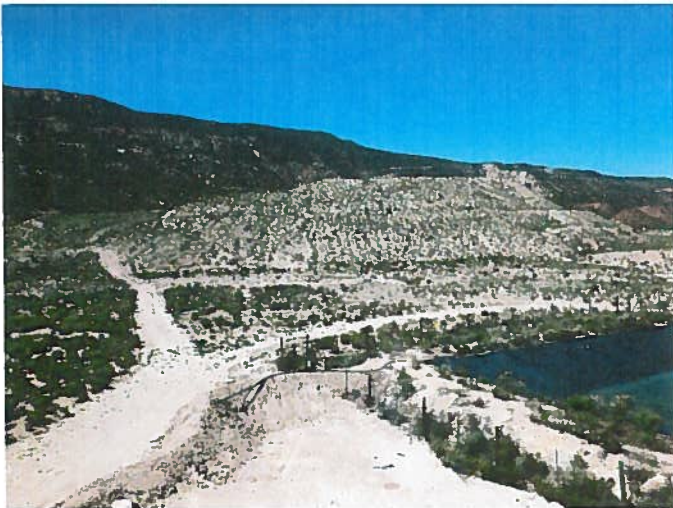
Figure 5: View toward waste rock pile

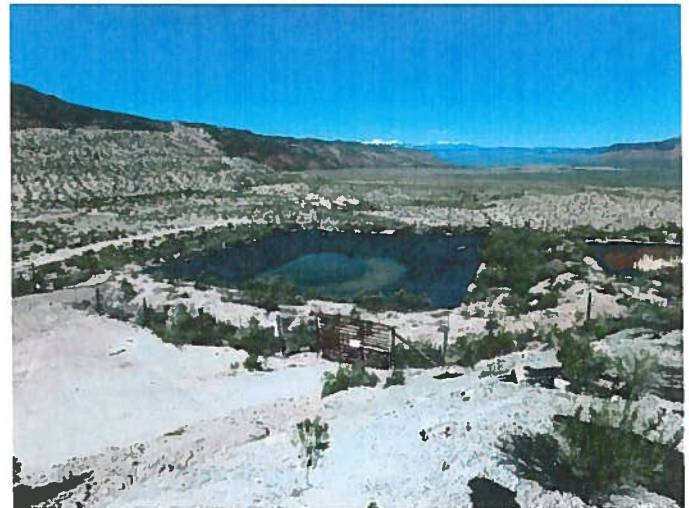
Settling ponds, located just west of the office area, appeared to be functioning properly.

Figure 6: Retention ponds

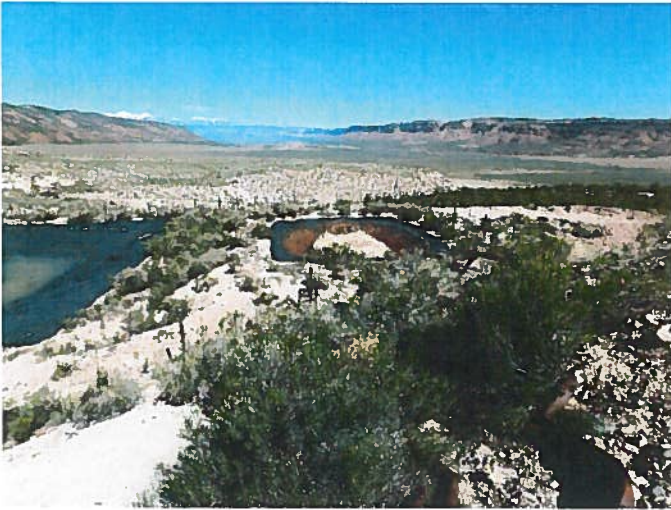
Figure 7: Retention ponds

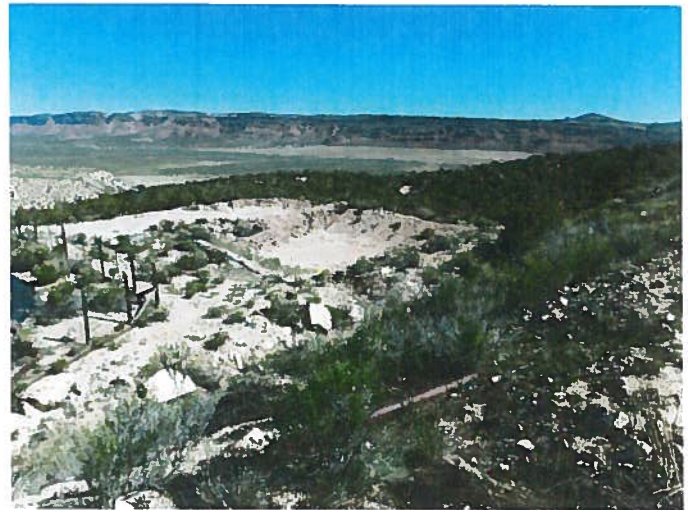
Figure 8: Retention ponds

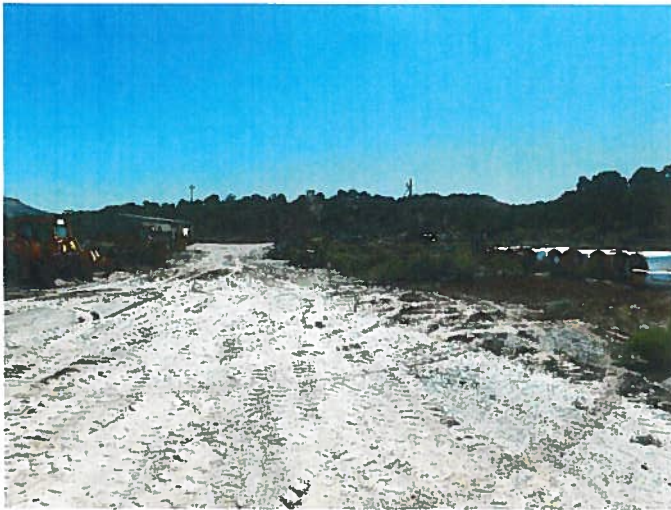
Figure 9: Shop/maintenance area
