**COLORADO DIVISION OF RECLAMATION, MINING AND SAFETY**  
**MINERALS PROGRAM INSPECTION REPORT**  
**PHONE: (303) 866-3567**

<b>MINE NAME:</b> CM-25	<b>MINE/PROSPECTING ID#:</b> P-2009-021	<b>MINERAL:</b> Uranium	<b>COUNTY:</b> Montrose
<b>INSPECTION TYPE:</b> Monitoring	<b>INSPECTOR(S):</b> Dustin Czaplá	<b>INSP. DATE:</b> April 29, 2015	<b>INSP. TIME:</b> 14:30
<b>OPERATOR:</b> Cotter Corporation	<b>OPERATOR REPRESENTATIVE:</b> Jim Sheridan	<b>TYPE OF OPERATION:</b> MP - Mineral Prospecting

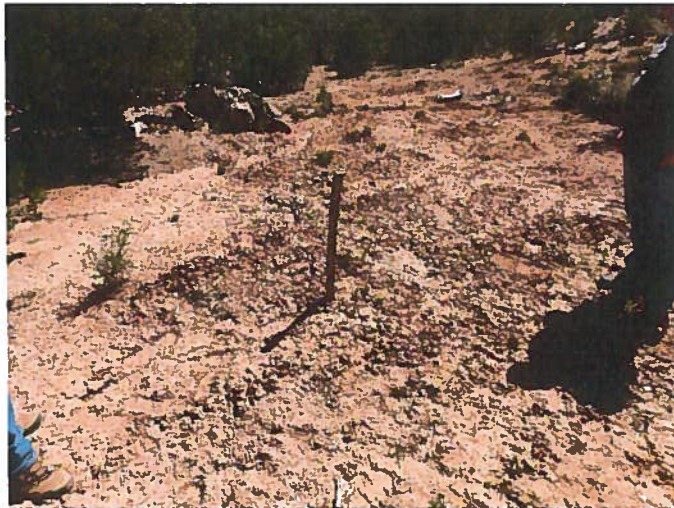
Figure 1: CM-25 drill hole

This inspection verified that reclamation of the hole is complete. No sign of subsidence was noted.

The Division recommends the Operator submit a release request for this project.
