COLORADO DIVISION OF RECLAMATION, MINING AND SAFETY
MINERALS PROGRAM INSPECTION REPORT
PHONE: (303) 866-3567

MINE NAME: C-JD-5	MINE/PROSPECTING ID#: M-1977-248	MINERAL: Uranium and vanadium	COUNTY: Montrose
INSPECTION TYPE: Monitoring	INSPECTOR(S): Dustin Czapla	INSP. DATE: April 29, 2015	INSP. TIME: 09:30
OPERATOR: Gold Eagle Mining, Inc.	OPERATOR REPRESENTATIVE: None	TYPE OF OPERATION: 112d-1 - Designated Mining Operation

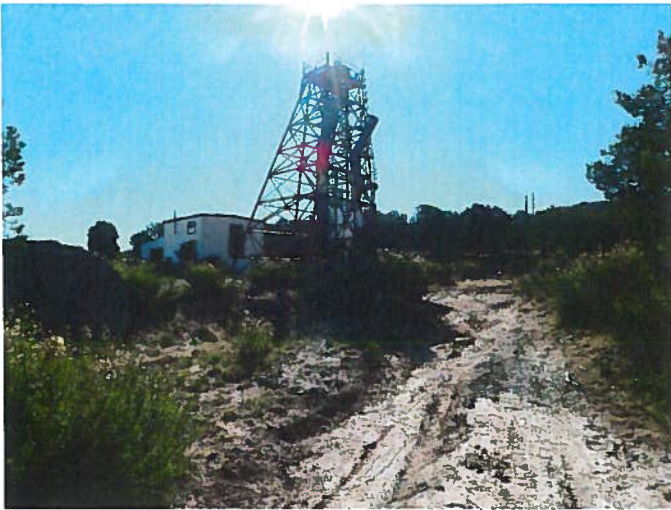
Figure 1: Primary shaft and hoist

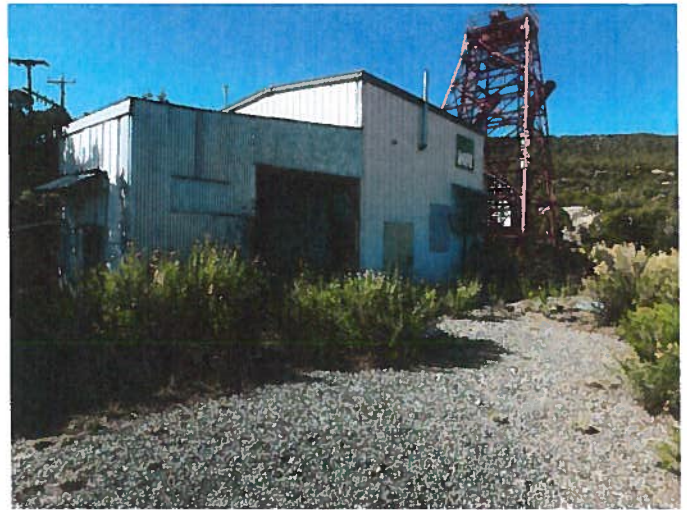
Adequate mine identification signage was posted on the hoist house visible from the entrance to the mine site.

The mine building remains damaged do to vandalism. A portion of the west facing wall was torn out during theft of an air tank.

Figure 2: Hoist house

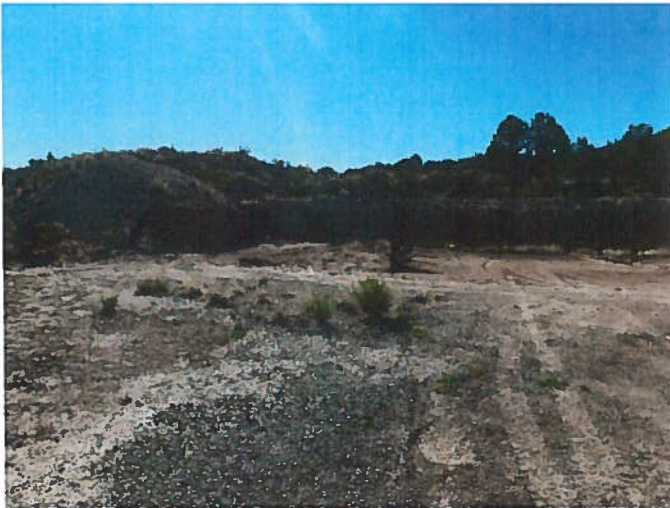
Figure 3: Ore pad

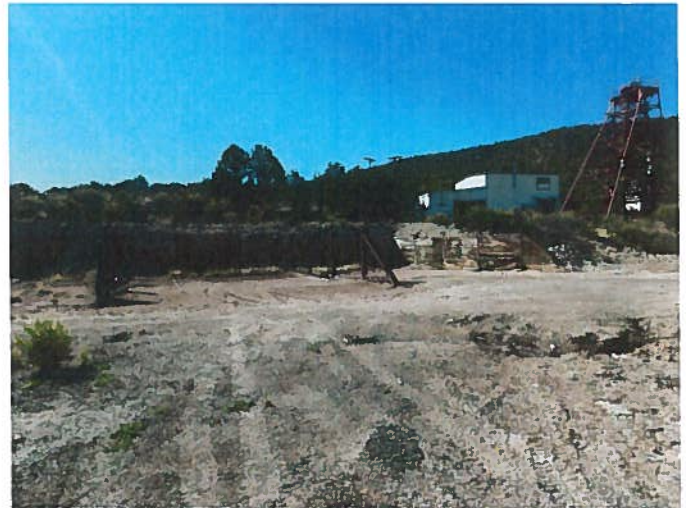
Figure 4: Ore pad
