COLORADO DIVISION OF RECLAMATION, MINING AND SAFETY MINERALS PROGRAM INSPECTION REPORT

MINE NAME: Van 4 Shaft	MINE/PROSPECTING ID#: M-1997-032	MINERAL: Uranium and vanadium	COUNTY: Montrose
INSPECTION TYPE: Monitoring	INSPECTOR(S): Dustin M. Czaplá	INSP. DATE: April 29, 2015	INSP. TIME: 13:00
OPERATOR: Pinon Ridge Mining LLC	OPERATOR REPRESENTATIVE: None	TYPE OF OPERATION: 110d - Designated Limited Impact

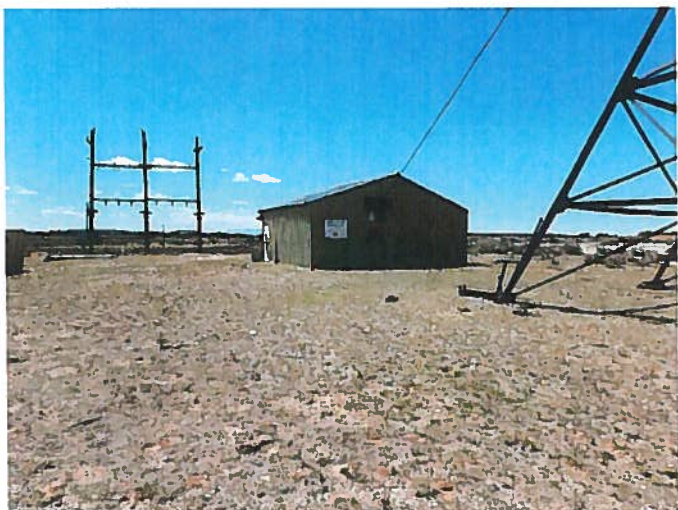
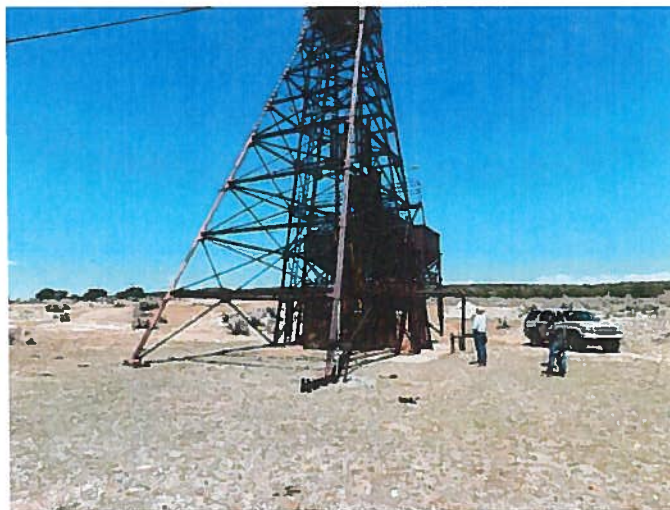
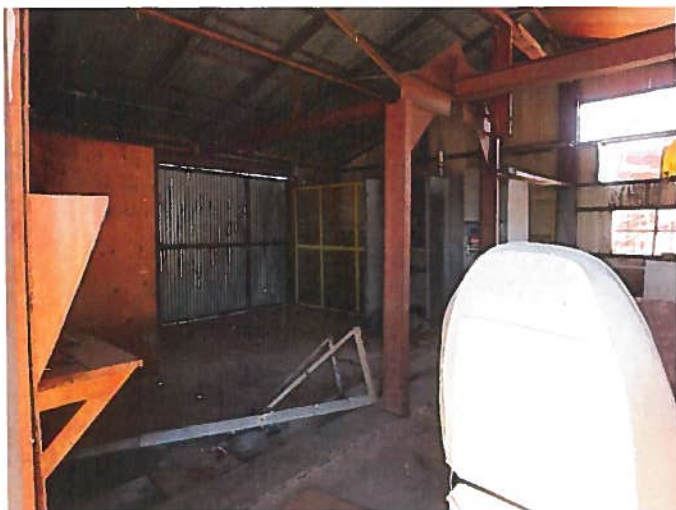
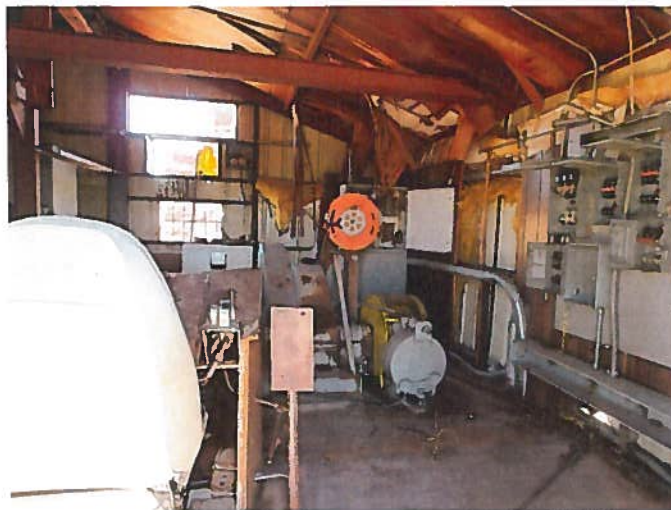
Adequate mine identification signage was located on the hoist building, which is visible from the site entrance.

This site is currently in temporary cessation. The hoist building, hoist and shop are still located on site. No storage of hazardous materials was noted. The mine buildings appear dilapidated due to site inactivity and vandalism.

The shaft is secured with fencing and a padlocked gate.

The drainage ditch adjacent to the county road appeared in good condition.
