**COLORADO DIVISION OF RECLAMATION, MINING AND SAFETY  
MINERALS PROGRAM INSPECTION REPORT**

<b>MINE NAME:</b> Todd Haynes Unpermitted Operation	<b>FILE #:</b> M-2015-024	<b>MINERAL:</b> Sandstone	<b>COUNTY:</b> Ouray
<b>INSPECTION TYPE:</b> Illegal(Unpermitted Operation)	<b>INSPECTOR(S):</b> Dustin Czapla, Lucas West	<b>INSP. DATE:</b> May 19, 2015	<b>INSP. TIME:</b> 11:00
<b>OPERATOR:</b> Todd Haynes	<b>OPERATOR REPRESENTATIVE:</b> Todd Haynes	<b>TYPE OF OPERATION:</b> ILL - Illegal

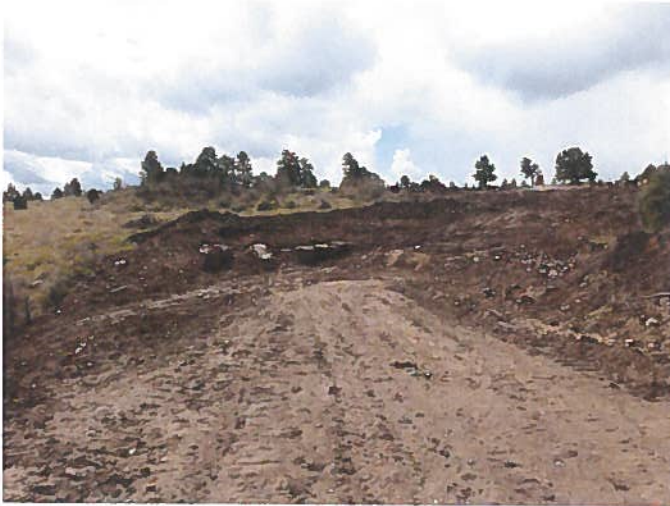
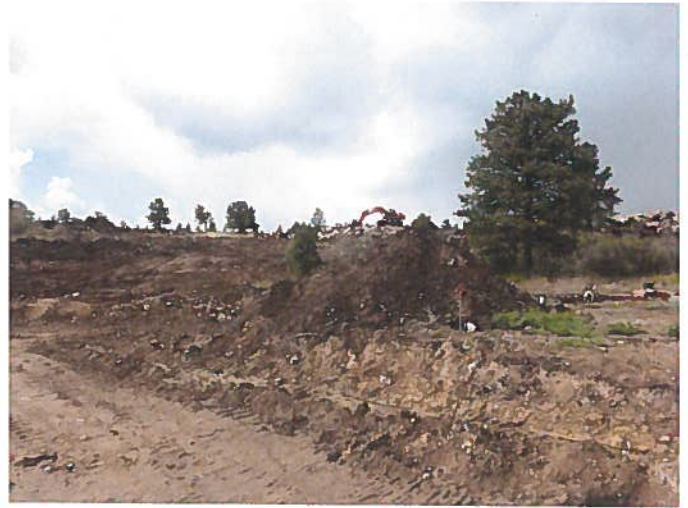
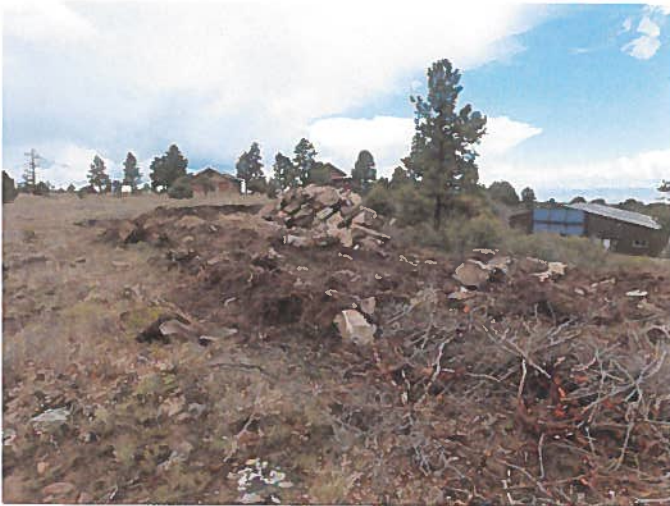
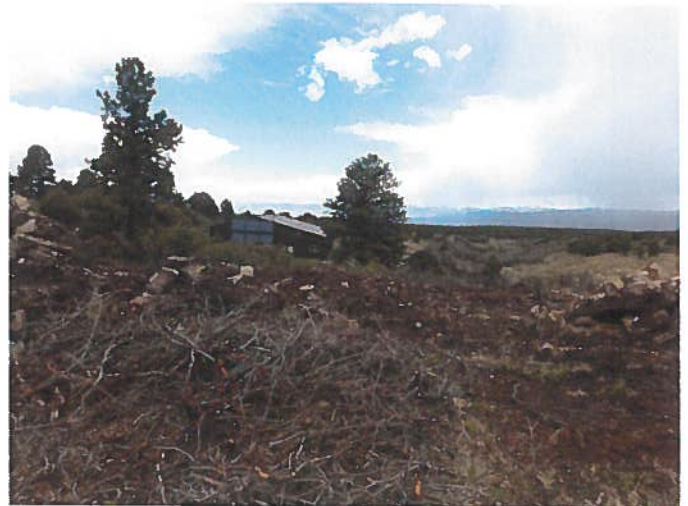
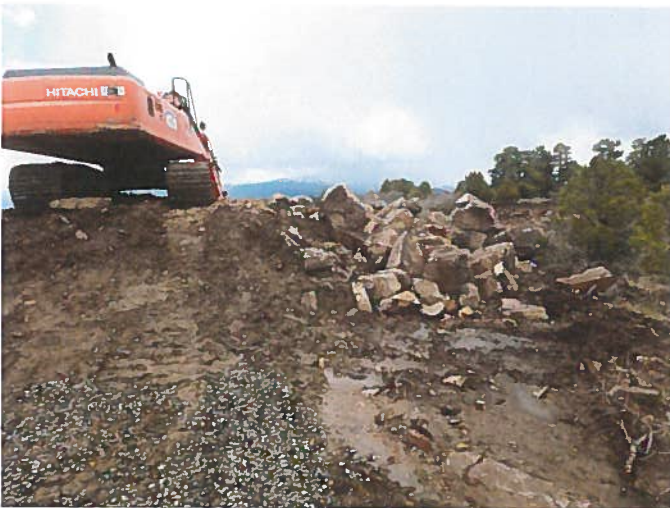
This was an inspection of an unpermitted mining operation. Todd Haynes, landowner and operator, was present during the inspection. Photographs are included with this report in order to illustrate the conditions observed.

The operation removes surplus sandstone boulders from Mr. Haynes property that are generated during land improvement projects on the property. The boulders are used for projects on the property, but also for off-site construction projects, such as the Montrose River Park.

Approximately one acre, on the east side of the gymnasium facility, is currently disturbed by the operation. No imminent hazards, erosion or stability concerns were noted during the inspection.
