**COLORADO DIVISION OF RECLAMATION, MINING AND SAFETY**  
**MINERALS PROGRAM INSPECTION REPORT**  
**PHONE: (303) 866-3567**

<b>MINE NAME:</b> South D-20 Pit	<b>MINE/PROSPECTING ID#:</b> M-1992-102	<b>MINERAL:</b> Sand and gravel	<b>COUNTY:</b> Montrose
<b>INSPECTION TYPE:</b> Monitoring	<b>INSPECTOR(S):</b> Stephanie J. Mitchell	<b>INSP. DATE:</b> April 6, 2015	<b>INSP. TIME:</b> 09:00
<b>OPERATOR:</b> The Uncompahgre Valley Water Users Assoc	<b>OPERATOR REPRESENTATIVE:</b> Ed Supples	<b>TYPE OF OPERATION:</b> 112c - Construction Regular Operation

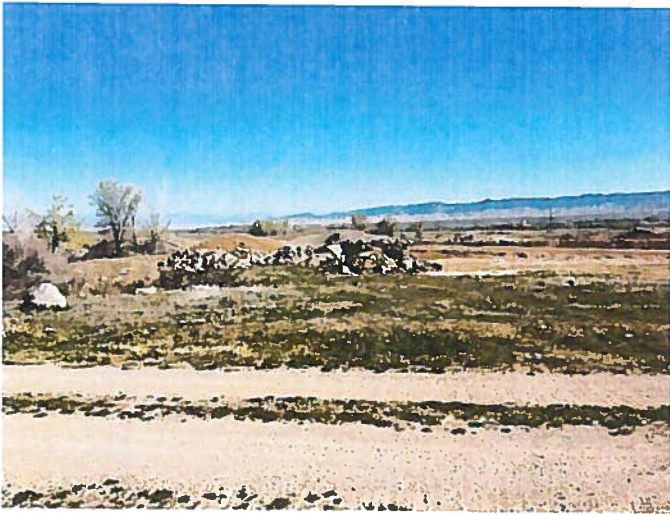
Throughout the site, there were several piles of concrete, asphalt and various pipe debris. These items are considered offsite material. This is also noted as a problem at the beginning of the inspection report.

Offsite Material piles

The operator shall provide a notarized affidavit, stating that the fill is, in fact, inert and addressing all requirements pursuant to Rule 3.1.5(9), which describes the intended use of inert/off-site fill by the corrective action date.

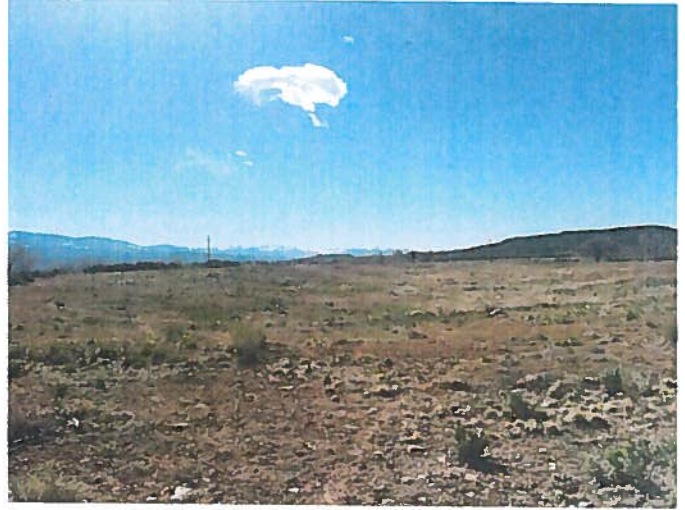
Looking South at Phase 2---undisturbed

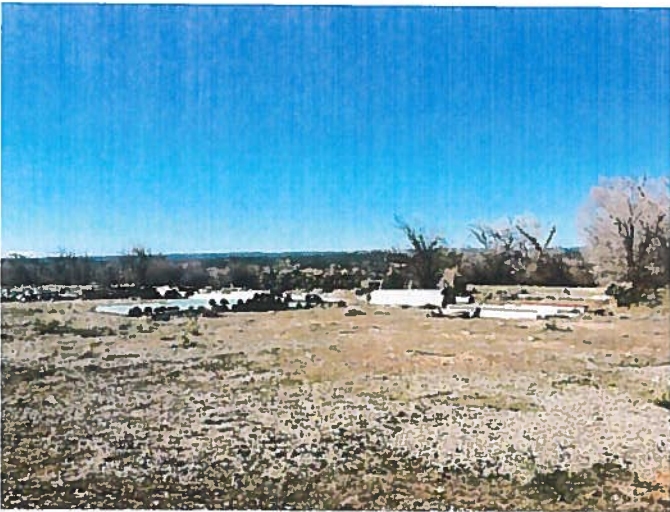
Pipe Storage

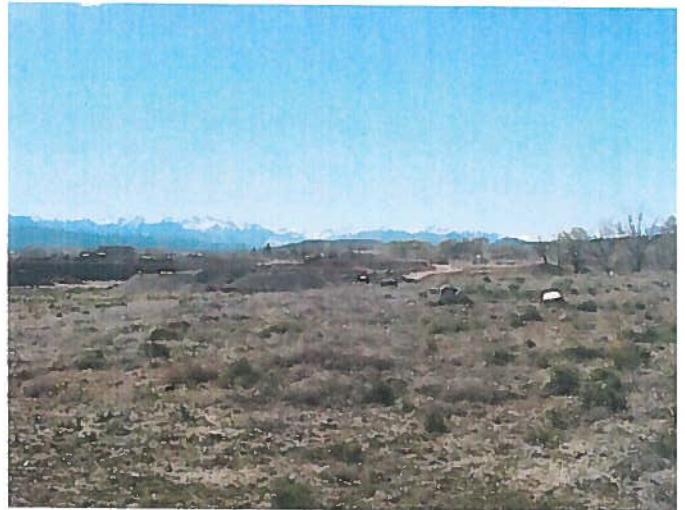
There are two mining areas and there are about 20 acres disturbed in this site, they are designated as Phase 1 and Phase 2. Currently the new Operator, UWVUA has opened up the northern portion of Phase 1 and moving into Phase 2. There is a thirty foot (30') highwall running North-South currently at the site.

Looking South into recently disturbed northern portion of  
Phase 1~ 20 acres

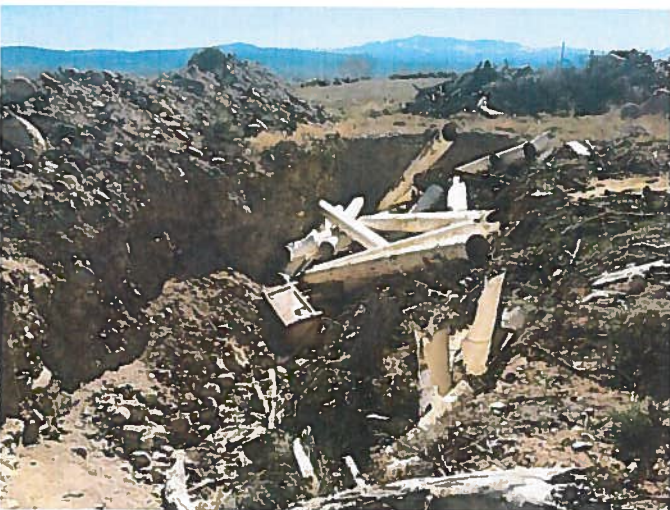
"Burn Pit" - unapproved offsite material

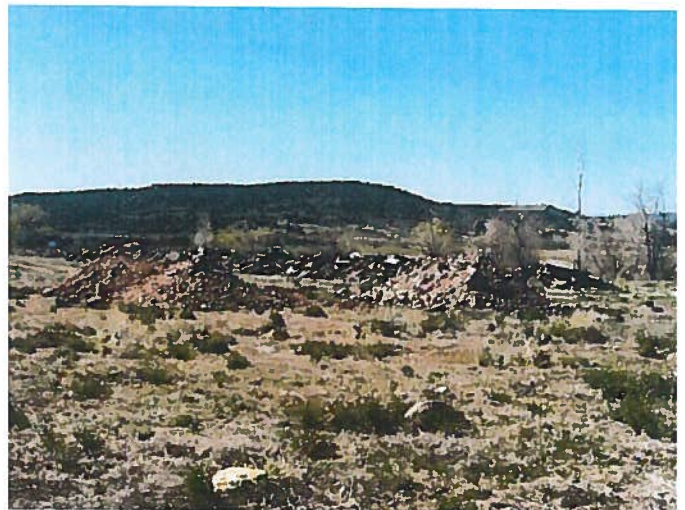
Unapproved offsite material

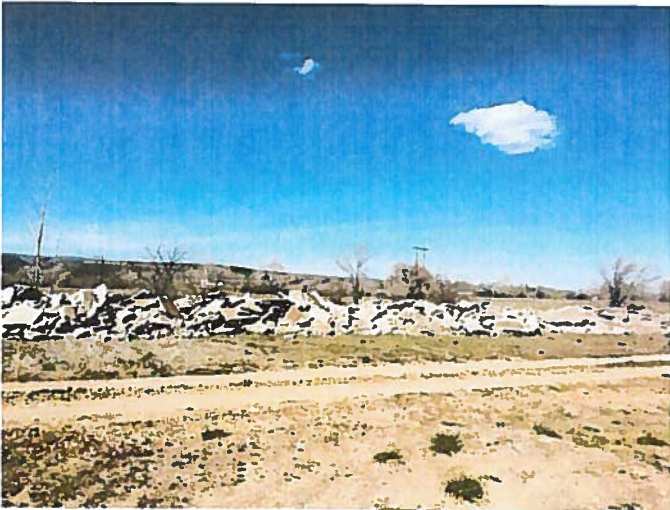
Unapproved Offsite Material

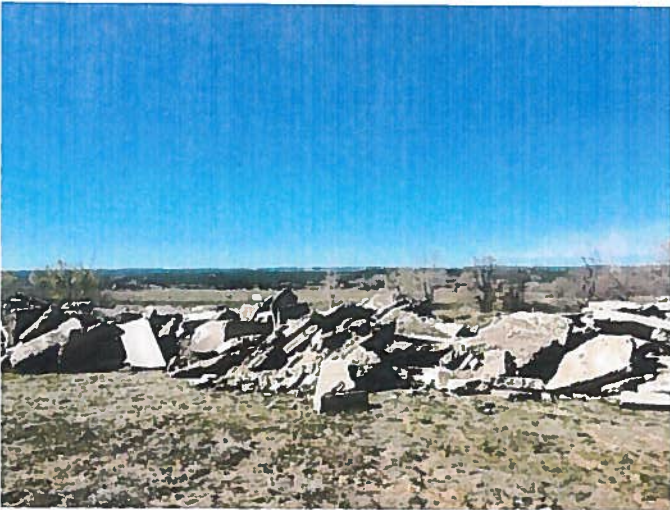
Unapproved Offsite Material

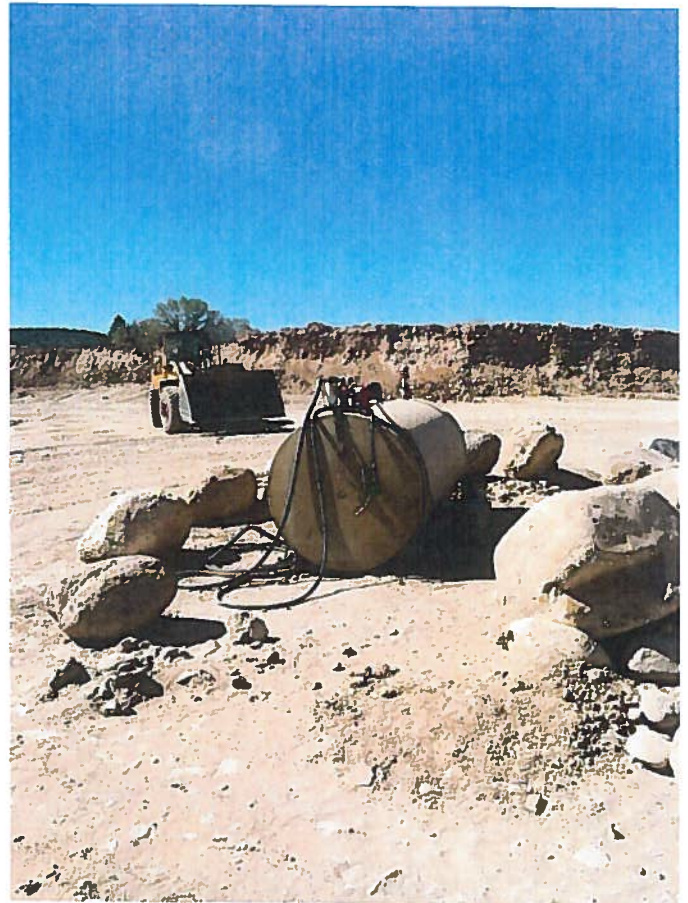
**PROBLEM/POSSIBLE VIOLATION:** Problem: Improper storage and containment of fuels and/or other hazardous materials was present on site.

The southwestern portion of Phase 1 consists of a large stockpiles of overburden that lines the permit boundary. A problem was noted in this portion of the mine area and in the pit area, there are two (2) fuel tanks that do not have secondary containment. This is noted as a problem at the beginning of the inspection report.

Improper Storage of Fuel

**CORRECTIVE ACTIONS:** All storage tanks, petroleum and any hazardous materials on site for any period of time shall have appropriate secondary containment. The site will also have to comply with all applicable SPCC requirements. Please supply photo documentation that any fuel or hazardous materials containers are stored properly - including applicable secondary containment structures by the corrective action date. Note that secondary containment structures shall consist of an impermeable containment which could contain all contents of the tanks and various containers (when full) plus 10% of the total capacity. The operator may also provide photo documentation that all containers have been removed from the site on or before the corrective action date.

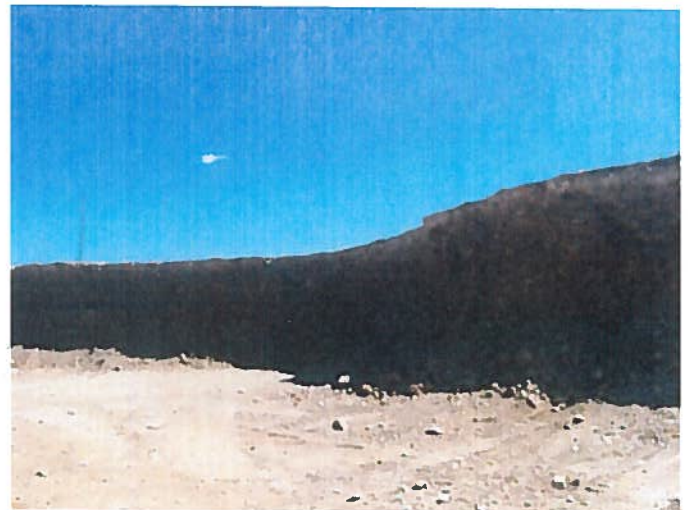
Highwall

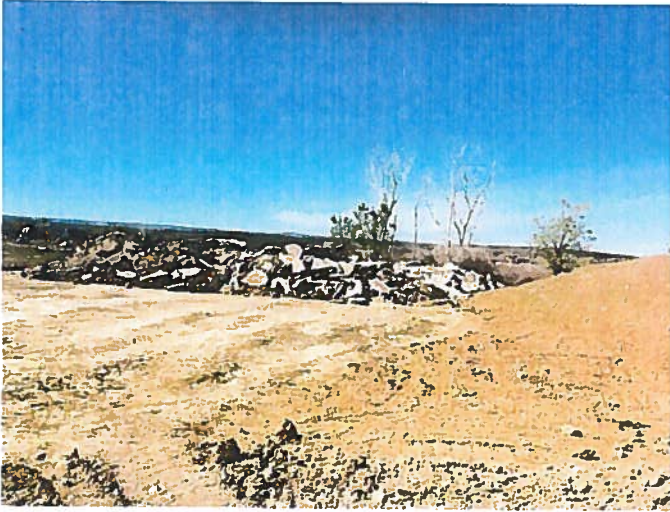
Unapproved Offsite Material
