COLORADO DIVISION OF RECLAMATION, MINING AND SAFETY
MINERALS PROGRAM INSPECTION REPORT
PHONE: (303) 866-3567

MINE NAME: Branson Gravel Pit	MINE/PROSPECTING ID#: M-1997-100	MINERAL: Gravel	COUNTY: Las Animas
INSPECTION TYPE: Preoperation Inspection	INSPECTOR(S): Amy Eschberger	INSP. DATE: May 20, 2015	INSP. TIME: 01:00
OPERATOR: Las Animas County	OPERATOR REPRESENTATIVE: Blair Weurding	TYPE OF OPERATION: 112c - Construction Regular Operation

M1997-100 / Branson Gravel Pit / Las Animas County

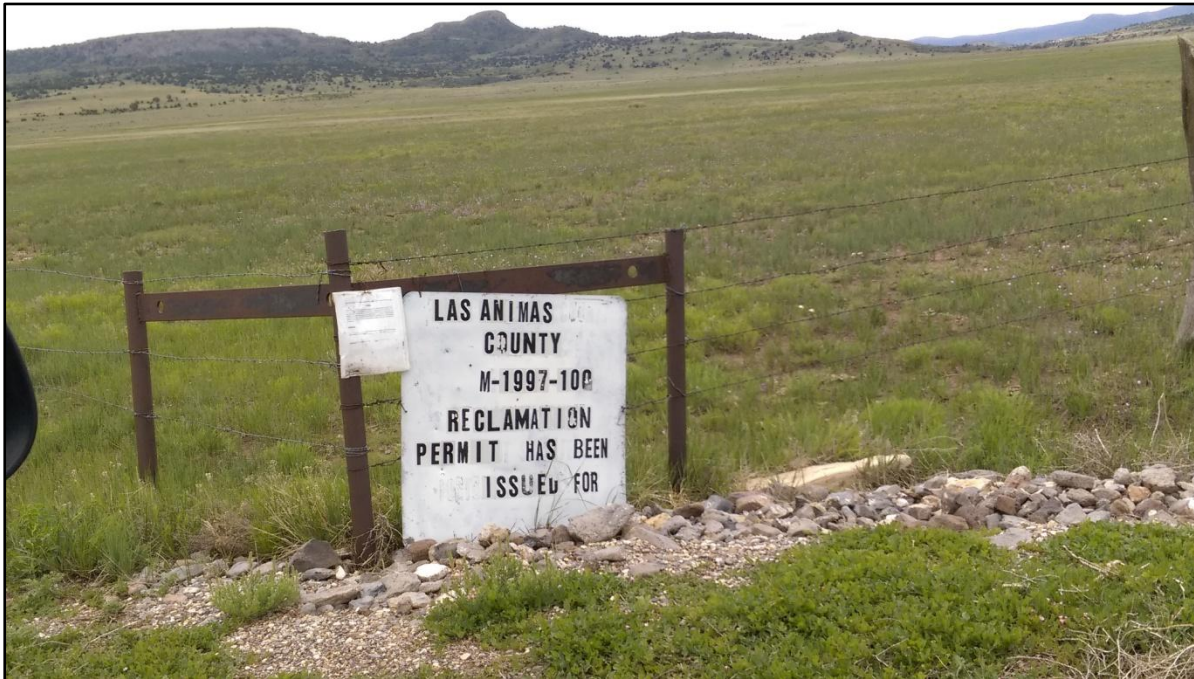
At the time of the inspection, the weather was partly cloudy and cool, and the ground was wet due to recent storm events. Standing water was present in the existing pit, as it was observed throughout the region. The permit sign was posted at the site entrance off of Co Rd 4 (Photo 1). The existing permit boundary was marked with metal posts (Photo 2). However, the western permit boundary of the proposed additional acreage had not yet been marked. It was not difficult to determine where the proposed boundary will be located since the boundary follows the base of the hill. Mr. Weurding stated they will soon place posts in this area in accordance with the GPS coordinates submitted with the AM-01 application. The operator should get the new markers in place before the operation moves into the proposed expansion area.

Photo 1. View of permit sign posted at site entrance off of Co Rd 4. The AM-01 public notice sign was also posted here.

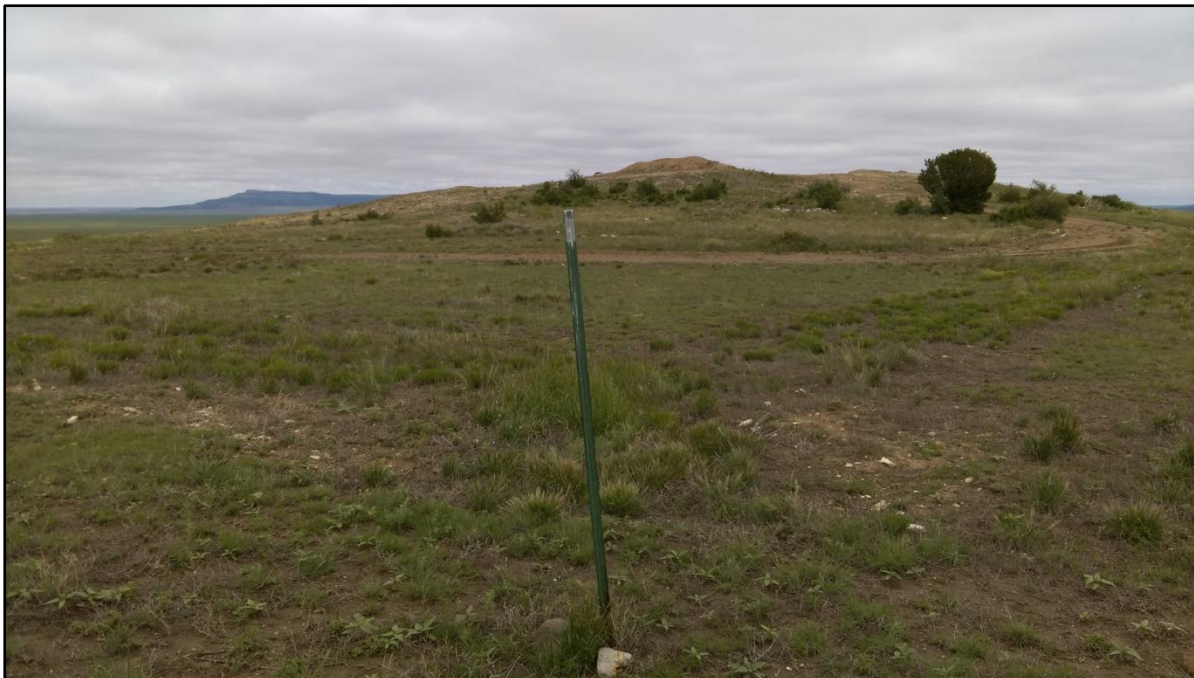
Photo 2. View looking northeast toward existing pit, showing boundary marker placed at southwest corner of existing permit area which will mark the proposed south-central permit boundary.

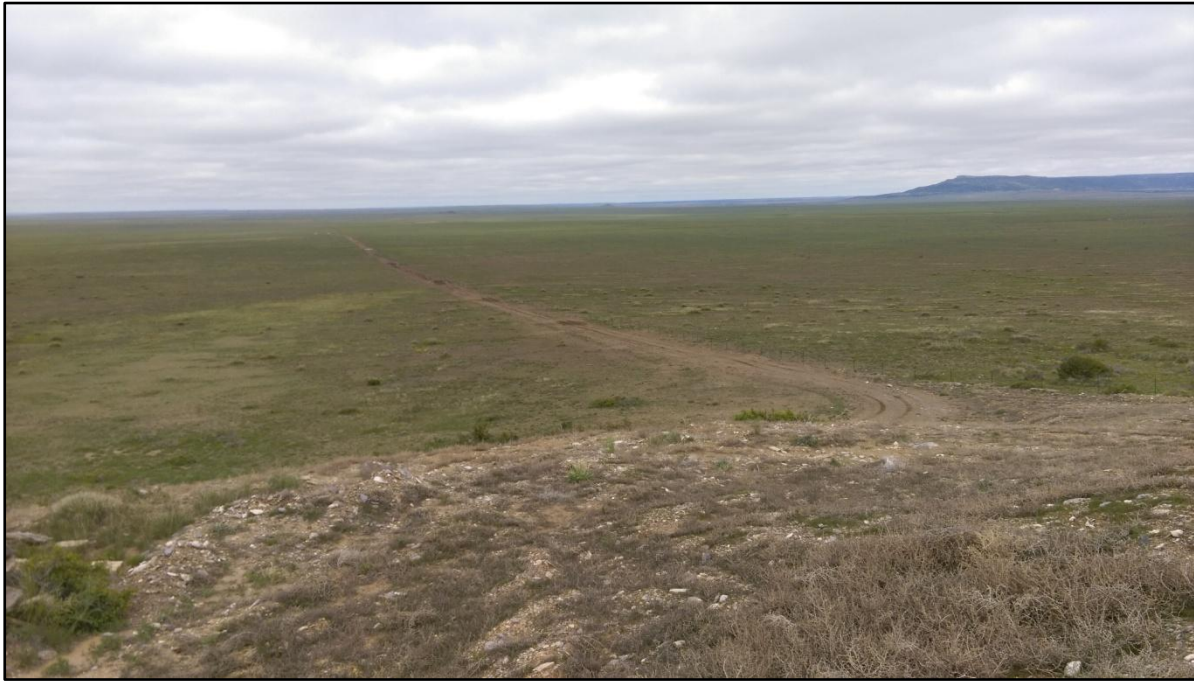
There are three existing structures located within 200 feet of the affected area and proposed affected area (besides the haul road), including, a barbed wire fence that runs north-south along the east side of the haul road (Photo 3), a water storage tank located just outside of the northwestern boundary of the proposed extension (Photo 4), and an underground water line that runs southwest-northeast outside of the northern permit boundary. All of these structures are owned by the landowner, Doherty Ranches, Inc., for which a proper structure agreement was included in the AM-01 application. No additional structures were noted during the inspection. The barbed wire fence used to run straight through the eastern portion of the permit area; however, that portion was temporarily relocated east of the permit boundary. The operator has an agreement with the landowner to move this portion of the fence back to its previous position once the mining operation concludes.

Photo 3. View looking northeast from top of hill in existing permit area, showing barbed wire fence present along east side of access road.

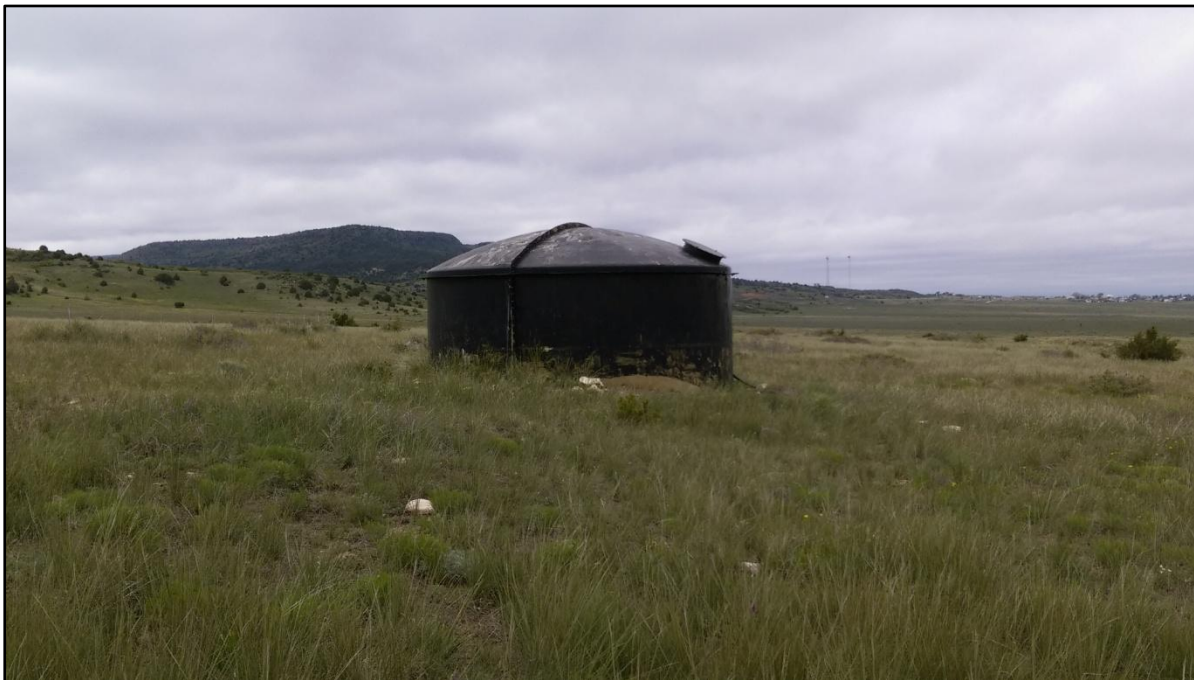
Photo 4. View of water storage tank located within 200 feet of proposed northwestern permit boundary.

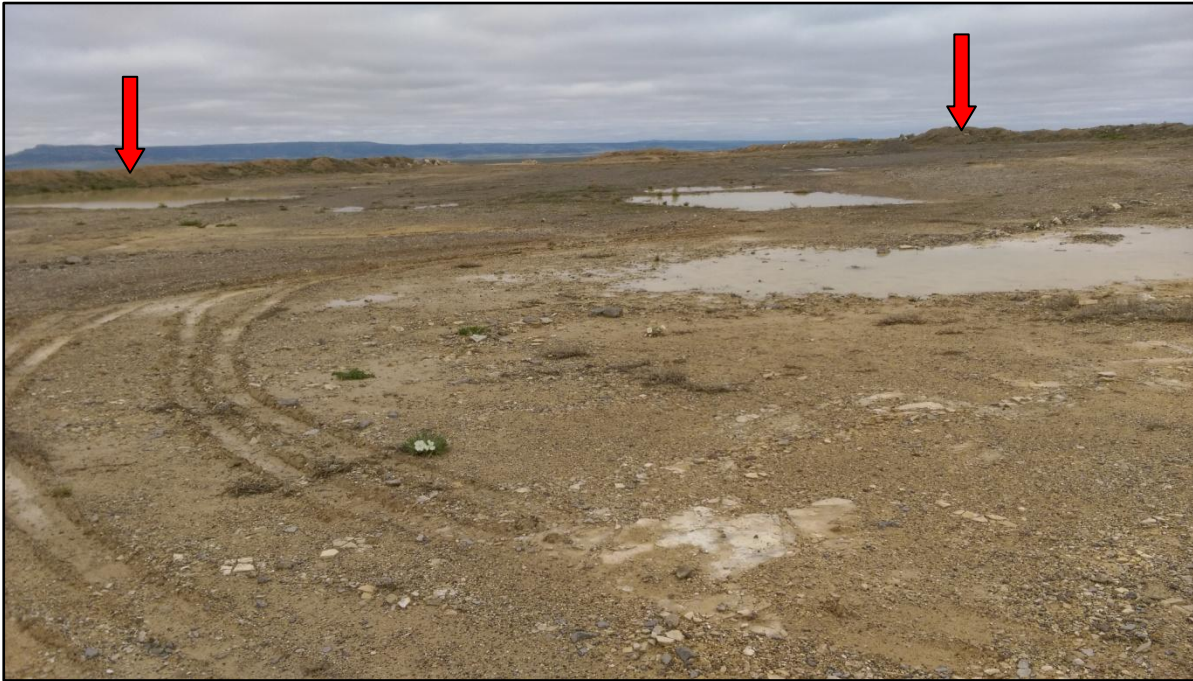
No mining activities were occurring on site during the inspection, and no equipment was present. The Division estimates current disturbance to be approximately 12.2 acres (see enclosed Google Earth image), including the mined hill top encircled by topsoil berms (Photos 5-7), and a dirt haul road that circles through the western portion of the pit. No material stockpiles remain on site. This method of mining does not produce a highwall.

Photo 5. View looking northeast across mined hilltop in existing permit area. Note topsoil berms around edges of pit (indicated). Standing water from recent storm.

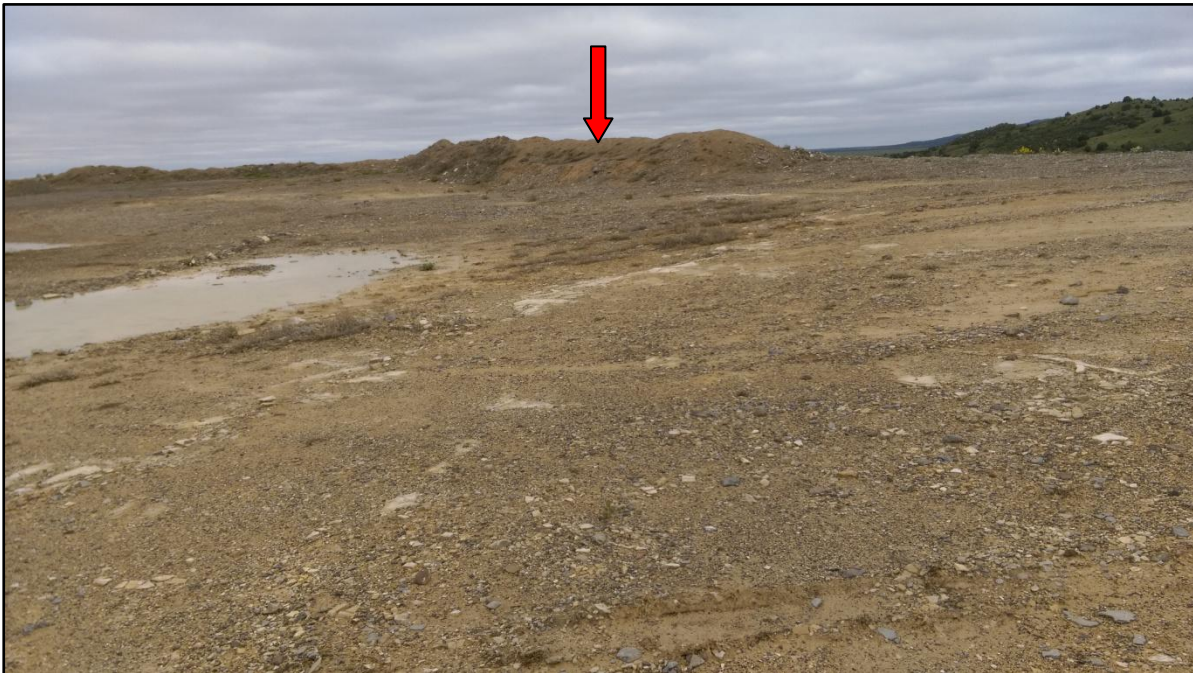
Photo 6. View looking southeast across mined hilltop in existing permit area. Note topsoil berms around edges of pit (indicated). Standing water from recent storm.

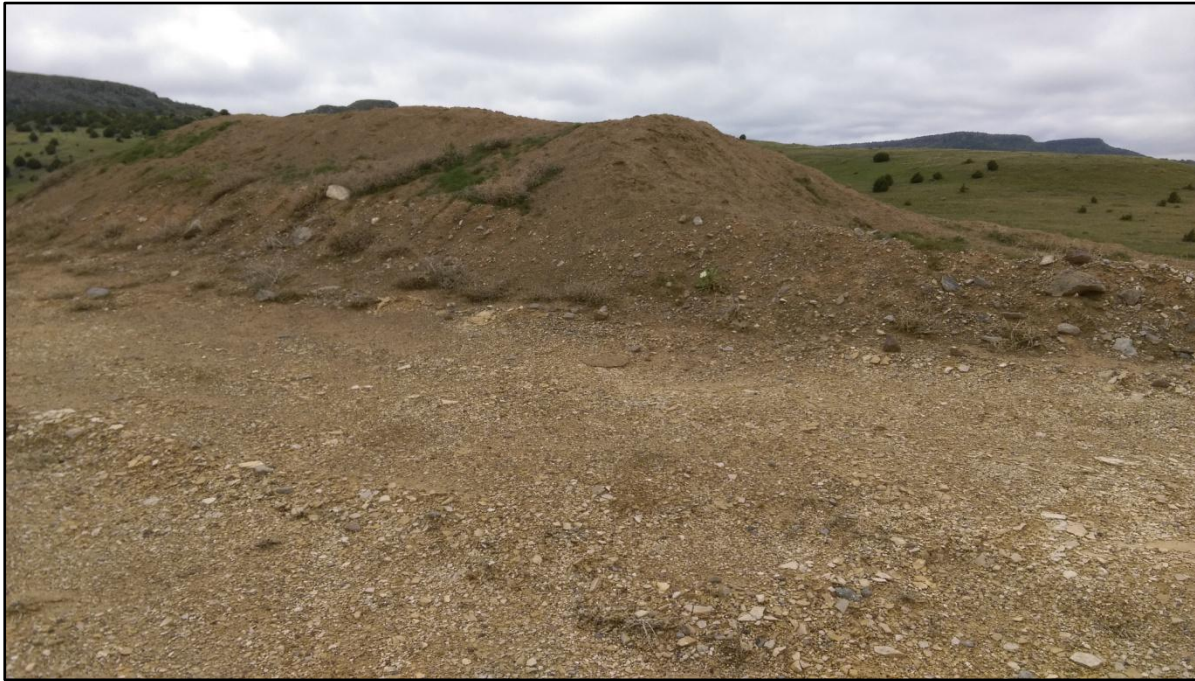
Photo 7. View of topsoil stockpile located at southwestern edge of mined hilltop in existing permit area.

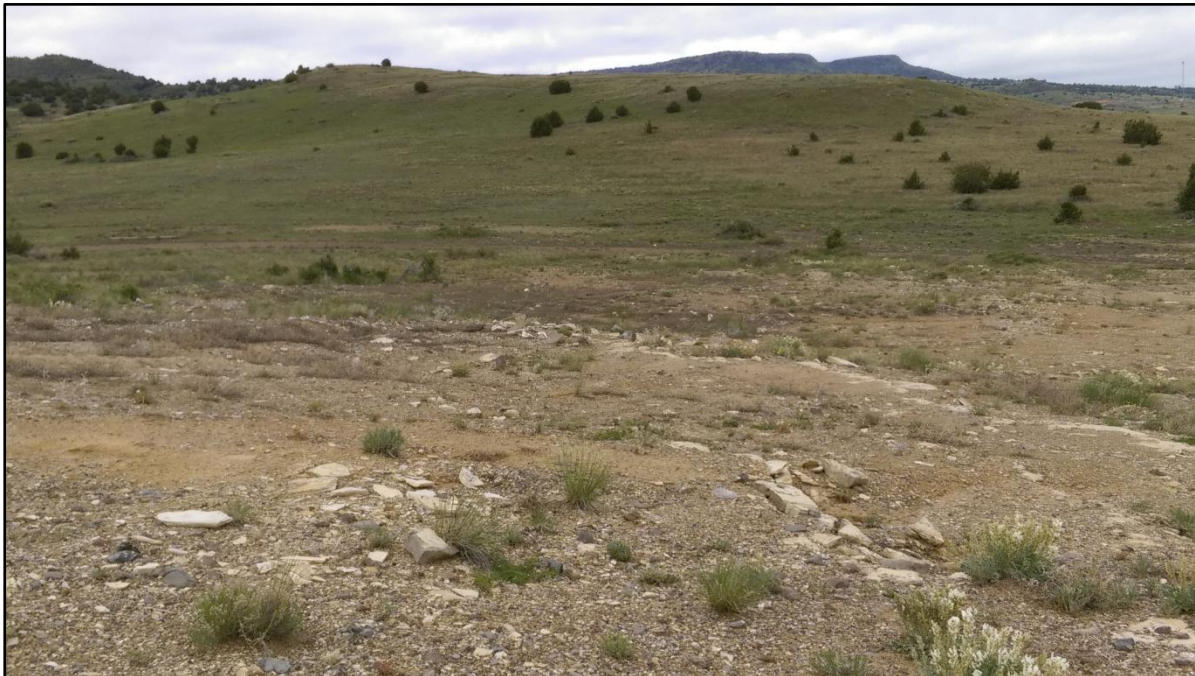
The vegetative cover across undisturbed areas includes a mixture of native grasses, forbs, fringed sagebrush, some annual weeds, yucca, and juniper trees (Photos 8-15). The reclamation plan will be the same as the approved plan, which includes grading all mined slopes to 3H:1V or flatter, replacing any overburden that remains and a minimum of 6 inches of topsoil, and seeding the disturbed land with the NRCS recommended seed mixture [included with the Conversion application (CN-01) from 2008]. Mr. Weurding indicated they intend to begin mining the expanded area later this summer once it remains dry long enough. No problems were observed at this site. The Division will continue reviewing the AM-01 application, for which the decision due date is set for 08/31/2015.

Photo 8. View looking west from existing permit area at adjacent hill to be mined in proposed expansion.

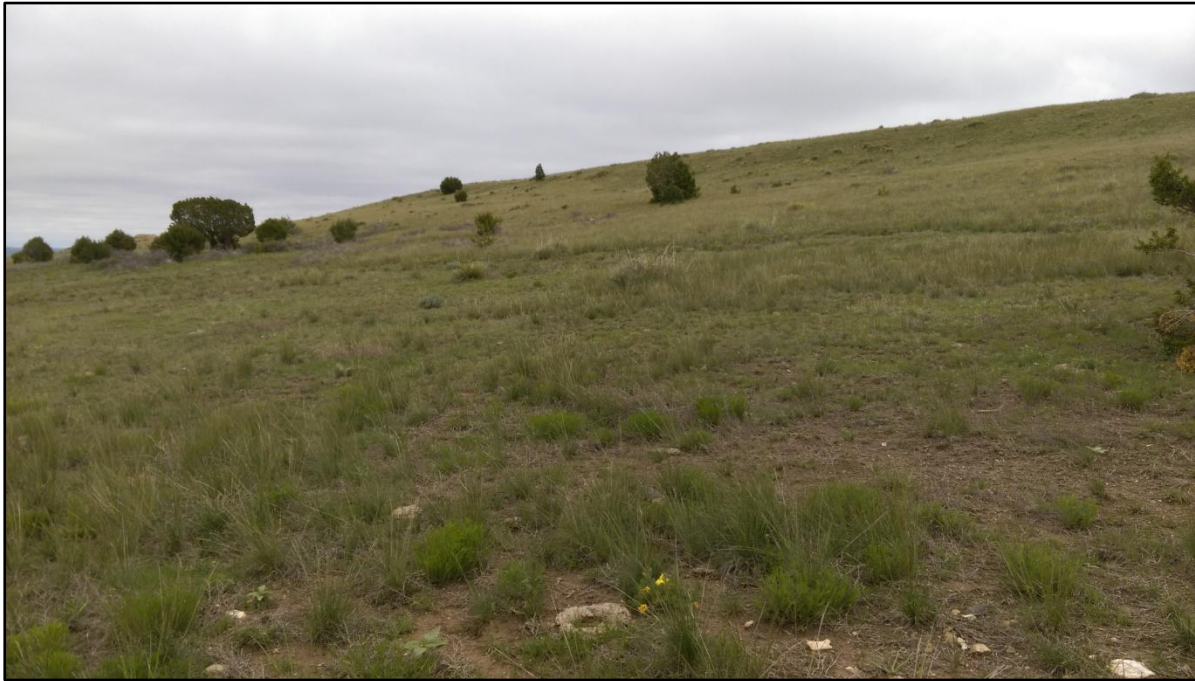
Photo 9. View looking southeast from proposed northwestern permit boundary, showing adjacent hill to be mined.

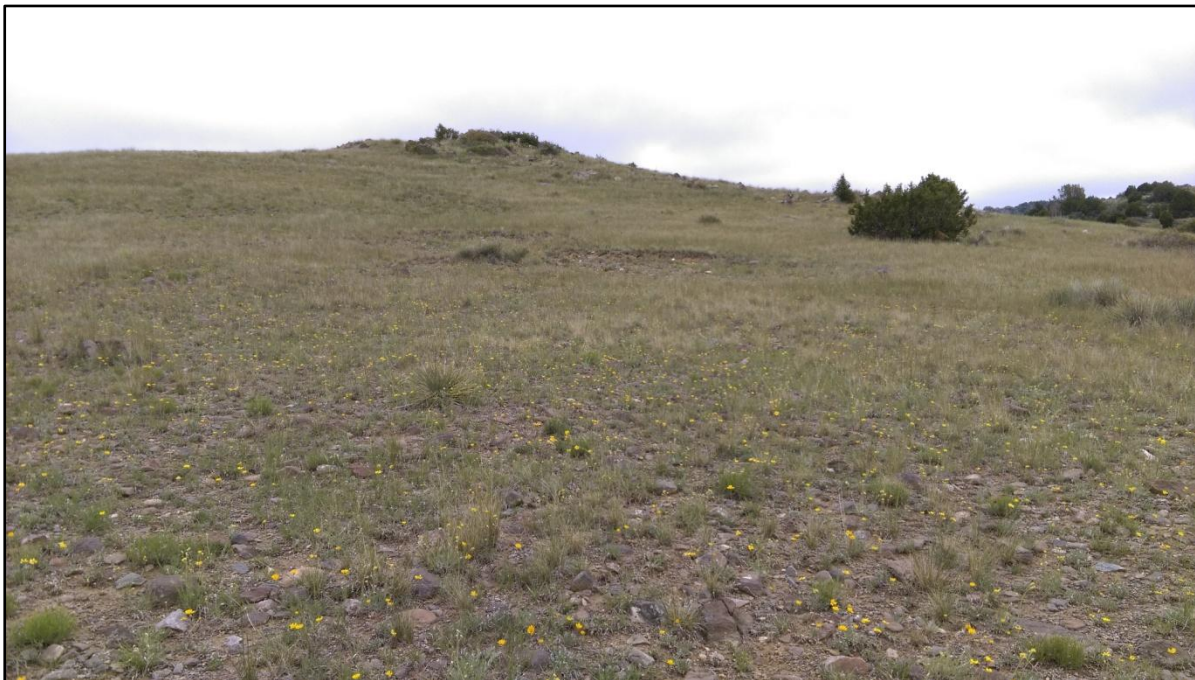
Photo 10. View looking southeast from proposed western permit boundary, showing adjacent hill to be mined.

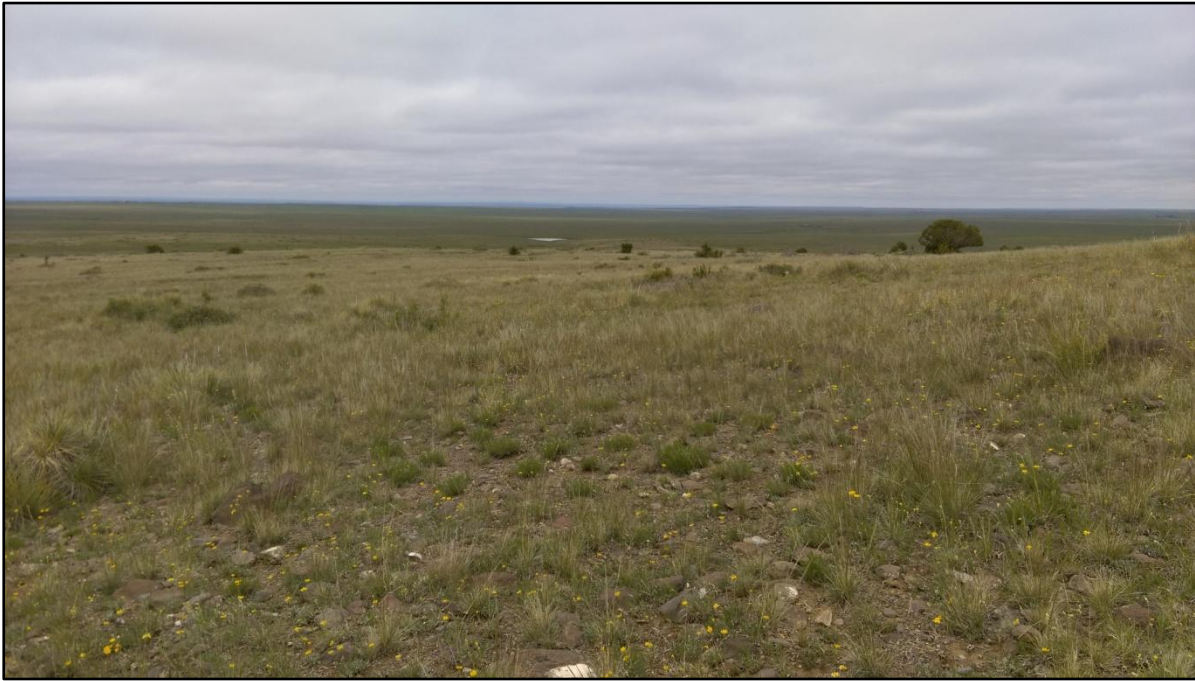
Photo 11. View looking northwest across bottom of adjacent hill in proposed expansion area.

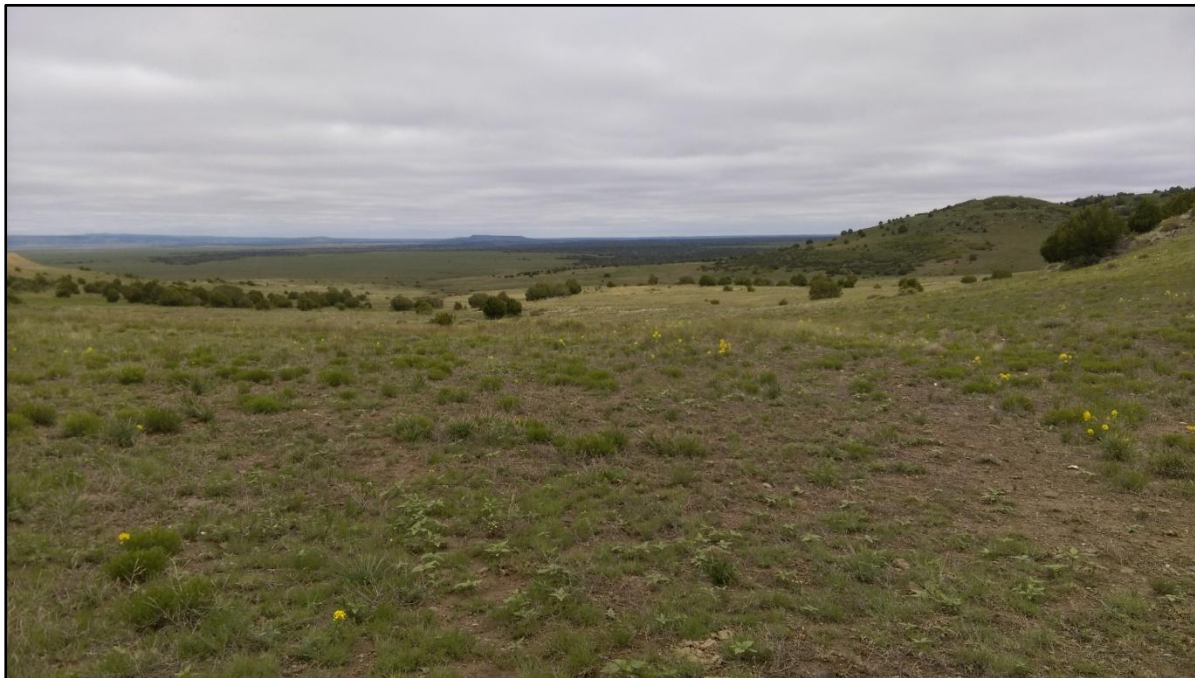
Photo 12. View looking southeast along proposed southwestern permit boundary.

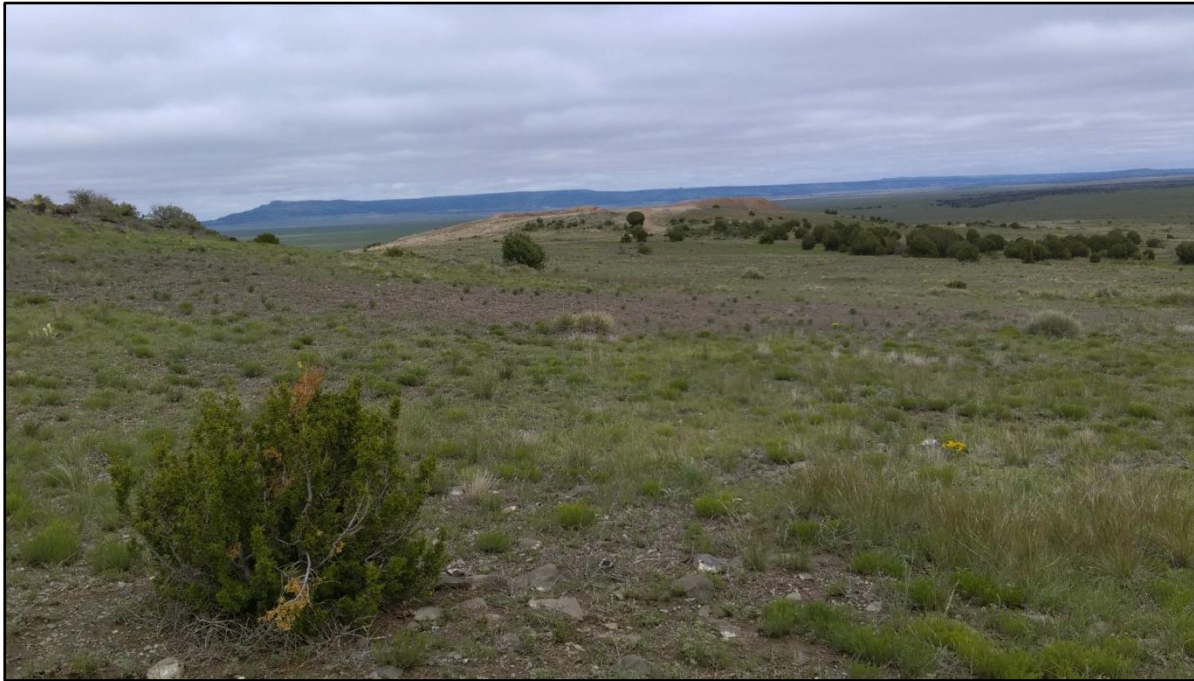
Photo 13. View looking east from southwestern proposed permit boundary, looking toward mined hilltop in existing permit area.

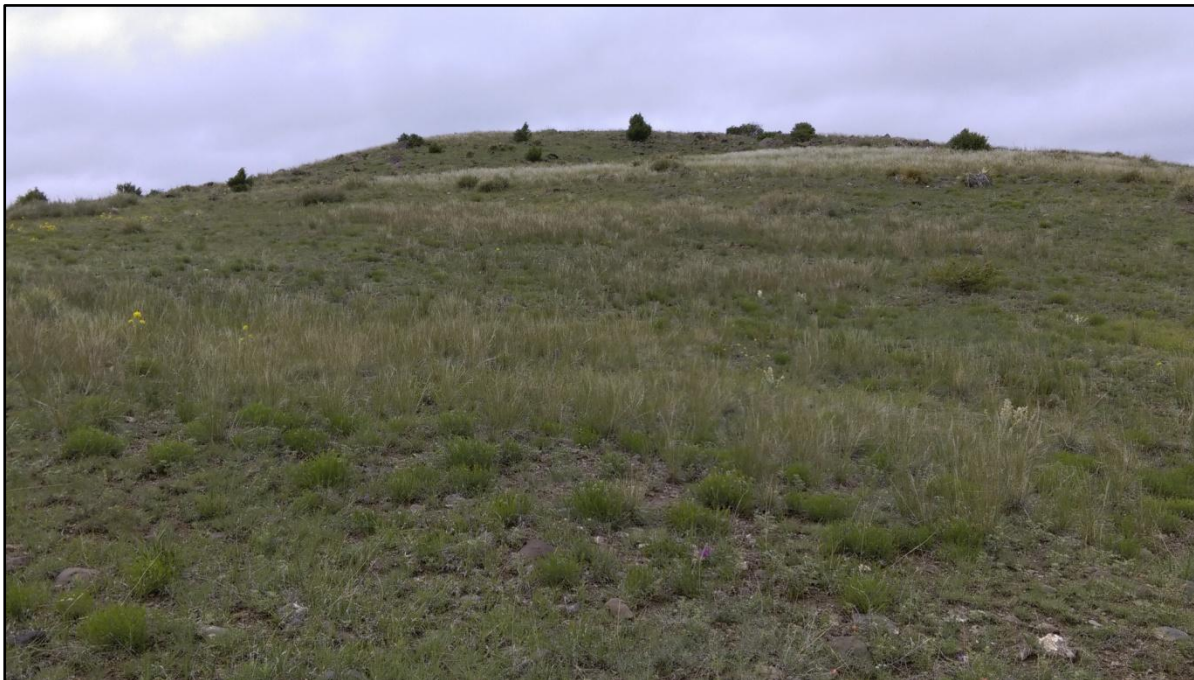
Photo 14. View looking north up south side of hill to be mined in proposed extension area.

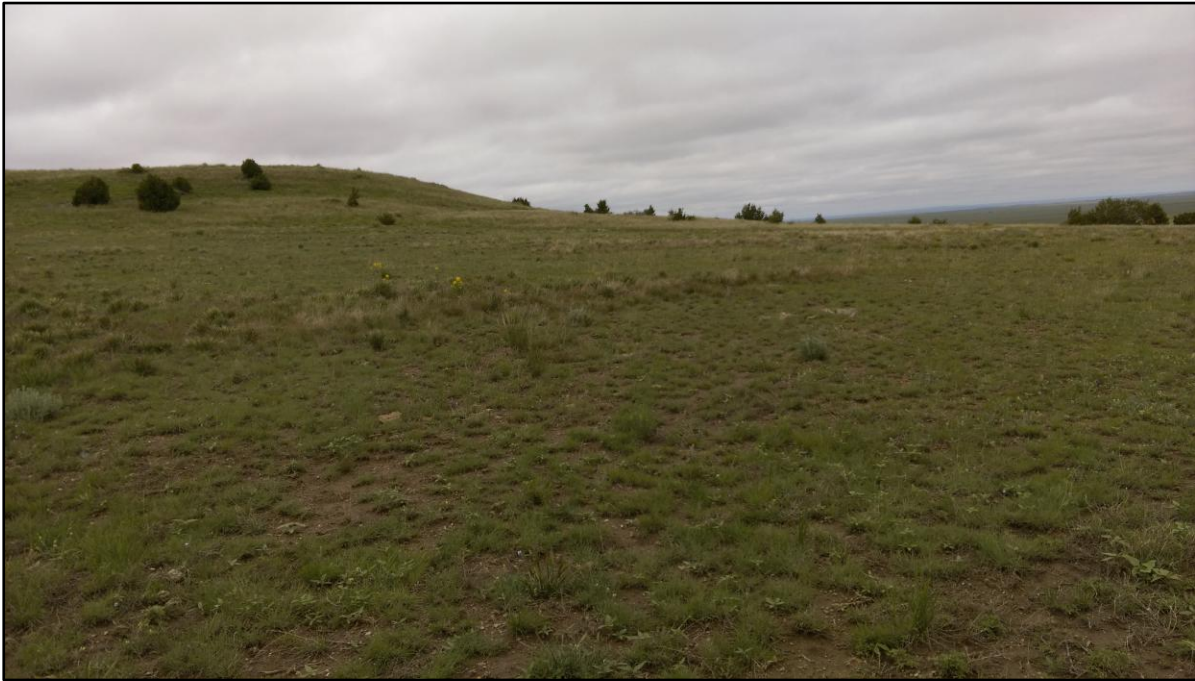
Photo 15. View looking northwest from between two hills in proposed permit area, showing eastern portion of hill to be disturbed.

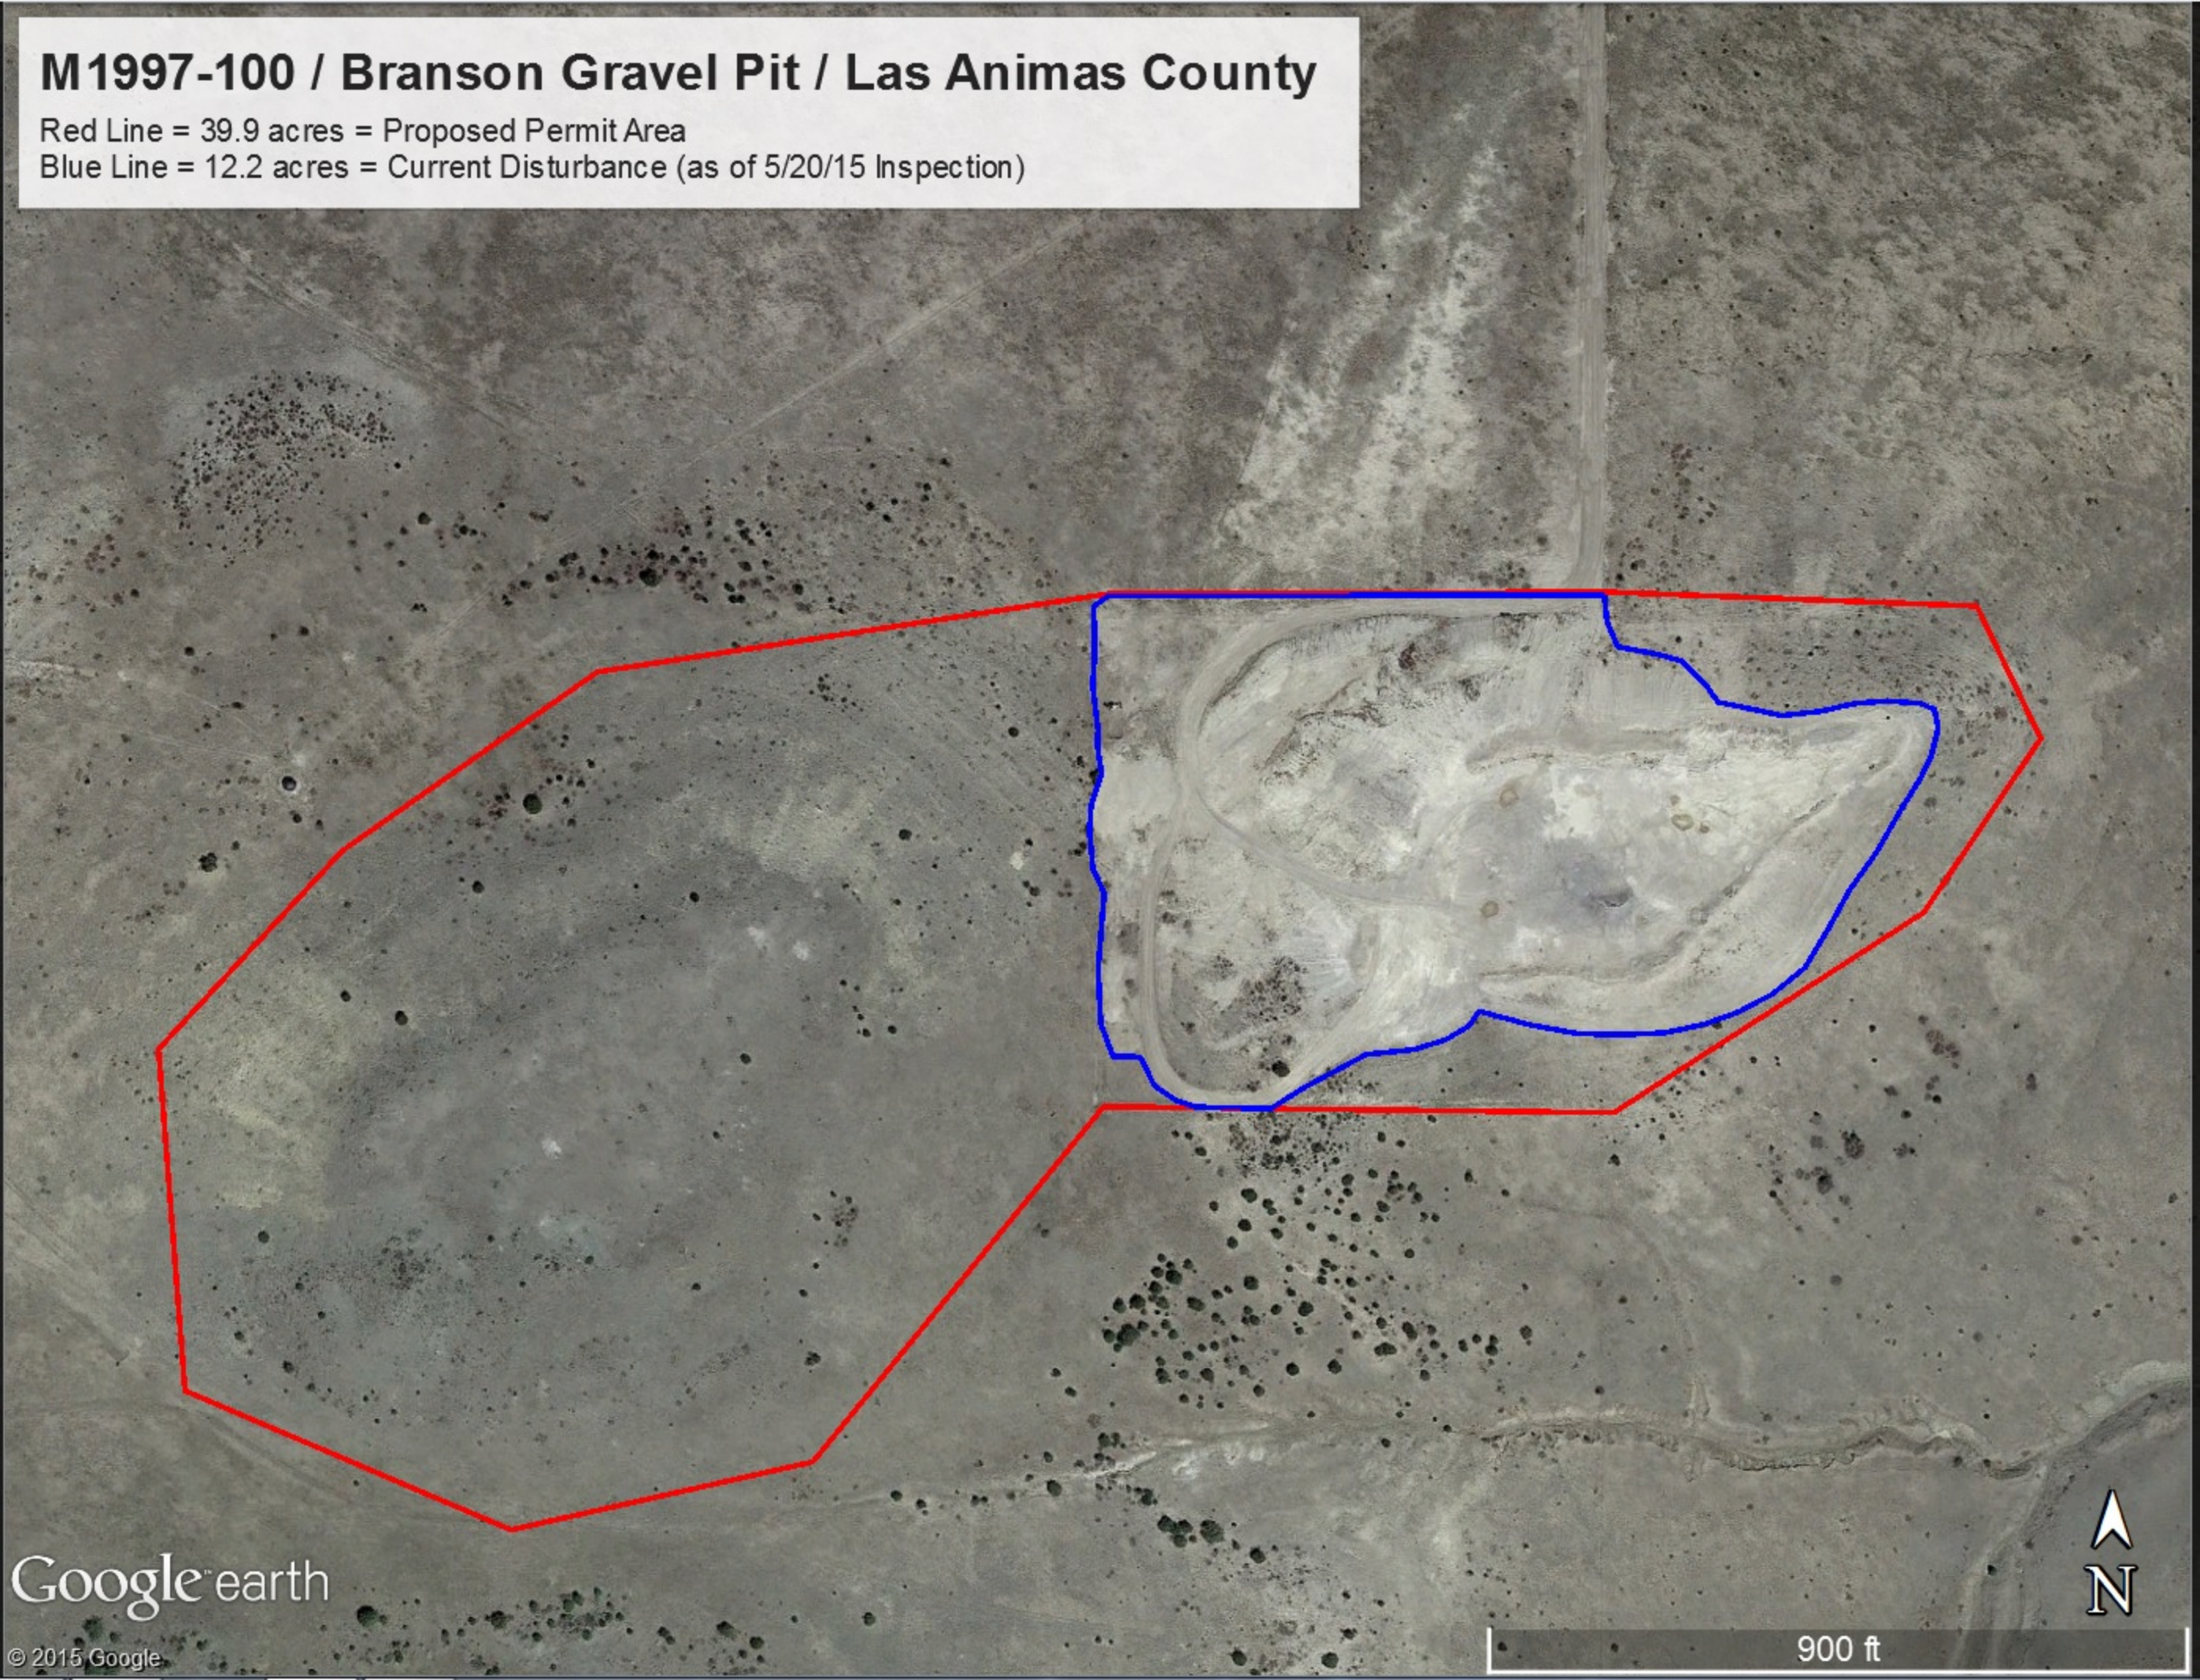
Red Line = 39.9 acres = Proposed Permit Area

Blue Line = 12.2 acres = Current Disturbance (as of 5/20/15 Inspection)
