COLORADO DIVISION OF RECLAMATION, MINING AND SAFETY
MINERALS PROGRAM INSPECTION REPORT
PHONE: (303) 866-3567

MINE NAME: Ross Pit	MINE/PROSPECTING ID#: M-1990-134	MINERAL: Gravel	COUNTY: Moffat
INSPECTION TYPE: Monitoring	INSPECTOR(S): Stephanie J. Mitchell	INSP. DATE: March 25, 2015	INSP. TIME: 09:00
OPERATOR: James H & Kathleen H Ross	OPERATOR REPRESENTATIVE: Joe Bower	TYPE OF OPERATION: 110c - Construction Limited Impact	
REASON FOR INSPECTION: Normal I&E Program	BOND CALCULATION TYPE: Complete Bond	BOND AMOUNT: \$20,545.00	
DATE OF COMPLAINT: NA	POST INSP. CONTACTS: None	JOINT INSP. AGENCY: None	
WEATHER: Cloudy	INSPECTOR'S SIGNATURE:

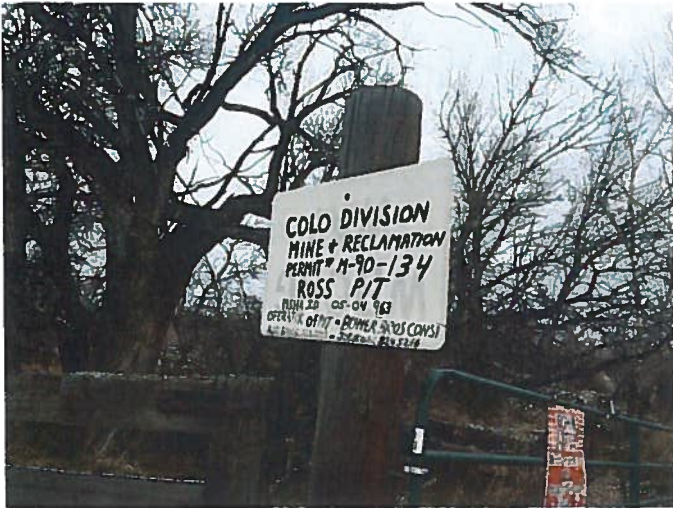
This is a 9.56 acre 110c mining operation for sand and gravel. A mine identification sign was in place at the entrance to the mine site. Permit boundaries were marked by a berm that surrounds the permit area. There is a berm in place to reduce (and slow the velocity of) the surface runoff to areas outside the permit area. The site is stable and no disturbance was observed outside of the approved permit boundaries.

Mine Identification Sign

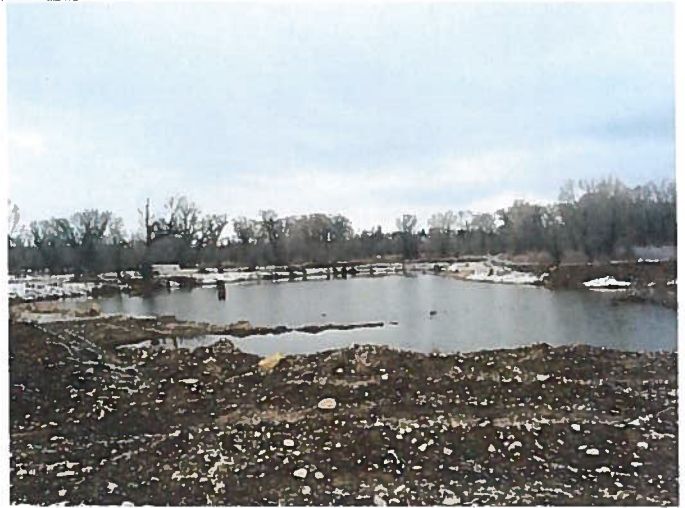
Pond

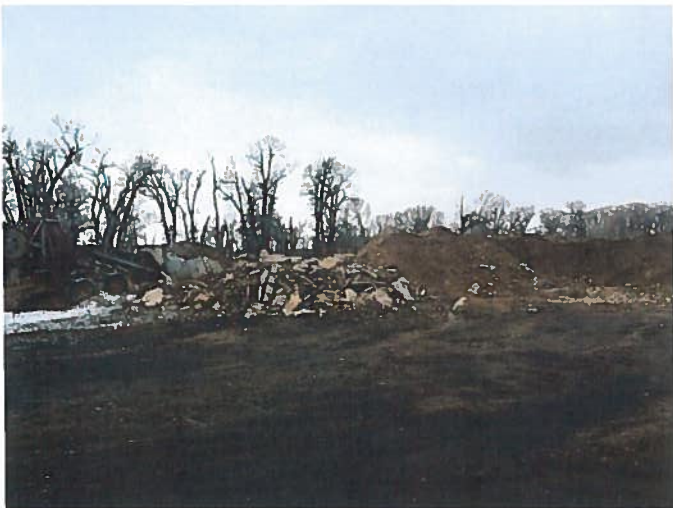
PROBLEM/POSSIBLE VIOLATION: Problem: The site is utilizing off-site fill without prior approval by the Division per 3.1.5(9) of the Rule.

There were several stockpiles of concrete and asphalt on site. If not being used for the active mine operation, all debris must be legally removed from the site before August 10, 2015. The Operator has the option of burying the concrete portion of the material (Per Rule 3.1.5(9)) under the following criteria:

Offsite Material Stored on Site- Concrete

CORRECTIVE ACTIONS: The operator shall provide a notarized affidavit, stating that the fill is, in fact, inert and addressing all requirements pursuant to Rule 3.1.5(9), which describes the intended use of inert/off-site fill by the corrective action date.

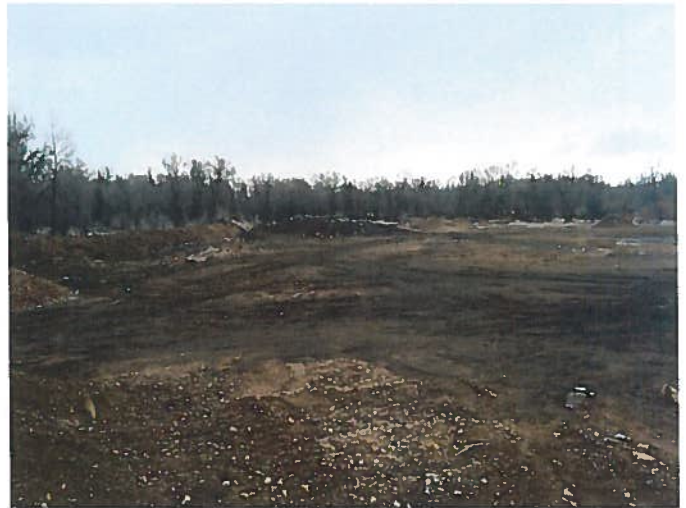
Overall pit floor

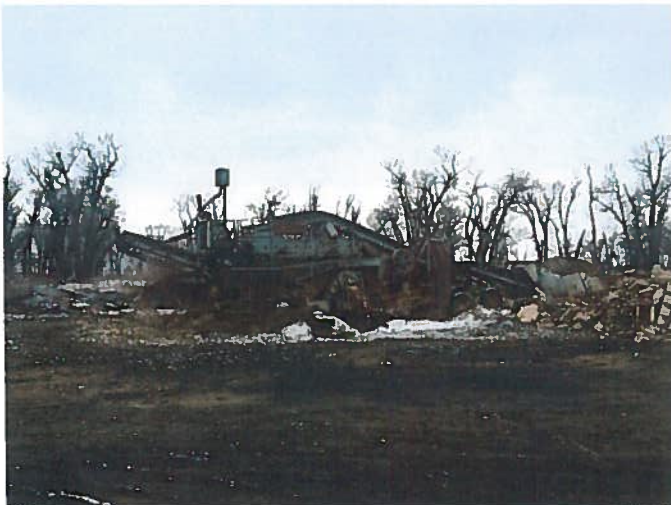
No fuel was being stored at the mine site. There is an old crusher present at the site that appears to be inoperable.

Old Crusher on Site

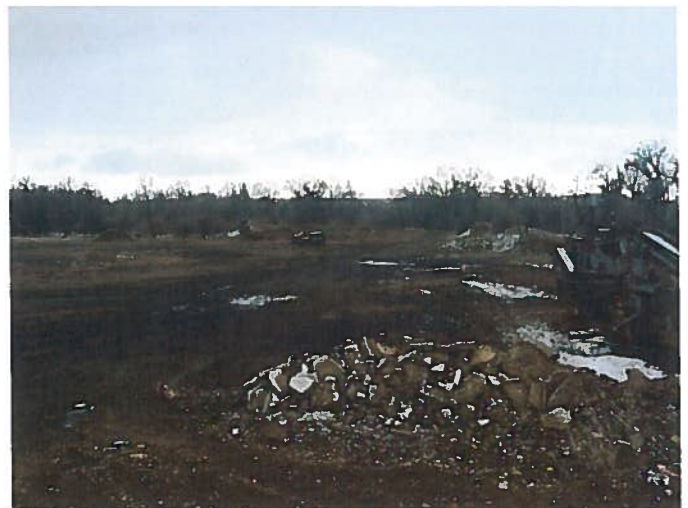
Offsite Material - Concrete

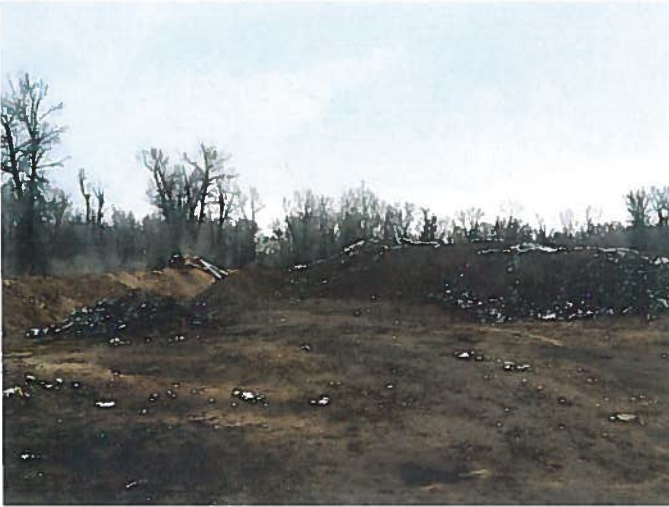
Offsite Material – asphalt on left side of photograph

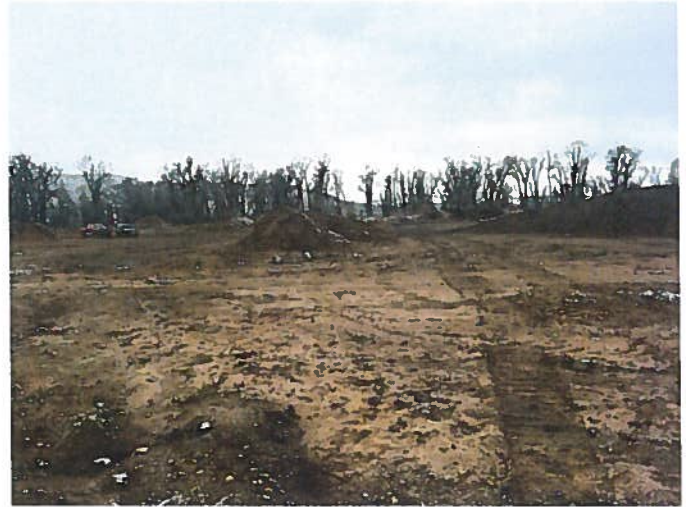
Pit Floor
