**COLORADO DIVISION OF RECLAMATION, MINING AND SAFETY**  
**MINERALS PROGRAM INSPECTION REPORT**  
**PHONE: (303) 866-3567**

<b>MINE NAME:</b> Jemadojin Sand Mine	<b>MINE/PROSPECTING ID#:</b> M-2006-017	<b>MINERAL:</b> Sand	<b>COUNTY:</b> El Paso
<b>INSPECTION TYPE:</b> Surety-Related Inspection	<b>INSPECTOR(S):</b> Timothy A. Cazier	<b>INSP. DATE:</b> June 9, 2015	<b>INSP. TIME:</b> 13:30
<b>OPERATOR:</b> Premier Silica LLC	<b>OPERATOR REPRESENTATIVE:</b> George Munger, Jim Barnes	<b>TYPE OF OPERATION:</b> 112c - Construction Regular Operation

# M-2006-017 Jemadojin Sand Mine

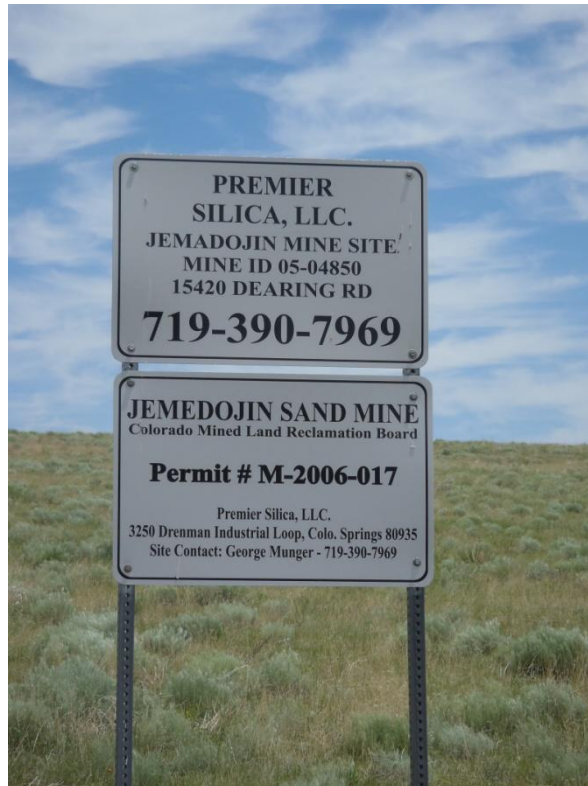
Permit Boundary: The permit sign (**Photo 1**) was properly posted at the time of the inspection.

Photo 1. Required permit sign (at pit entrance).

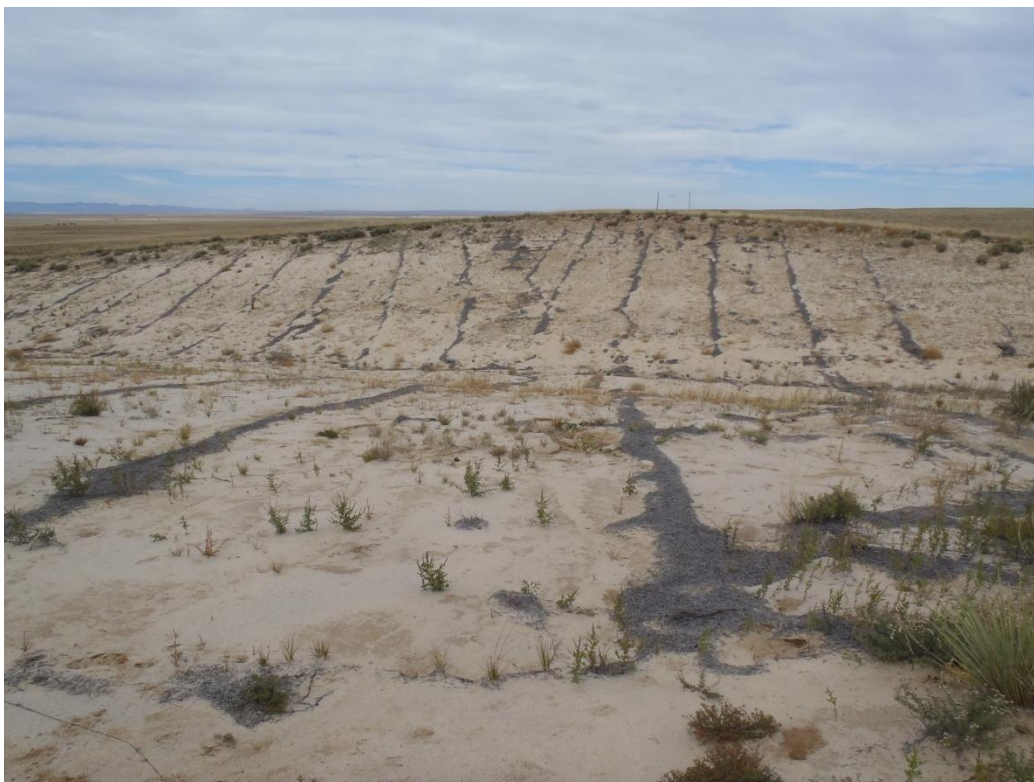
Pit & Permit Area: No additional disturbance was noted from the previous inspection. However, due to recent heavy rains additional erosion has occurred. This was most evident in the diversion cut on the north end of the site. **Photos 2** and **3** illustrate the difference. This inspector recommended contacting the local County Extension Agent for seed mix options and implementing best management practices (BMPs) such as contour furrowing (also called contour bunding – see **diagram** below and **Photo 4** as an example) on the diversion cut and pit slopes. Note: if the seed mix needs to be changed, the Division will require a technical revision (TR) to the permit.

Photo 2. Diversion cut – 10/8/2013 inspection (looking north).

1. Contour furrowing BMPs should be implemented on the diversion cut and pit slopes.
2. The will recommend the MLRB grant the requested five-year TC extension after a written commitment to continue mining the site is recieved from either the Operator or the land owner.
3. Future annual reports should reflect the affected area to be 35 acres until a release request is received and approved by the Division.

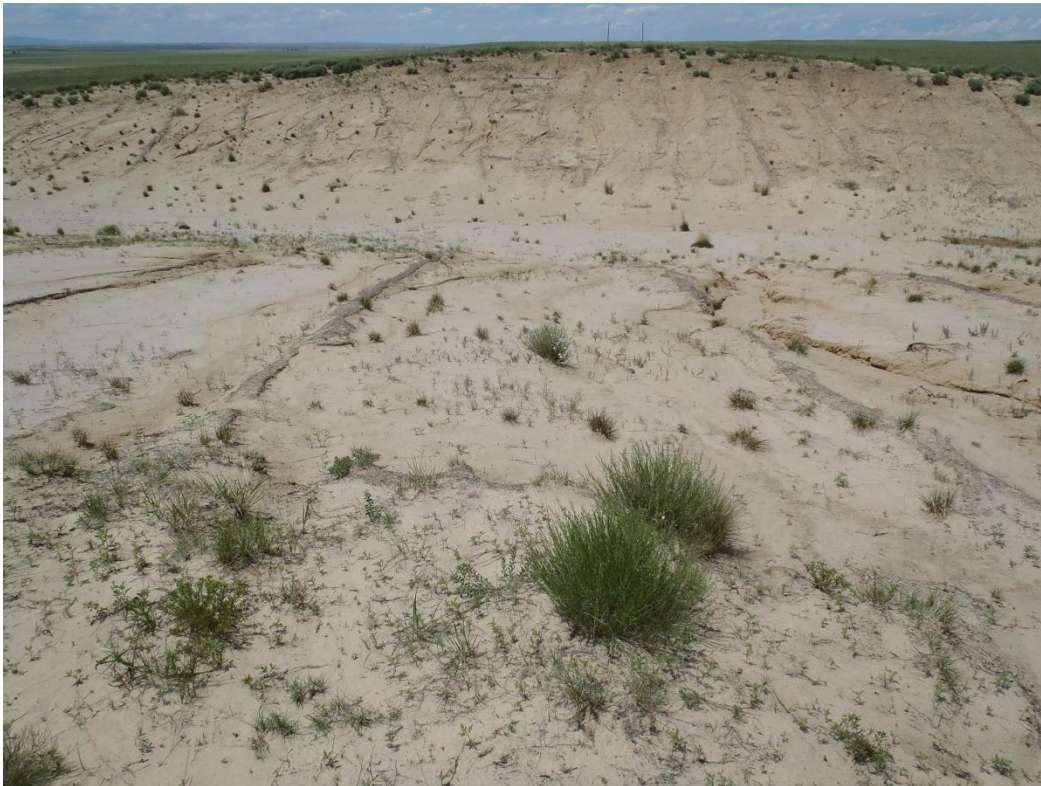
Photo 3. Diversion cut – 6/9/2013 inspection (looking north).

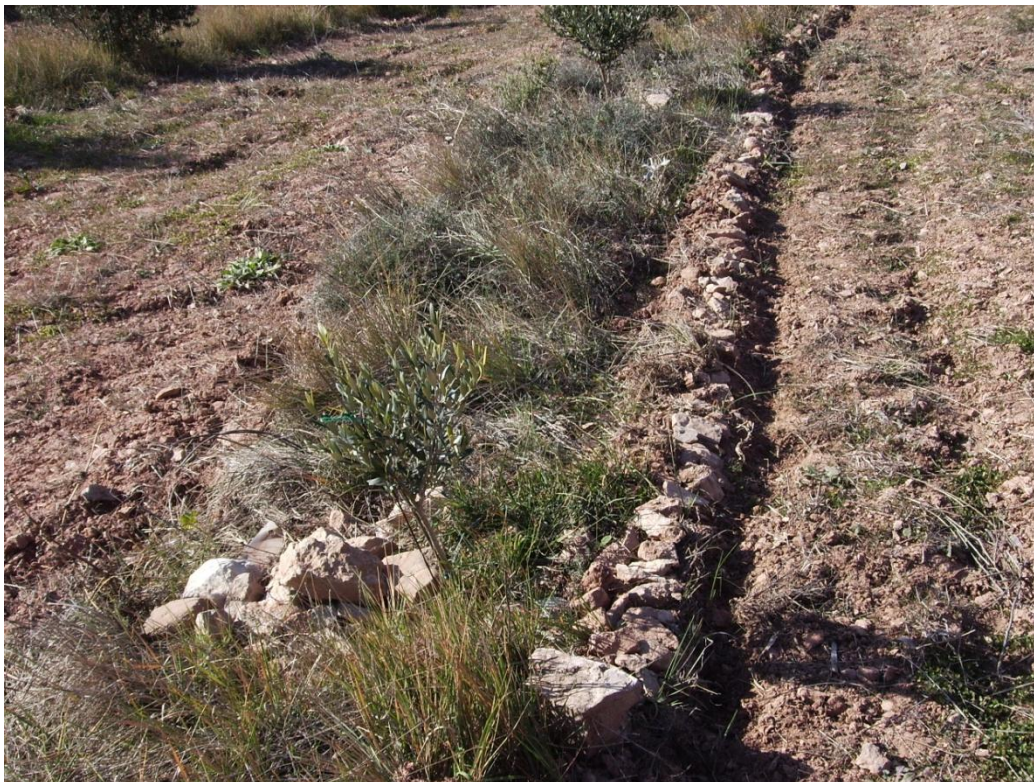
Photo 4. Example contour furrowing (bunding) from a different site.
