COLORADO DIVISION OF RECLAMATION, MINING AND SAFETY
MINERALS PROGRAM INSPECTION REPORT
PHONE: (303) 866-3567

MINE NAME: Mask Ranch Gravel Pit	MINE/PROSPECTING ID#: M-2002-087	MINERAL: Gravel	COUNTY: Archuleta
INSPECTION TYPE: Monitoring	INSPECTOR(S): Lucas J. West	INSP. DATE: June 2, 2015	INSP. TIME: 13:00
OPERATOR: Mask Ranch, LLC	OPERATOR REPRESENTATIVE: Roger August, Ranch Manager	TYPE OF OPERATION: 110c - Construction Limited Impact

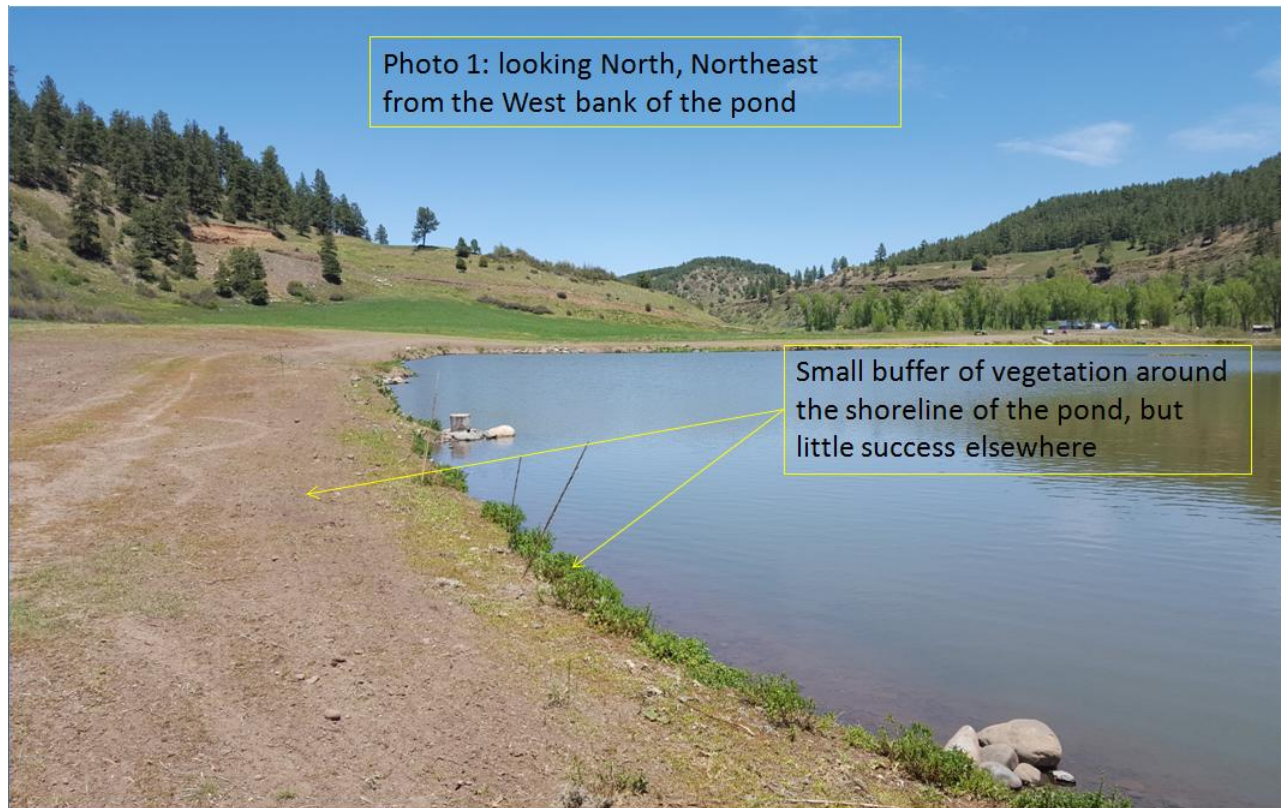
The affected area is in final reclamation for the intended post reclamation land use of wildlife habitat and developed water resources. An exposed ground water pond, approximately five (5) acres in surface area occupies most of the site. The pond structure is sufficient with an undulating shoreline, island, and peninsula with an average depth of around eight (8) feet. The pond slopes appear to be no steeper than required 3H:1V and are compliant with Rule 3.1.5(7). No stockpiles remain on site, and grading has been completed.

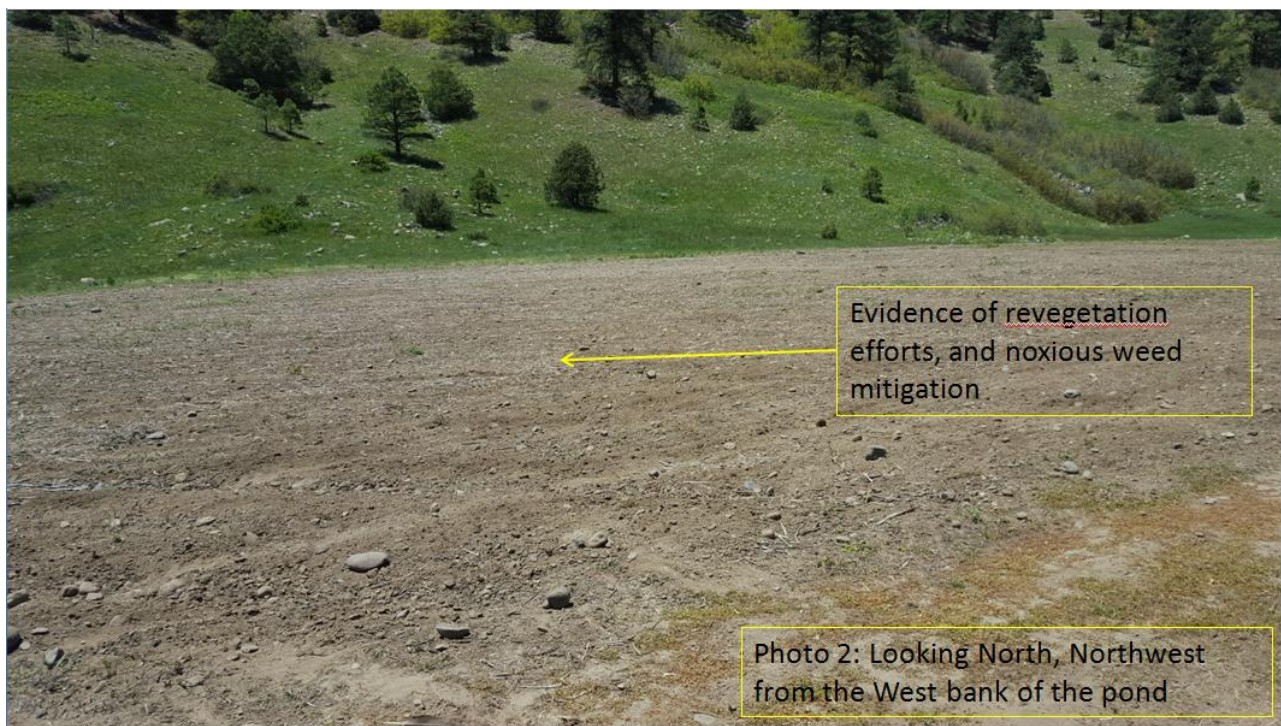
Evidence of noxious weed mitigation and revegetation efforts were observed during the inspection. The Operator expressed that lack of vegetative success is due to waterfowl species overgrazing the area. The upper areas of the banks were noticed to have little vegetation due to poor growth medium as seen in Photos 1, 2, 4, and 5. It is recommended that the operator have a soil chemistry analysis performed to identify the soils deficiencies and add the appropriate amendments, or some other measure of the Operator's choosing to amend the soils and promote vegetative success. Any changes determined to be necessary in order to achieve successful revegetation may require the operator to submit a technical revision to incorporate the changes into the approved reclamation plan.

The overall condition of the site was good, with the exception of little vegetation. All grading and slopes were satisfactory, no stockpiled materials, no trash or debris and an evidence of active vegetation management was observed. The Operator is encouraged to explore options to improve the soil quality around the banks of the pond to increase vegetative success. The Operator is advised to apply for a surety reduction for the reclamation work that has been completed and is considered satisfactory. Such request must be made in accordance with Construction Materials act and rules, Rule 4.14.1. This section outlines the Operator requirements in requesting a surety reduction.

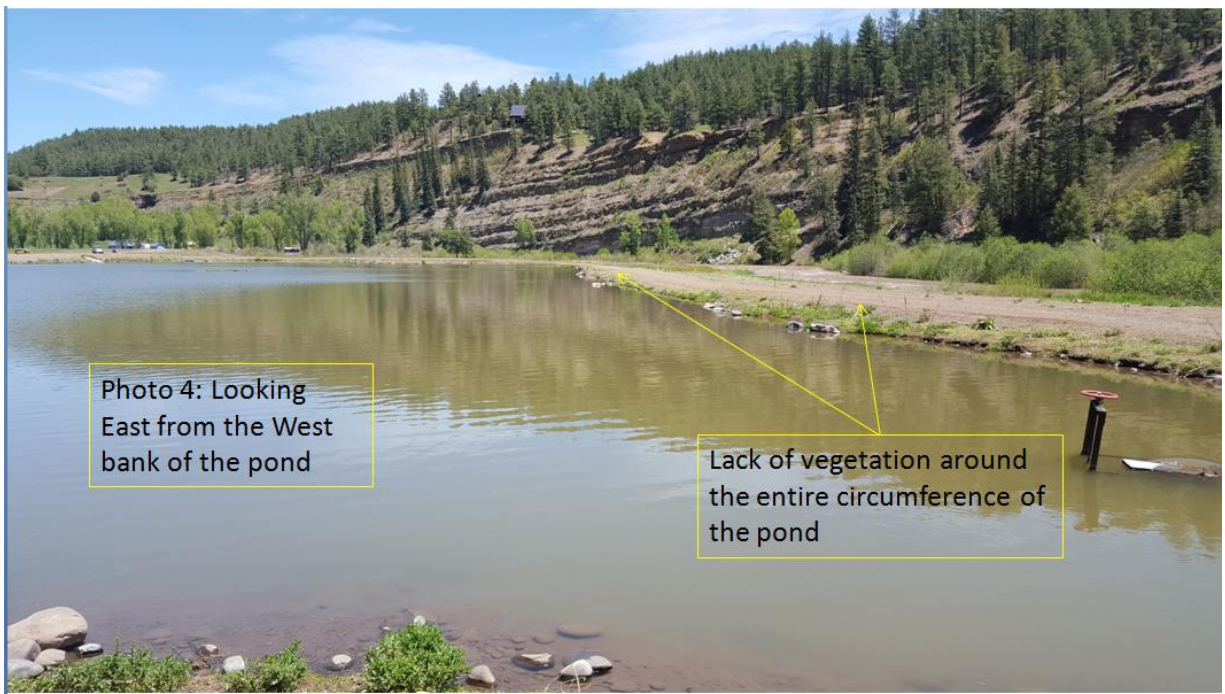
The pond is fed by groundwater and a freshwater inlet from the San Juan River located on the North east edge of the pond. The inlet was submerged so the approximate flow rate could not be observed. The outlet on the Southwest edge of the pond consists of a gated spillway leading to the San Juan River. It was also submerged as the river was running high; therefore an approximate flow rate could not be observed. As seen in Photo 3 a board is being used as a temporary debris screen. However, a full debris screen would be more effective and is recommended for the operator.
