**COLORADO DIVISION OF RECLAMATION, MINING AND SAFETY**  
**MINERALS PROGRAM INSPECTION REPORT**  
**PHONE: (303) 866-3567**

| <b>MINE NAME:</b><br>Cresson Project | <b>MINE/PROSPECTING ID#:</b><br>M-1980-244 | <b>MINERAL:</b><br>Gold | <b>COUNTY:</b><br>Teller |
| <b>INSPECTION TYPE:</b><br>Monitoring | <b>INSPECTOR(S):</b><br>Timothy A. Cazier | <b>INSP. DATE:</b><br>May 21, 2015 | <b>INSP. TIME:</b><br>08:10 |

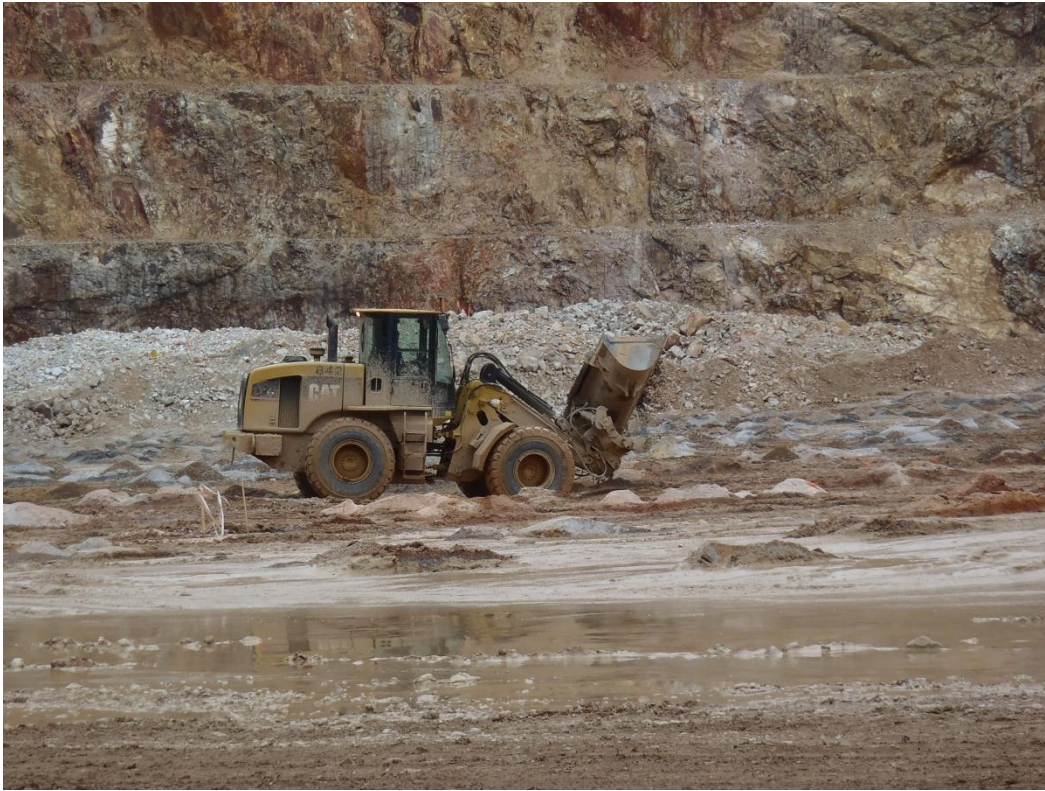
Mine plan: Production drilling and blasting continued in the Wildhorse Extension (WHEX) pit (see **Photo 1**). A retro-reflector (see **Photo 2**) used to monitor potential AGVLF slope movement was observed near the Phase V LVCS shed.

Photo 1. Side tipping loader filling blast holes with stemming material (WHEX Pit).

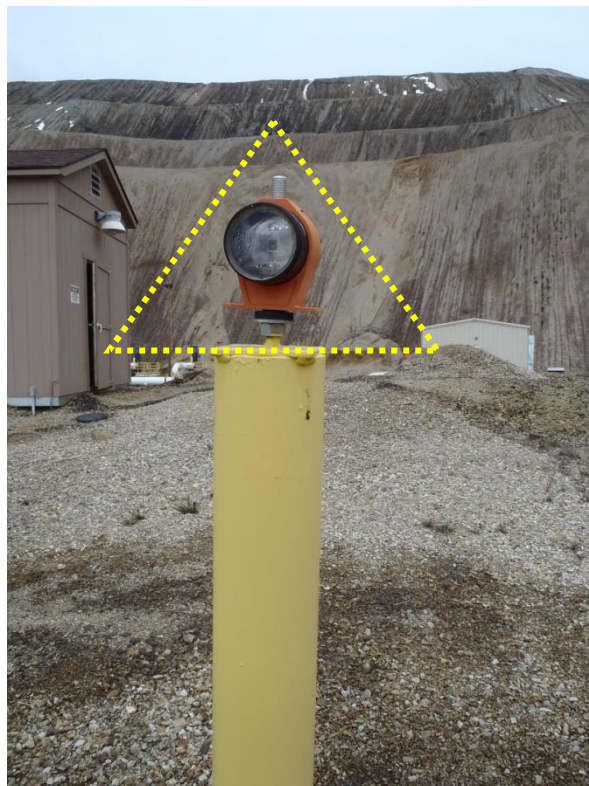
Photo 2. Retro-reflector used to monitor AGVLF slope movement (near Phase V LVCS shed).

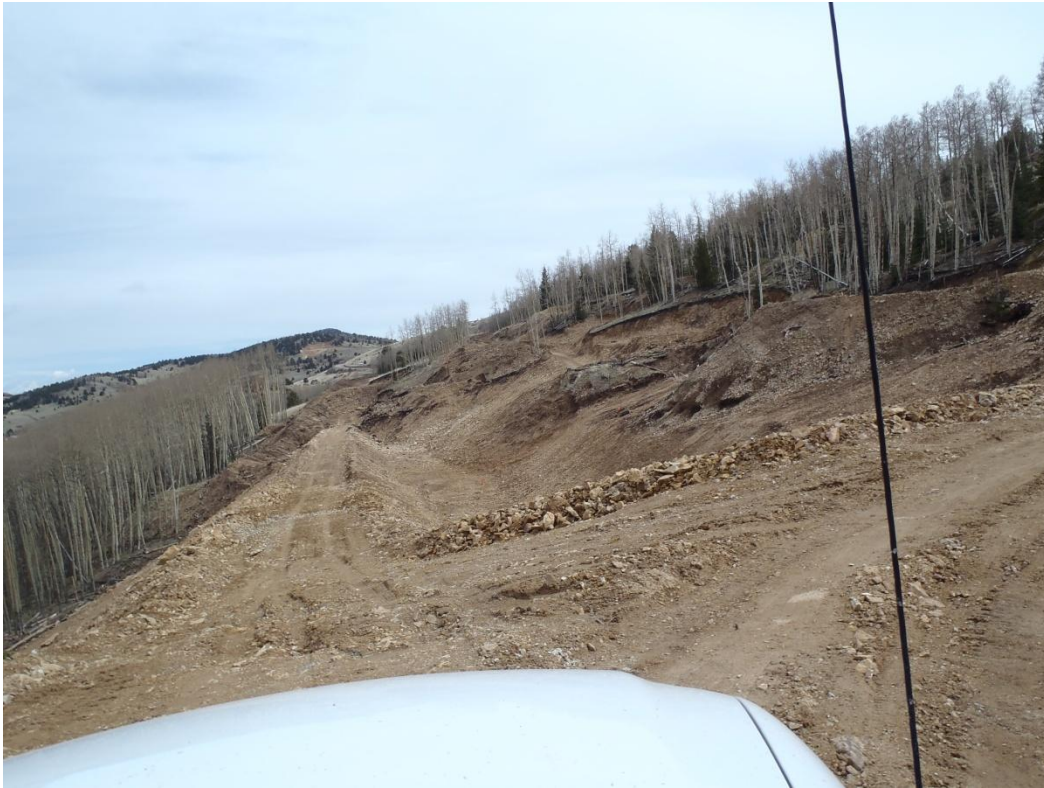
Construction: The Division observed the nearly completed EMP 021 sediment ponds (see **Photo 3**) and SGVLF progress (see **Photo 4**).

Photo 3. Nearly completed EMP 021 sediment ponds (looking NE).

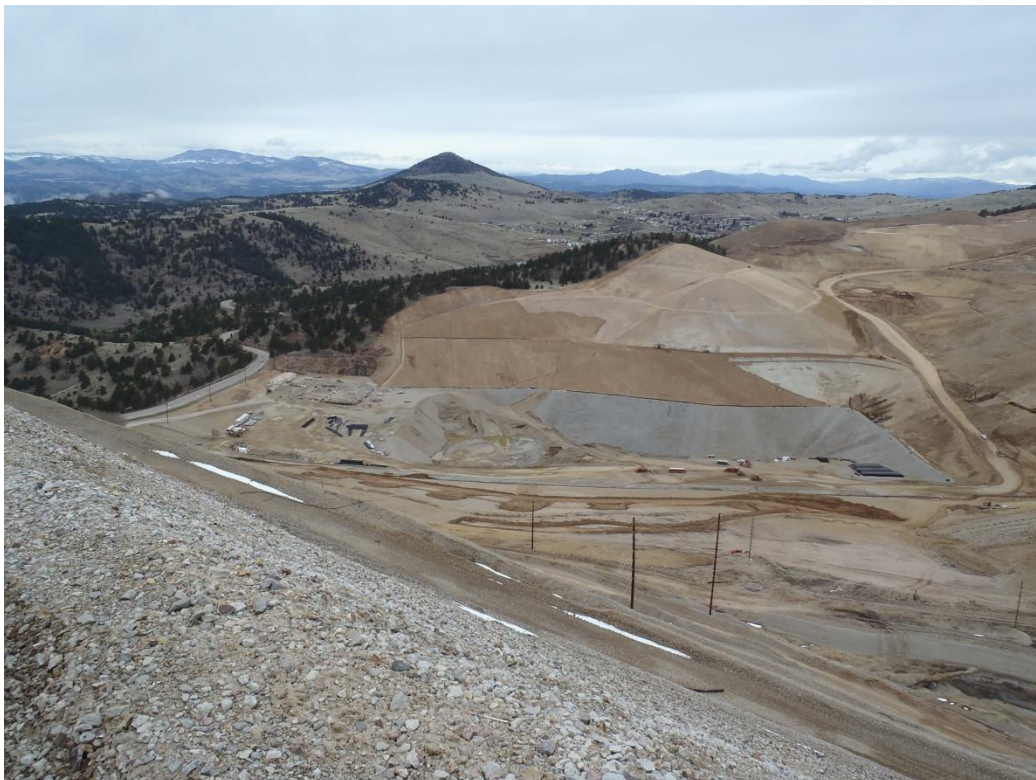
Photo 4. SGVLF construction progress (looking NW).

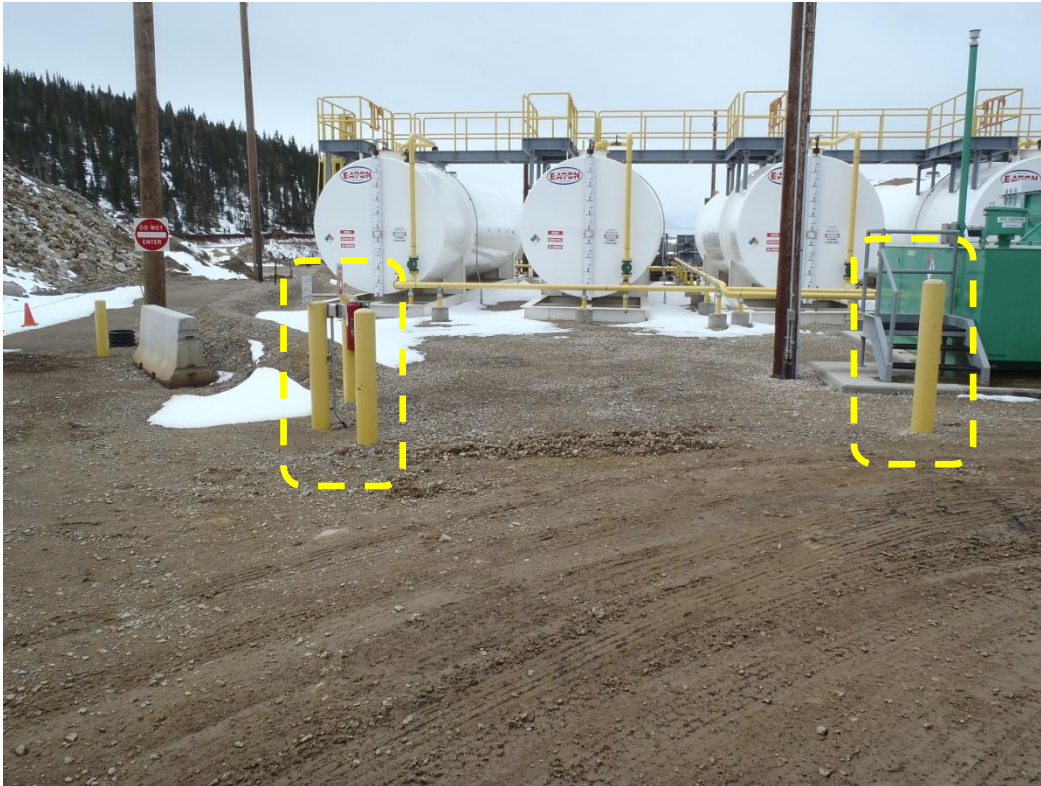
- The Fuel Island (Diesel and gasoline fueling station – see **Photos 5** and **6**) is located in the northern portion of the mine site, south of the WHEX pit. This is a lined facility with an oil/water separator (see **Photo 7**) and pipe bollards to prevent vehicles from accidentally colliding with the fuel tanks.

Photo 5. Fuel Island diesel storage tanks over liner with pipe bollards (looking SW).

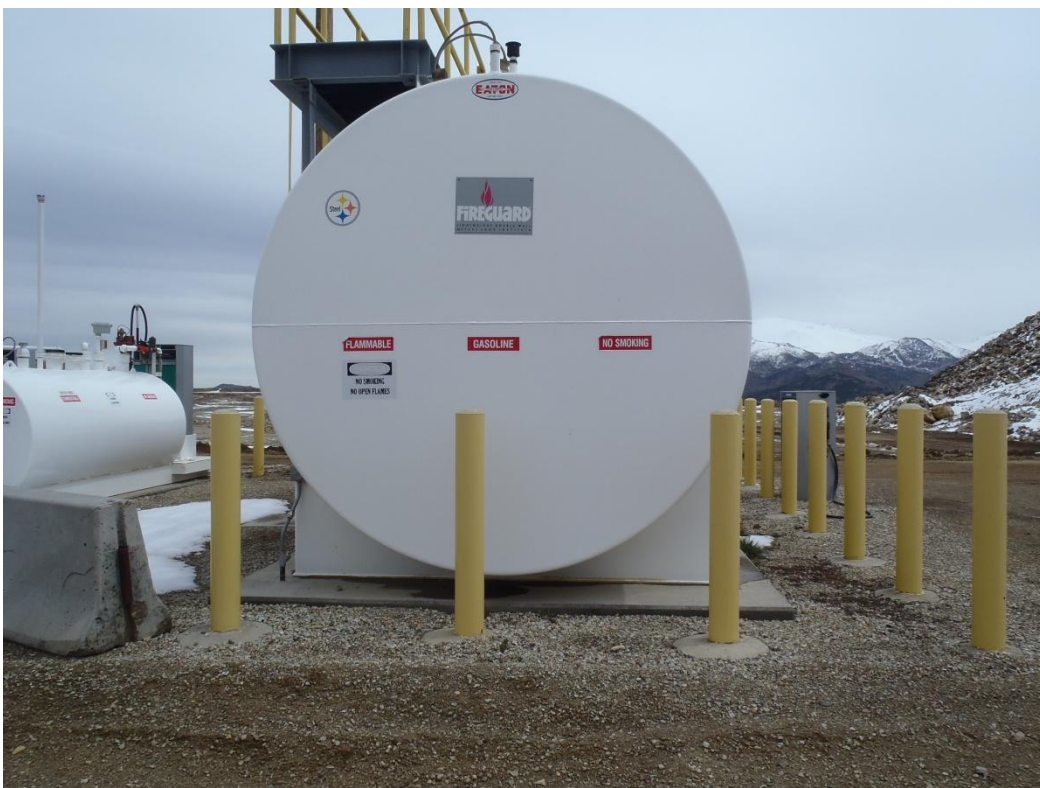
Photo 6. Fuel Island gasoline storage tank over liner with pipe bollards (looking NE).

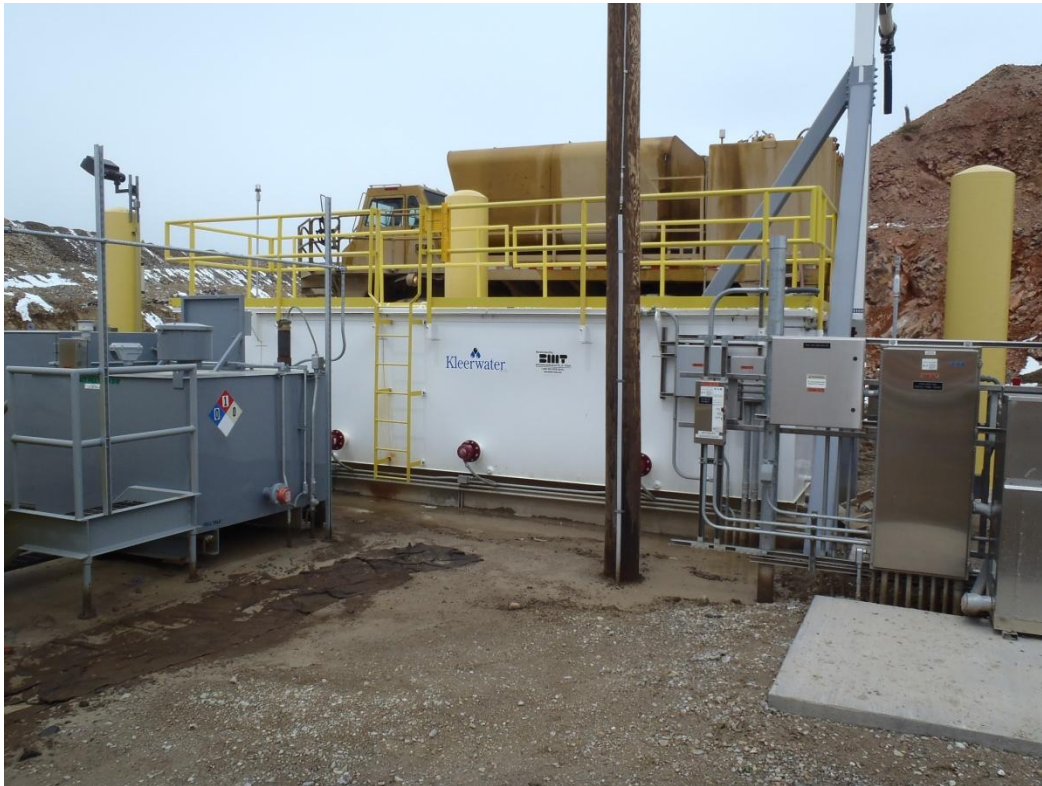
Photo 7. Fuel Island oil/water separator over liner (looking north).

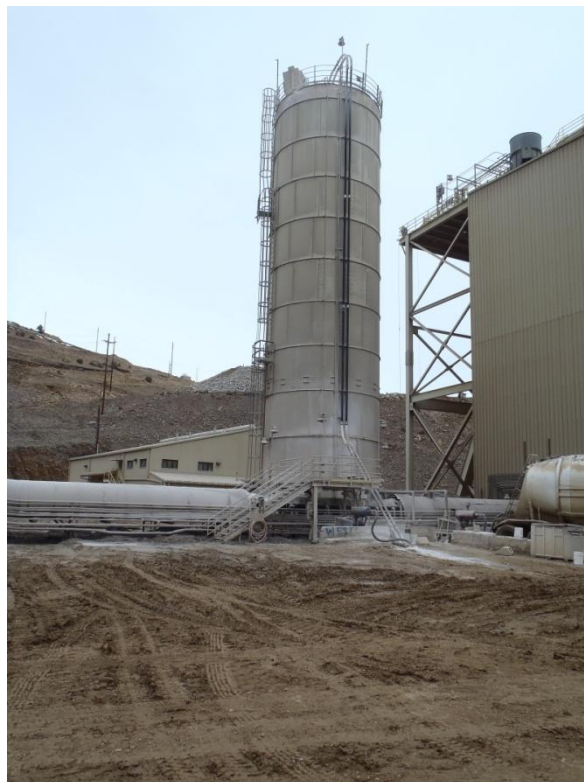
- The Lime Silo (see **Photo 8**) is located in the southern portion of the mine site near the crusher and northeast toe of the Phase IV VLF. Lime is added to the crushed ore destined for the VLF in order to help maintain a higher pH to facilitate cyanide leaching. 55-gallon drums observed in the area appeared in good condition and no leaks were observed (see **Photo 9**). Mr. Hanks pointed out the large electro-magnet (see **Photo 10**) used to remove iron and steel from the crushed ore prior to loading ore into haul trucks at the load out bin (LOB).

Photo 8. Lime Silo is located near the crusher and northeast toe of the Phase IV VLF (looking east).

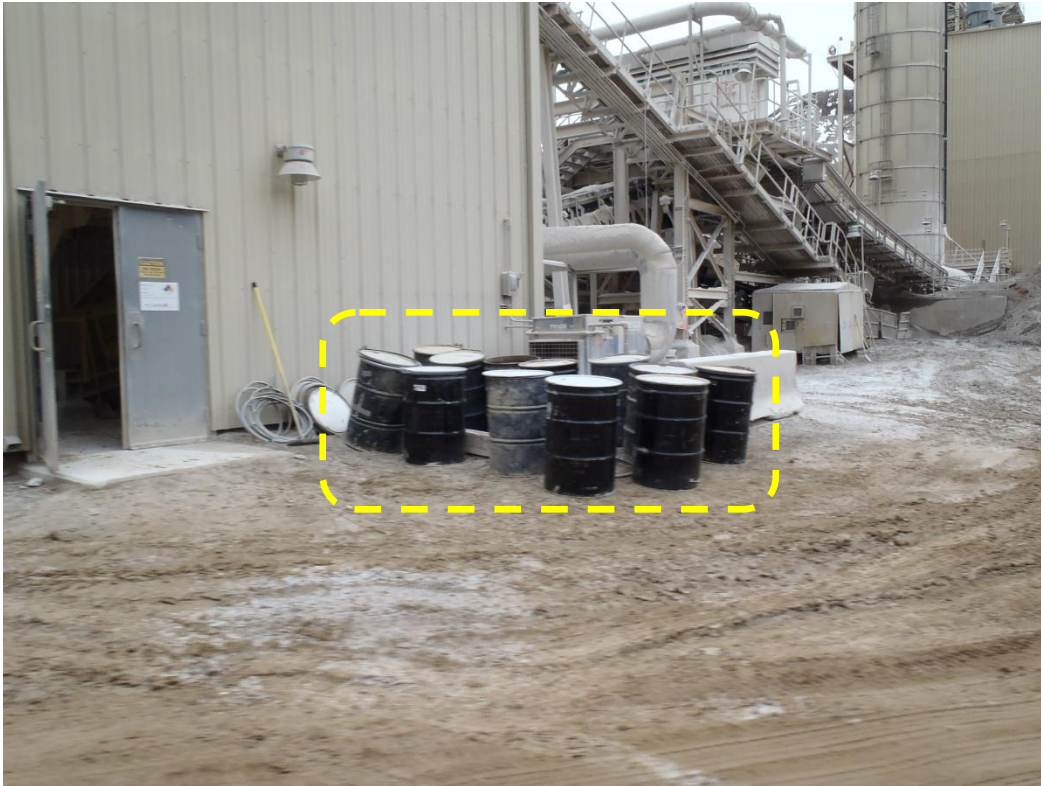
Photo 9. 55-gallon drums near Lime Silo appeared in good condition / no leaks were observed.

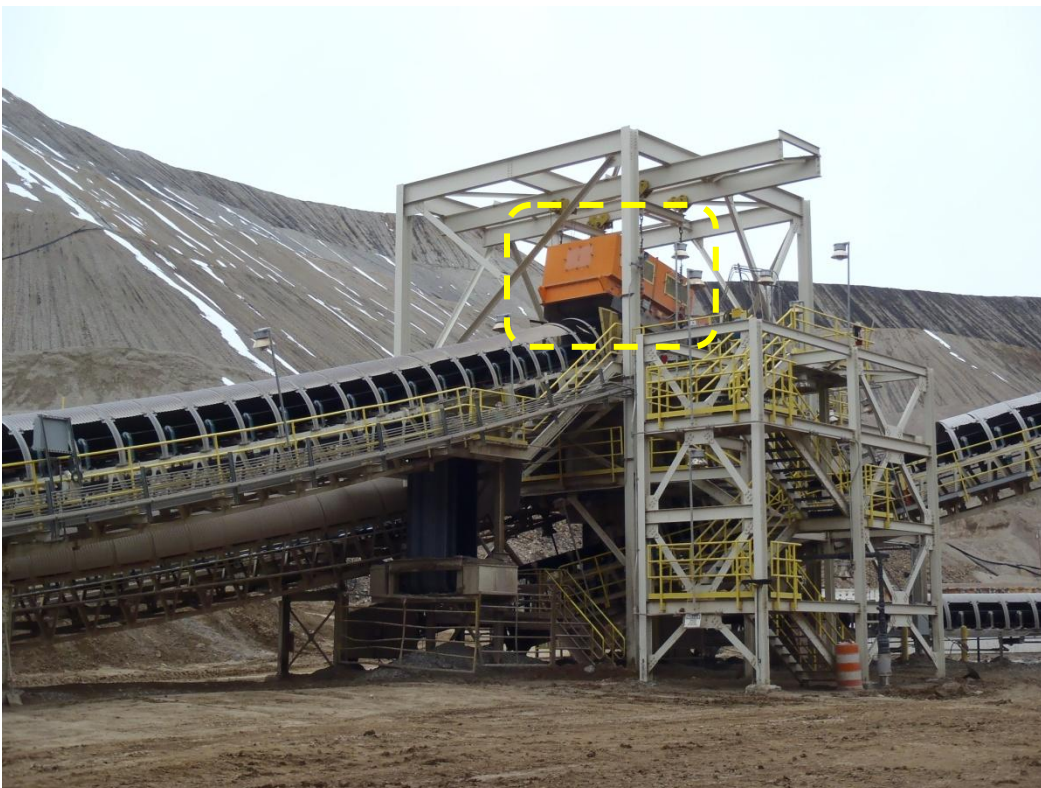
Photo 10. Large electro-magnet used to remove iron and steel from the crushed ore prior to loading the VLF.

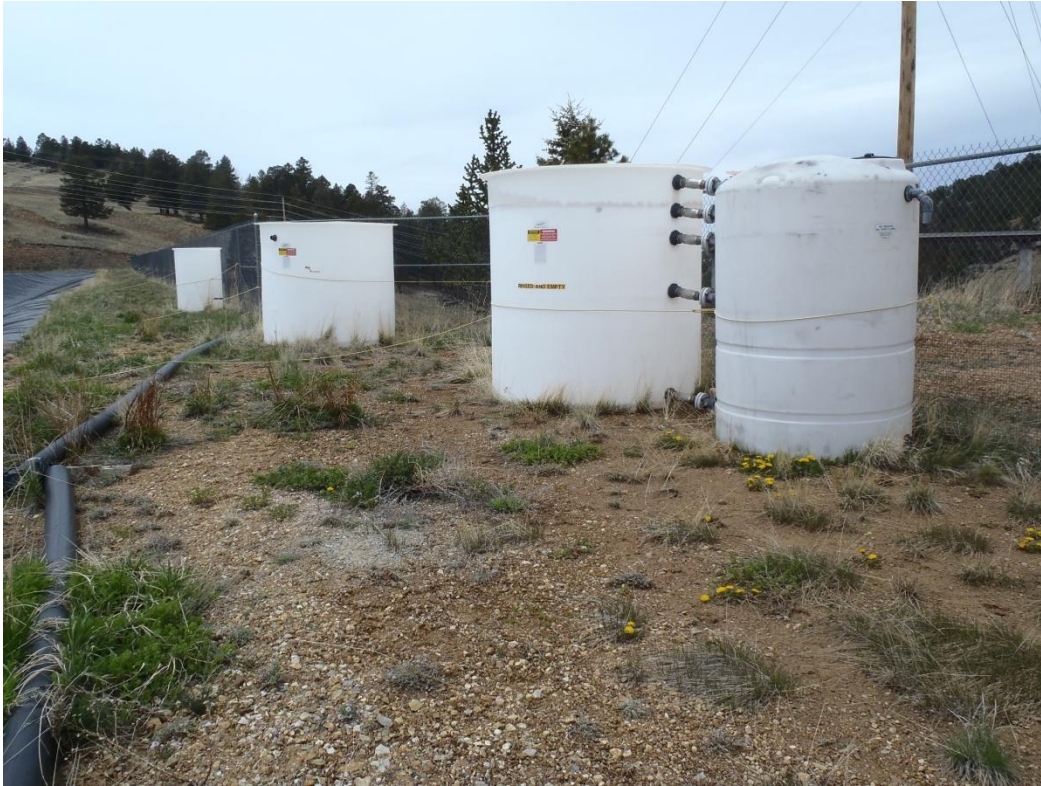
- The External Storage Pond (ESP) is located at the very southern tip of the site between Hwy 67 and the Arequa Gulch processing facilities: Adsorption/Desorption/Recovery (ADR) and Process Solution Enhancement System (PSES). The pipes for transferring solution to be treated and treatment tanks were observed in place (see **Photo 11**).

Photo 11. External Storage Pond treatment tanks observed in place on north side of pond.
