**COLORADO DIVISION OF RECLAMATION, MINING AND SAFETY**  
**MINERALS PROGRAM INSPECTION REPORT**  
**PHONE: (303) 866-3567**

| <b>MINE NAME:</b><br>Cresson Project | <b>MINE/PROSPECTING ID#:</b><br>M-1980-244 | <b>MINERAL:</b><br>Gold | <b>COUNTY:</b><br>Teller |
| <b>INSPECTION TYPE:</b><br>Monitoring | <b>INSPECTOR(S):</b><br>Elliott R. Russell | <b>INSP. DATE:</b><br>June 17, 2015 | <b>INSP. TIME:</b><br>07:30 |

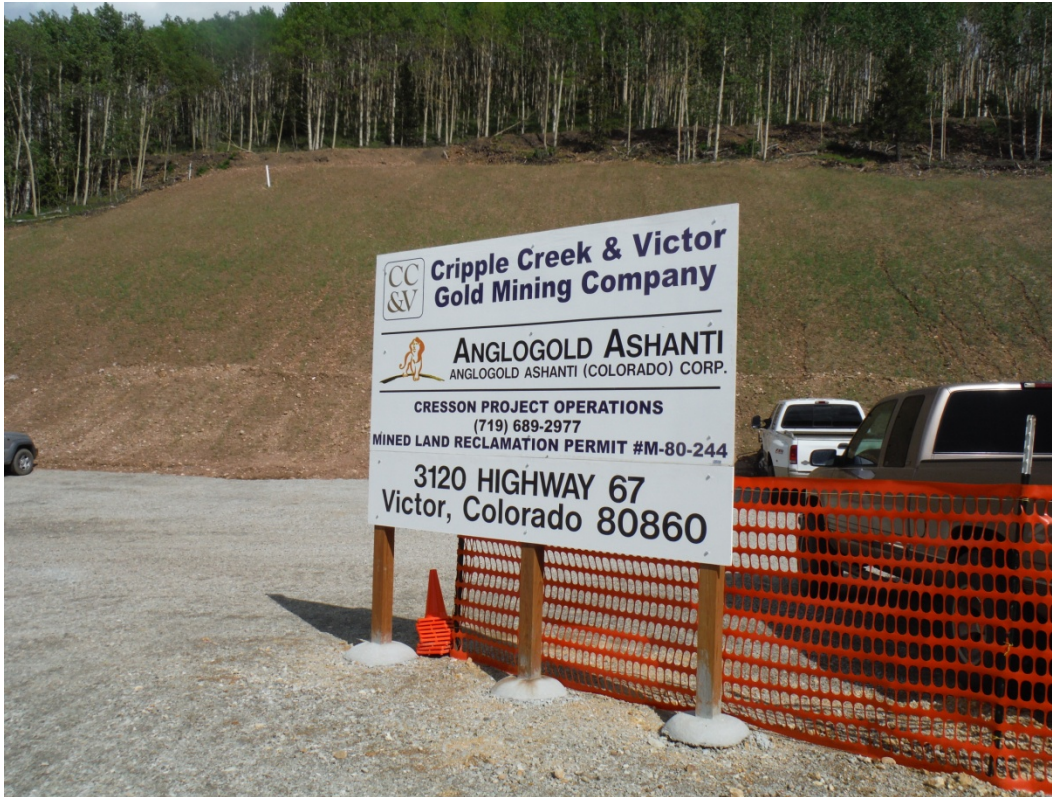
- A new mine site identification sign (see **Photo 1**) was observed at the Highway 67 entrance to the Squaw Gulch Valley Leach Facility (SGVLF) and was in compliance with Rule 3.1.12(1).

**Photo 1.** Site identification sign at the entrance of the SGVLF; looking southeast.

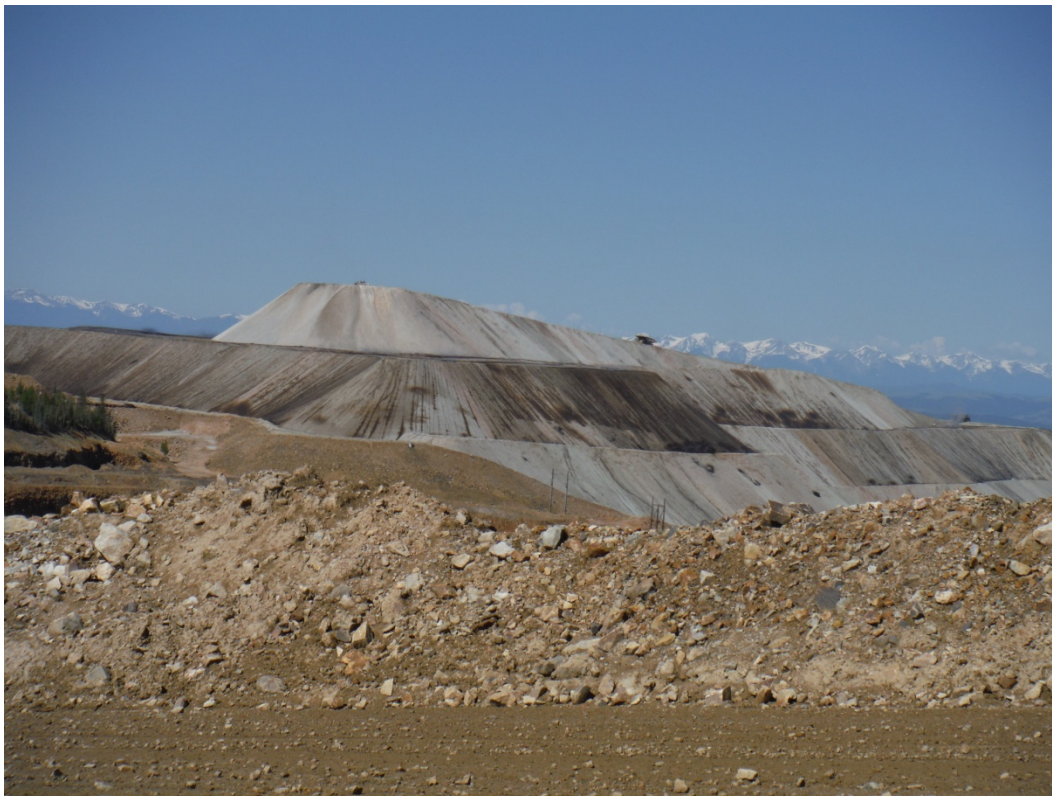
- The Phase V pad area of the Arequa Gulch Valley Leach Facility (AGVLF) was actively being loaded with ore and solution feeder lines were being laid down on various portions of the leaching pad. A new ramp was being constructed on the AGVLF to reach the 10,400' level (see **Photo 2**).

**Photo 2.** AGVLF ramp to the 10,400' level of the leach pad; looking southwest.

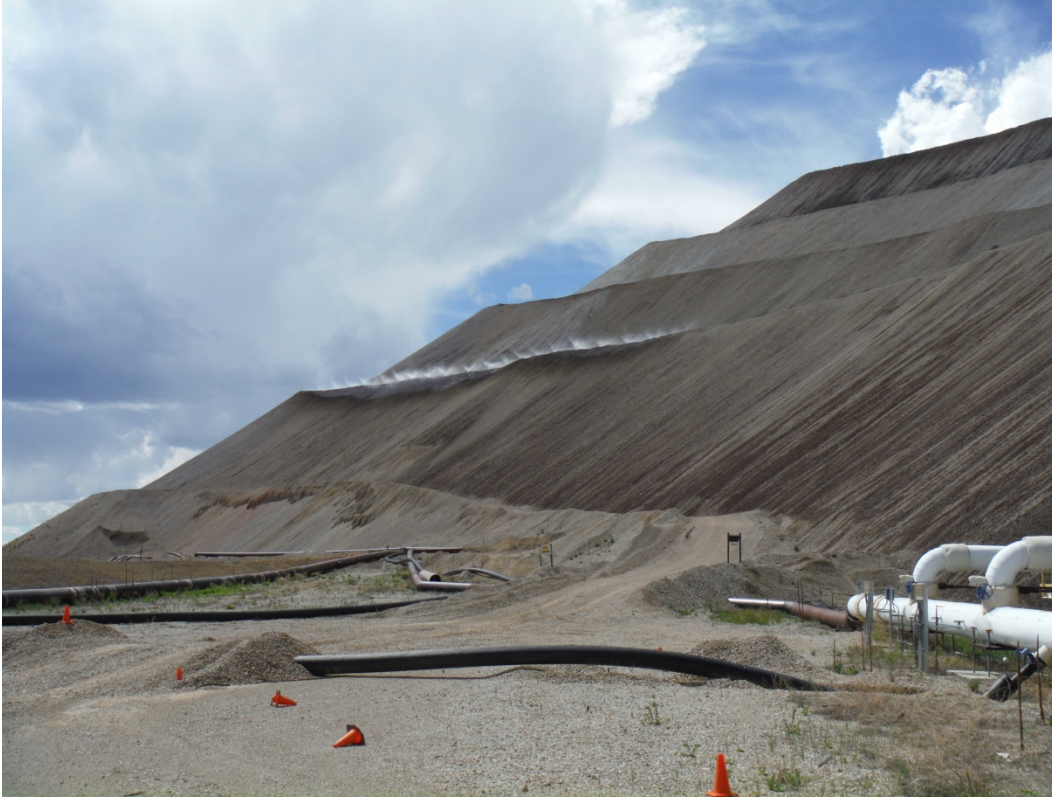
**PROBLEM/POSSIBLE VIOLATION:** Problem: Sprinklers may be causing an off-site odor

- Sprinklers and snow-making machines were being utilized on the AGVLF to help evaporate water and reduce the high volume of solution in the AGVLF (see **Photo 3**).

On June 8, 2015, the Division received a verbal complaint that a citizen of Victor, Colorado smelled cyanide and observed the use of sprinklers on the AGVLF. As mentioned above the sprinklers and snow-making machines are currently being utilized to help evaporate excess water within the AGVLF. Prior to the inspection, while driving along Highway 67 along the south side of the VLF, I smelled an odor which I had not smelled before on any of my other site inspections. This could be related to the use of the sprinklers and has been cited as a problem requiring corrective action; please see the specific requirements of this corrective action on page 2 of this report.

**Photo 3.** Solution sprinklers on the AGVLF southwest face; looking northwest from the Phase V pumps.

**CORRECTIVE ACTIONS:** The Operator shall submit the following requested information related to the sprinkler/snow-making machine evaporation operation: 1) cyanide concentration, 2) concentration of other constituents (including those that may be contributors to the detected odor), 3) estimated daily volume of solution emitted through the sprinklers/snow-making machines, and 4) confirmation that the emitted solution is barren.

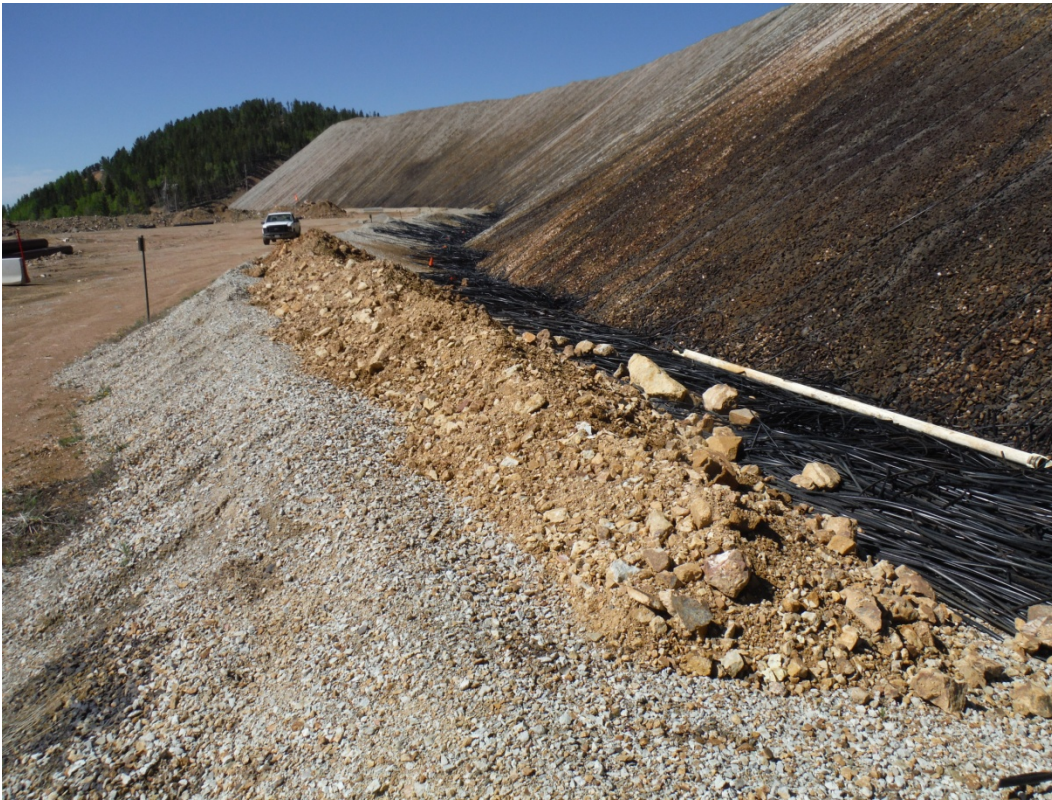
- The small area of impacted soil along the eastern edge of the AGVLF (between the Main Cresson and South Cresson Pits), where an off-liner spill occurred from a broken drip line, had been excavated and placed over the liner (see **Photo 4**). The berm where the spill occurred had been repaired.

**Photo 4.** Impacted soil placed over the liner, within the edge of liner berm, from off-liner spill; looking southwest

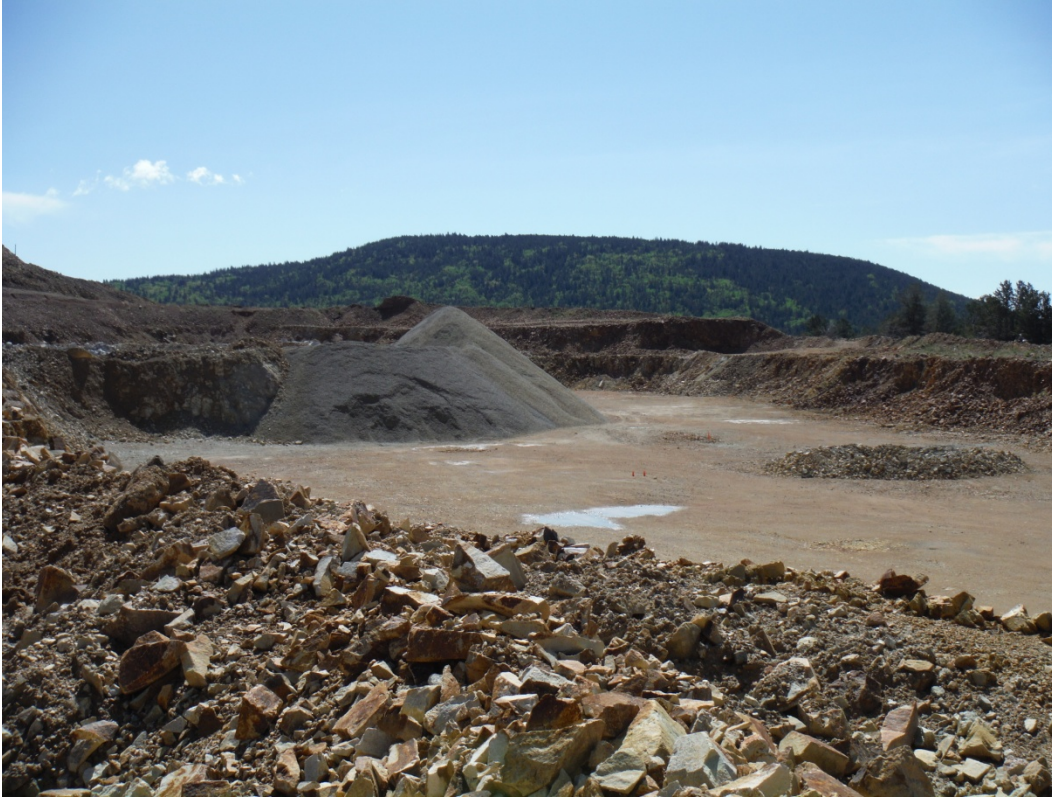
- The new location for crushing stemming material, used for packing blast holes, was observed in the South Cresson development pit (see **Photo 5**). Mr. Hanks anticipated that half the desired amount of material has been crushed, but the Operator was pursuing a new contractor to finish the crushing.

**Photo 5.** Crushed stemming material in the South Cresson Pit; looking east.

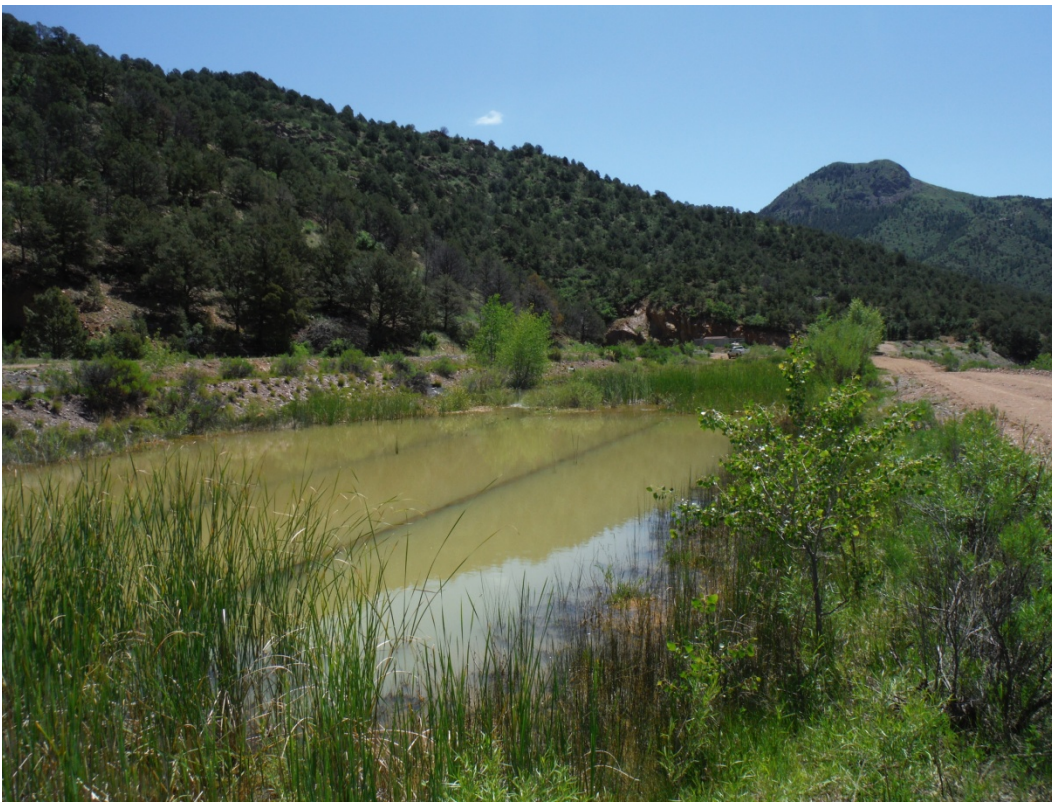
- Lawrence Myers accompanied the Division to the Carlton Tunnel discharge area. The Operator is currently having the 5 ponds at the facility cleaned out. They are also replacing the 2 plastic baffles that span the length of each pond (see **Photo 6**).

**Photo 6.** Pond #2 of the Carlton Tunnel discharge area; looking southeast.

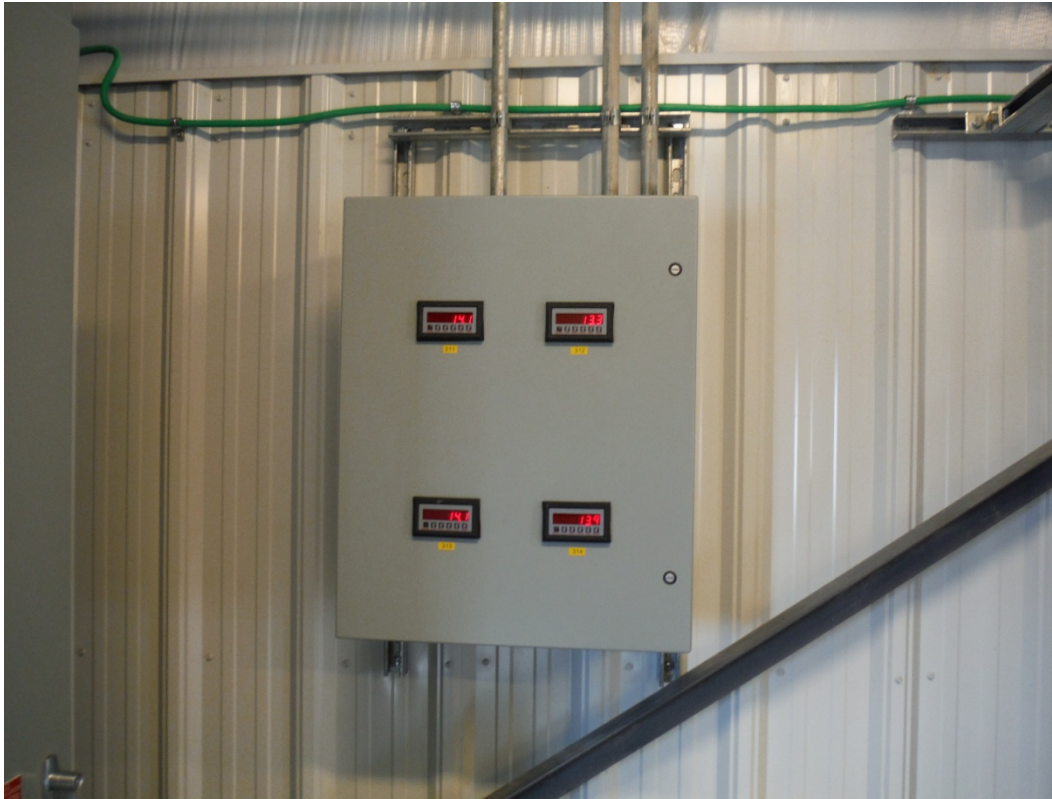
The Phase V gauges had just recently been updated and are no longer located on the pumps but are all centrally located within the Phase V support building (see **Photo 7**), just southeast of the pumps. The Operator is in the process of posting the exceedance limits and guidelines near the readouts.

**Photo 7.** New Phase V PSSA pump gauges; looking northwest.

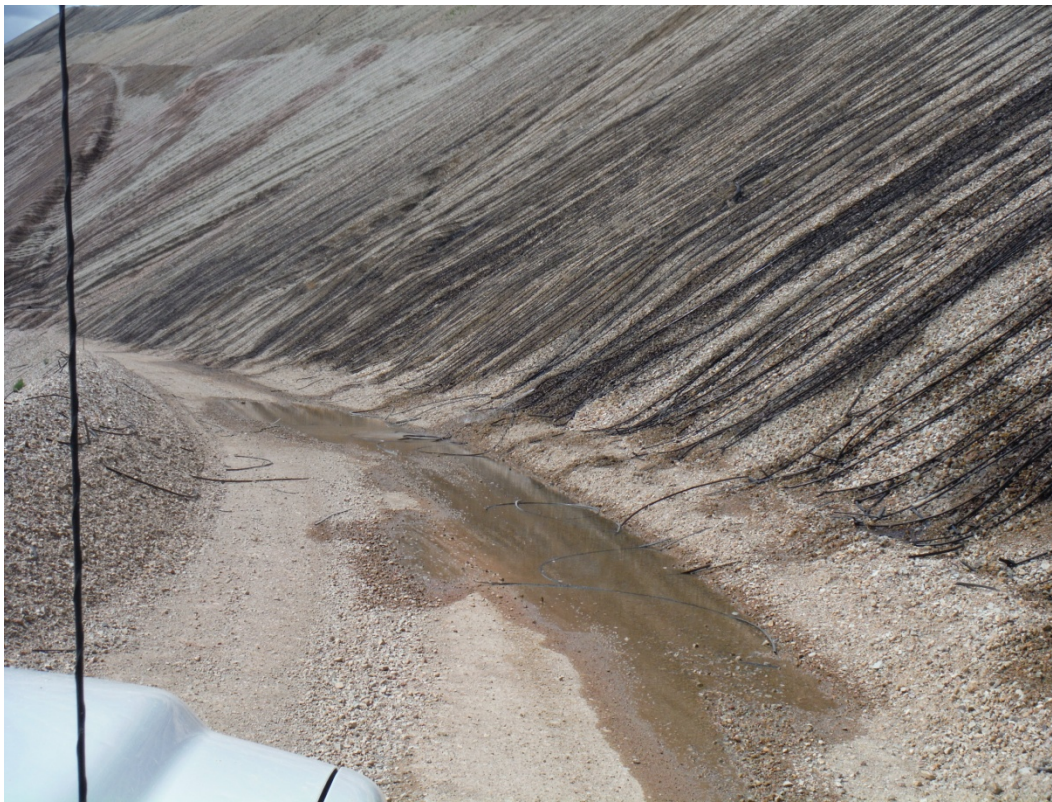
**PROBLEM/POSSIBLE VIOLATION:** Problem: Pondered solution was observed on the Arequa Gulch Valley Leach Facility.

While traveling across the southwestern face of the AGVLF to access the Phase V PSSA pumps, the Division observed a damaged slope drip-line that was causing solution to pond on the inside of the access road (see **Photo 8**). The area where this ponding has occurred is also of concern because pickup truck traffic could potentially track this material off the liner. Mr. Hanks contacted Process Operations to resolve the issue with the drip-line and, if necessary, to rip the ponded solution area to allow the solution to percolate into the pad. However, because no ponded solution of significant amount is allowed, it has been cited as a problem requiring corrective action.

**Photo 8.** Poned solution from faulty drip line along the Phase V PSSA access road; looking northwest.

**CORRECTIVE ACTIONS:** The Operator shall mitigate the cause of the pondered solution and submit photographs as proof that the solution has percolated into the pad.

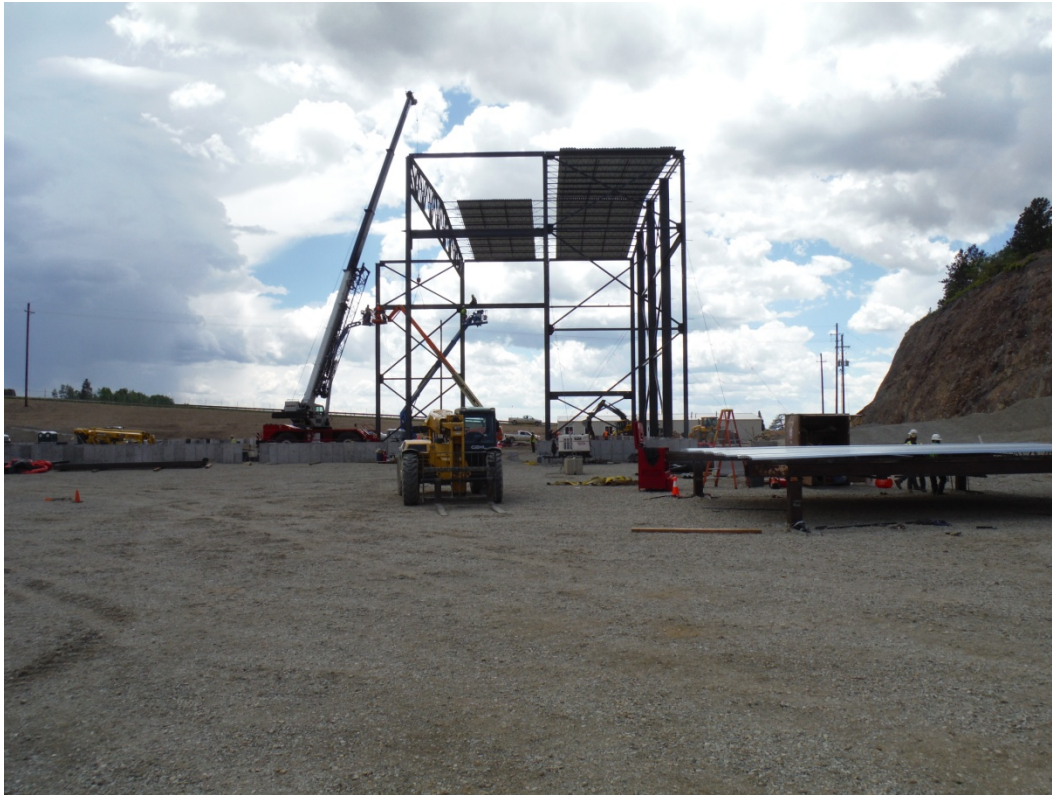
**Photo 9.** Construction on the ADR2, Low Volume Solution Collection System building located in the back right of the photo; looking southwest.

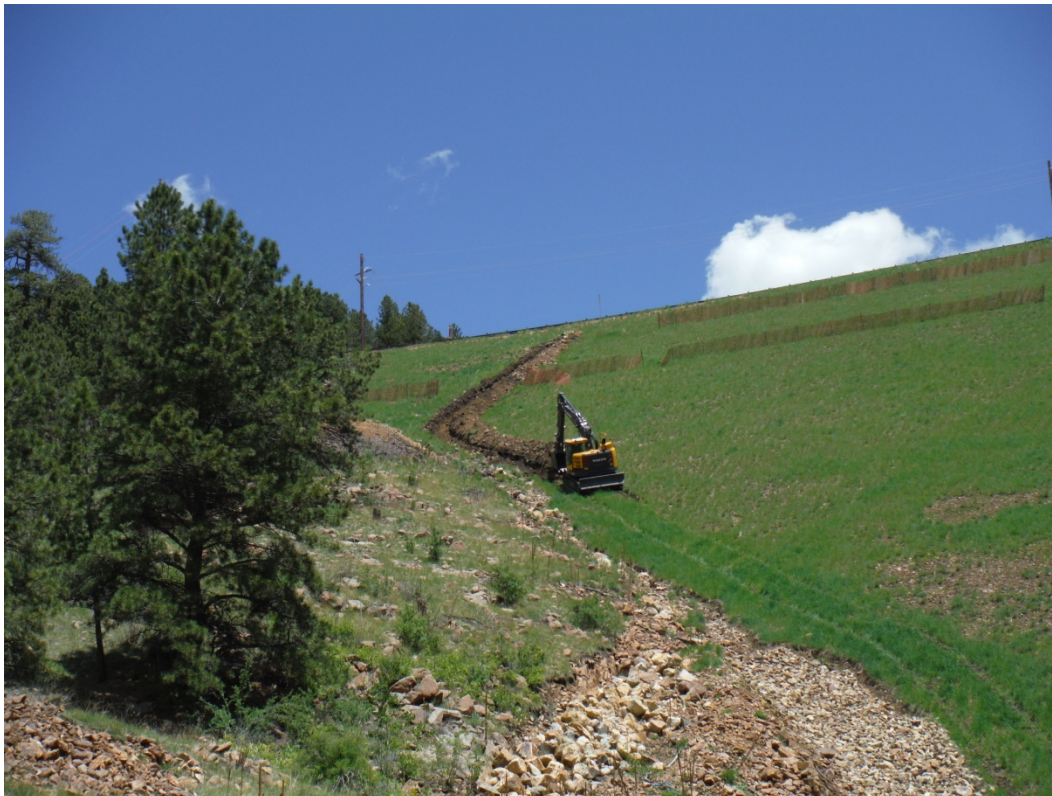
**Photo 10.** Trench being constructed for a temporary SGVLF underdrain pumpback line; northeast.

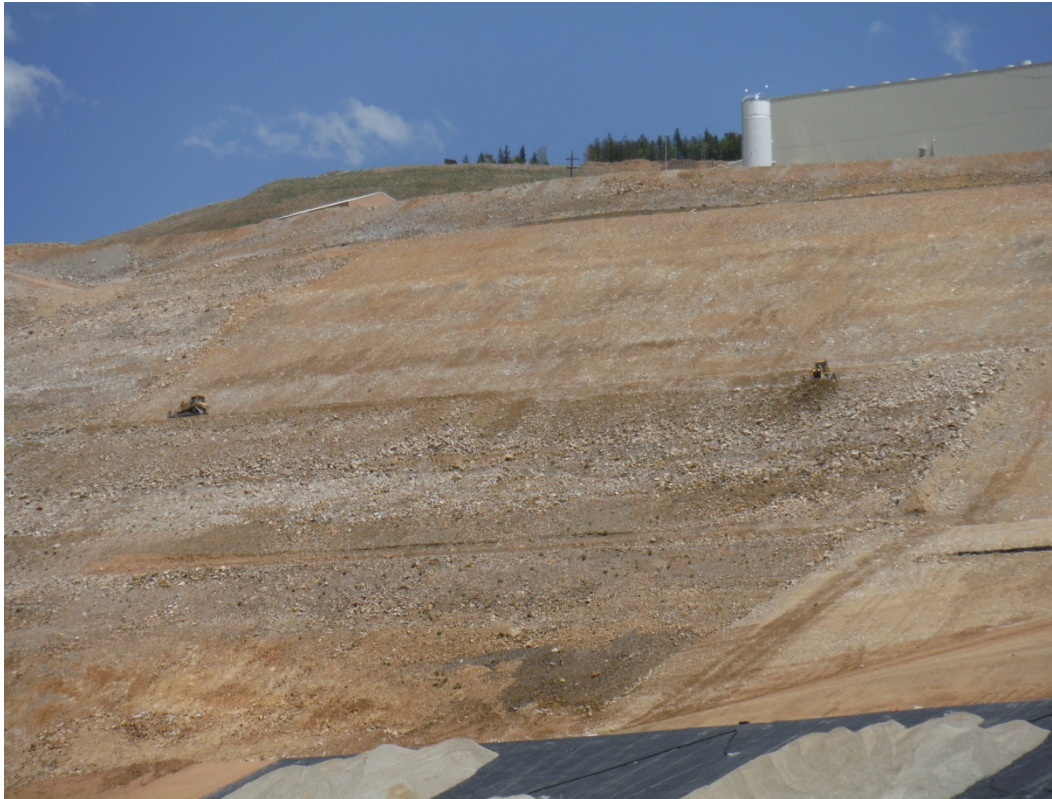
**Photo 11.** Bulldozers grading the ball mill slope; looking east.

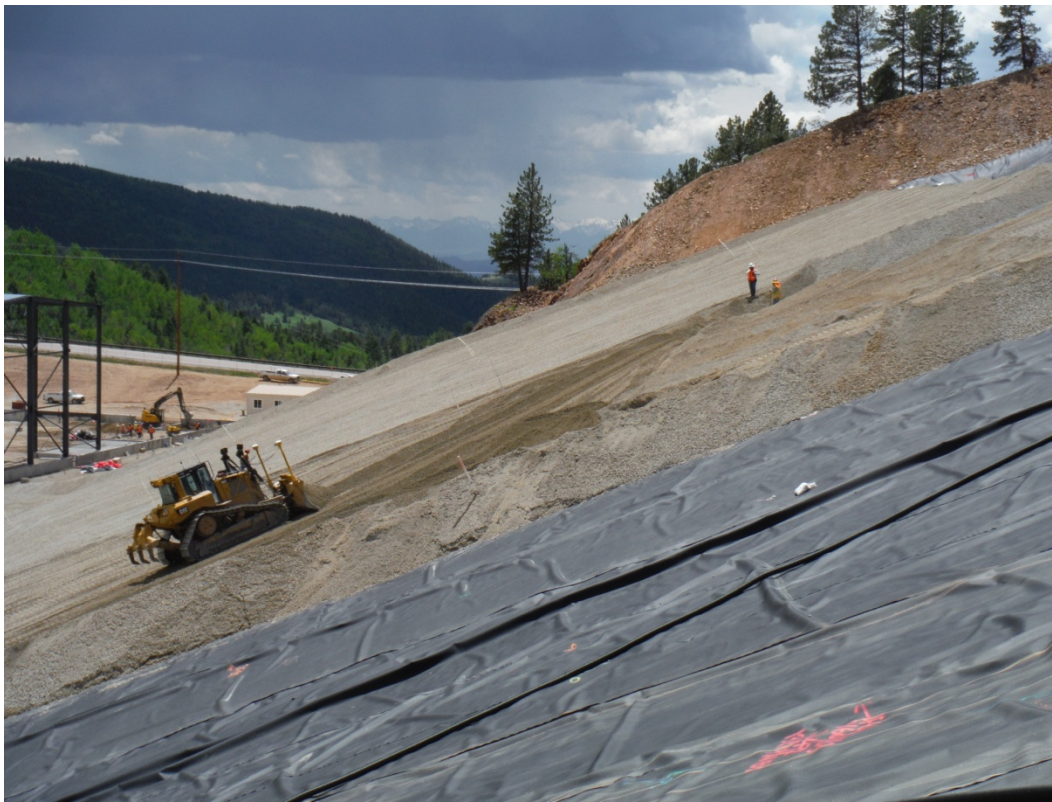
**Photo 12.** DCF placement; looking southwest.

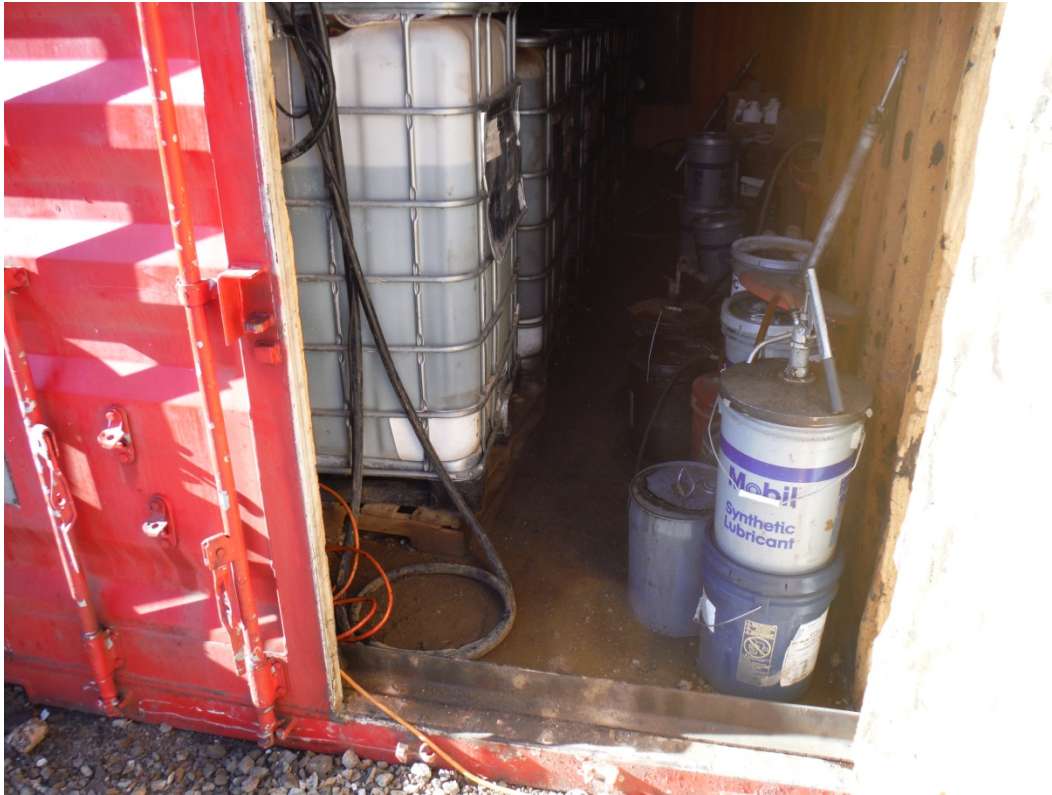
The contractor's (Ames Construction) laydown area and maintenance shop is located between the DCF crushing area and the Squaw Gulch Overburden Storage Area. Jeff Wright, representing the contractor, accompanied Mr. Hanks and the Division on the walk through of their facilities. Doubled walled tanks, spill kits, secondary containments structures and pallets, and designated areas were observed. The Division observed a conex storage container unit which contained 5-300 gallon IBC tanks and at least a dozen 5 gallon cans which contained oil and other miscellaneous products (see **Photo 13**). The Division requests the Operator or the contractor verify that the secondary containment capacity of the storage container is at least 110% of the largest container within the storage unit; the volume of cans, pallets, miscellaneous equipment which occupies the containment area should be subtracted from its total capacity. Mr. Wright informed the Division on how they use absorbent pads prior to pumping stormwater out of the large concrete secondary containment structure that encases the used motor oil tanks. The Division requests the Operator to verify that the contractor is utilizing the Appendix F form, provided in the 2010 CC&V Spill Response Plan (SRP), when water is being pumped to the ground outside of the containment, as specified in the SRP (this form has been attached for the Operator's reference). No other issues or concerns were raised regarding the walk through of these facilities.

**Photo 13.** Conex storage container unit, welded lip at door is the secondary containment; looking south.

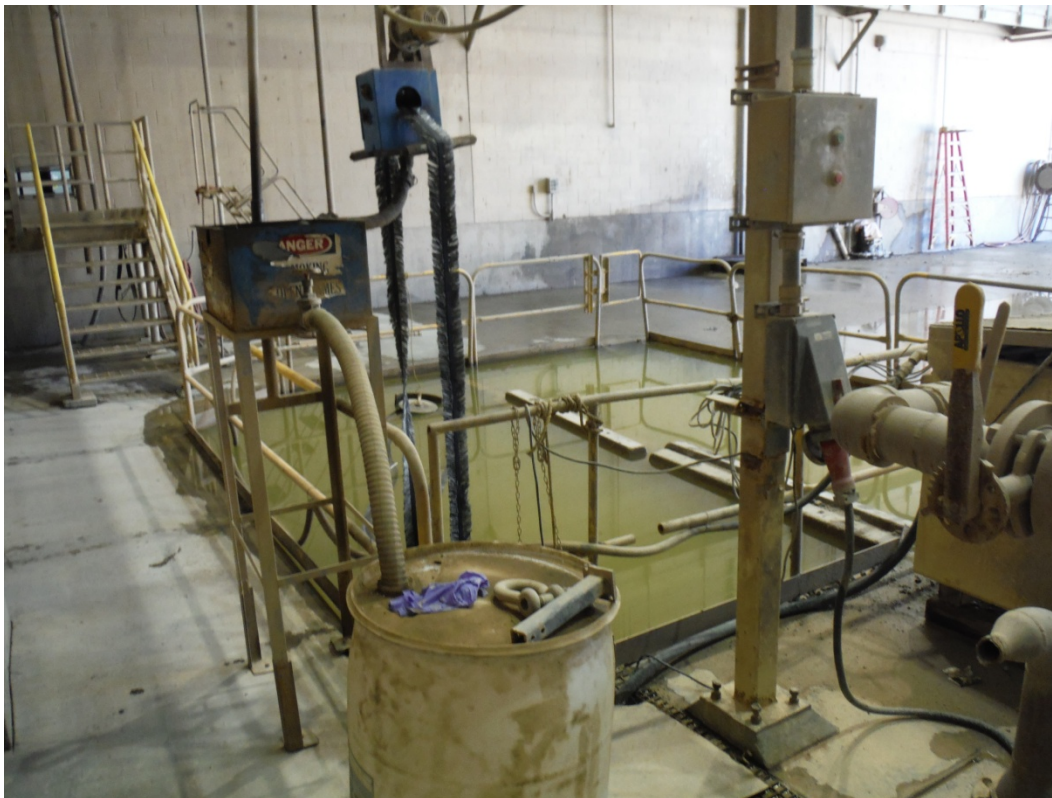
**Photo 14.** Hydrocarbon skimmer observed at the large vehicle washbay sump in the Ironclad Facility; looking southwest.

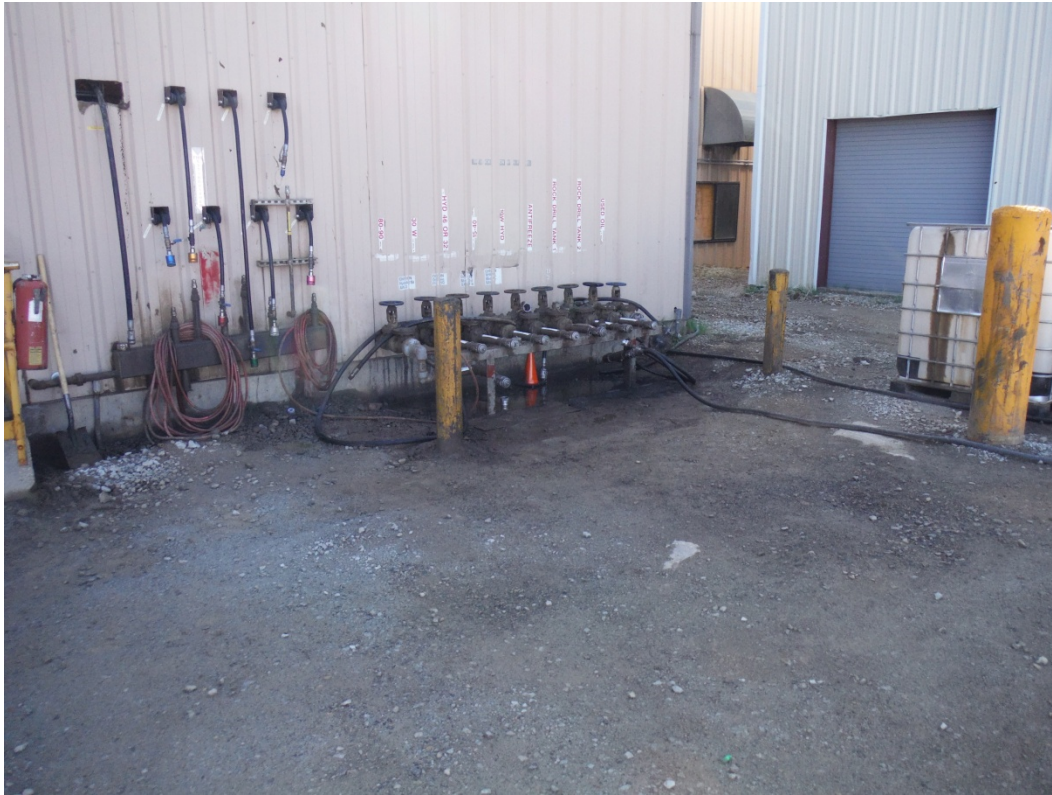
**PROBLEM/POSSIBLE VIOLATION:** Problem: A petroleum product spill(s) has/have occurred at the site which has impacted soils, surface water or groundwater.

The Ironclad Facilities (large vehicle shop, light vehicle shop, and warehouse) located in the northern portion of the mine site, just south of the WHEX pit, were inspected. Secondary containment structures, sumps, a washbay hydrocarbon skimmer (see **Photo 14**), aerosol can disposal stations, spill kit stations, a hazardous waste accumulation room, and a clay-lined sediment drying pond were observed. The Division observed a large amount of contaminated soils near the west side of the warehouse, just outside of the Oil Room near the vicinity of the 9 connection fill manifold which the mobile lube trucks utilize (see **Photo 15**). The SRP states that a small concrete pad provides minimal secondary containment at this off loading area. The Division believes this small pad is not adequate due to the amount of contaminated soils observed; this will be cited as a problem requiring corrective action. No other issues or concerns were raised regarding the walk through of these facilities.

**Photo 15.** Area of the contaminated soils outside of the Oil Room at the Ironclad Warehouse; looking southeast.

**CORRECTIVE ACTIONS:** The Operator shall immediately remediate the spill and submit a final report to the Division containing at least a description of how the spill was cleaned up (containing at a minimum - the appropriate maps, volumes removed, photo documentation, and disposal) and provide a plan on how the Operator will prevent this issue from occurring again. The plan may include a design modification in the secondary containment structure at the site of the spill.
